GILA RIVER, GILLESPIE DAM TO YUMA, AZ

RECONNAISSANCE REPORT

**US ARMY CORPS
OF ENGINEERS**
Los Angeles District
South Pacific Division

JANUARY 1995

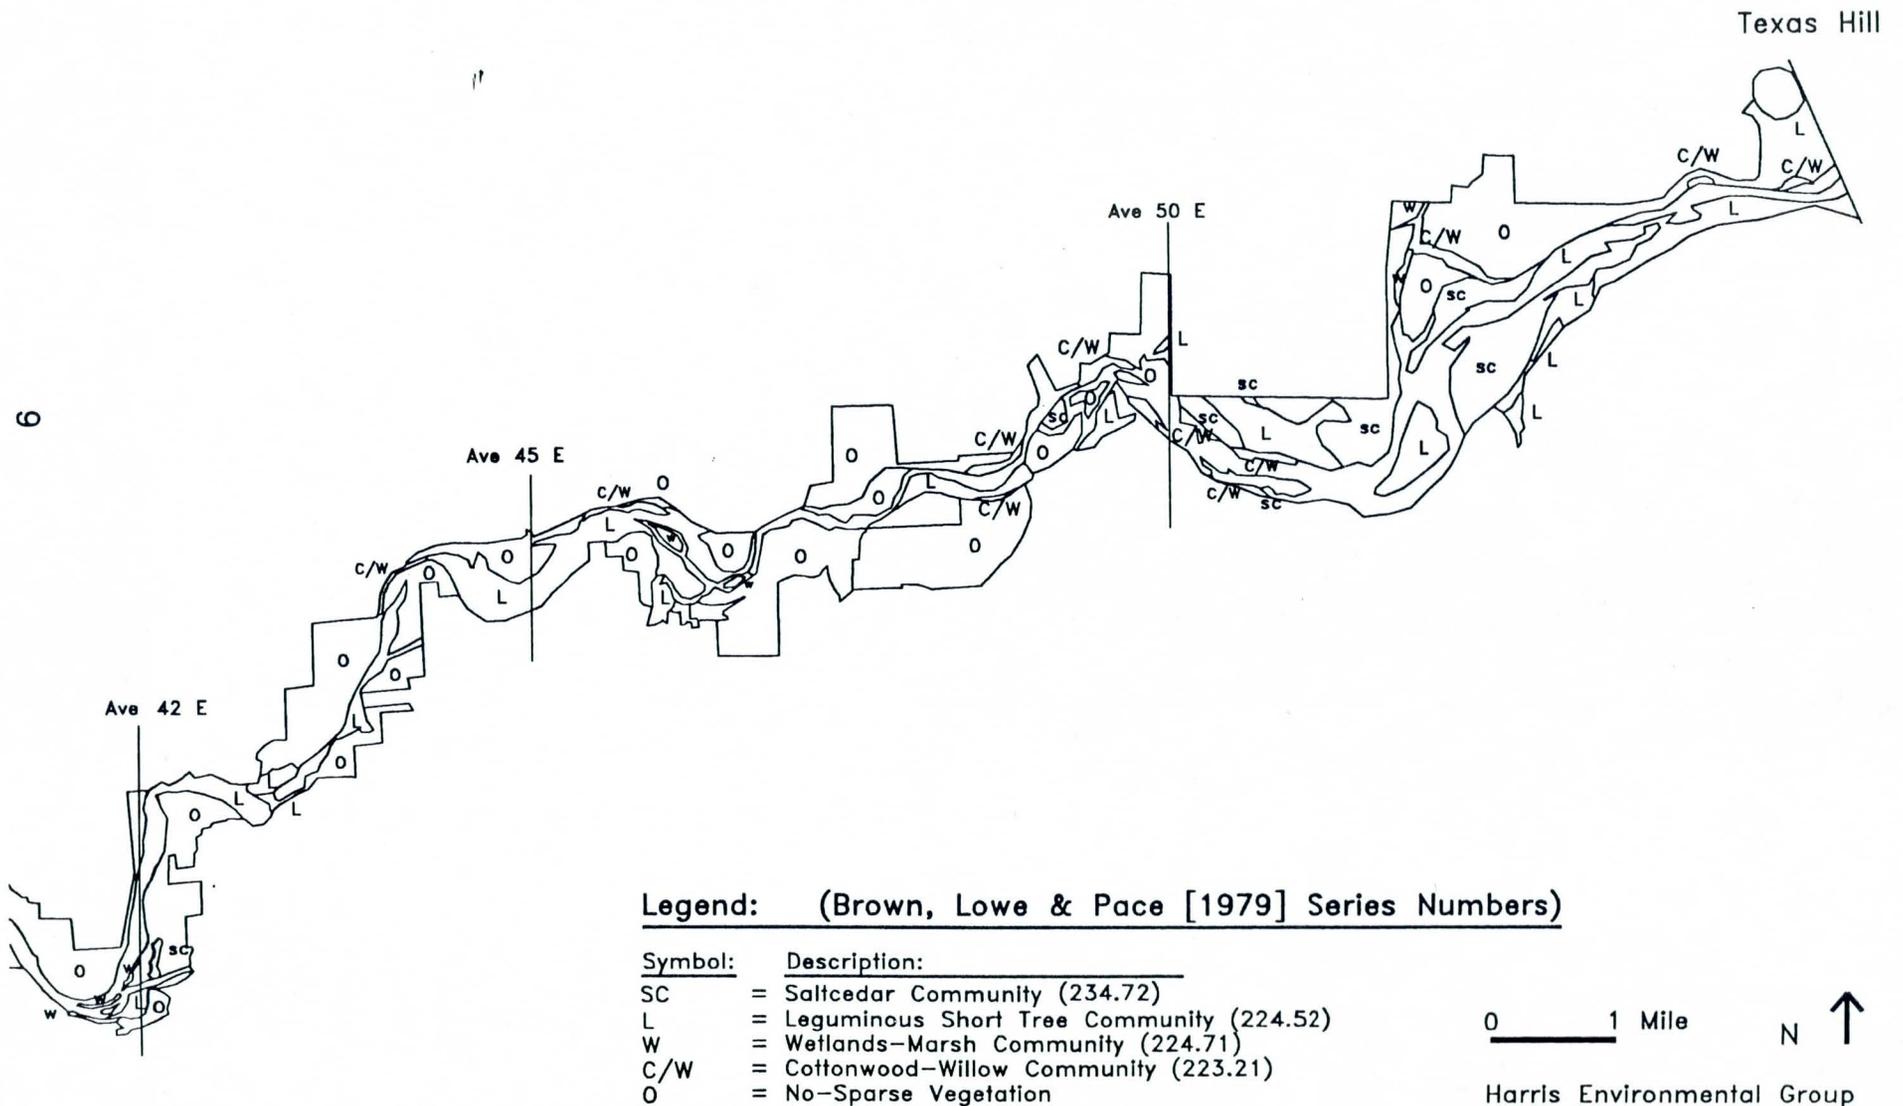
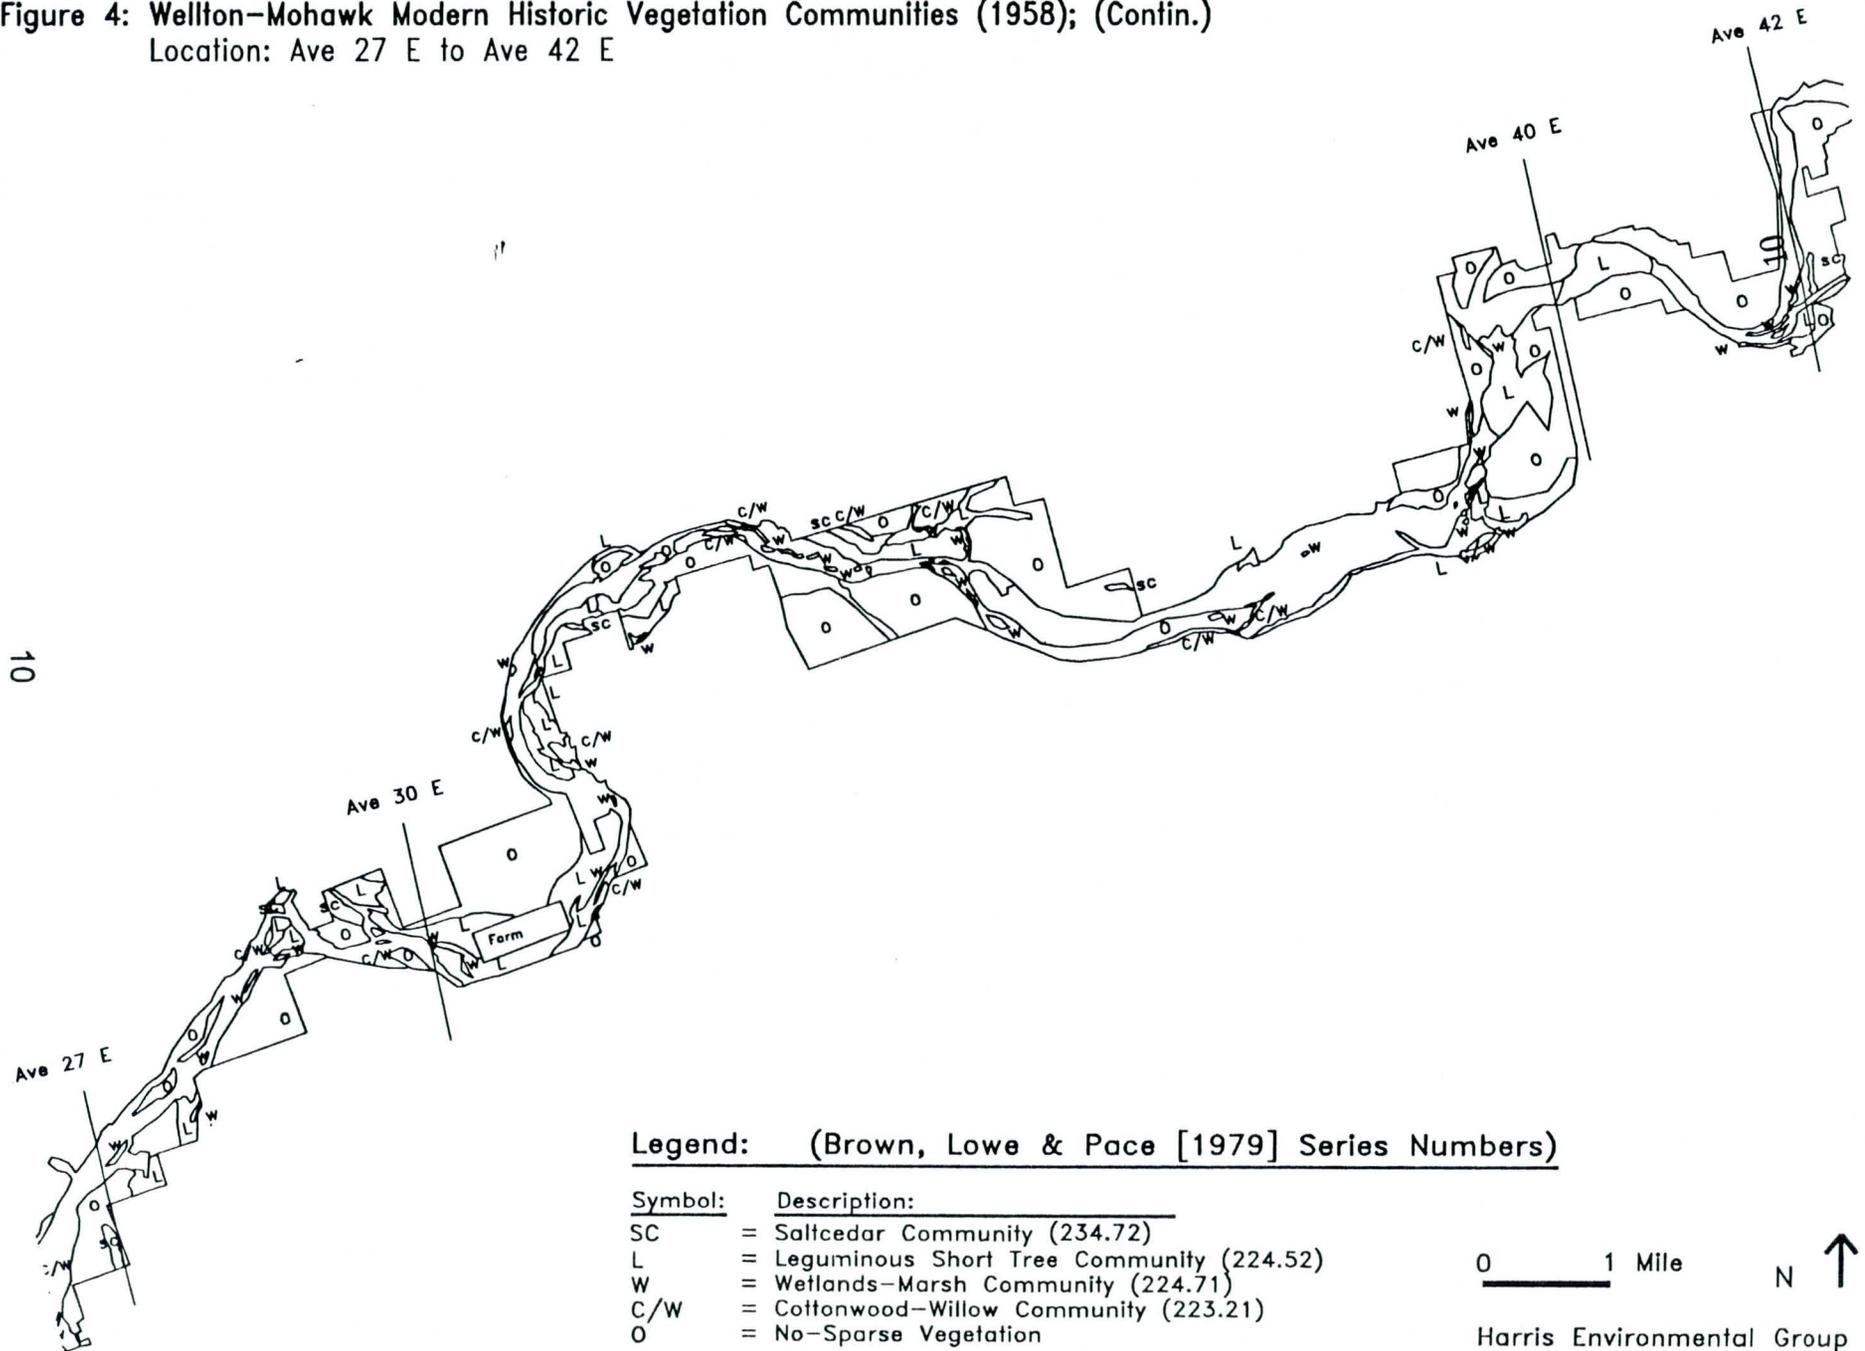
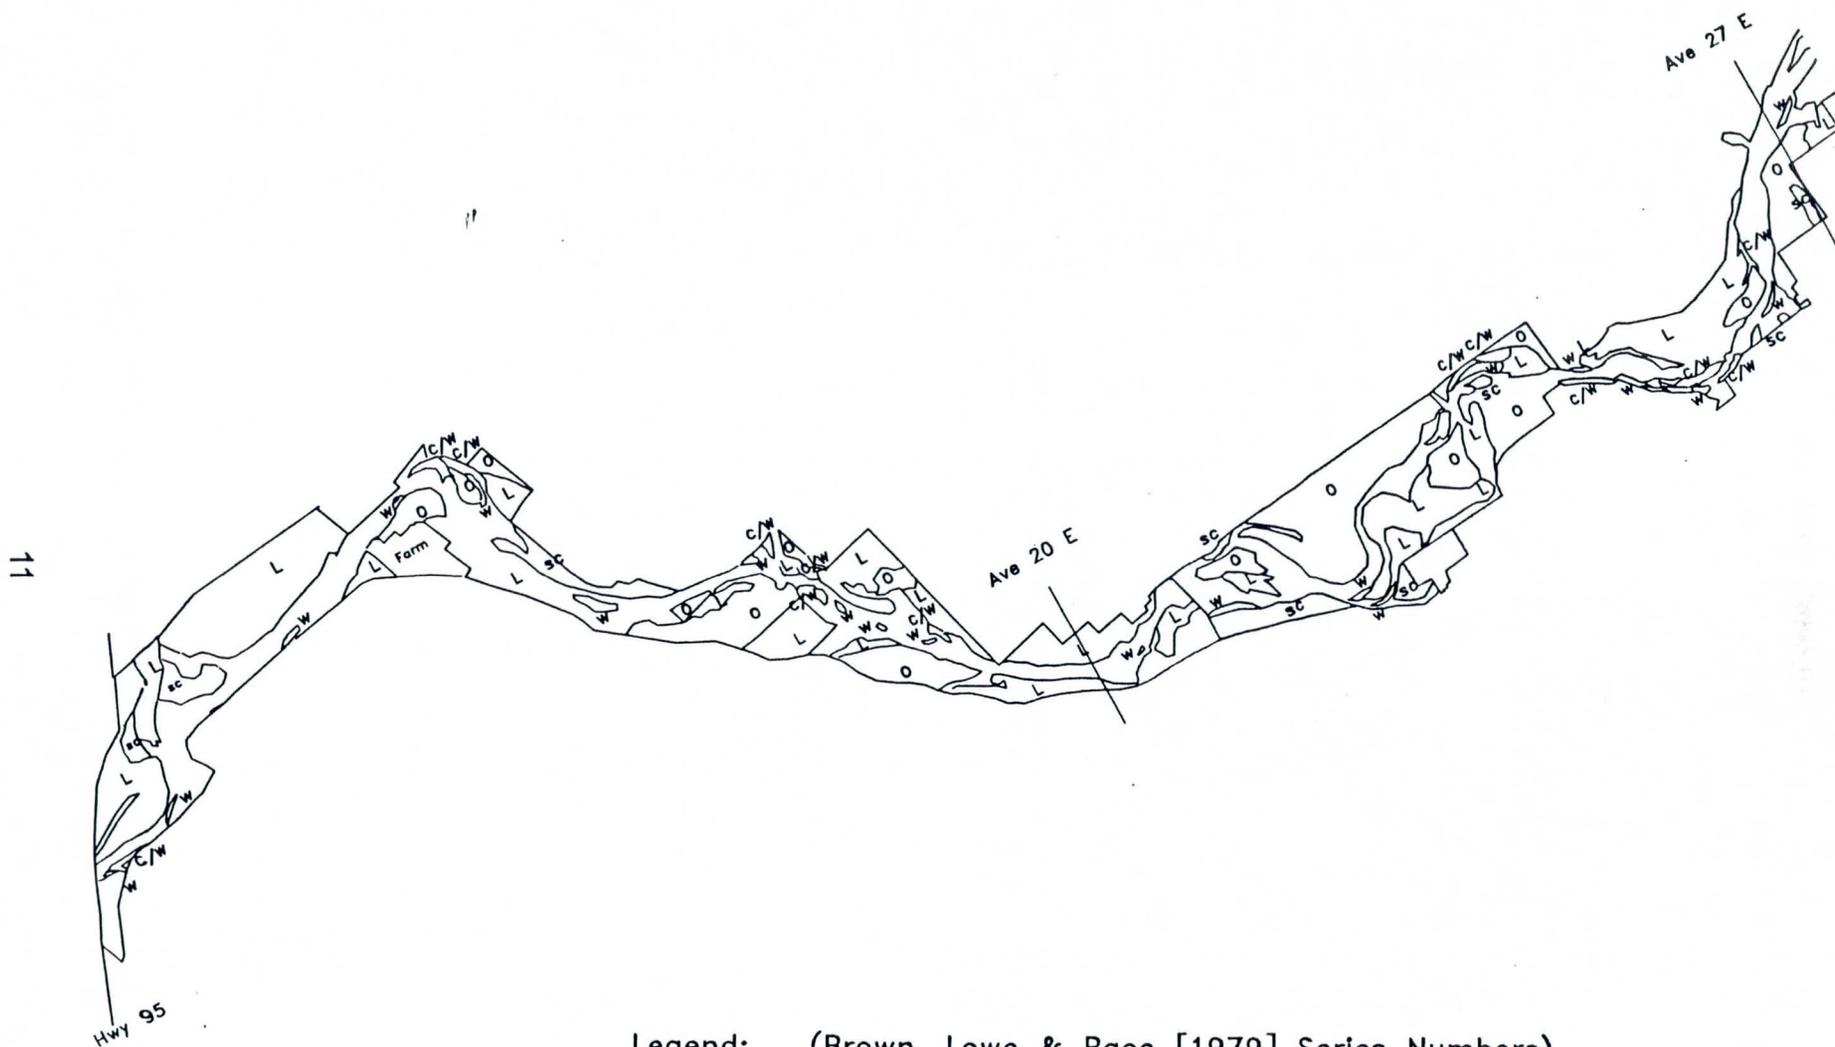
Figure 4: Wellton-Mowhawk Modern Historic Vegetation Communities (1958)
 Location: Ave 42 E to Texas Hill

Figure 4: Wellton-Mohawk Modern Historic Vegetation Communities (1958); (Contin.)

Figure 4: Wellton-Mohawk Modern Historic Vegetation Communities (1958); (Contin.)
 Location: Hwy 95 to Ave 27 E

In the upper portion of the Lower Gila River (BLM property, Aqua Caliente, and Dendora Valley), the predominant vegetation community contained leguminous short tree species, such as mesquite. The Wellton-Mohawk area was also dominated by leguminous short tree species (Figure 4). However, the mesquite trees were more dense in this area and formed mesquite bosques. In addition, there was more vegetation growing in the channel in the Wellton-Mohawk Valley than in the upper portion of the river, suggesting the presence of more marsh/wetland communities in the lower section of the river.

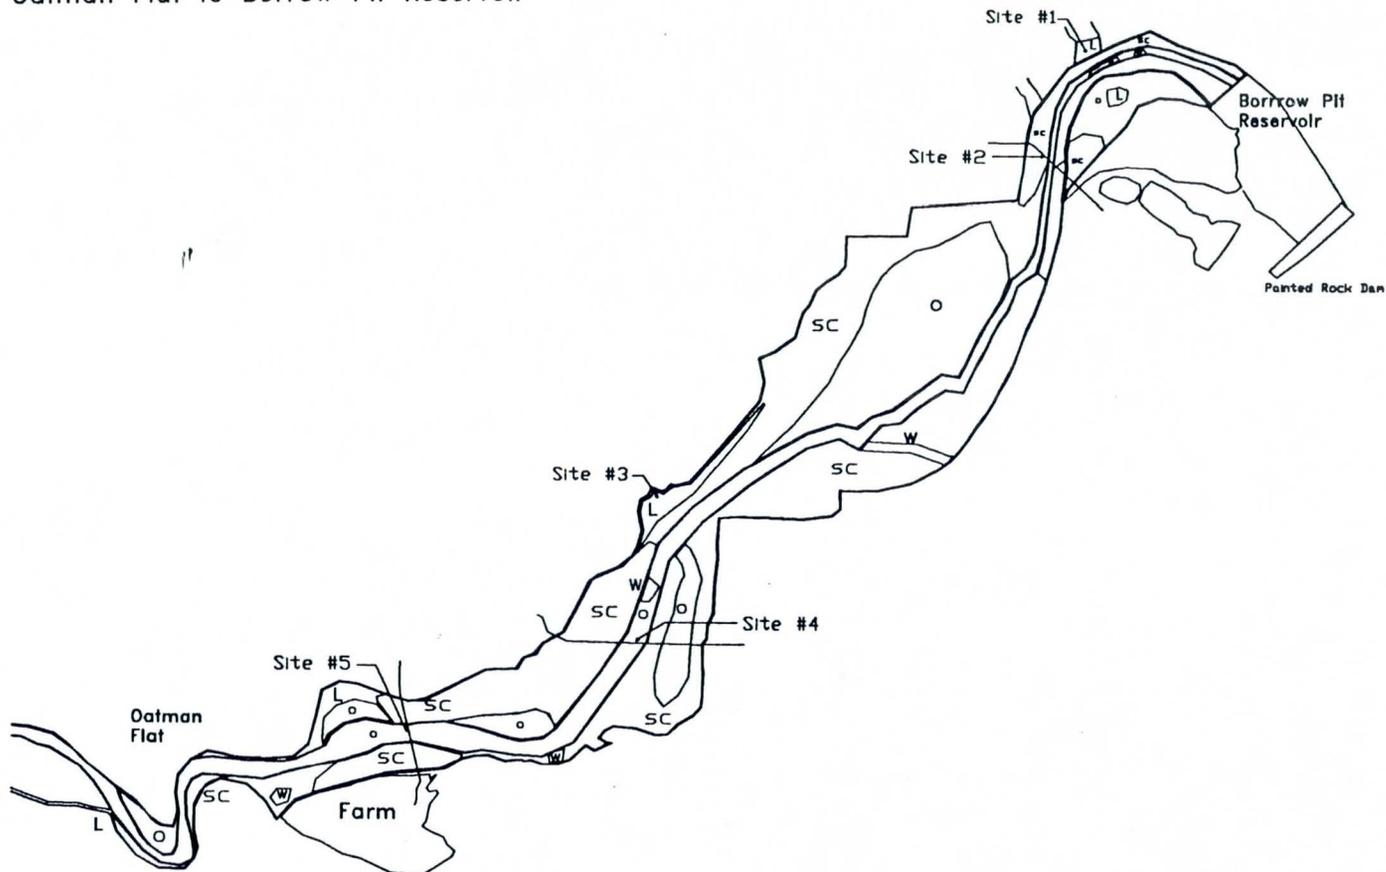
Figure 5: Dendora Valley Area Current Vegetation Communities
 Location: Oatman Flat to Borrow Pit Reservoir

The current vegetation communities within the three upper designated areas (Dendora Valley, Agua Caliente, and the BLM property) of the river, were primarily saltcedar, with remnant stands of mesquite (Figures 5 - 8). There were a few young cottonwood/willow communities within the BLM property. Cottonwood/willow, wetland/marsh, leguminous short trees, and saltcedar communities were found within the Wellton-Mohawk Valley area (Figure 8). Saltcedar plants were found in all of the sites.

There was no running water in the river channel in Dendora Valley (Figure 5), Agua Caliente (Figure 6), and the BLM property (Figure 7). However, because of agricultural practices in the Wellton-Mohawk Valley area, running water was found in the entire portion of that section of the river. The majority of the cottonwood/willow communities were young and originated from the 1993 flood. Only two sites (14, 16) had a few mature willow and/or cottonwood trees.

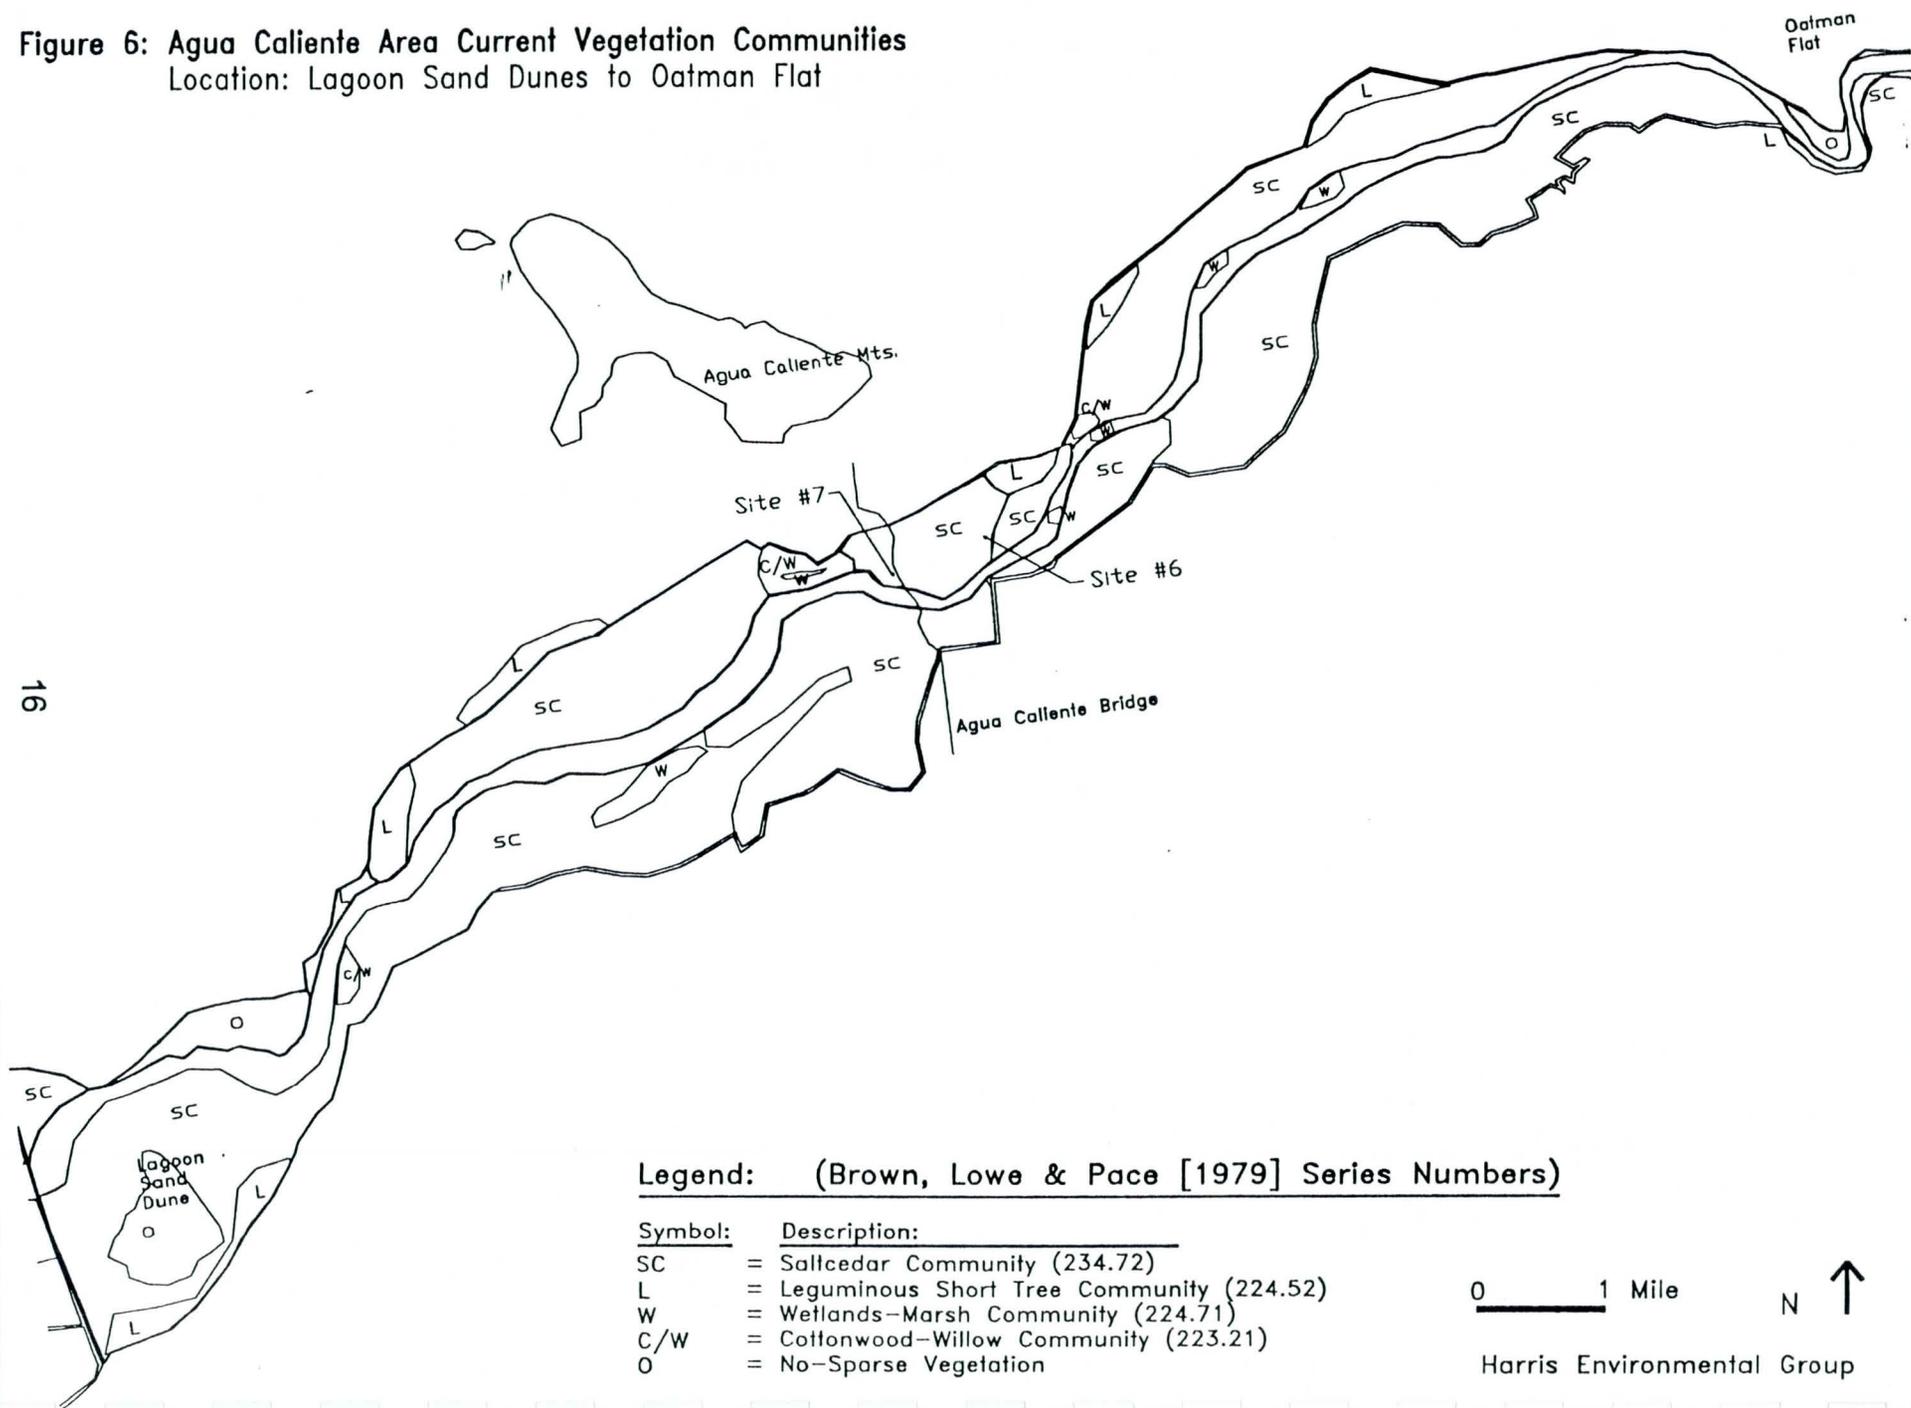
Figure 6: Agua Caliente Area Current Vegetation Communities
 Location: Lagoon Sand Dunes to Oatman Flat

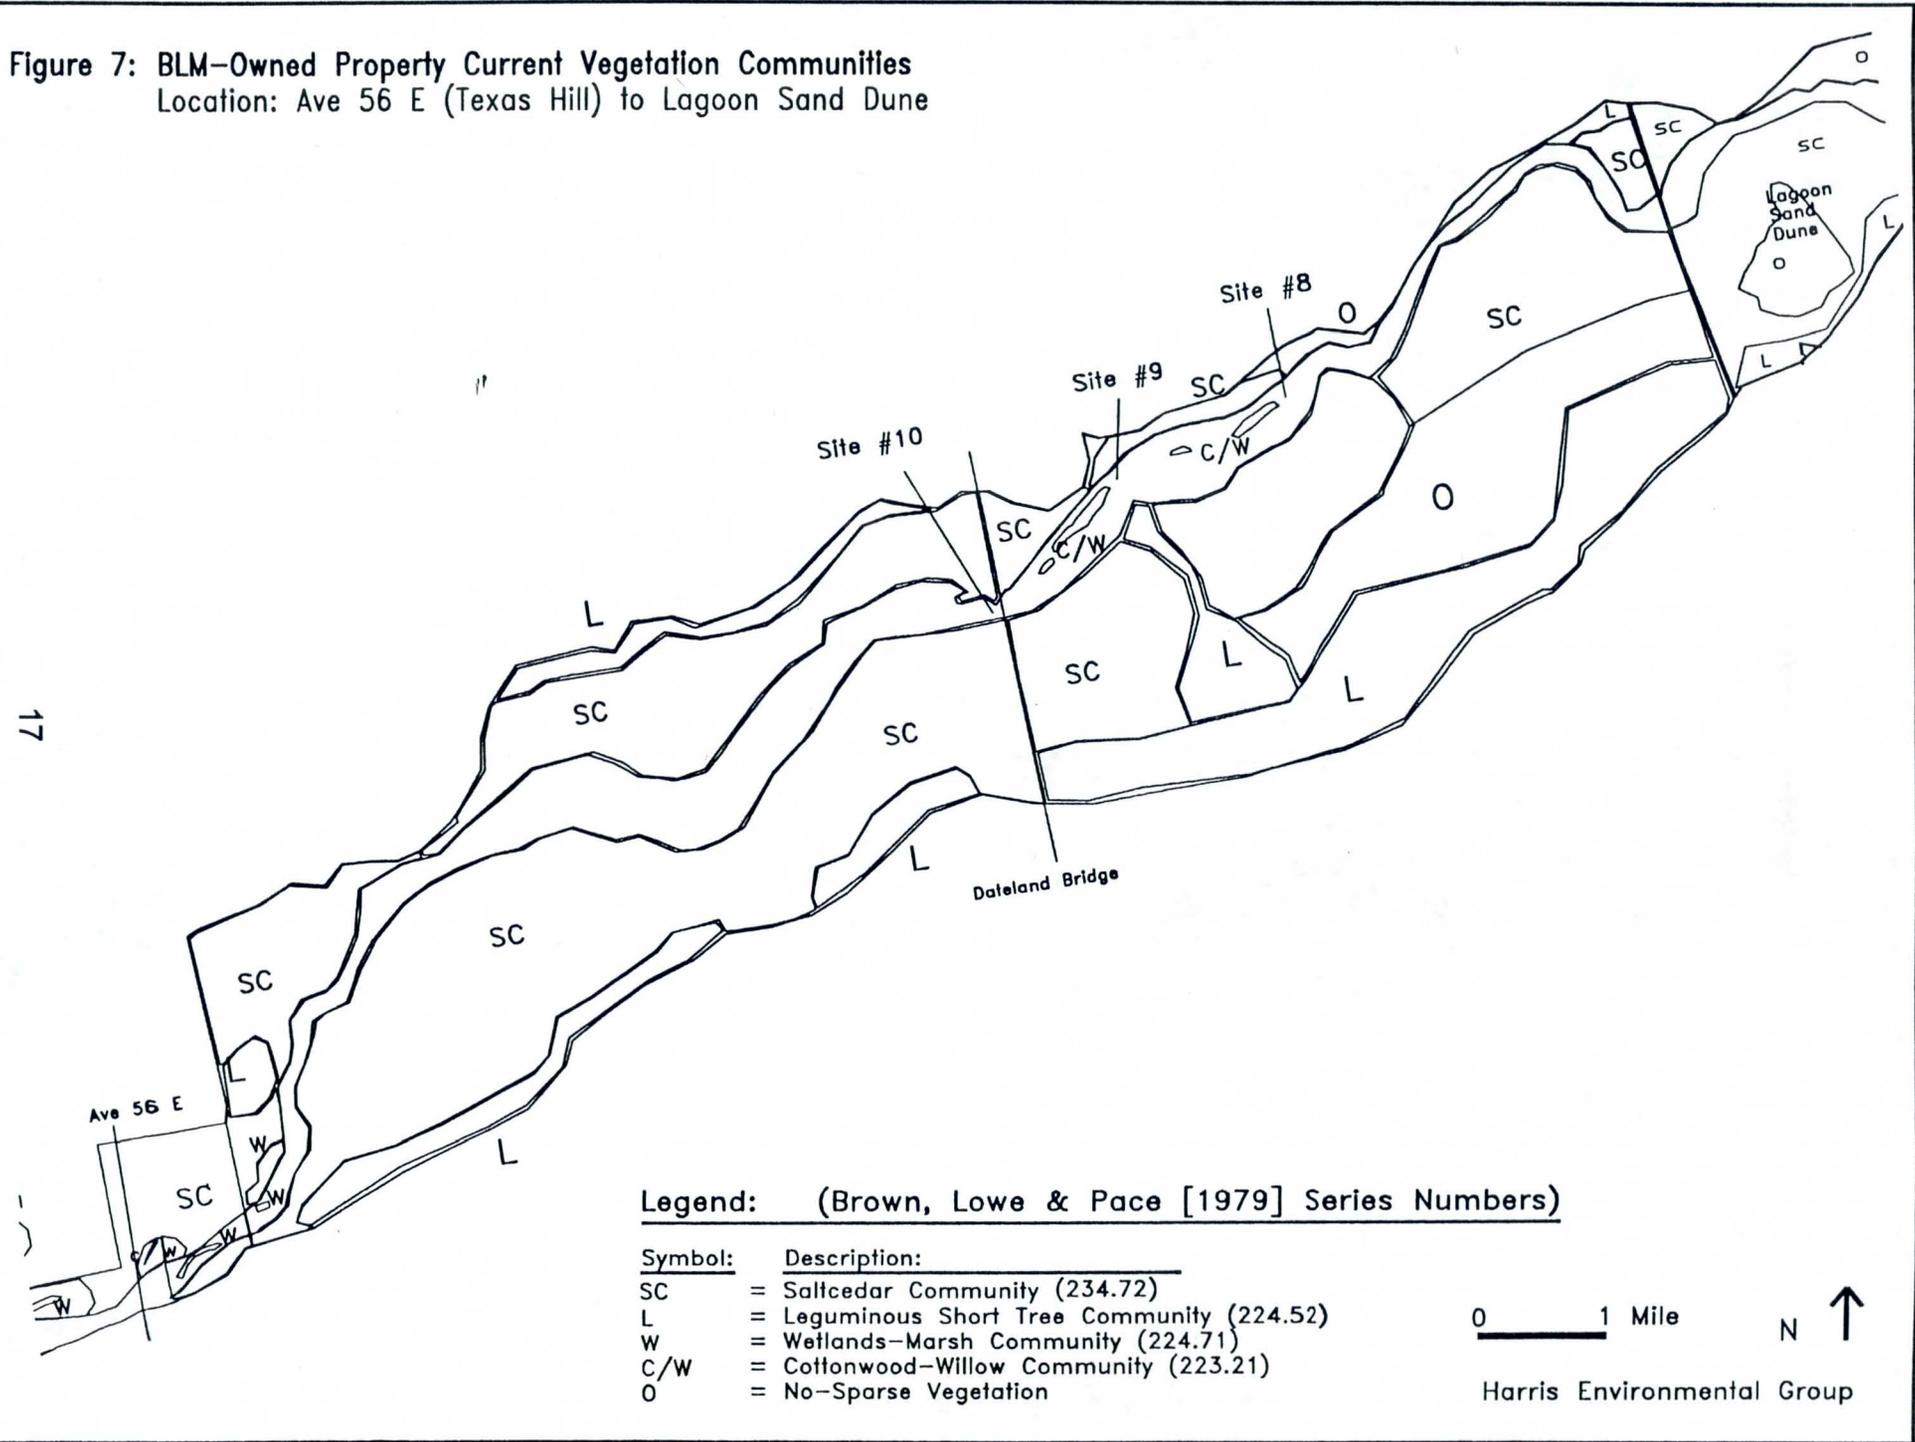
Figure 7: BLM-Owned Property Current Vegetation Communities
 Location: Ave 56 E (Texas Hill) to Lagoon Sand Dune

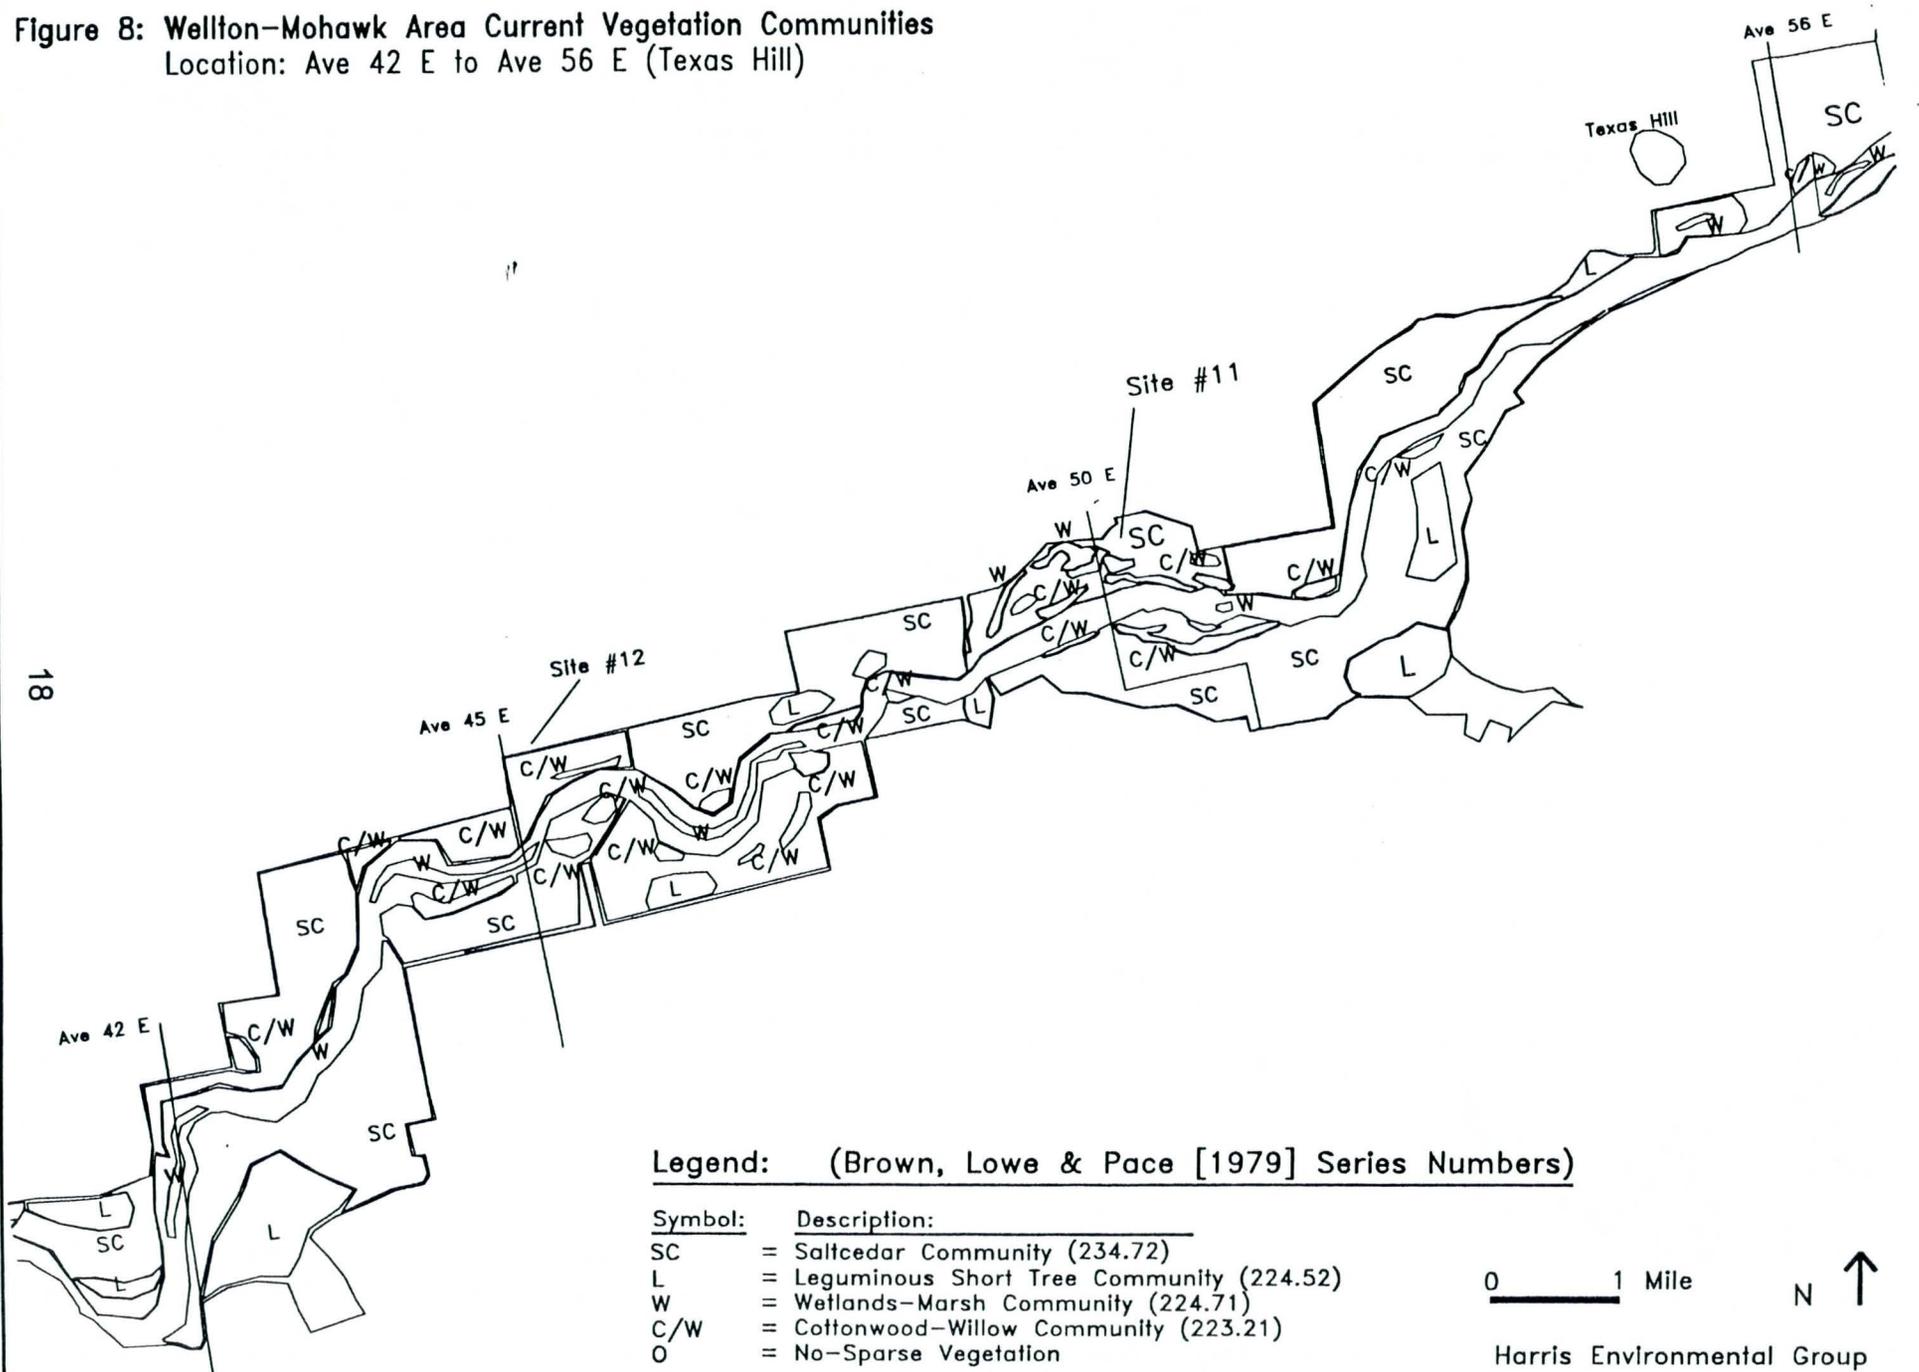
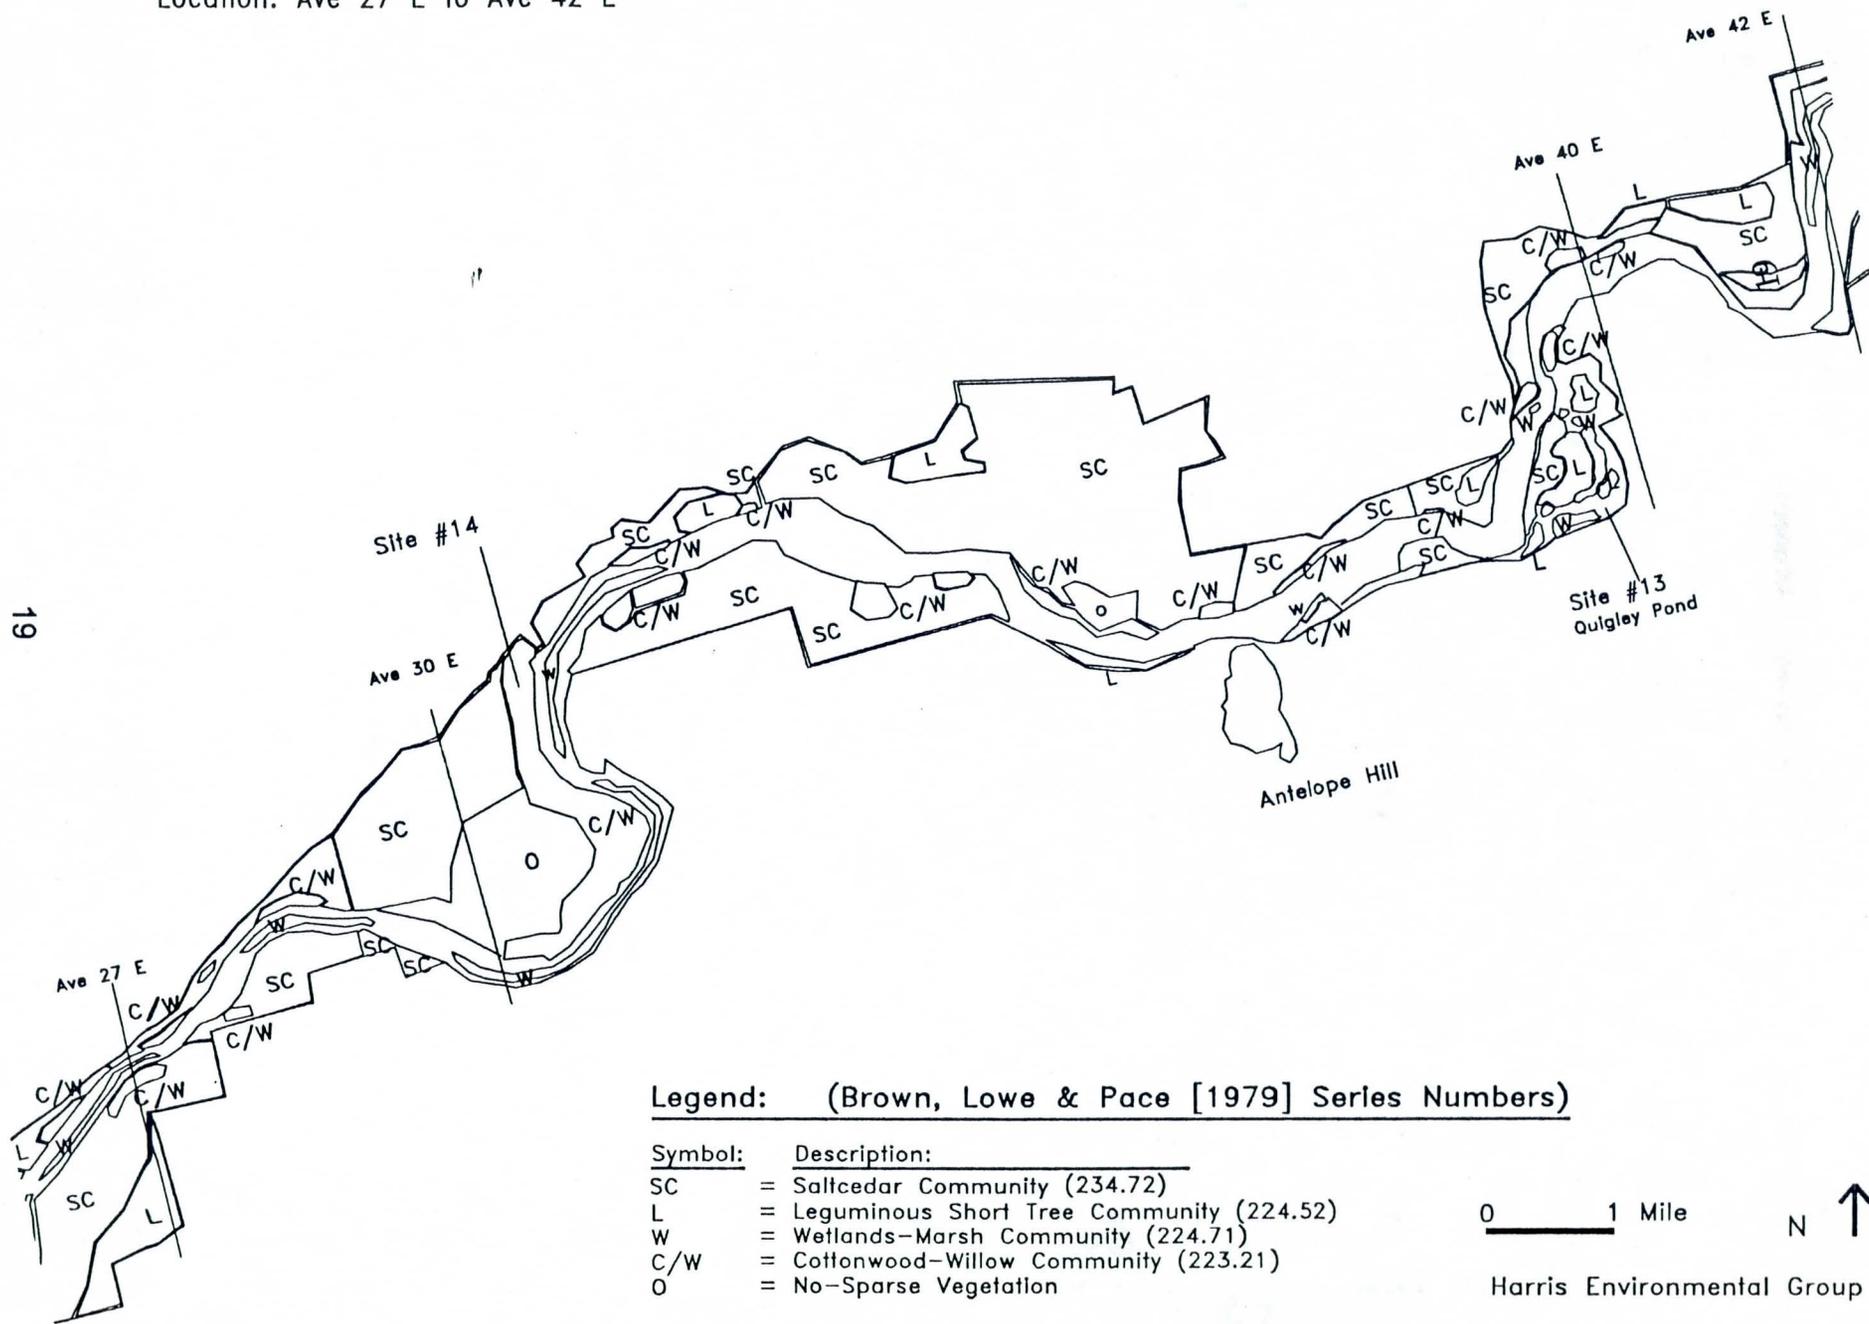
Figure 8: Wellton-Mohawk Area Current Vegetation Communities
 Location: Ave 42 E to Ave 56 E (Texas Hill)

Figure 8: Wellton-Mohawk Area Current Vegetation Communities; (Continued)

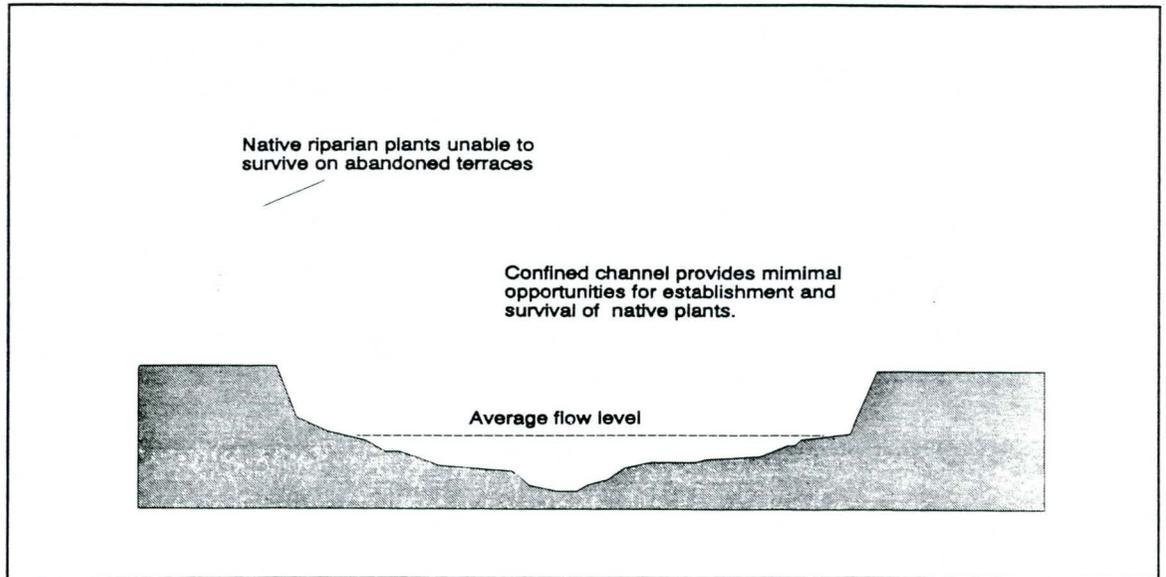
Figure 9. Flood-bank engineering that is not conducive to the establishment of native riparian species.

Altering the cross sectional form of the channel to mimic a more natural situation can be used to promote the conservation and enhancement of wildlife habitat (Nature Conservancy Council 1983). One example of this is to shape and position stream banks to encourage the establishment of native vegetation. Narrow channels that cut through significantly elevated flood plains offer little potential for the establishment of native riparian species. Such a situation offers only two landforms for vegetation establishment: the narrow channel where plants are vulnerable to flood damage, and the abandoned flood plain, where water availability may be a problem (Fig. 9).

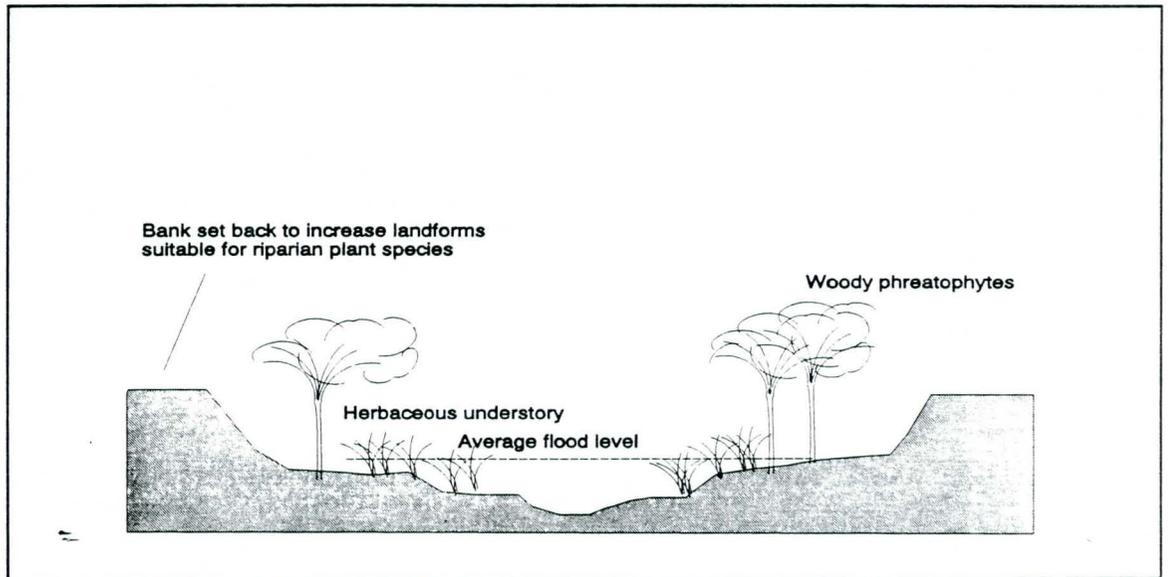
Figure 10. Multi-stage channel design. Channel has been widened to form a multi-step design, where lower steps are inundated at least several times each year.

Altering the cross sectional shape of the channel so that elevation change from the main channel to abandoned terraces occurs much more gradually will provide a greater diversity of sites for vegetation establishment (Fig. 10). Low elevation terraces may provide sufficient water availability for native riparian species (e.g., cottonwoods) and yet be high enough in elevation to afford some protection from flooding. Higher terraces may be better suited to species like mesquite that can survive in drier conditions. However, mesquite is adapted to finer particle size in terms of soil characteristics.

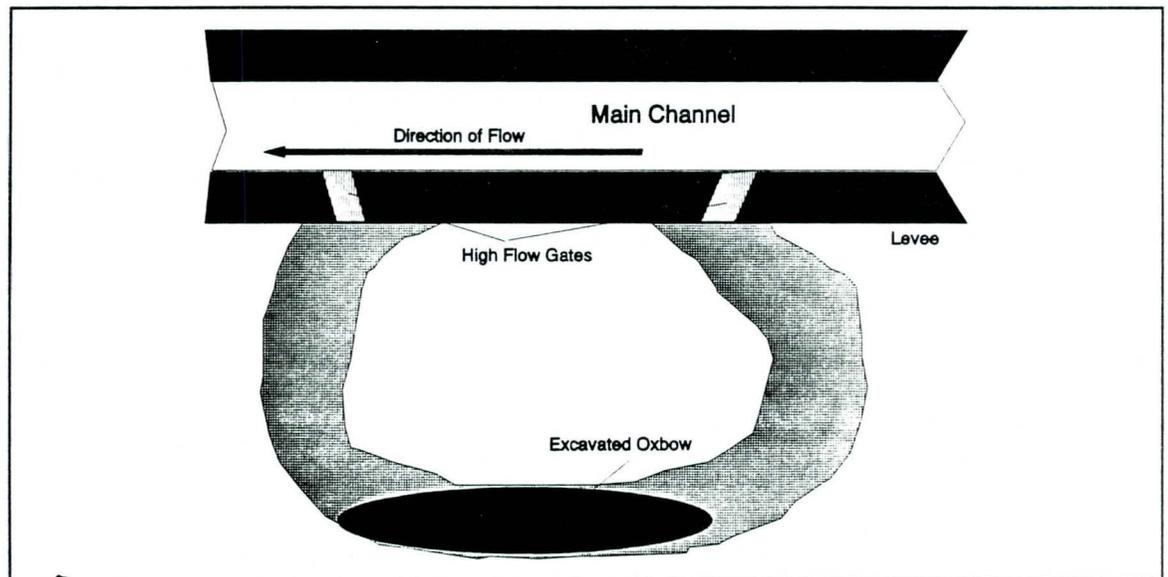
Figure 11. Plan view of the first strategy for preserving meanders. Levees damaged by flooding are repaired across channel meanders. Gates installed in the levees ensure that some water replenishment occurs during high flow events. Oxbows are excavated to roughly a meter below the saturated zone of the soil profile, providing open water habitat.

The Wellton Mohawk Irrigation and Drainage District (WMIDD) is proposing rebuilding and modifying existing flood-damaged levees at specific sites along a 60 mile reach of the river, between Texas Hill and Dome. Some levees on either side of the main channel may be reinstalled across meanders, and the Corps of Engineers and local sponsors can take advantage of the WMIDD's proposed projects by utilizing oxbows at these sites. (Fig. 11).

Flow gates installed in the levees will supply replenishing flows to the oxbows during periods of high flow. Oxbows can be excavated to groundwater to ensure that a certain amount of open water exists throughout the year. Cattails, bulrushes, reeds (*Phragmites* spp.) can be planted along the sides of the oxbow lake. Willows, cottonwoods, and other woody riparian plant species can be planted around the periphery of the excavated lake. In addition, selective clearing of saltcedar will have to occur to ensure that the newly created wetland will not be overrun by this pervasive species.
