# EAST MARICOPA FLOODWAY CHANDLER HEIGHTS BASIN RITTENHOUSE BASIN FAILURE MODE AND CONSEQUENCE ANALYSIS REPORT

**Flood Control District**  
of Maricopa County

**JANUARY 2002**

**KIRKHAM MICHAEL & ASSOCIATES, INC**  
**9201 NORTH 25TH AVENUE, SUITE 195**  
**PHOENIX AZ 85021**  
(602) 944-6564

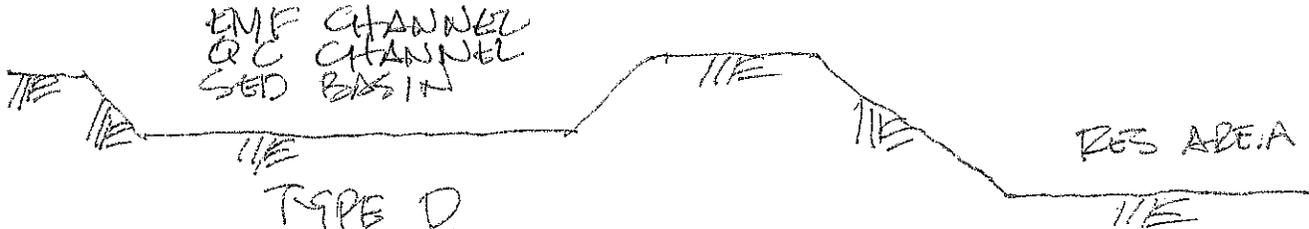
TYPE C

EMF CHANNEL  
QC CHANNEL  
SED BASIN

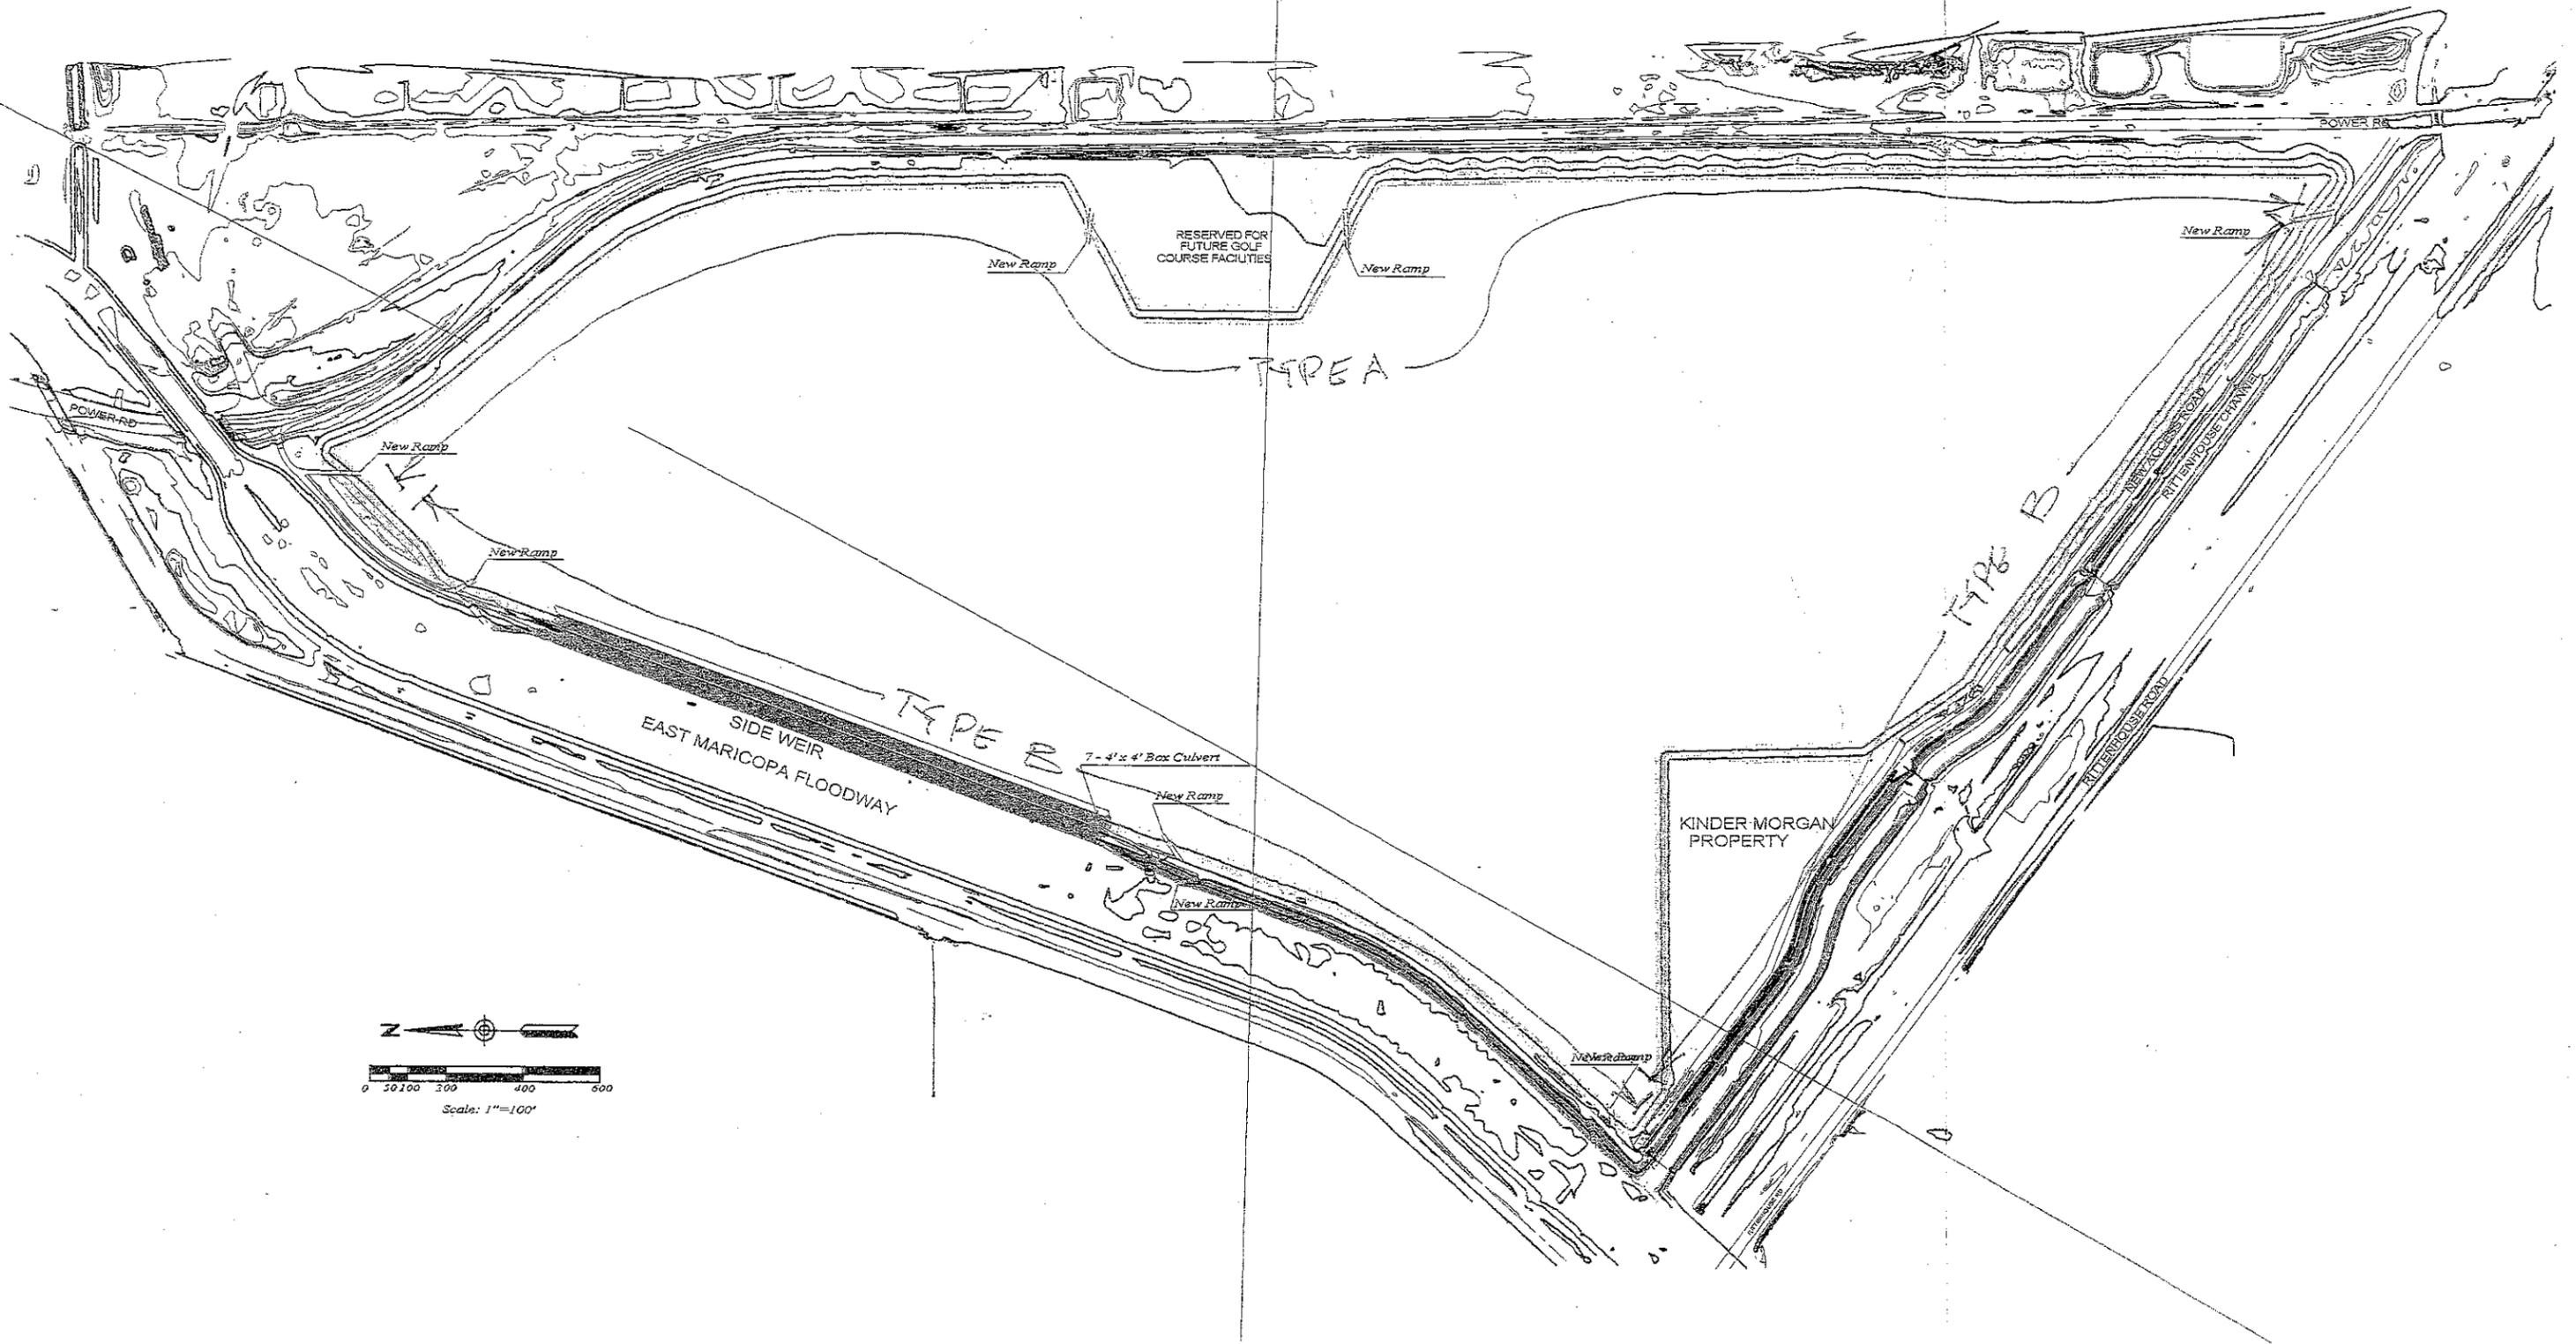
Figure 25. This sketch shows the planned improvements to create the Rittenhouse Basin. The typical sections shown cut in this sketch are shown in more detail in Figure nn.

The proposed basins are the Rittenhouse Basin (RB) and the Chandler Heights Basin (CHB). These are described in detail in the predesign reports. Figure 25 from the Rittenhouse report and Figure 34 from the Chandler Heights report are included in the Appendix for reference here. In each case, these figures present the concept plan for the respective basins.

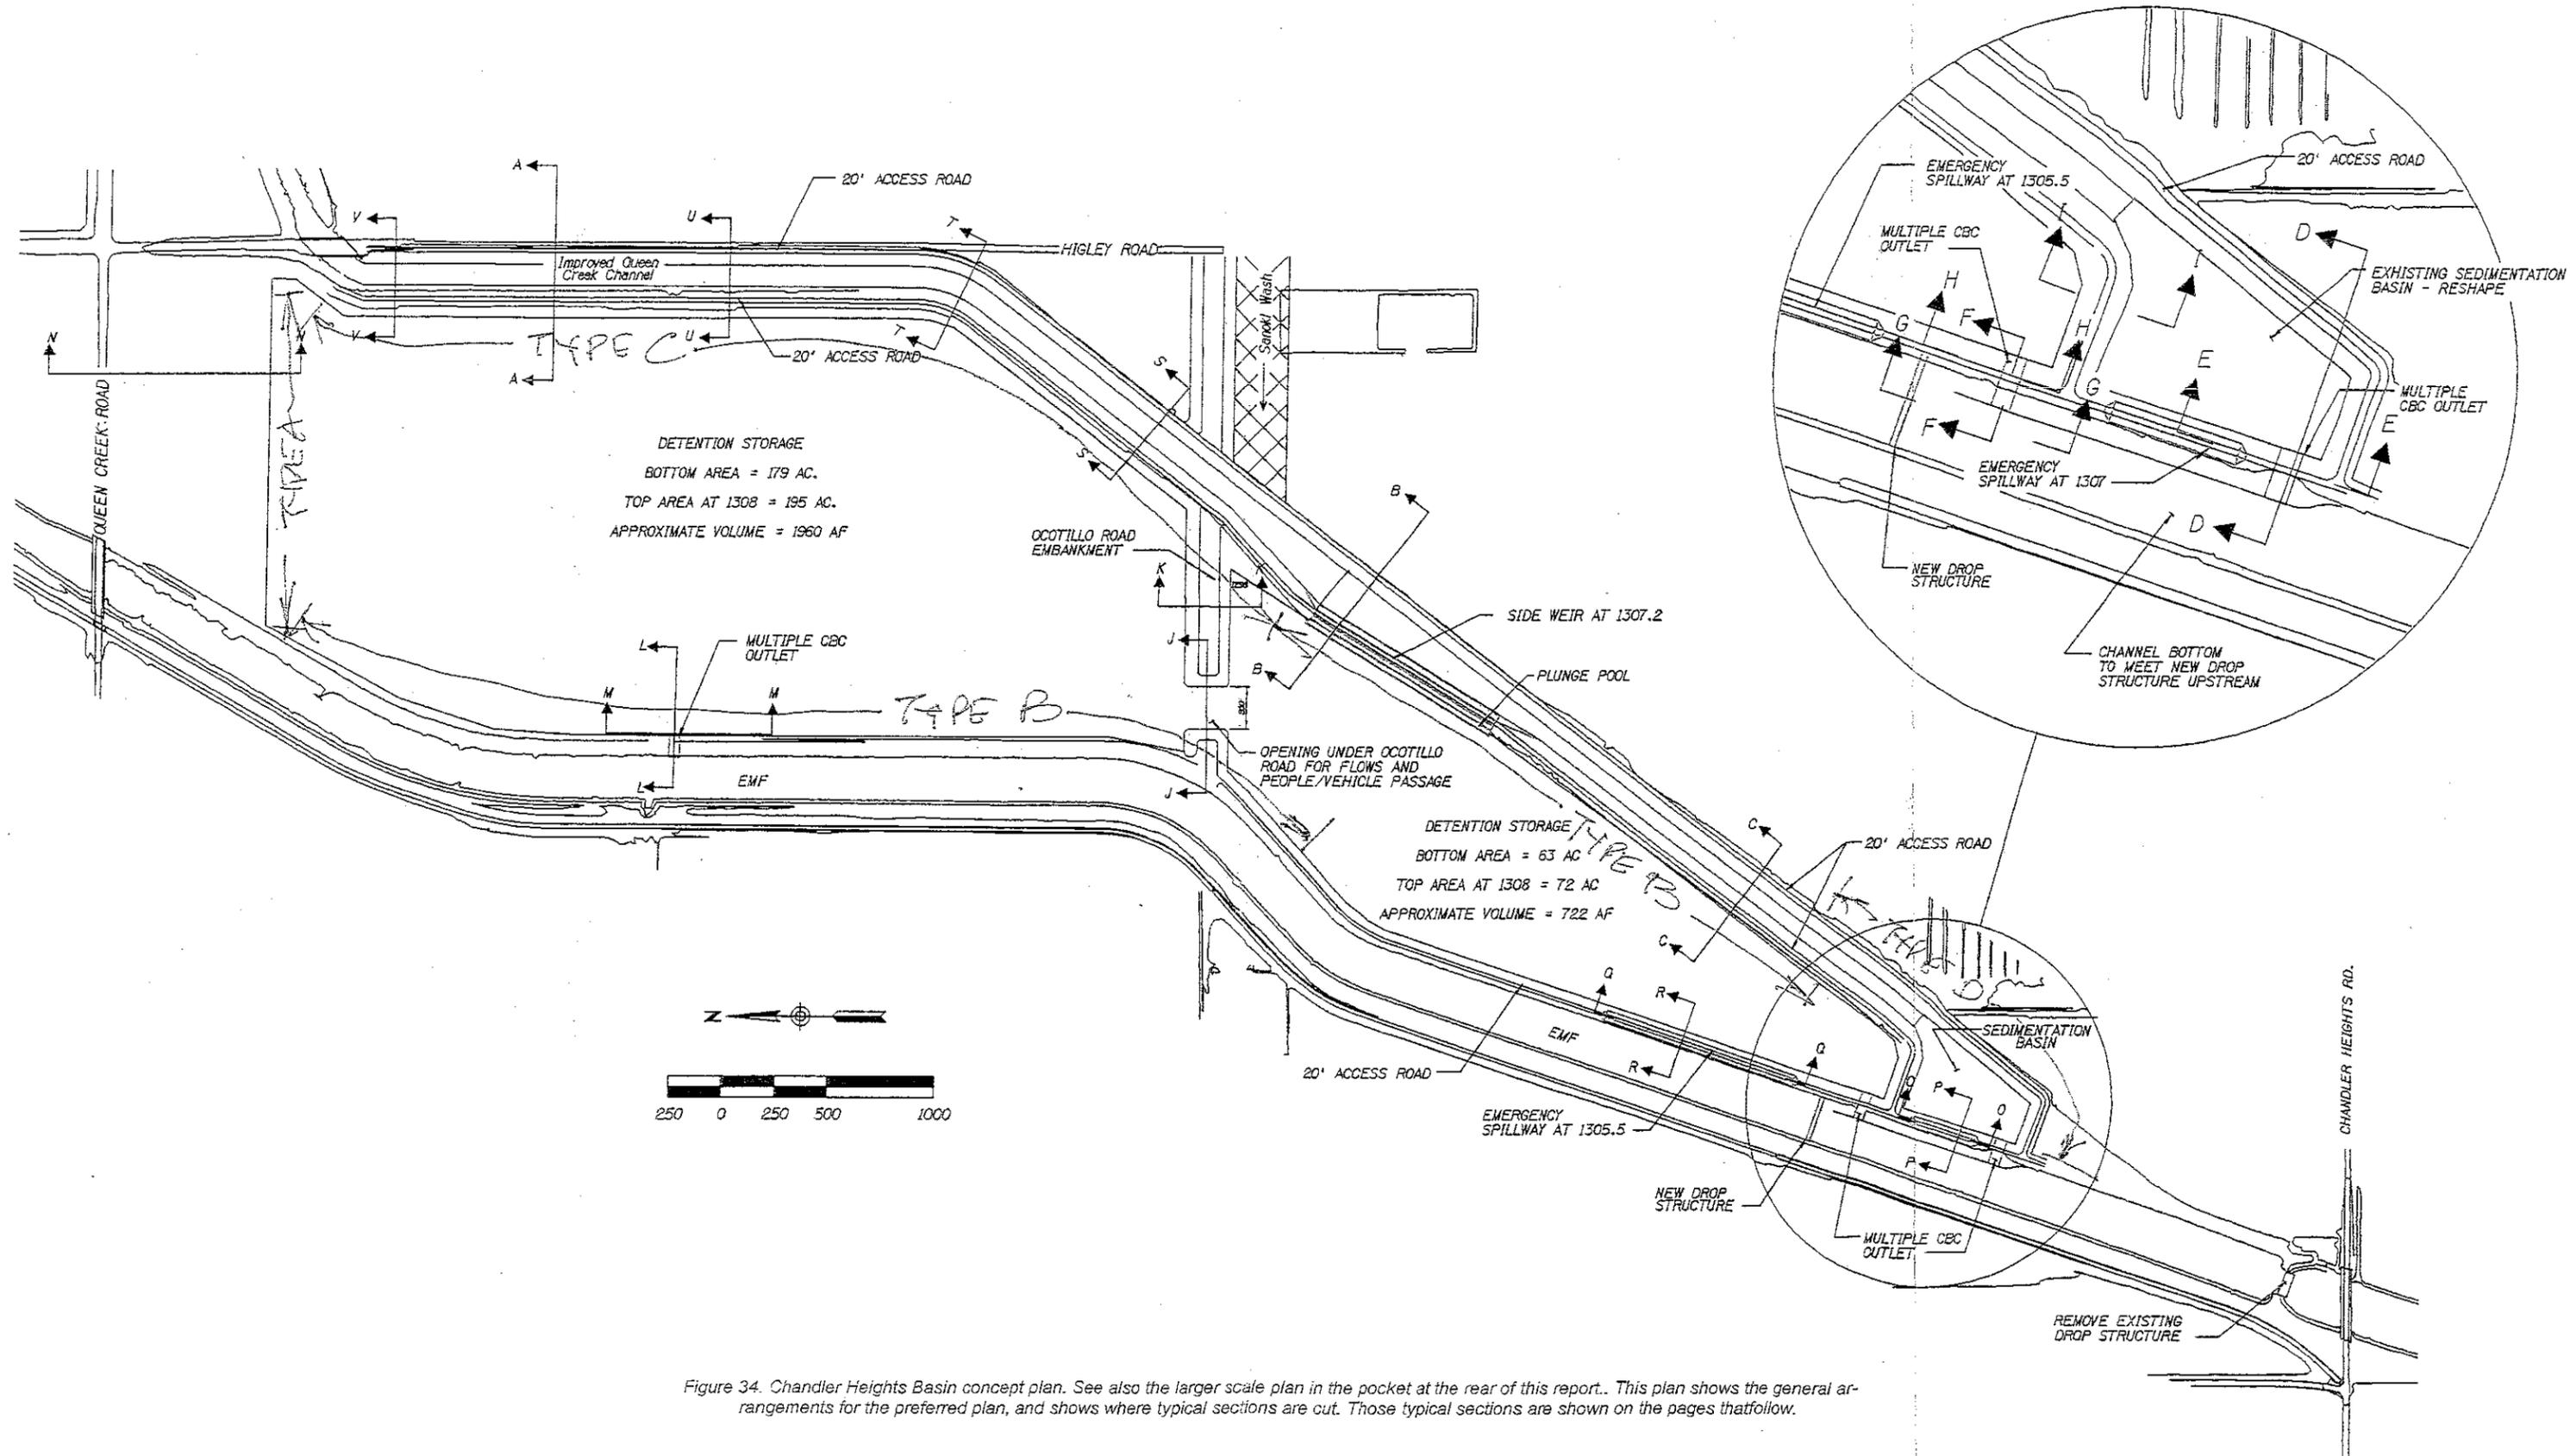
Figure 34. Chandler Heights Basin concept plan. See also the larger scale plan in the pocket at the rear of this report. This plan shows the general arrangements for the preferred plan, and shows where typical sections are cut. Those typical sections are shown on the pages that follow.

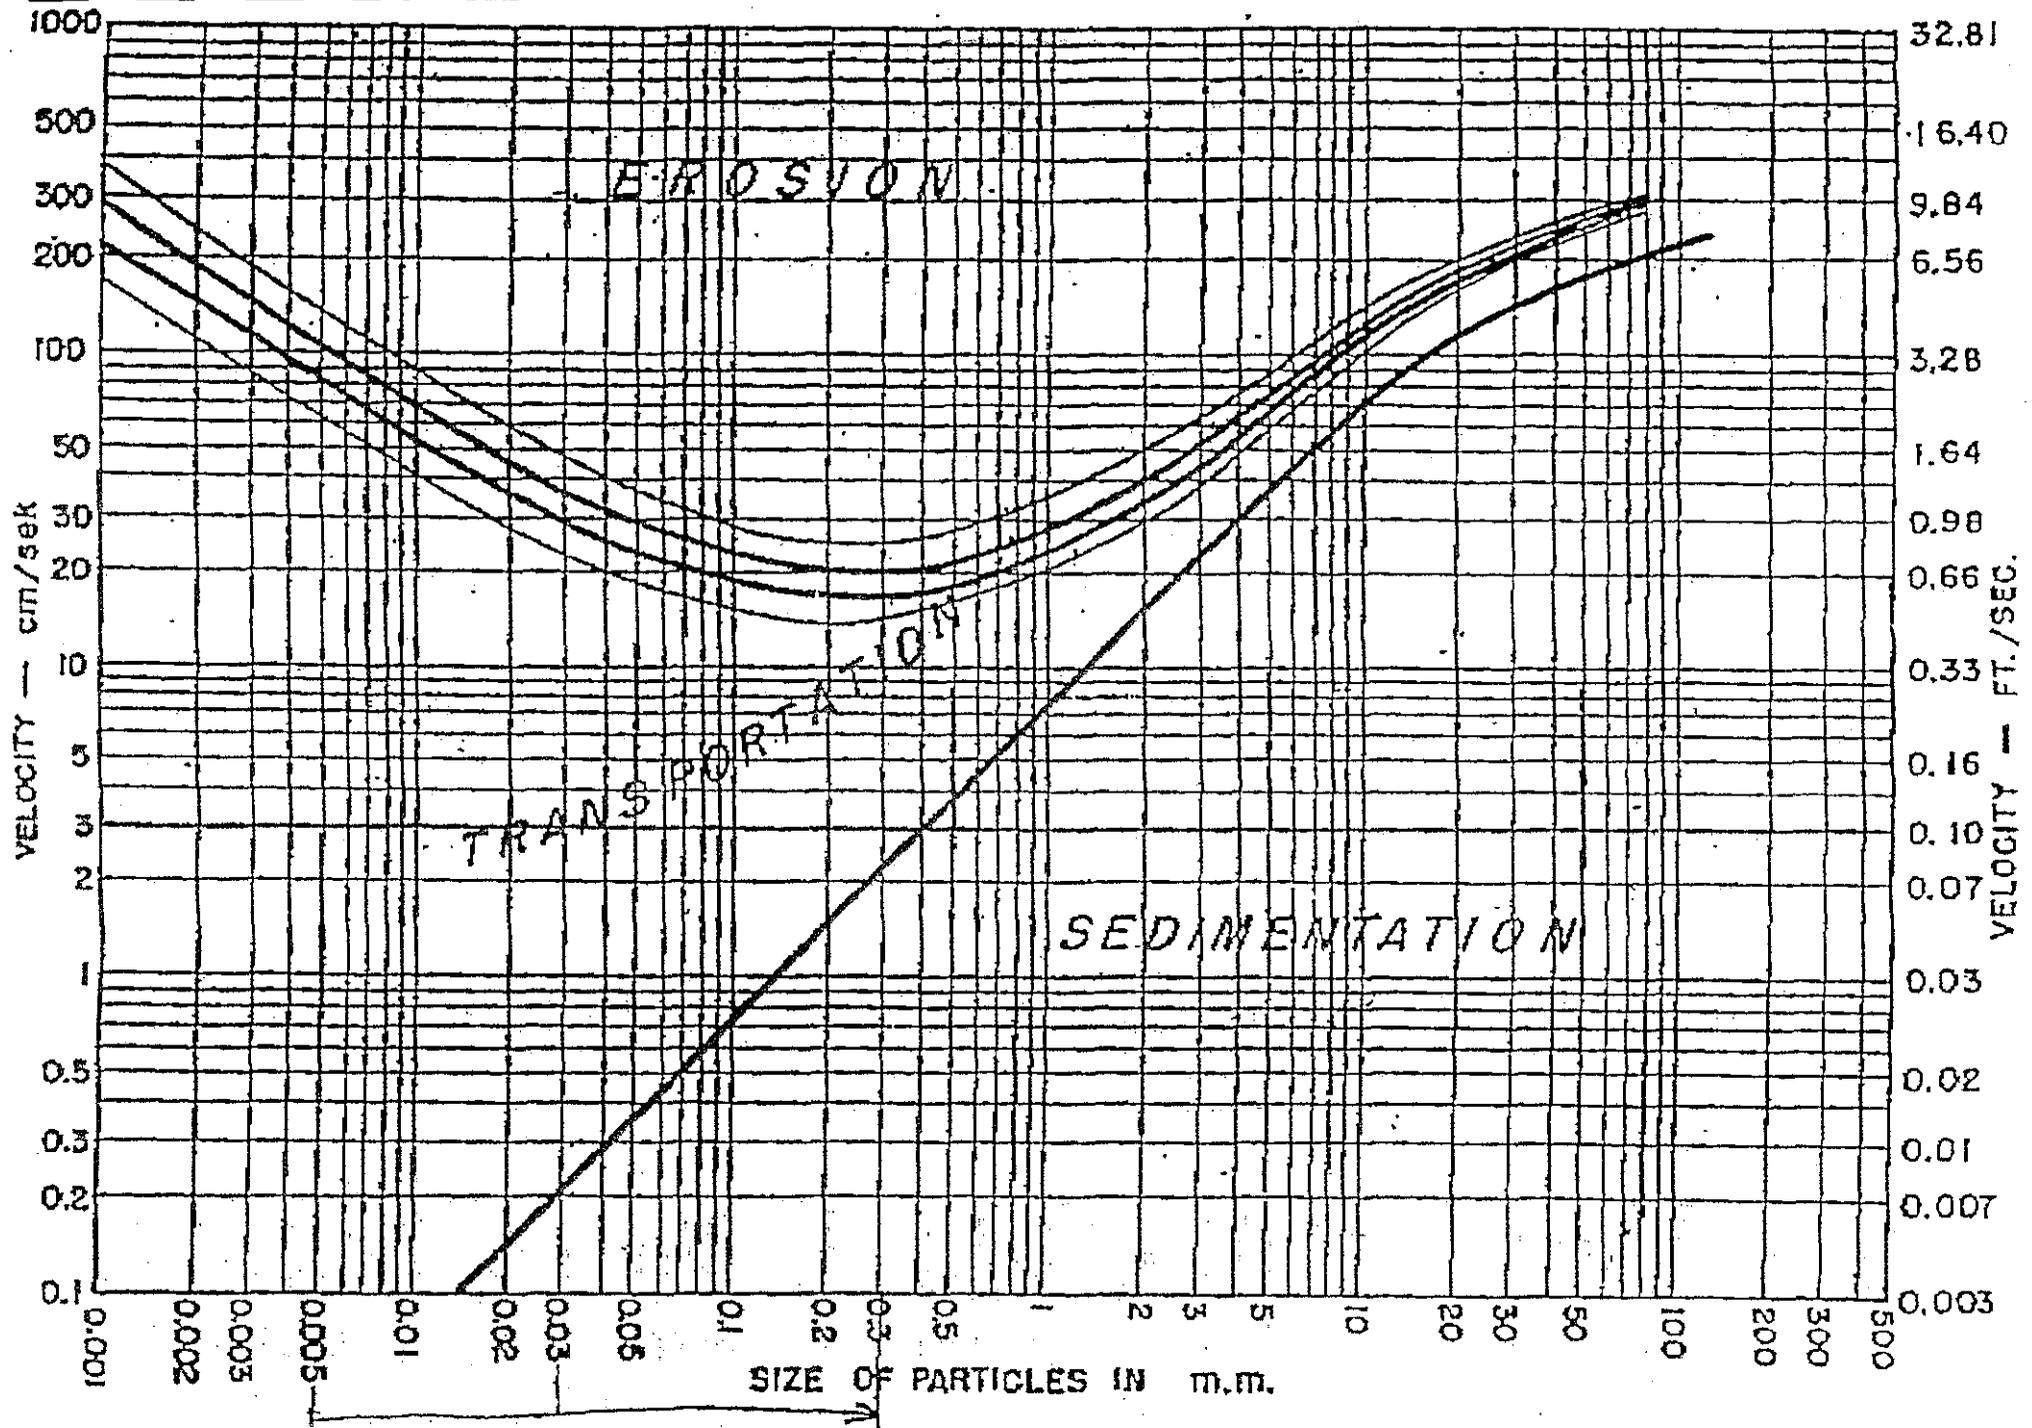
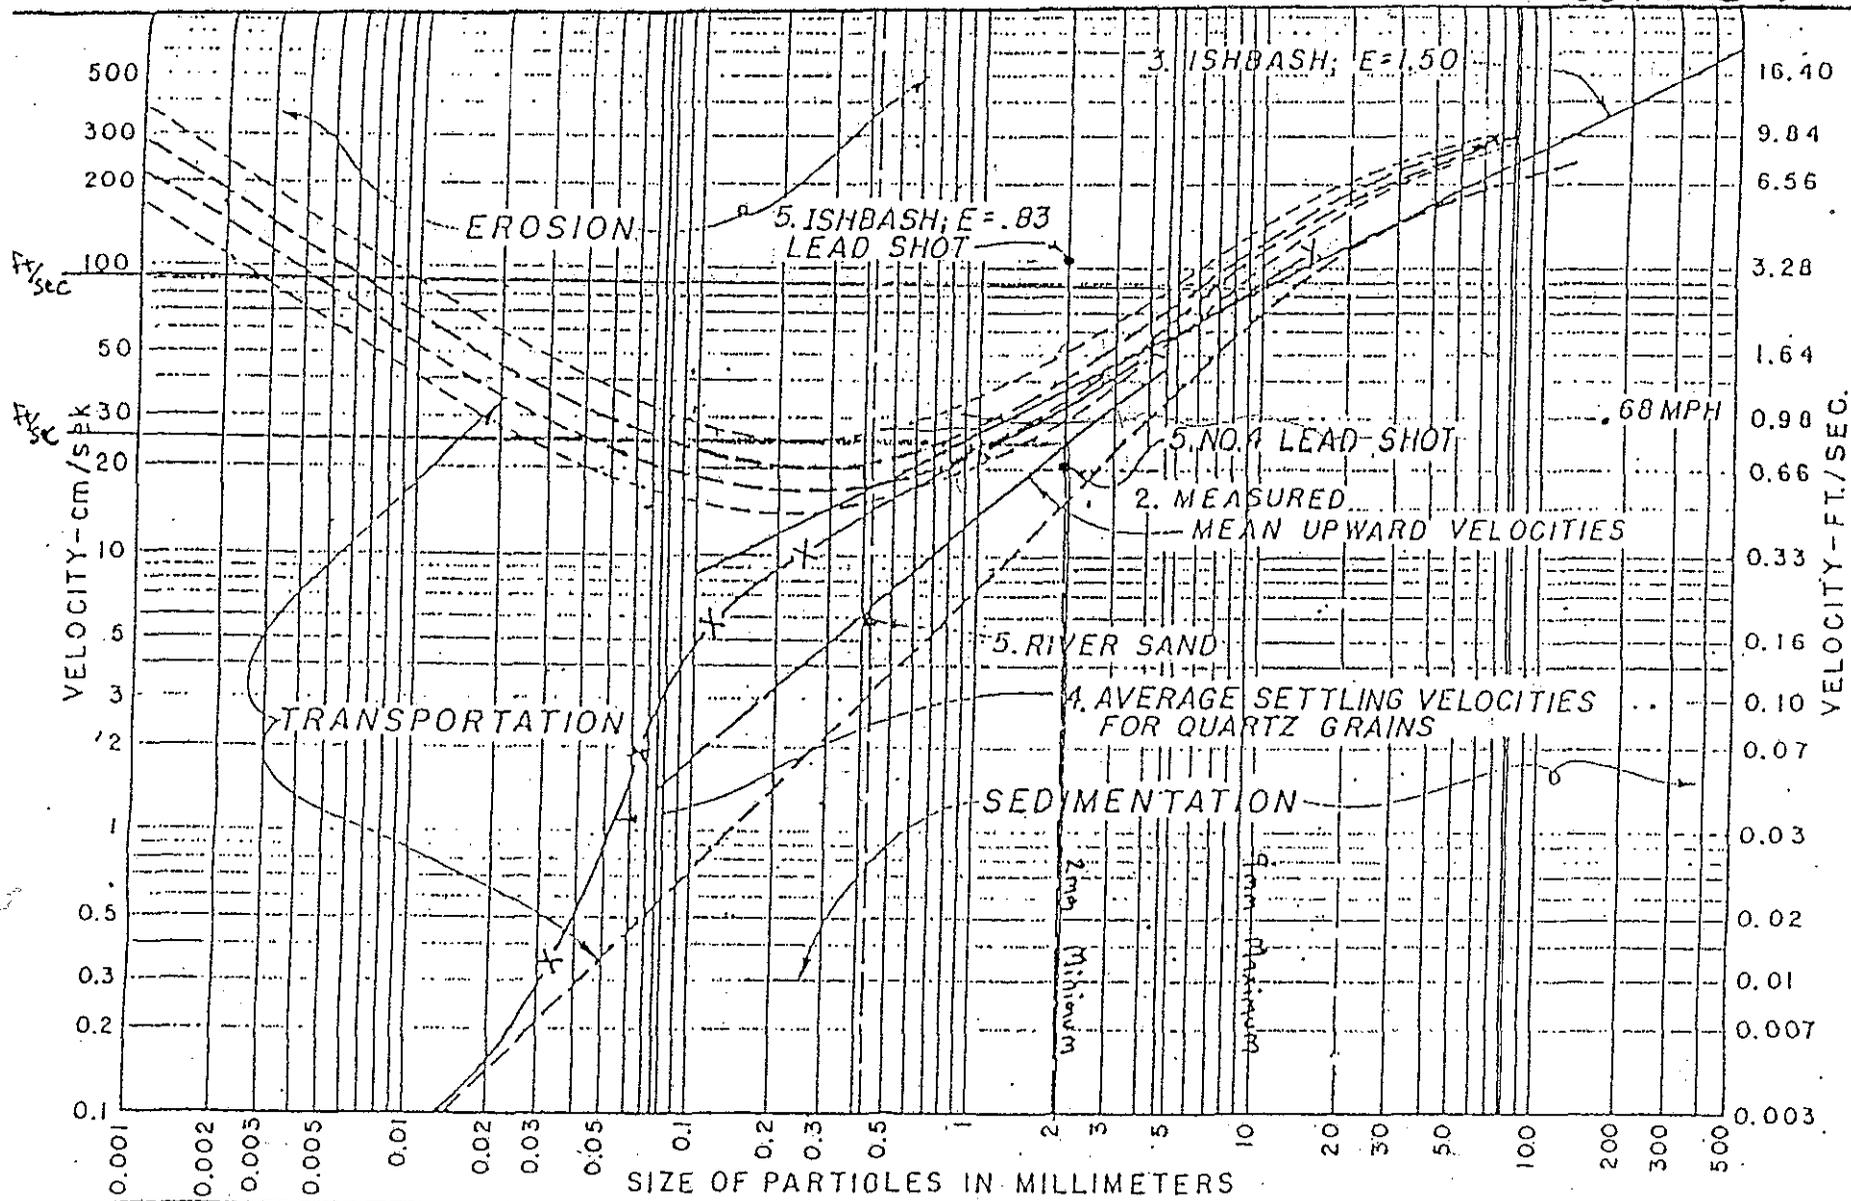
THE CURVES FOR EROSION AND DEPOSITION OF A UNIFORM MATERIAL

88 Ft/sec ⇒ 60 mph

CLAY (PLASTIC) TO SILT (NON-PLASTIC)	SAND			GRAVEL		COBBLES
	FINE	MEDIUM	COARSE	FINE	COARSE

Adapted from: F.Hjulström; Bulletin of Geol. Inst. of Upsala, Vol. XXX and 2. M.D. Campbell and J.H. Lehr; Water Well Technology; 3. S.V. Ishbash; 2nd Conf. on Large Dams, Vol. V, 1936; 4. W.W. Rubey, Amer. Jour. of Sci.; Vol. 25, 1933. 5. C.A. Mockmore & J.W.; Dougherty; Vol. 100, Trans. ASCE.
