**PALADIN ROAD BOX CULVERT  
WEST INTERCEPTOR DRAINAGE CHANNEL  
FLOOD CONTROL DISTRICT OF MARICOPA COUNTY  
ATL JOB NO. 197026**

**GEOTECHNICAL INVESTIGATION**

**Re: Geotechnical Investigation Report  
 Paladin Road Box Culvert  
 West Interceptor Drainage Channel  
 Flood Control District of Maricopa County  
 ATL Job No. 197026**

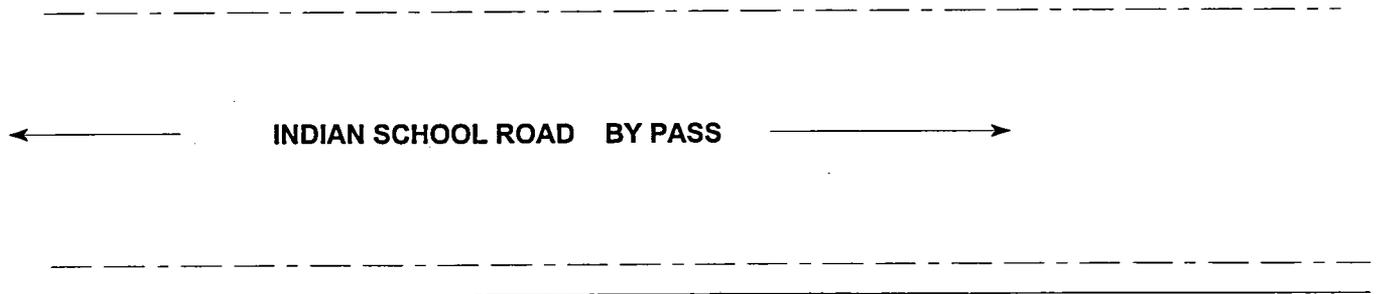
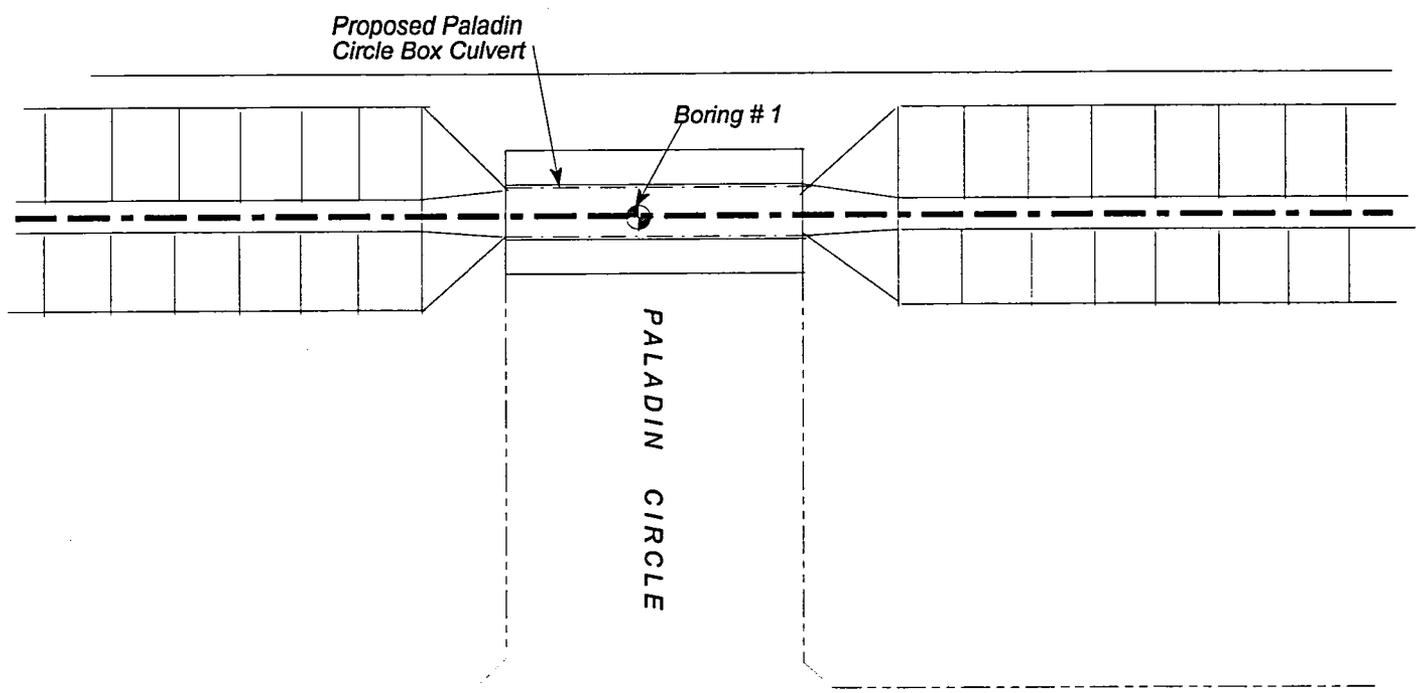
**BORING LOCATIONS**

⊕ BORING LOCATIONS

Three (3) soil strata were encountered in the one (1) boring drilled for this project. The top 4 feet consisted of a **light, brown silty SAND (SM)** in a damp condition. Between 4 and 5½ feet below grade, a **light brown, clayey SAND (SC)** with a trace of cementation was encountered. From 5½ feet to the bottom of the boring at 13 feet, a **light brown sandy lean CLAY (CL)** with a trace of cementation was encountered. SPT "N" values increased as depth increased, from 29 blows/foot to 50 blows in six inches. This indicates a "Hard" and "Very Dense" material.

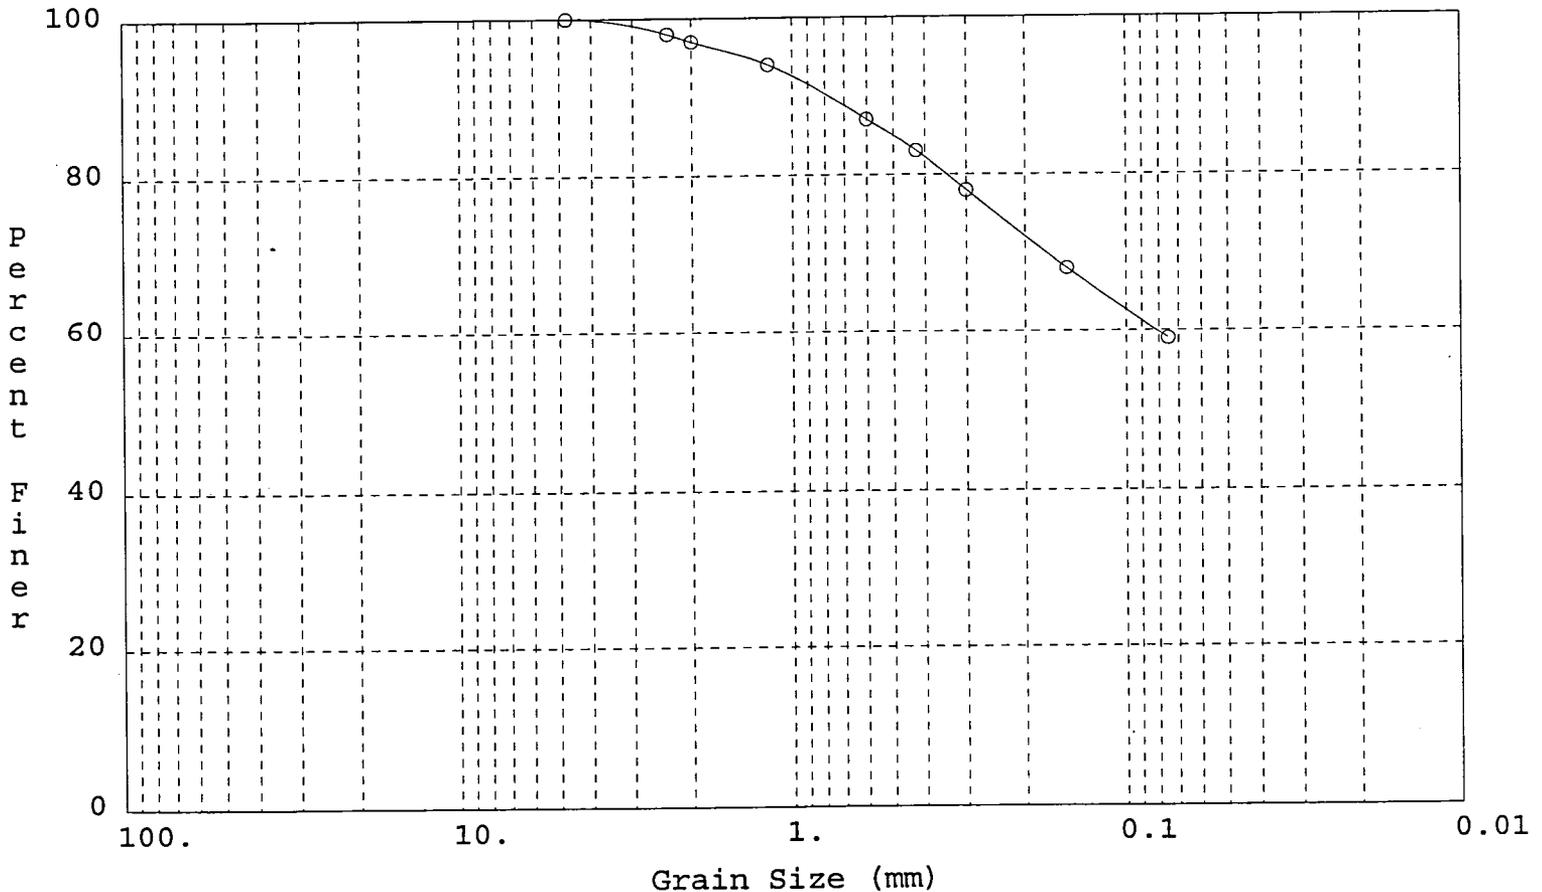
Sieve Analysis

SIEVE NUMBER	SIEVE OPENING (mm)	RETAINED WEIGHT (g)	PERCENT OF WEIGHT RETAINED	CUMULATIVE PERCENT RETAINED	PERCENT FINER (%)
#4	4.750	0.00	0.00	0.00	100.00
#8	2.360	20.00	2.00	2.00	98.00
#10	2.000	10.00	1.00	3.00	97.00
#16	1.180	30.00	3.00	6.00	94.00
#30	0.600	70.00	7.00	13.00	87.00
#40	0.425	40.00	4.00	17.00	83.00
#50	0.300	50.00	5.00	22.00	78.00
#100	0.150	100.00	10.00	32.00	68.00
#200	0.075	90.00	9.00	41.00	59.00
Pan	0.000	0.00	0.00	41.00	59.00

Laboratory results for material sampled in the 5½ to 11½ depth range, revealed a fine material with 59% passing the No. 200 screen and a plasticity index of 14. The in-situ moisture content was 25.9%.
