# Method to Estimate Effects of Flow-Induced Vegetation Changes on Channel Conveyances of Streams in Central Arizona

Water-Resources Investigations Report 98-4040

*Prepared in cooperation with the  
Flood Control District of Maricopa County*

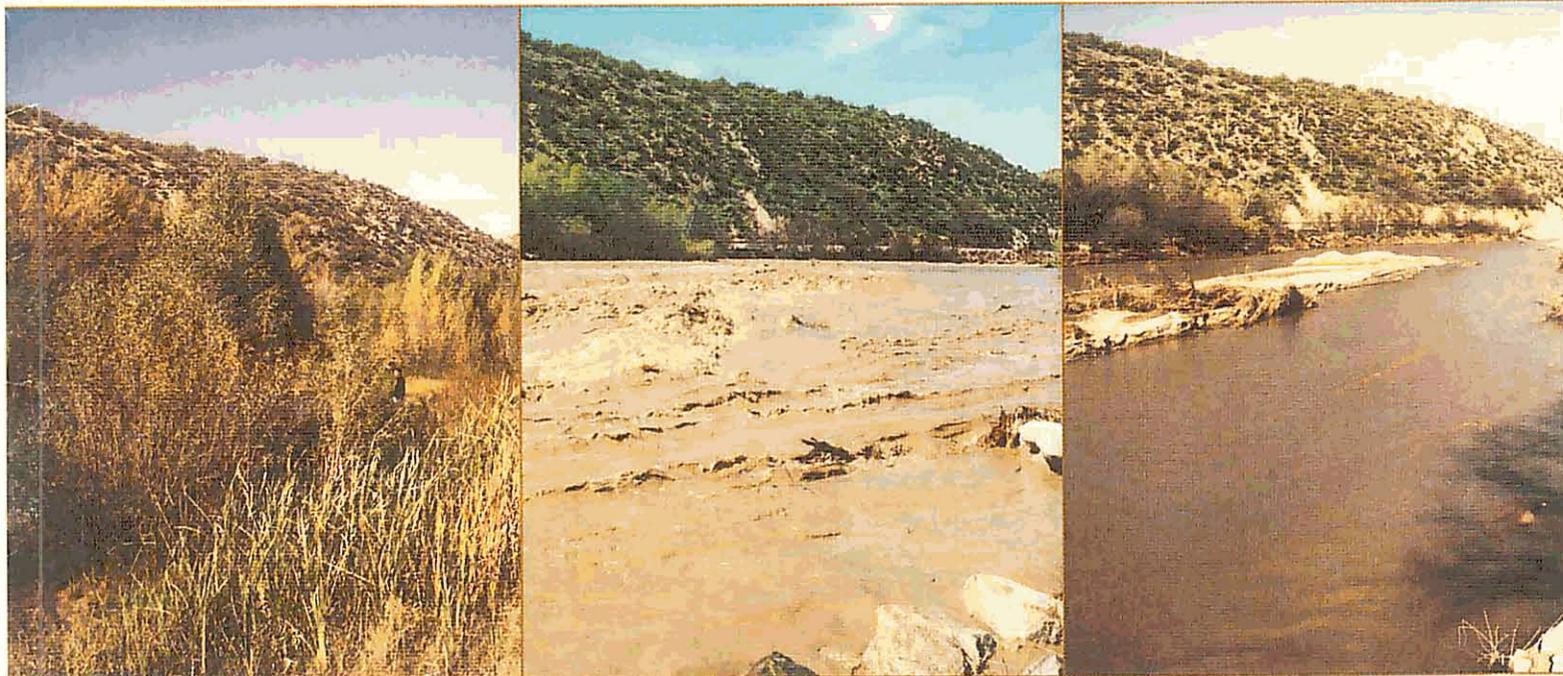
Cover photographs: Three photographs of the same reach of the Hassayampa River near Wickenburg. Photographs were taken before, during, and after flow of February 15, 1995, and illustrate flow-induced changes to riparian vegetation conditions.

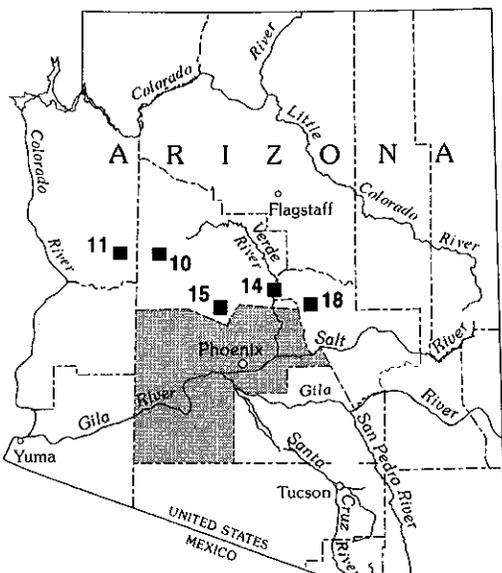
**Figure 1.** Study area and selected sites in central Arizona.

1. Verde River near Scottsdale
2. Skunk Creek above Interstate 17
3. Indian Bend Wash above Curry Road
4. Agua Fria River below New Waddell Dam
5. Hassayampa River near Arlington
6. Salt River above Interstate 10
7. Cave Creek above New River Road
8. New River above Interstate 17
9. Hassayampa River near Wickenburg
10. Francis Creek near Bagdad
11. Big Sandy River near Wikieup
12. Vekol Wash near Stanfield
13. Agua Fria River tributary at Youngtown
14. Verde River below Tangle Creek
15. Humbug Creek near Castle Hot Springs
16. New River above New River Road
17. Salt River tributary in South Mountain Park
18. Tonto Creek above Gun Creek
19. Hassayampa River below Old U.S. 80 Bridge

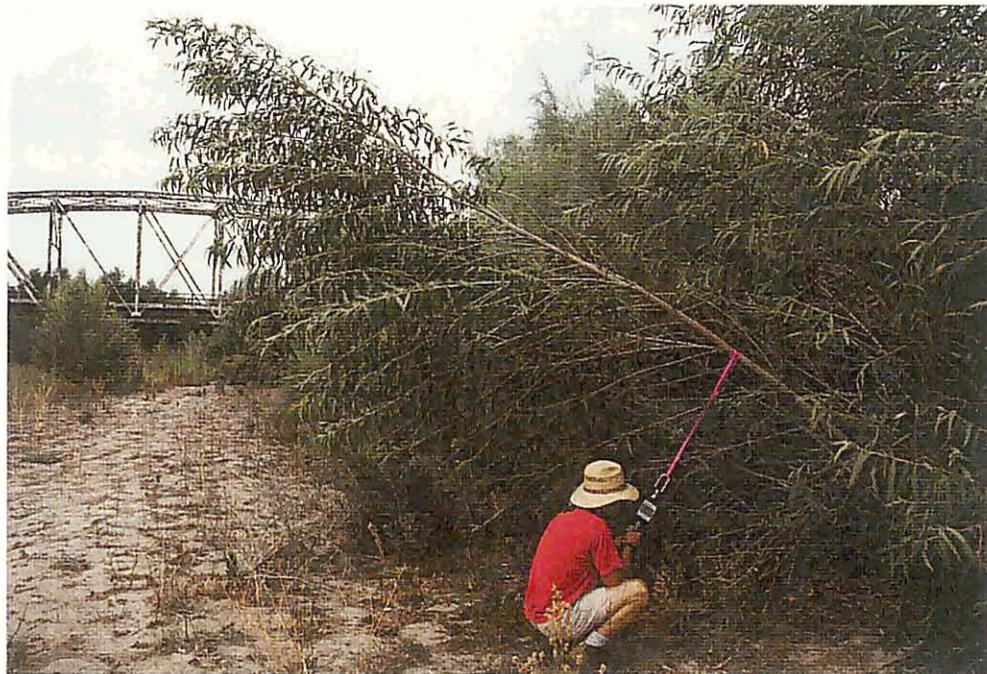
**Figure 2.** Dynamometers used to determine vegetation bending-moment values.

Dynamometers, which are mechanical devices that measure magnitude of tension in cables, were used to determine the force required to lay over four types of vegetation. The vegetation included saltcedar, willow, mesquite, and palo verde, and ranged in height from 3 to 18 ft. Bending moments were determined by computing the product of the moment arm (distance from the base or pivot point to the location where force was applied) and the force required to bend the vegetation to 45° from the vertical (fig. 2; table 13, see the section entitled "Basic Data" at the end of the report).

Attempts were made to place the dynamometer at a vertical distance from the base of the vegetation of about 0.4 times the height of the vegetation (table 13, see the section entitled "Basic Data" at

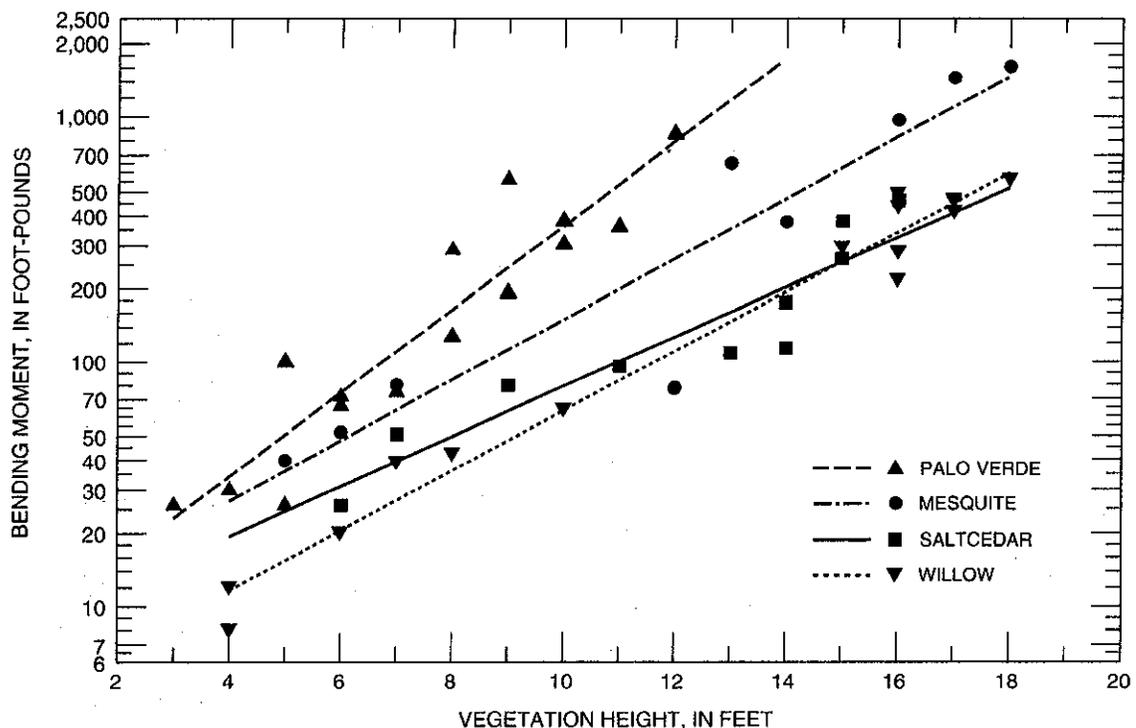
**Figure 3.** Bending-moment values for four types of vegetation in central Arizona.

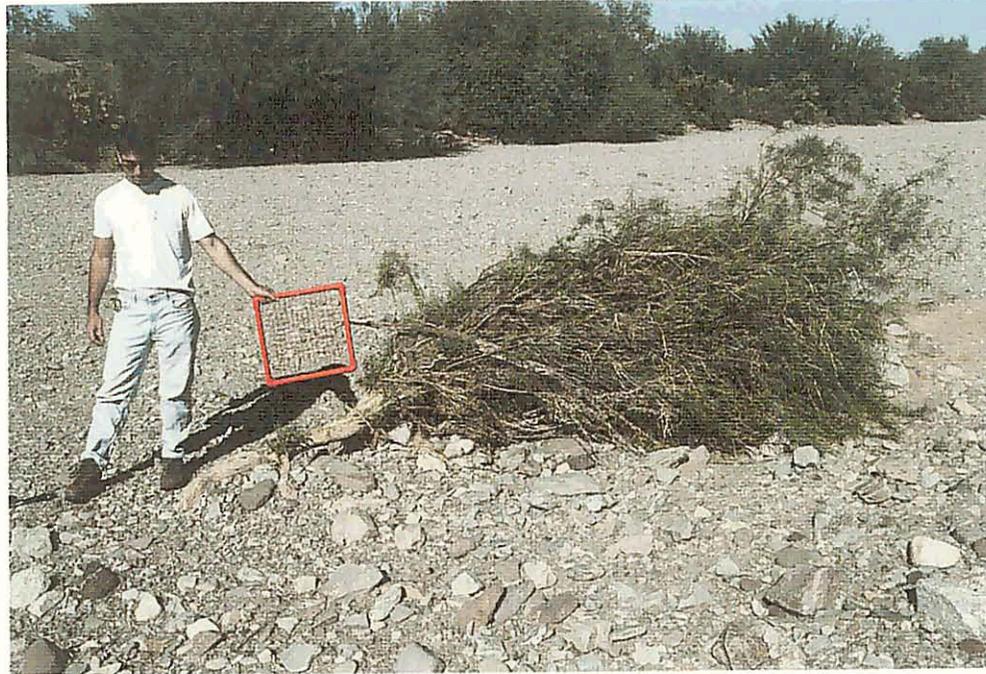
**Figure 4.** A lone willow approximately 15 feet tall in a prone position after the flow of September 10, 1994, Vekol Wash near Stanfield (ratio of hydraulic radius to height of vegetation was 0.3 and average velocity was 9.2 feet per second).

Although uncertainties are associated with this simplified approach, data collected during this investigation seem to support these assumptions. For example, figure 4 shows a lone willow about 15 ft tall that was laid over during a flow of 6,590 ft<sup>3</sup>/s; whereas, figure 5 shows a lone 16-foot-tall palo verde that remained erect throughout a flow of 9,760 ft<sup>3</sup>/s. Duration of flow for the events was about equal. The magnitude of stream power that affected the palo verde was 20.2 ft-lb/s/ft<sup>2</sup>; whereas, the magnitude of stream power to which the willow was subjected is equal to 12.9 ft-lb/s/ft<sup>2</sup> (table 1). These data indicate that the large flexural strength of the palo verde enabled it to resist the stream power that was substantially larger than the computed stream power that altered or laid over a willow with similar dimensions. The

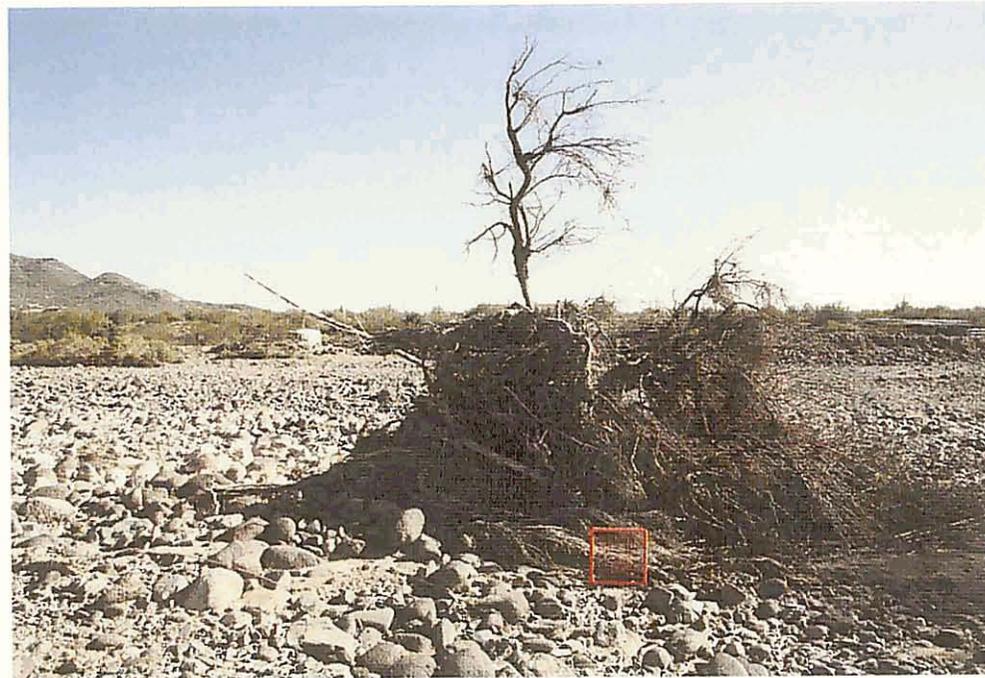
**Figure 5.** An erect 16-foot-tall palo verde after the flow of January 8, 1993, Cave Creek above New River Road (ratio of hydraulic radius to height of vegetation was 0.2 and average velocity was 10.0 feet per second).

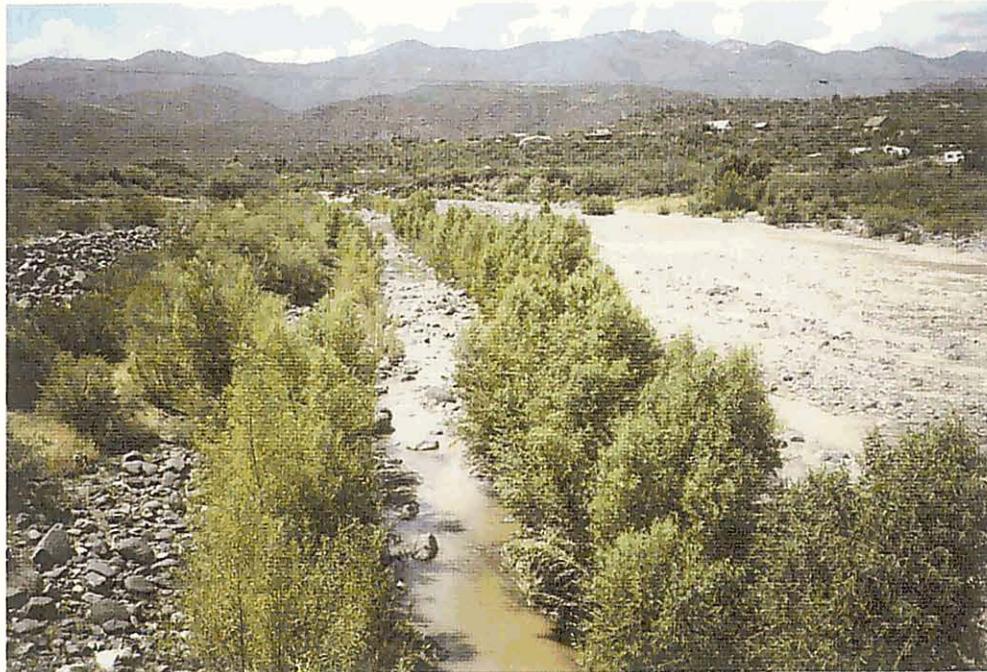
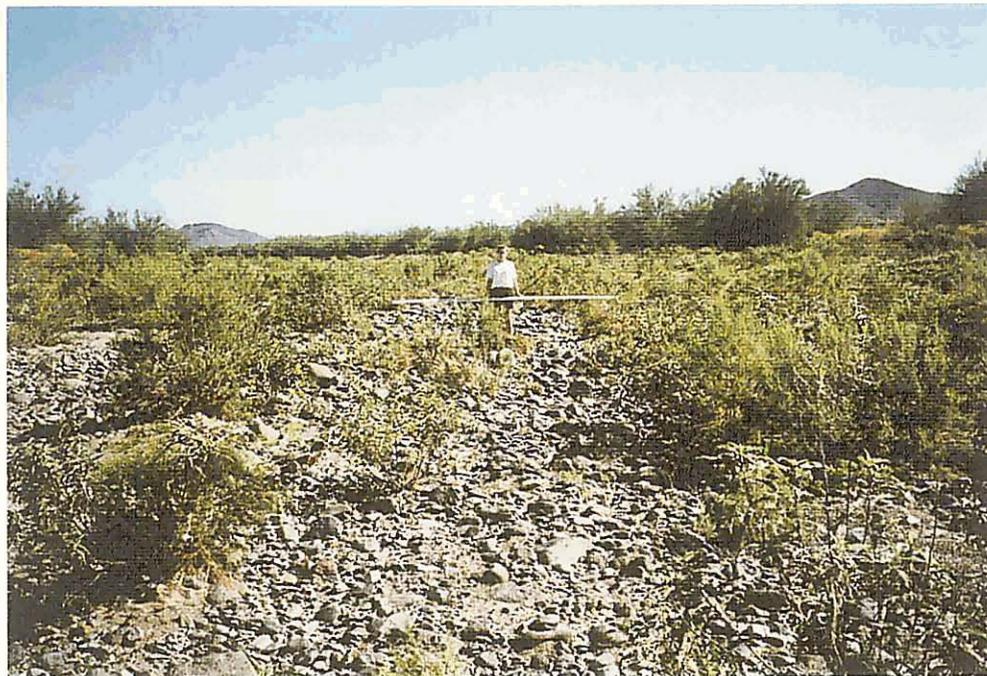
**Figure 6.** Spatial distribution of vegetation in stream channels. *A*, Vegetation aligned parallel to flow. *B*, Randomly distributed vegetation.

Collected data for this report suggest that the spatial distribution of riparian vegetation in natural and constructed channels could substantially influence the effects of flow on the vegetation. Vegetation aligned parallel to the direction of flow that generally is the result of consistent base flow (fig. 6A) can result in the redistribution of velocities across the channel section because of the combined resistant effect of the vegetation. The combined resistance causes a decrease in the velocities at the immediate location of the vegetation and mitigates the effects of flow on vegetation conditions. Past experiments in controlled laboratory environments resulted in similar conclusions (Li and Shen, 1973). For vegetation conditions categorized as randomly distributed (fig. 6B), velocity profiles are assumed to remain fairly constant across the channel. Dimensionless vegetation-distribution coefficients ( $C_{dist}$ ; see equation 3), therefore, were determined for two categories—vegetation aligned parallel to the flow and vegetation distributed randomly throughout the main channel (table 5). Determination of the  $C_{dist}$  value (parallel or random) is subjective and requires a certain amount of experience and engineering judgment.

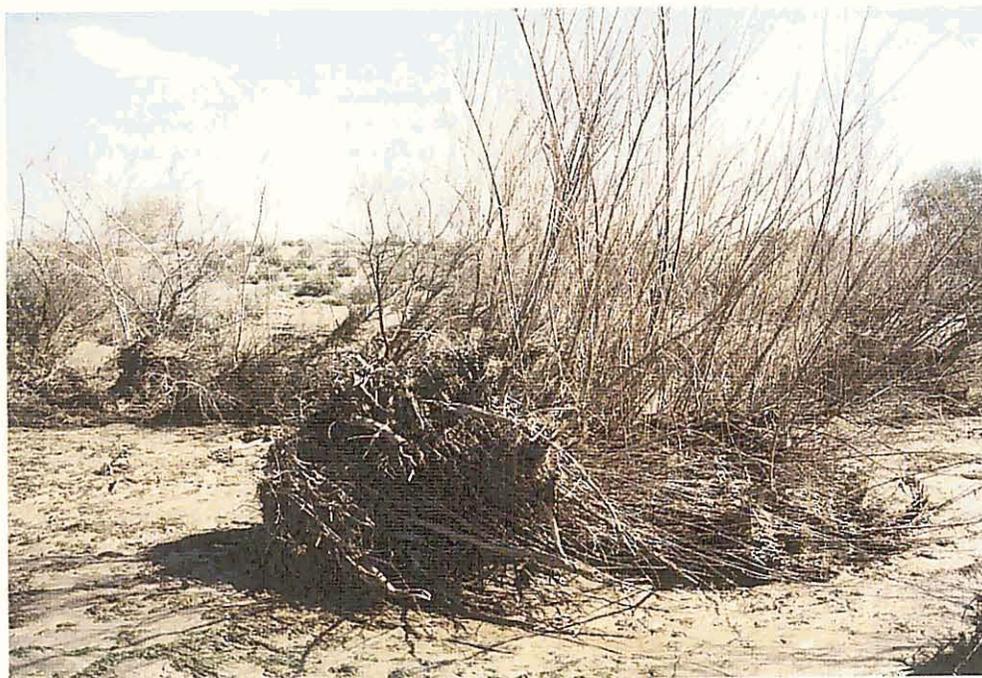
**Figure 7.** Saltcedar that was little affected by flow primarily because of the relatively low ratio of flow depth to vegetation height.

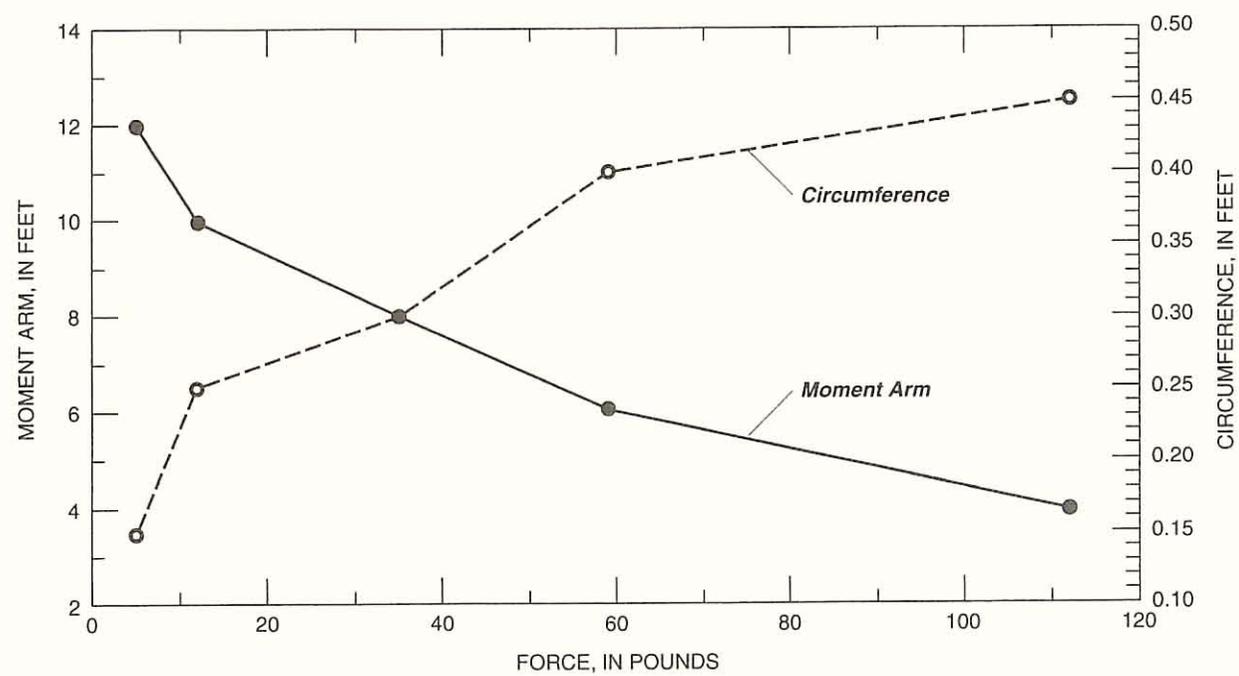
**Figure 8.** Relation between moment arm and the force required to bend vegetation to 45° past vertical. Circumference was measured at the immediate location in which the dynamometer was placed. A 15-foot-tall saltcedar was used for this example.

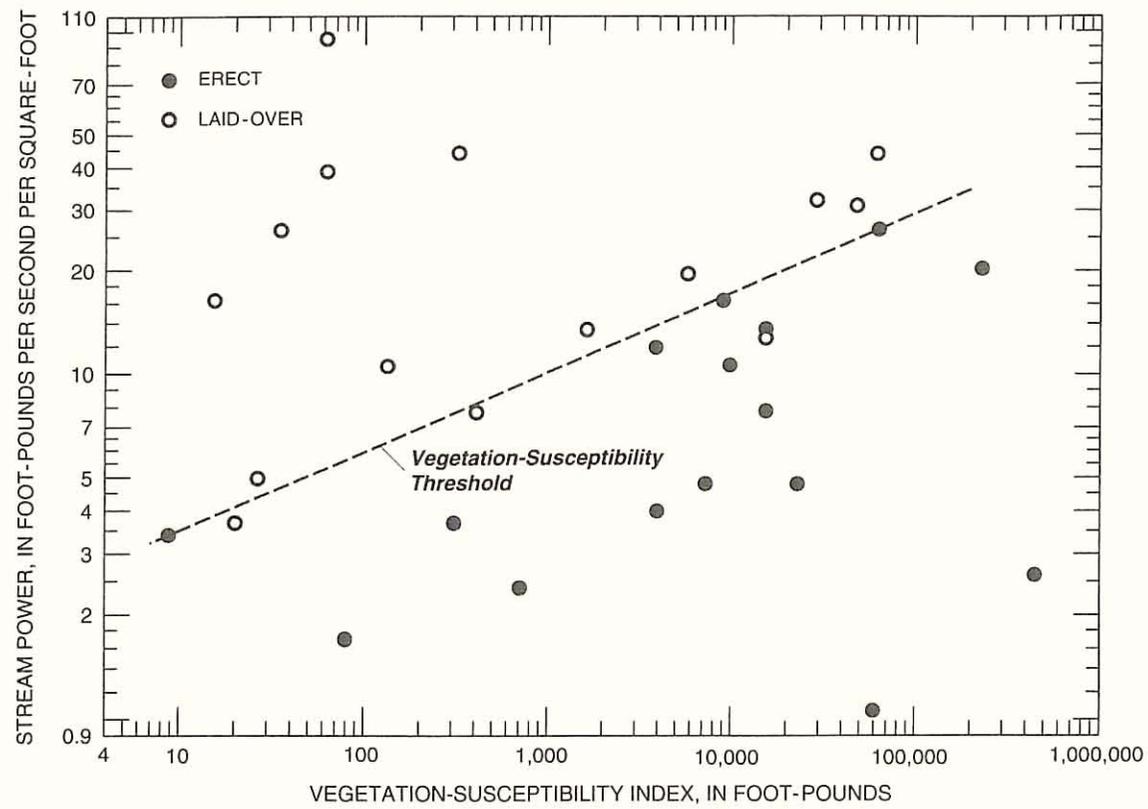
**Figure 9.** Vegetation conditions resulting from 22 flows at 17 sites, as a function of stream power and the vegetation-susceptibility index. The equation for the line in the figure is,  $SP = 2.054 K_v^{0.231}$ .

Vegetation removal does not necessarily depend on initial proneness of the vegetation. Although the power of flow may not be of sufficient magnitude to substantially lay over the vegetation, the flow may still be large enough to degrade the channel substrate to the point that the vegetation's root system is exposed and may result in total removal of the vegetation. Data from flows that removed the majority of the channel vegetation, therefore, were not used for the relation in figure 9.

Use of the relation (fig. 9) presented in this report to estimate the effect of flow on vegetation conditions requires quantification of the stream power as well as the vegetation-susceptibility index. Information obtained from a detailed description of the channel and vegetation conditions in the reach as well as a survey of the study reach can be used to compute the vegetation-susceptibility index. For the hydraulic computations, the standard-step method (Shearman, 1990) is used. This method requires solution of the energy equation, continuity equation, and Manning's equation. Components required to compute stream power are obtained from the standard-step computational results.

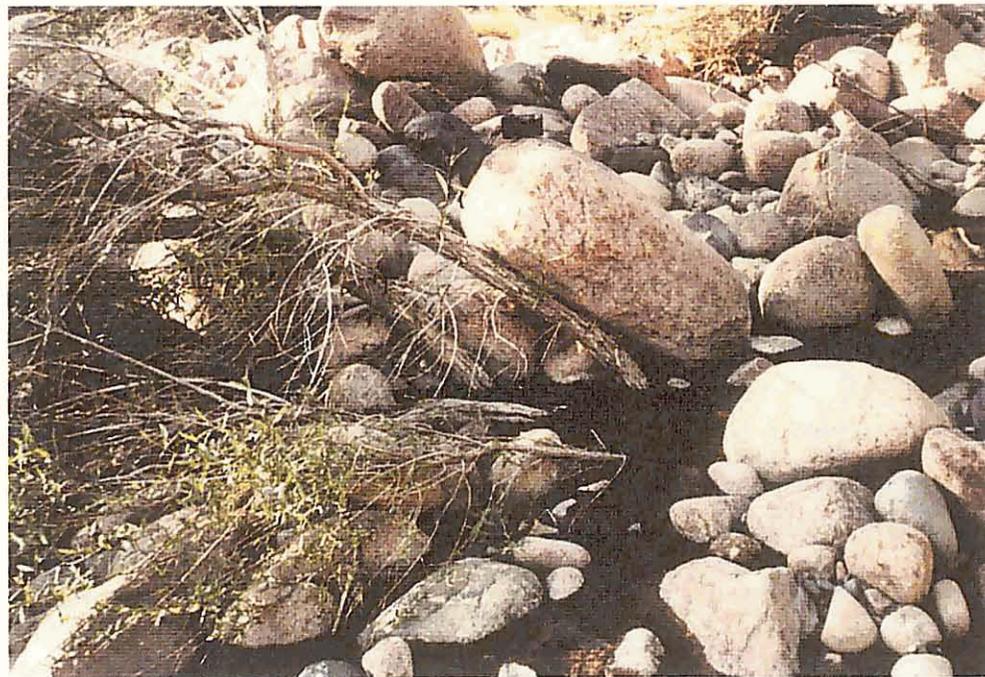
**Figure 10.** Effect of transported cobbles and boulders on riparian vegetation.

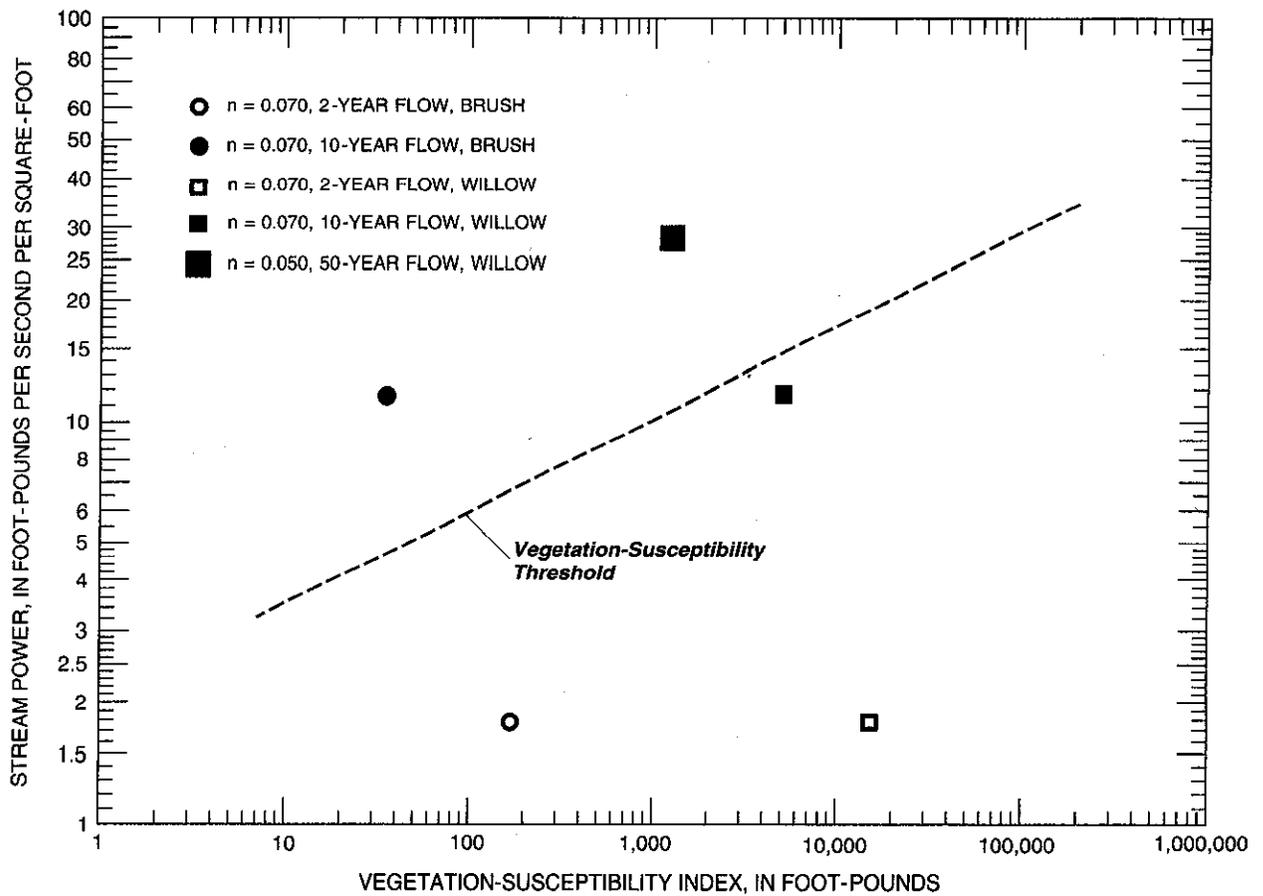
**Figure 11.** Effect of the 2-year and 10-year flow on brush and willow for roughness coefficient (*n*) equal to 0.070. Also shown is the effect of the 50-year flow on willow for *n* equal to 0.050.

Because it was determined that a 50-year flow is adequate to lay over vegetation growing in this channel, it is assumed that the vegetation will be laid over on the rising limb of the hydrograph for the 100-year flow. The resultant effect would be a dynamic decrease of flow resistance and increase in channel conveyance compared to conveyance computations made on the basis of preflow-vegetation conditions.

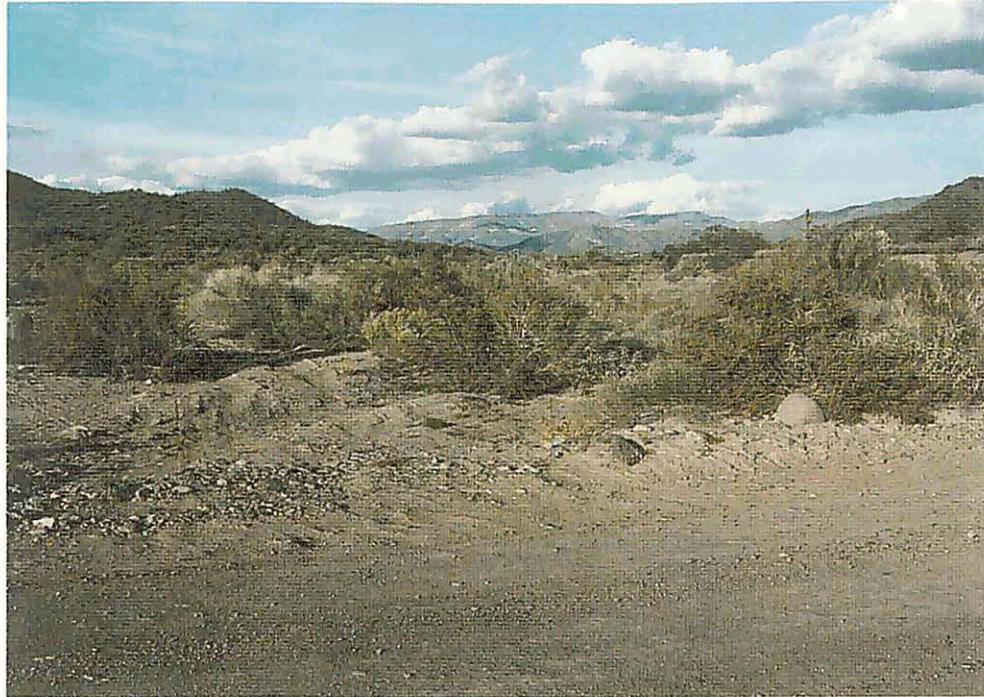
**Figure 12.** View from New River Road crossing looking upstream before the flow of January 8, 1993, Cave Creek above New River Road (site 7).

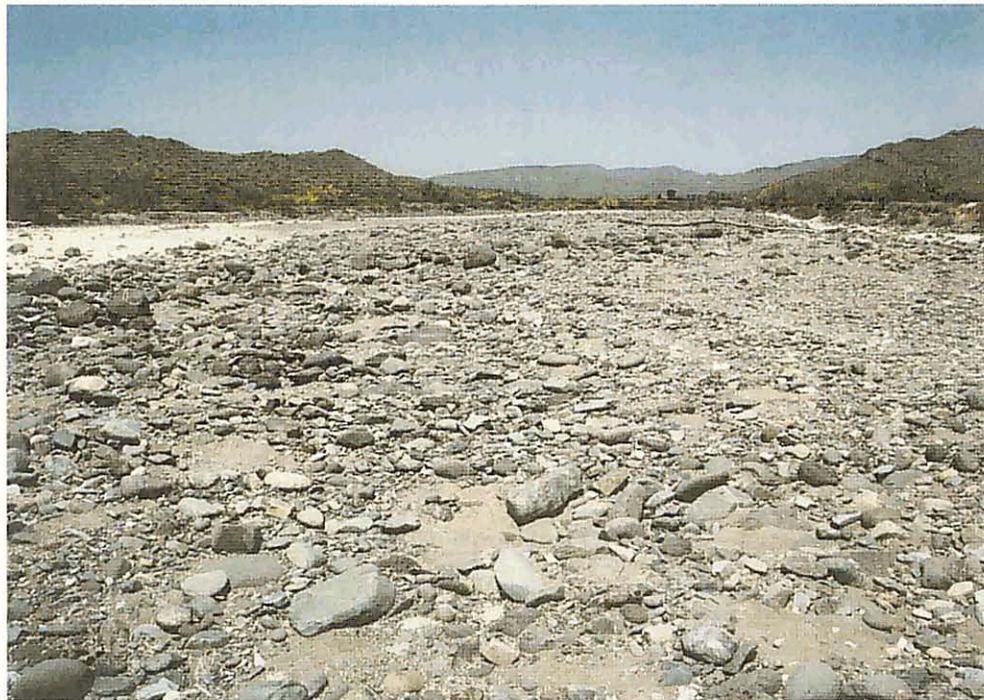
**Figure 13.** View from New River Road crossing looking upstream after the flow of January 8, 1993, Cave Creek above New River Road (site 7). Road crossing was washed out as a result of significant bedload transport during the flow.

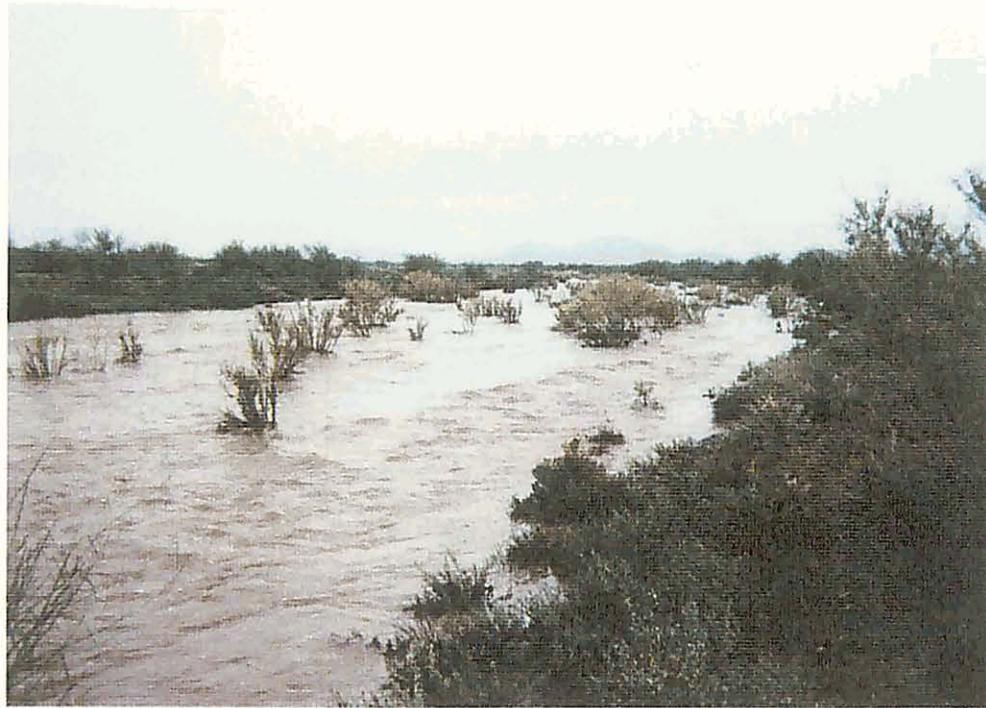
**Figure 14.** Looking upstream from left bank during the flow of March 1, 1991, Skunk Creek above Interstate 17 (site 2).

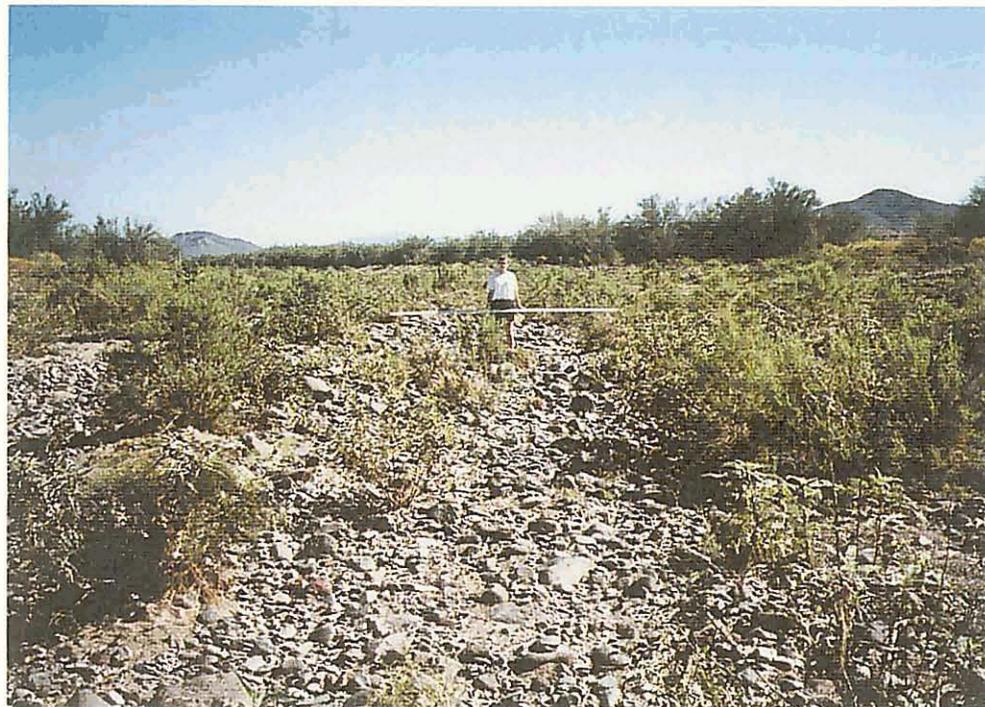
**Figure 15.** Looking upstream from midchannel after the flow of September 28, 1995, Skunk Creek above Interstate 17 (site 2).

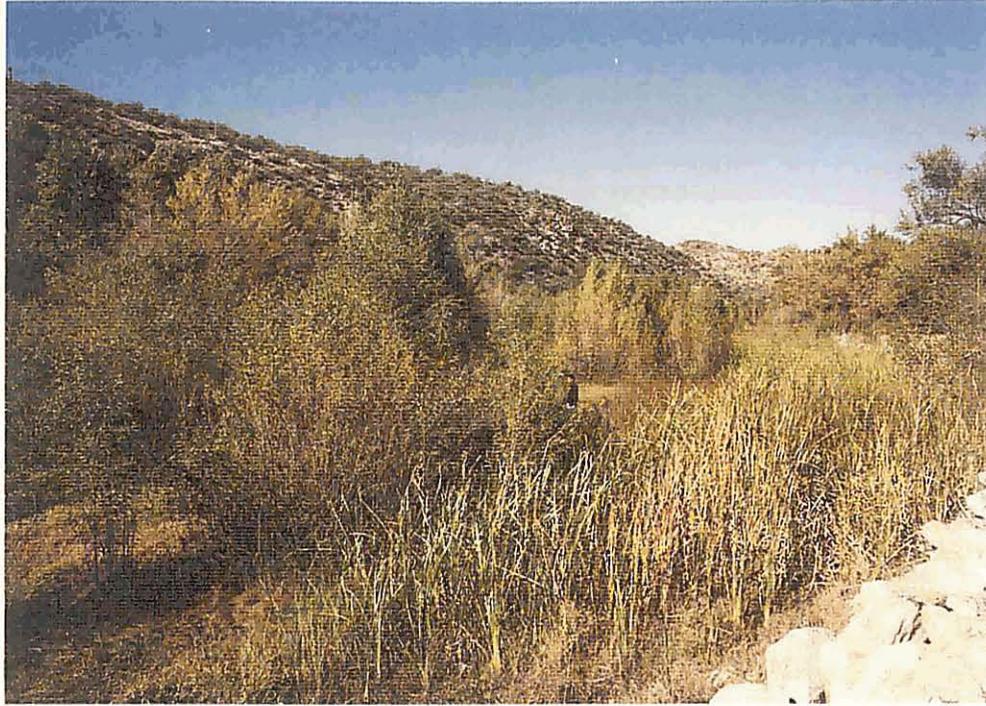
**Figure 16.** View from left bank of channel looking upstream before the flow of February 15, 1995, Hassayampa River near Wickenburg (site 9).

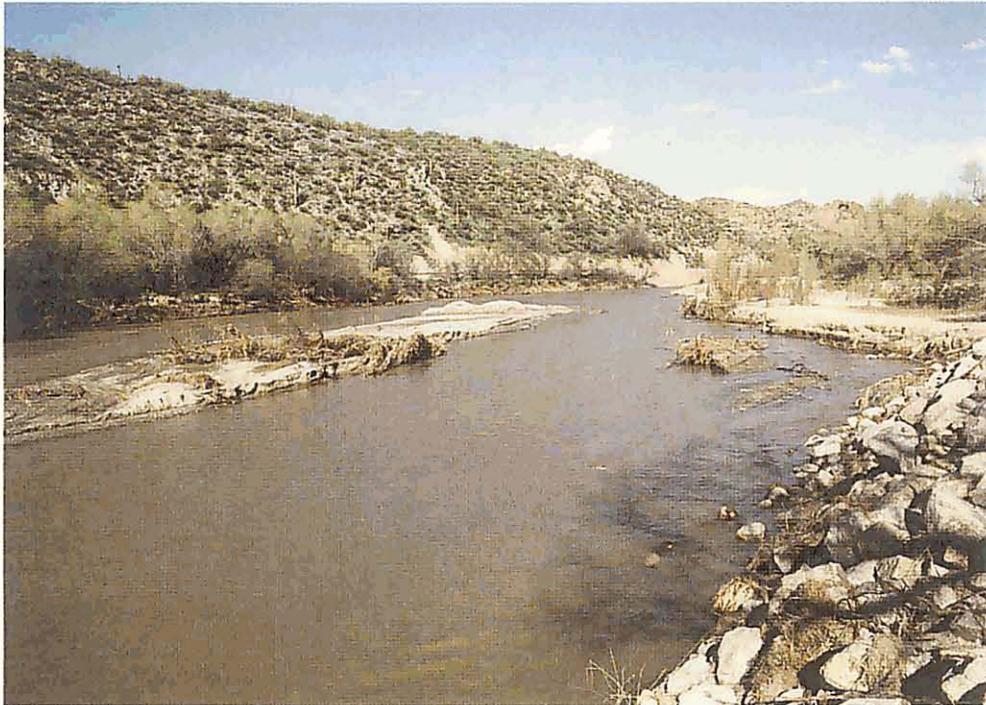
**Figure 17.** View from left bank of channel looking upstream after the flow of February 15, 1995, Hassayampa River near Wickenburg (site 9).

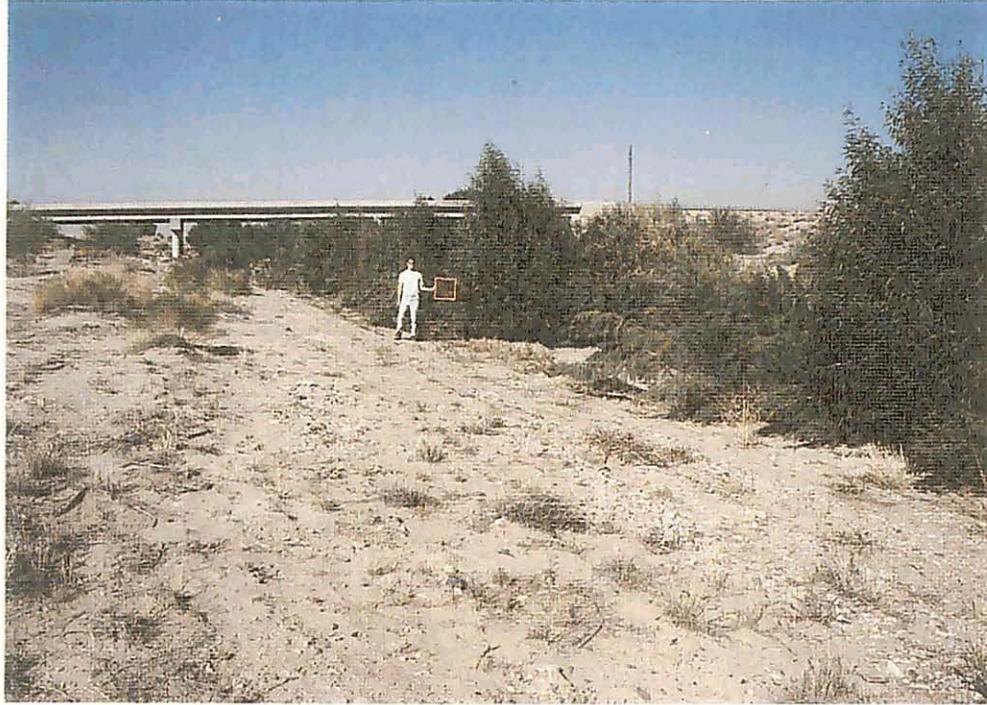
**Figure 18.** View from right bank looking upstream before the flow of February 15, 1995, Hassayampa River near Arlington (site 5).

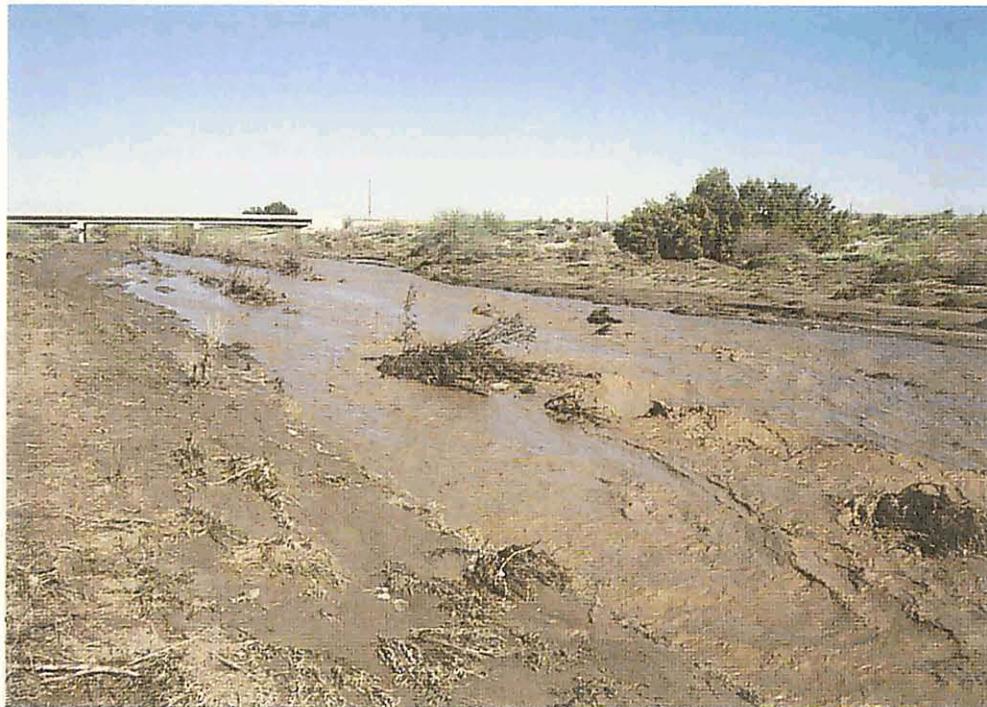
**Figure 19.** View from right bank looking upstream after the flow of February 15, 1995, Hassayampa River near Arlington (site 5).

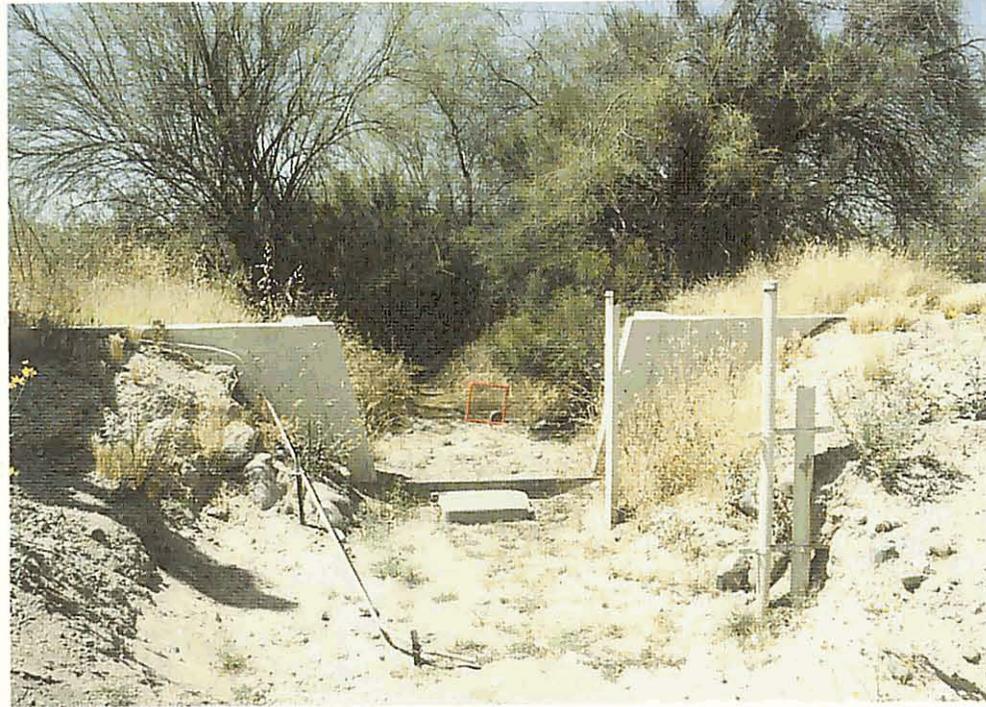
**Figure 20.** Looking downstream from midchannel before the flow of December 10, 1991, Agua Fria River tributary near Youngtown (site 13).

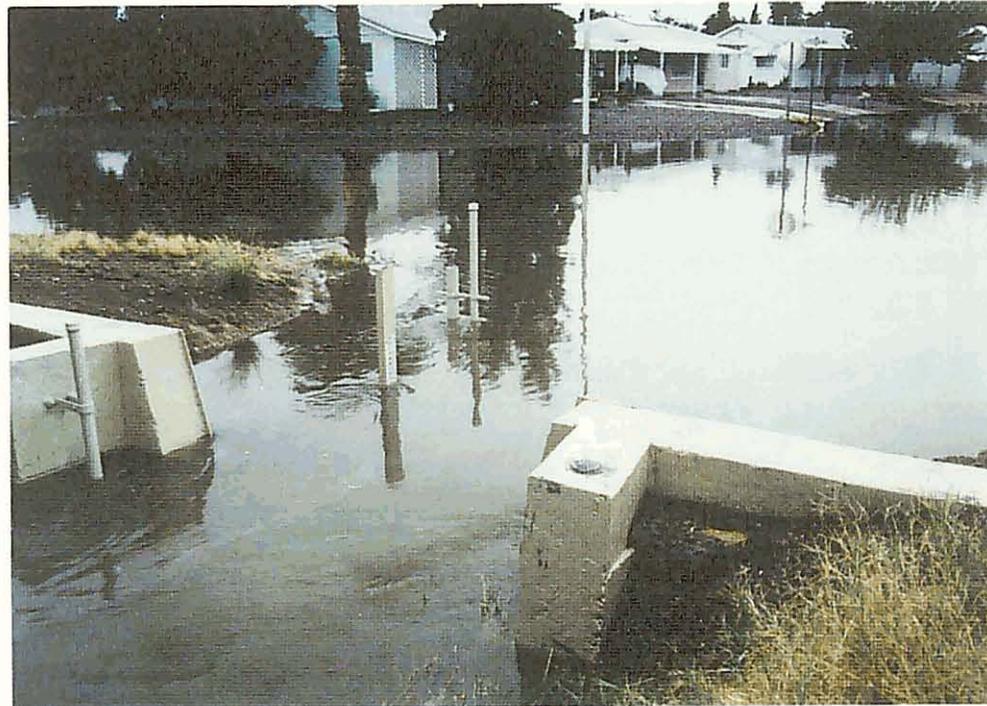
**Figure 21.** Looking upstream from left bank during the flow of December 10, 1991, Agua Fria River tributary near Youngtown (site 13). Vegetation was unaffected by flow and resulted in a significant backwater effect and road closure.

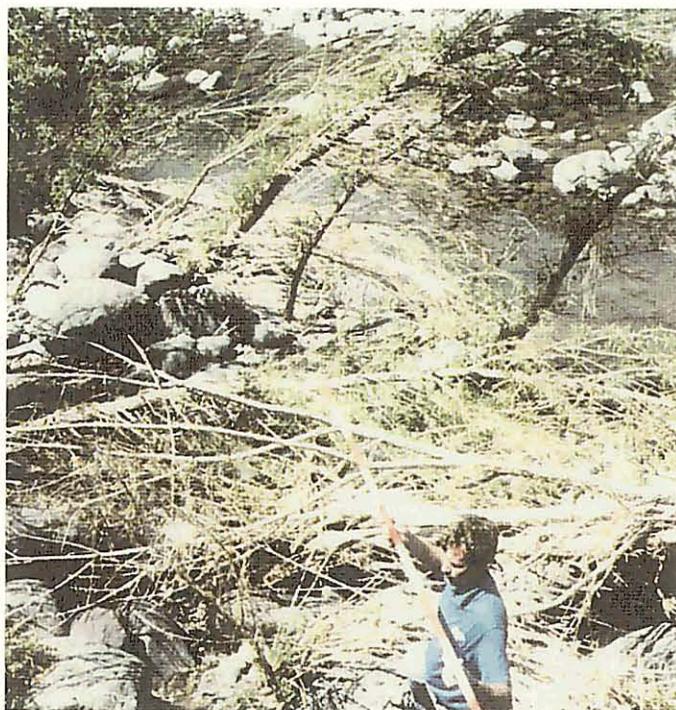
**Figure 22.** View from right bank looking toward laid-over willow in the main channel after the flow of January 8, 1993, Francis Creek near Bagdad (site 10).

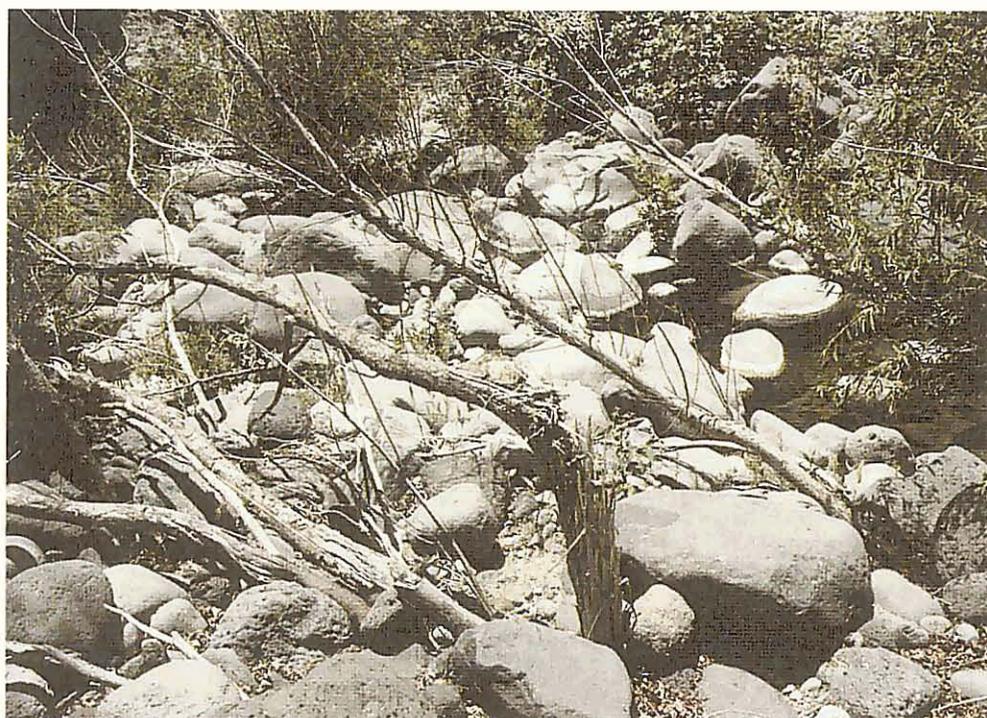
**Figure 23.** Looking across the channel from left bank toward several laid-over willows after the flow of January 8, 1993, Francis Creek near Bagdad (site 10).

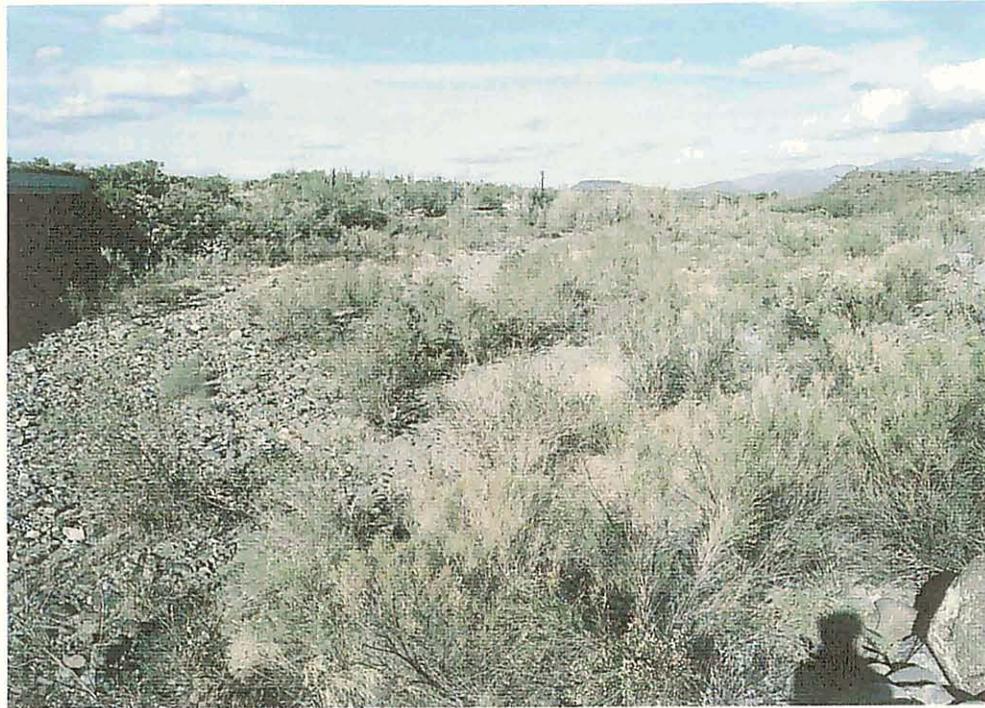
**Figure 24.** Looking upstream from left bank before the flow of January 8, 1993, New River above Interstate 17 (site 8).

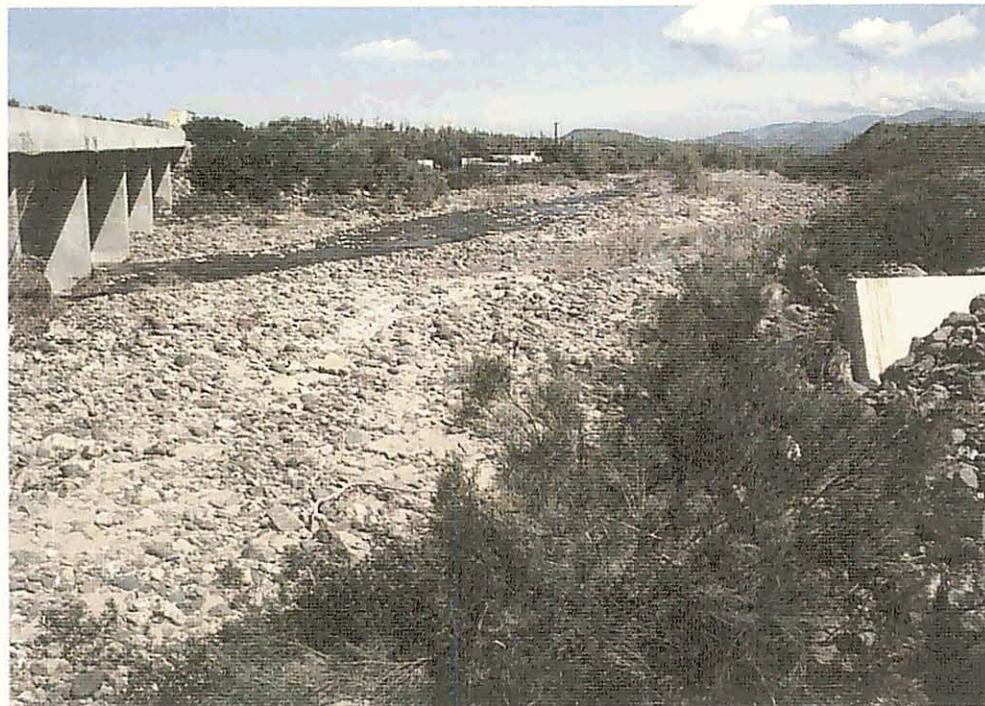
**Figure 25.** Looking upstream from left bank after the flow of January 8, 1993, New River above Interstate 17 (site 8).

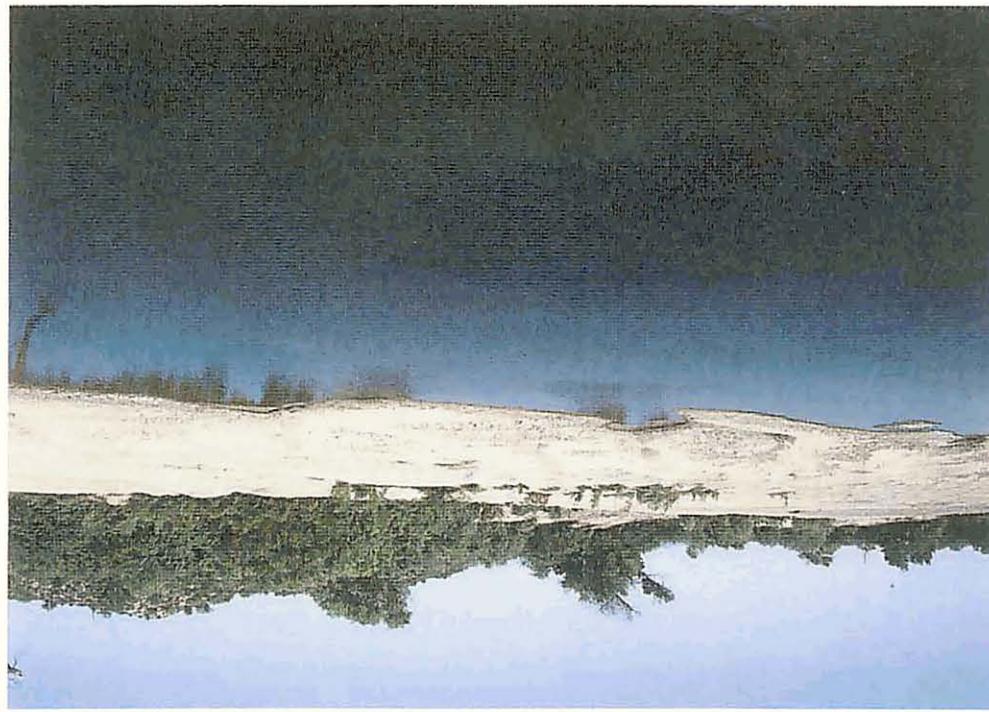
Figure 26. Looking upstream from right bank before the flow of January 8, 1993, Verde River near Scottsdale (site 1).
