# Method to Estimate Effects of Flow-Induced Vegetation Changes on Channel Conveyances of Streams in Central Arizona

Water-Resources Investigations Report 98-4040

*Prepared in cooperation with the  
Flood Control District of Maricopa County*

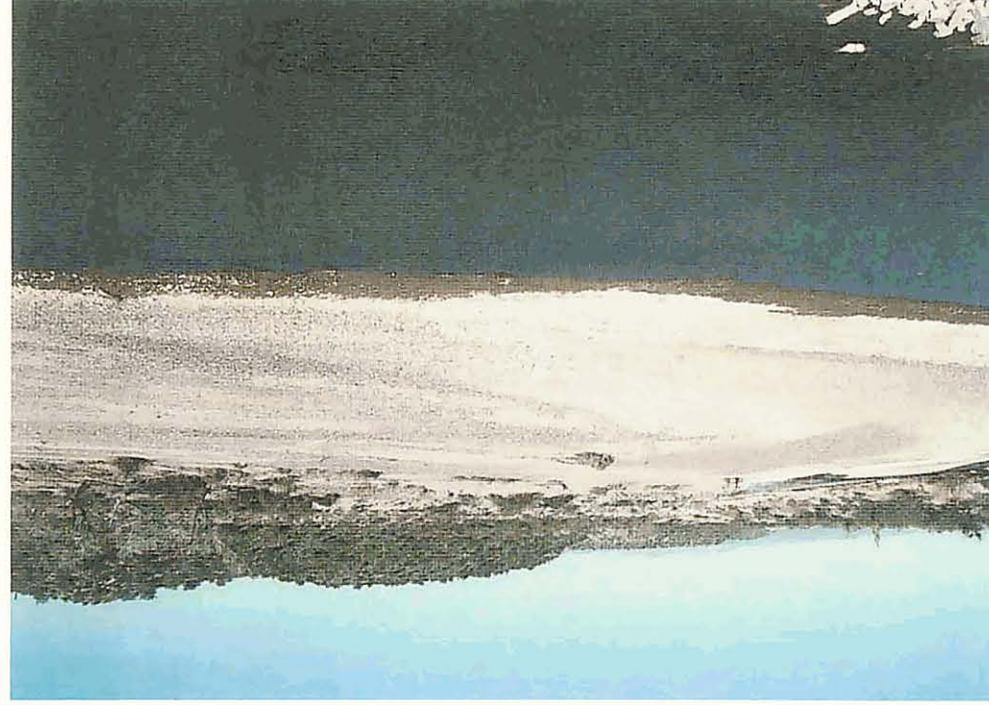
Figure 27. Looking upstream from right bank after the flow of January 8, 1993, Verde River near Scottsdale (site 1). Vegetation on left bank was substantially affected by flow.

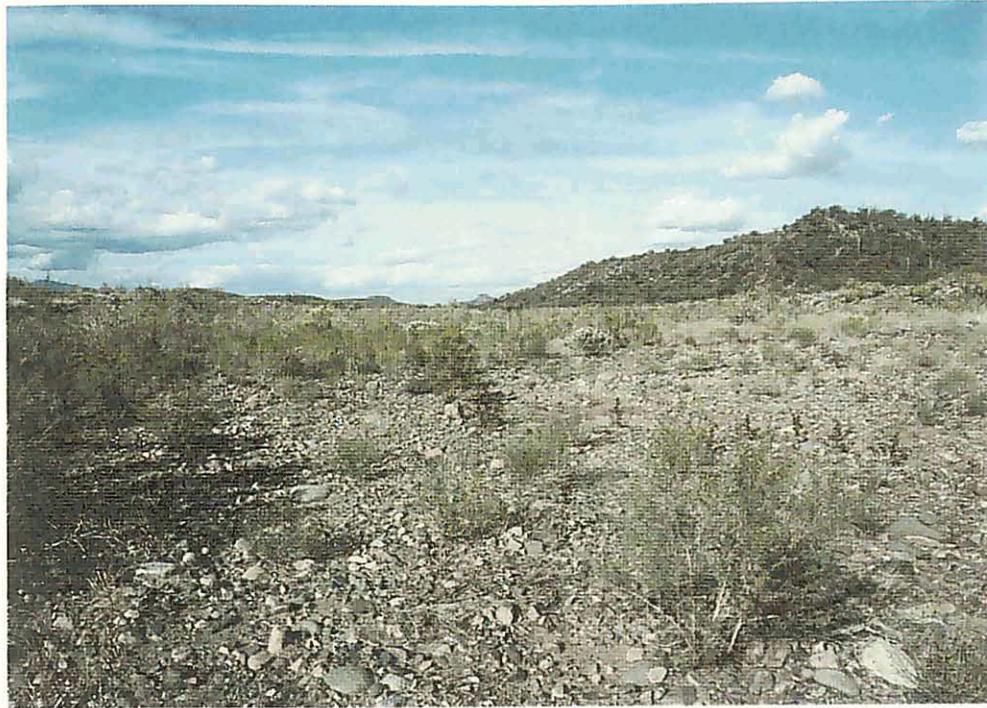
**Figure 28.** Looking upstream from midchannel before the flow of January 8, 1993, New River above New River Road (site 16).

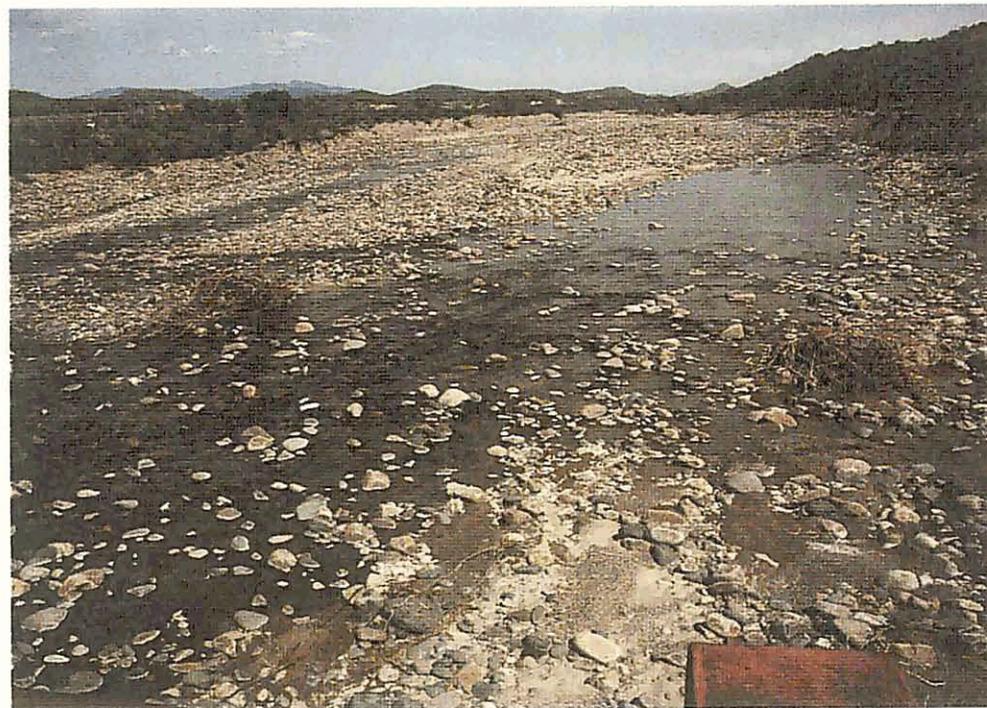
**Figure 29.** Looking upstream from midchannel after the flow of January 8, 1993, New River above New River Road (site 16).

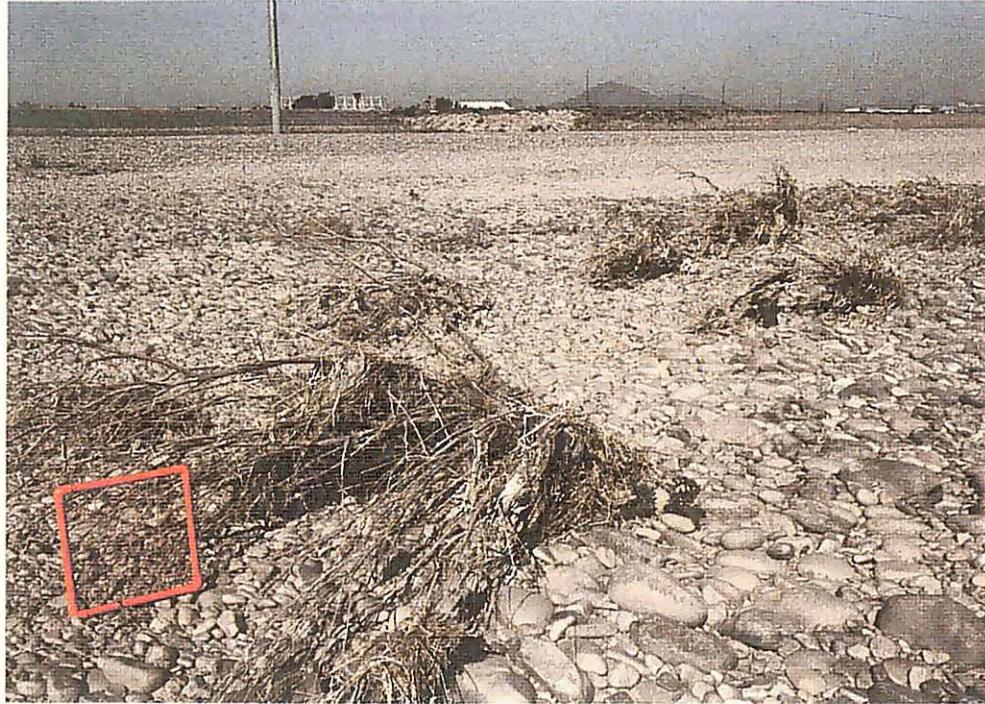
**Figure 30.** Looking upstream from midchannel at laid-over brush after the flow of January 8, 1993, Salt River above Interstate 10 (site 6). The square reference (painted orange) has an outside dimension of 1.5 feet.

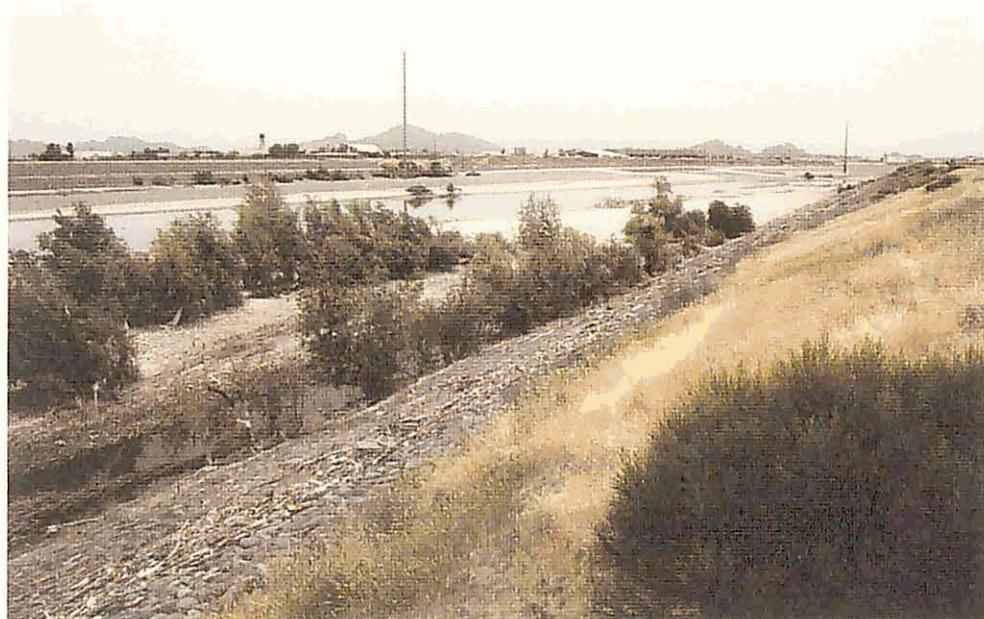
**Figure 31.** Looking upstream from left bank at willow after the flow of January 8, 1993, Salt River above Interstate 10 (site 6).
