ARIZONA DEPARTMENT OF TRANSPORTATION

REPORT NUMBER: FHWA-AZ-7904

PERFORMANCE OF CONCRETE JOINT SEALANTS IN HOT CLIMATES

Final Report

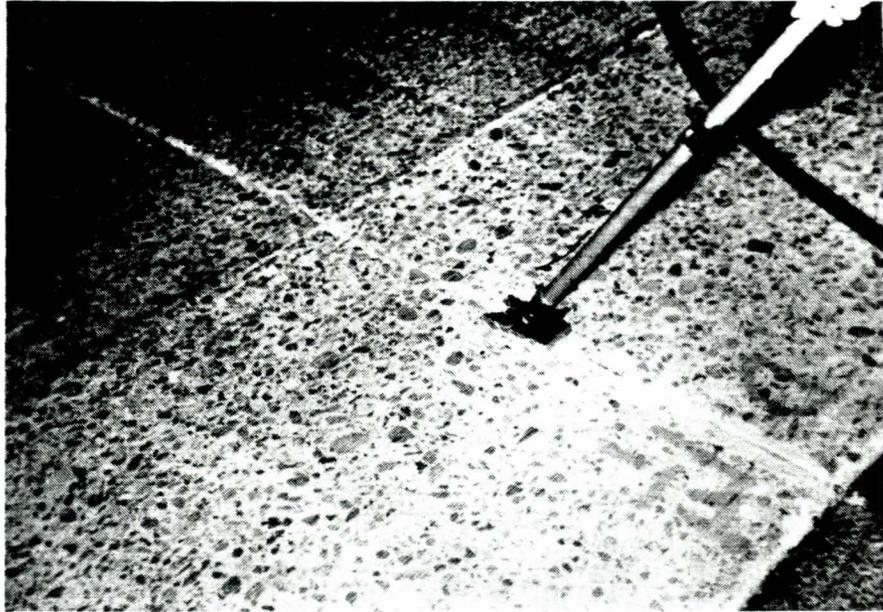
FIGURE 9. - PLACING DOW CORNING 888

The equipment used to place the sealant consisted of a pneumatic pump designed to pump the material from five gallon containers through a flexible hose to an operator held wand (Figures 8 and 9). The four foot long wand was held at a sixty degree angle to the pavement surface during operation. An operator controlled flow valve was mounted at the upper end of the wand and a nozzle tapered to fit into the joint was attached to the lower end of the wand. In order to guide the cold-flow

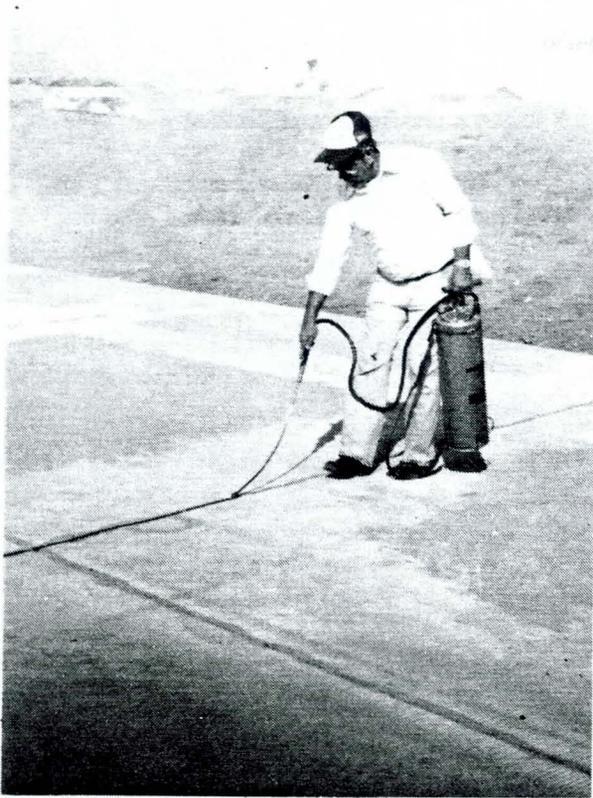
FIGURE 16 - PRIMING JOINTS

A 5/8" polyurethane backer rod was placed and a primer was sprayed on the joint faces. The sealant was handled and placed the same as the I-17 silicone sealant. The experimental and conventional material were placed using the same procedures.

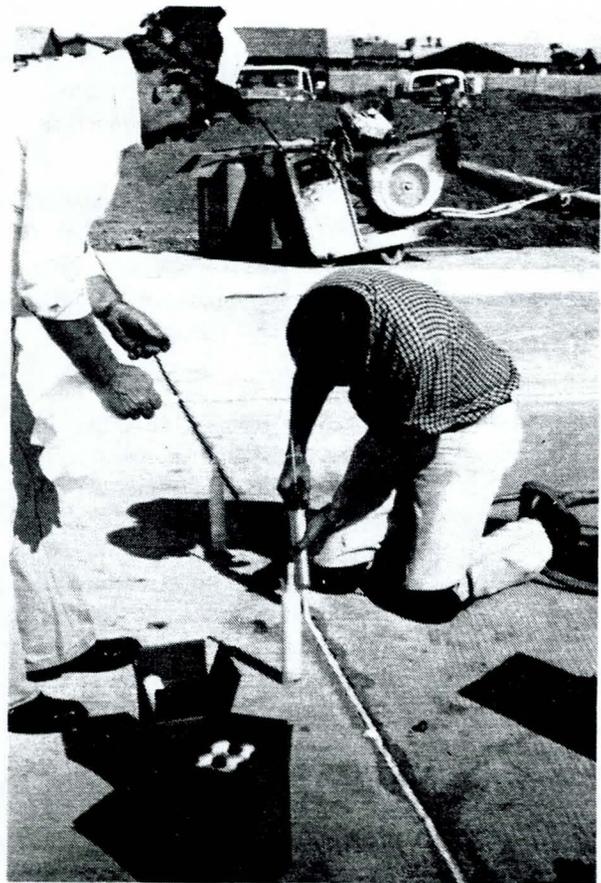
FIGURE 17. - PLACING POLYURETHANE

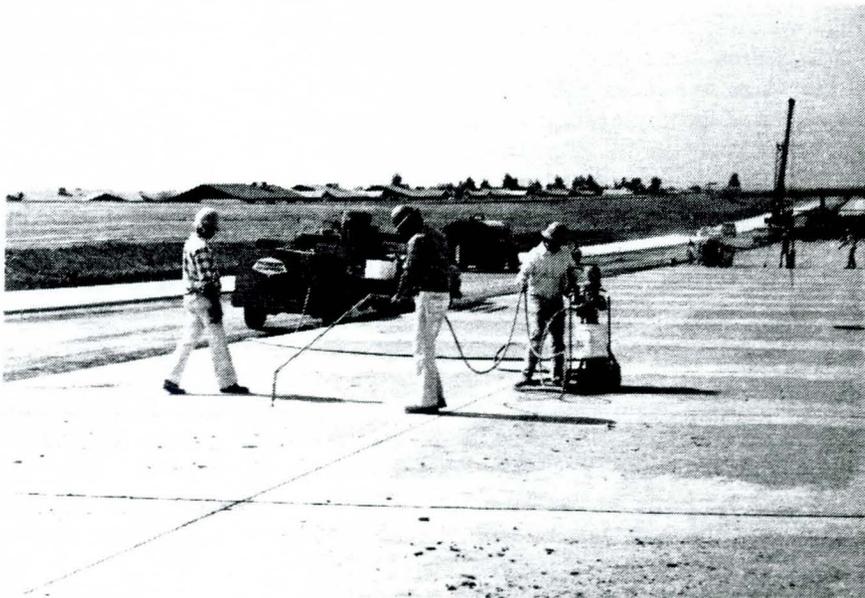
FIGURE 18- PLACING G. E. SILICONE

Immediately following construction the G. E. Silicone sealant looked good. It was easy to place and produced a neat joint. In 1985 the product was still performing well. The joints were sealed and the material was resilient. In 1987 it was noted that nine of the joints had bond failure along portions of the joint. Where it was not bonded the sealant was black and at the rest of the joint it was brown. Further inspection revealed that the sealant had failed where it had not been properly tooled. The material was too high and traffic had caused the material to debond. At the locations where the sealant was tooled below the surface the sealant was performing well.
