Property of  
Flood Control District of MC Library  
Please Return to  
2801 W. Durango  
Phoenix, AZ 85009

Rittenhouse Flood Retarding Structure - Tuesday, April 26, 1977

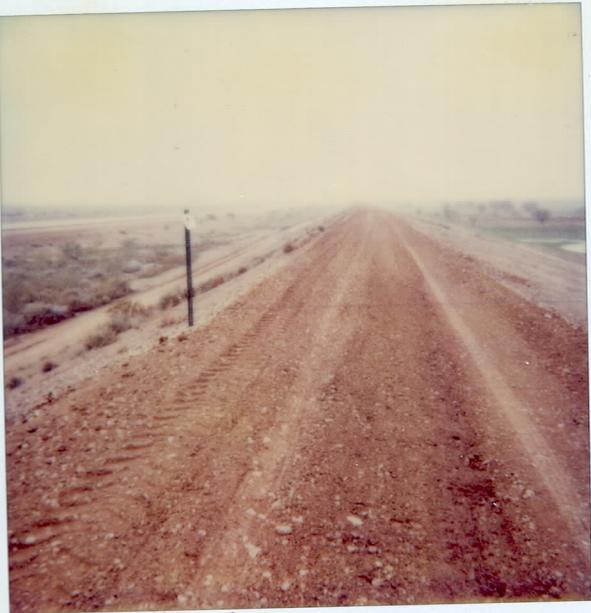
Jan 9, 91. VINEYARD PLATING  
STA 320+00 LOOKING NORTH

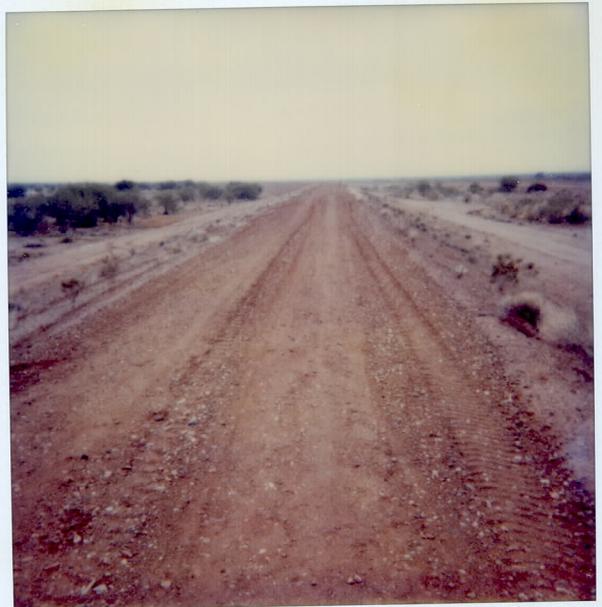
VINEYARD PLATING. JAN 3 91  
STA 175+00 LOOKING SOUTH

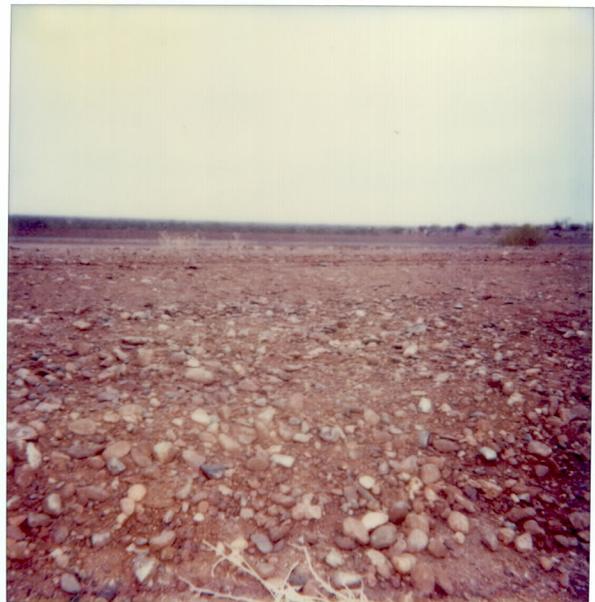
JAN 3, 90 VINEYARD RD.  
PLATING MATERIAL -  
NOTICE EXCESS ROCKS

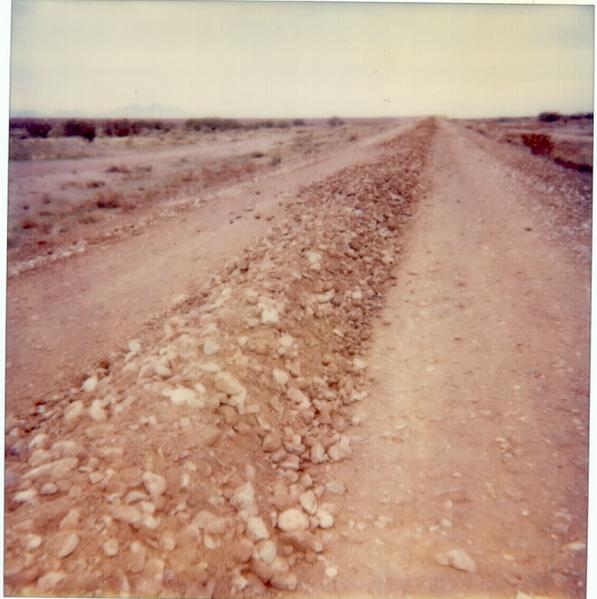
VINEYARD PLATING. JAN 3, 91  
NOTE THE BIG SIZE ROCKS

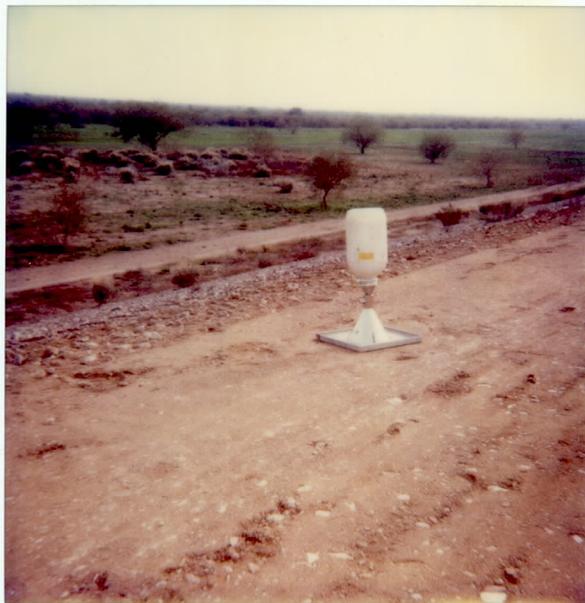
VINEYARD FRS -  
"SAND CONE" COMPACTION TESTING  
OF PLATING - JAN 11, 91.

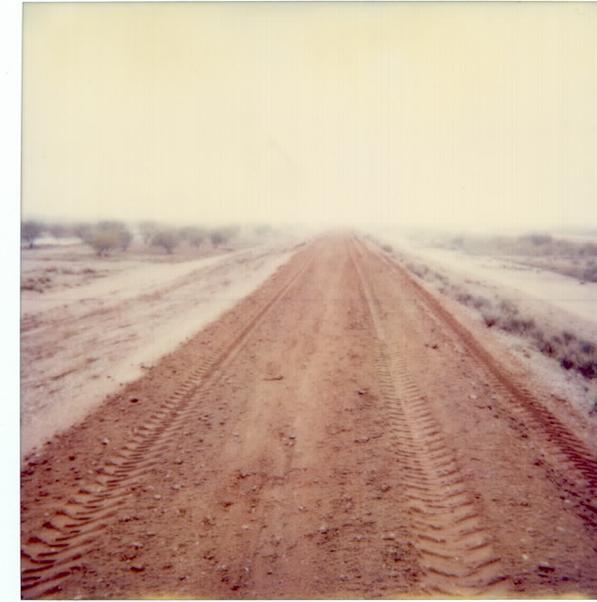
JAN 9, 91. VINEYARD PLATING -  
STA 215+00 LOOKING NORTH  
MATERIAL WITH LESS ROCK.

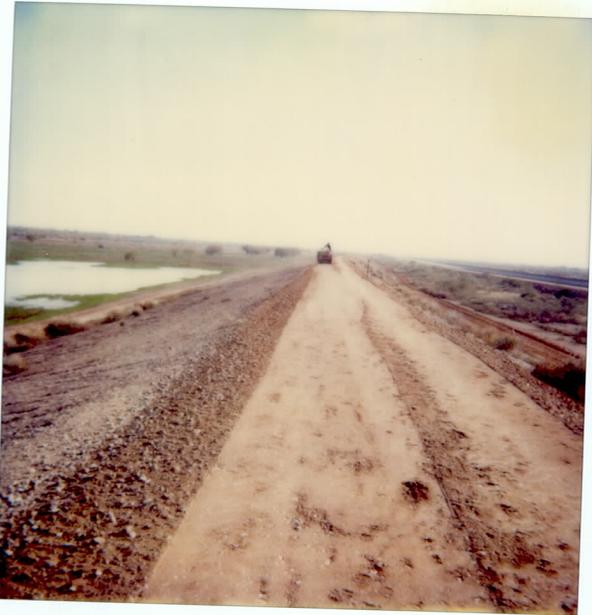
VINEYARD PLATING. 1.10.91.  
ROLLING OF 4" PLATING WITH 8TON  
VIBRATORY ROLLER.

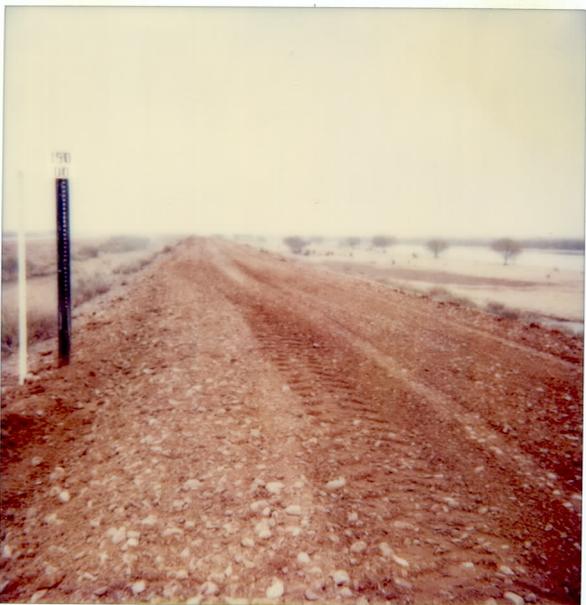
Jan 9, 91. VINEYARD PLATING  
STA 40+00 LOOKING N.  
NOTICE BIGGER ROLLS at edge.

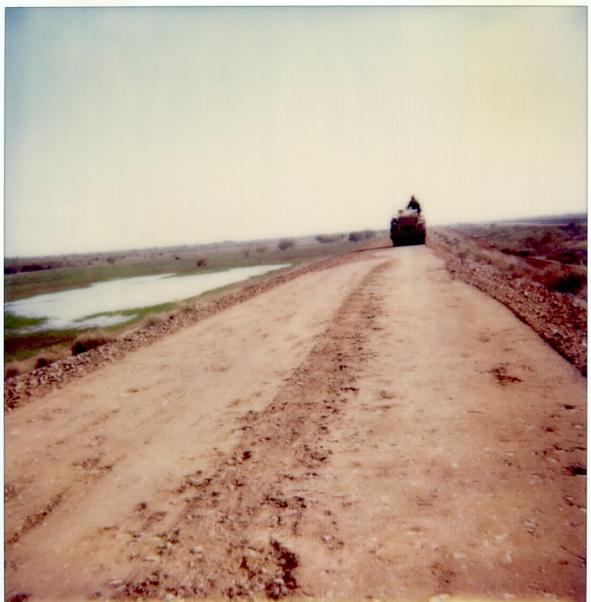
VINEYARD FRS. PLATING. 1.10.91  
ROLLING OF SERVICE ROAD WITH  
8TON VIBRATORY ROLLER AFTER PLATING

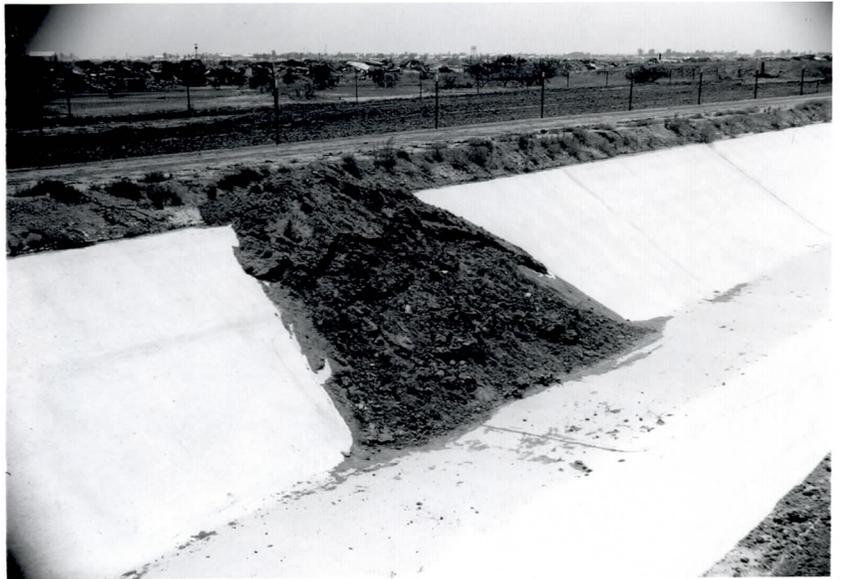
68-12 Dirt in channel to allow  
cattle to get out of  
channel (Before fencing)

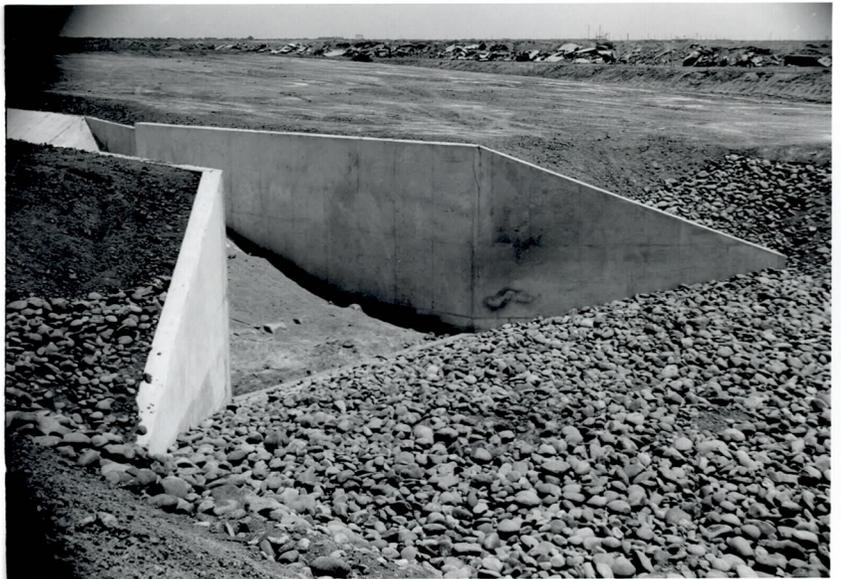
68-9 Transition section, Concrete to dirt-riprap. Energy dissipators almost fully covered with silt.

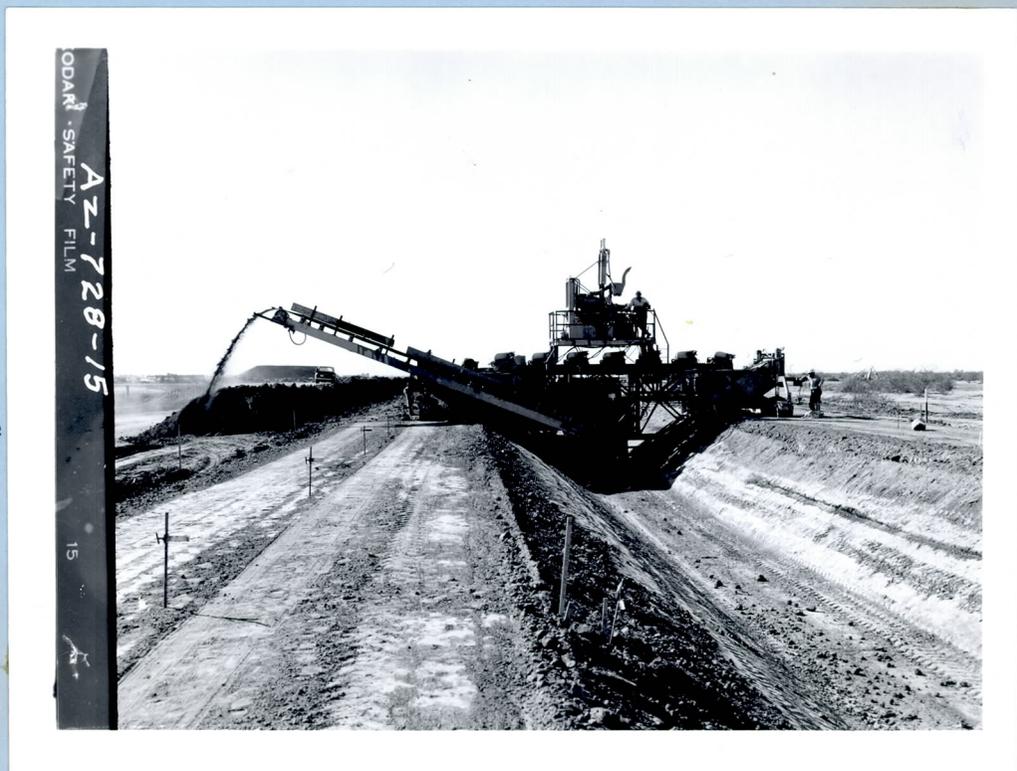
Trimmer shaping concrete  
section.

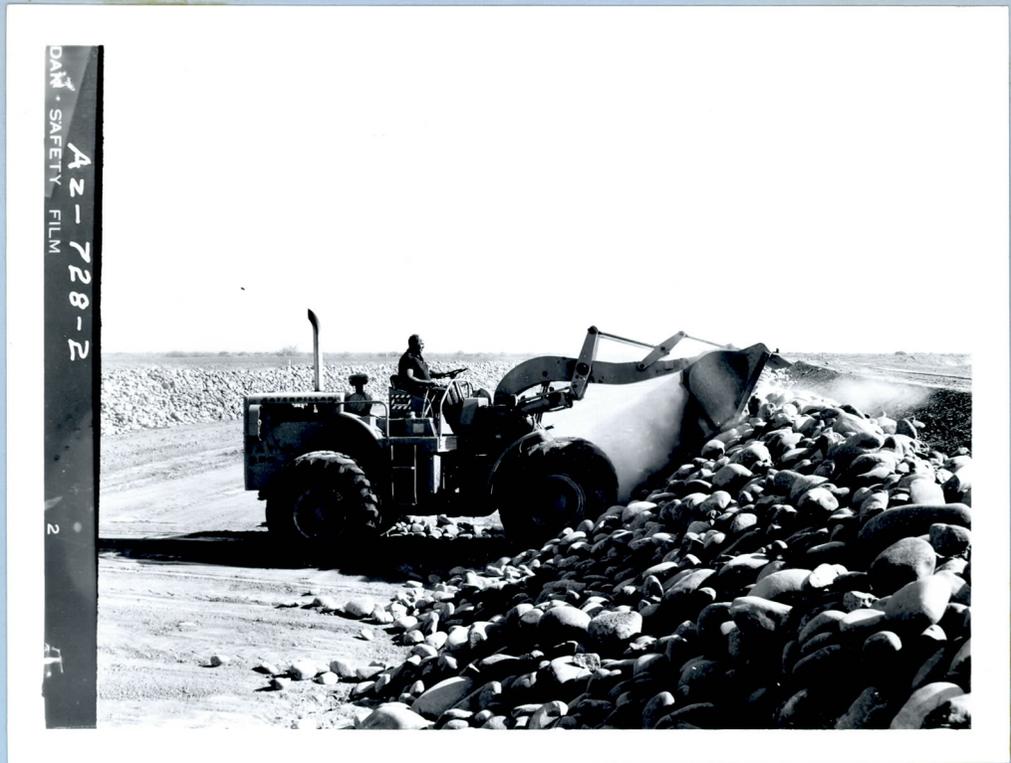
Powerline Floodway

Placing rock riprapping  
on slopes of Powerline  
Floodway.

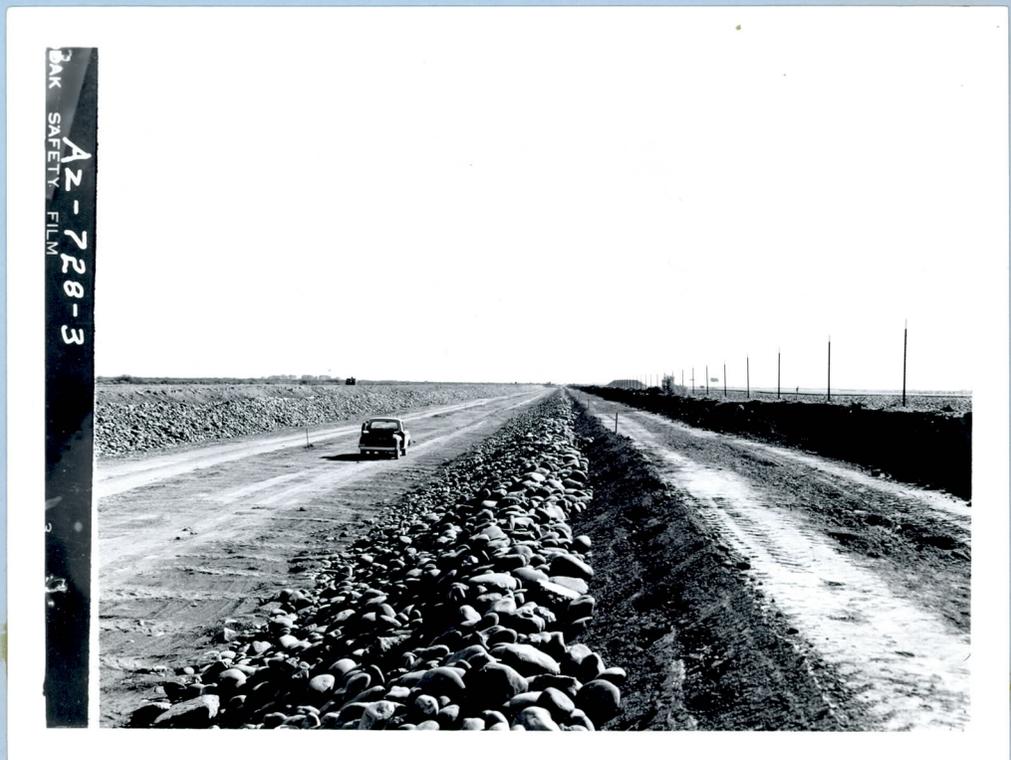
Rock riprapped section  
of Powerline Floodway  
along north side of  
W.A.F.B.

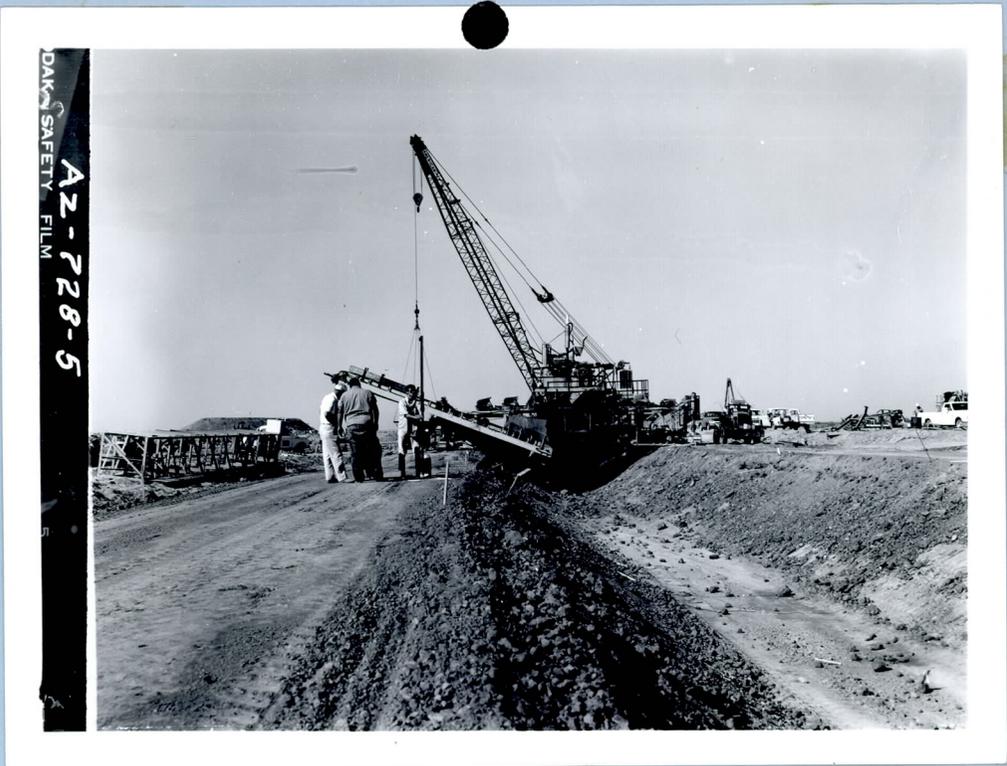
Assambling equipment  
for shaping and placing  
of concrete section of  
Powerline Floodway.

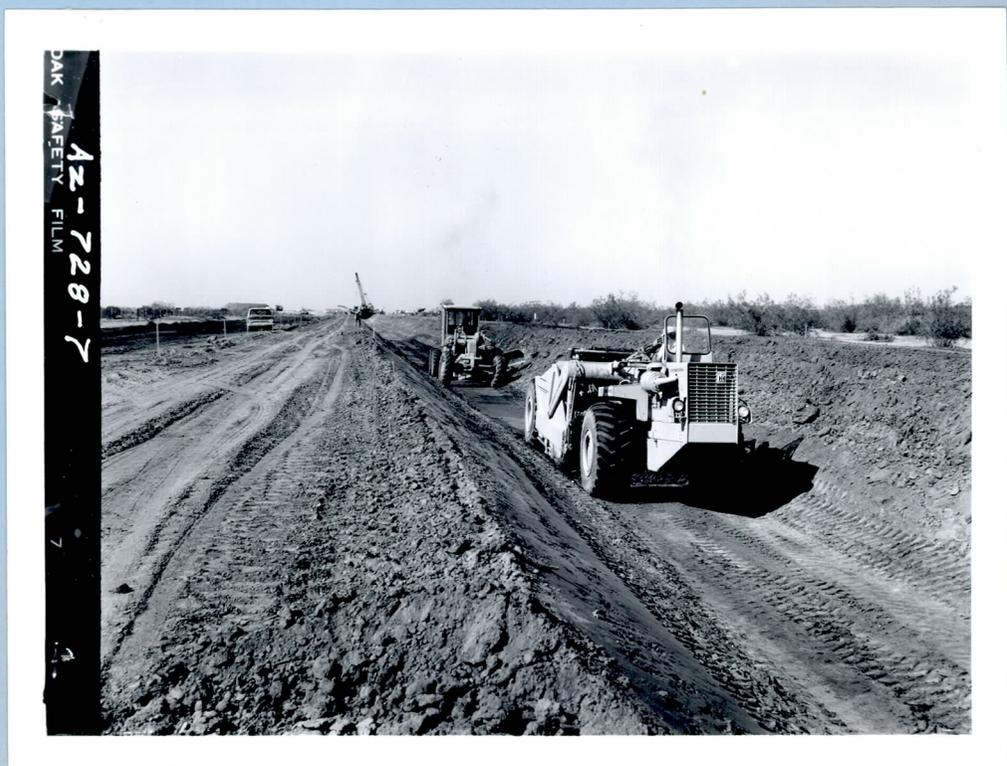
Excavation for concrete  
section of Powerline  
Floodway.

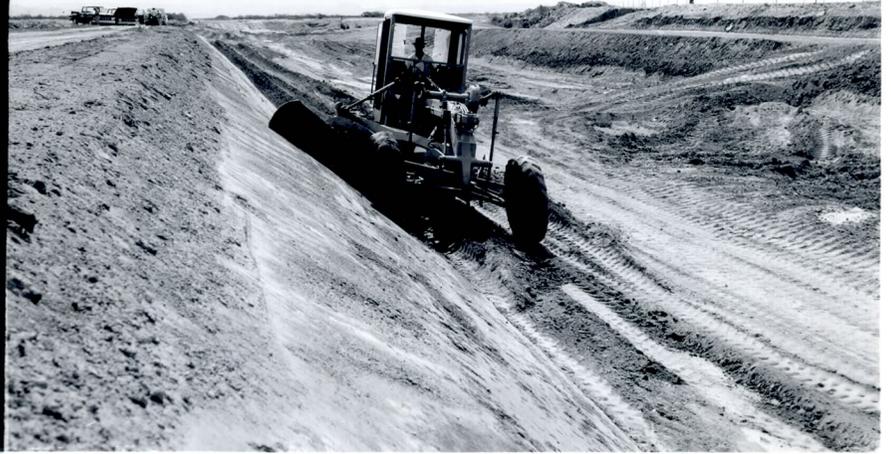
Az-683-1  
DAK SAFETY FILM

Trimming side sbpes of  
Powerline Floodway.

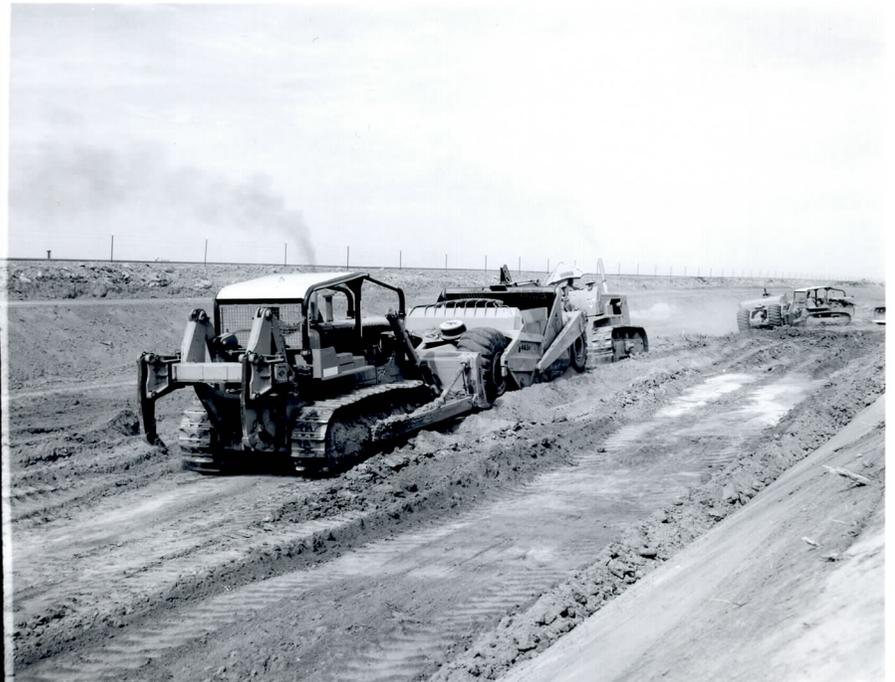
Az-683-2

Equipment excavating  
Powerline Floodway north  
of W.A.F.B.

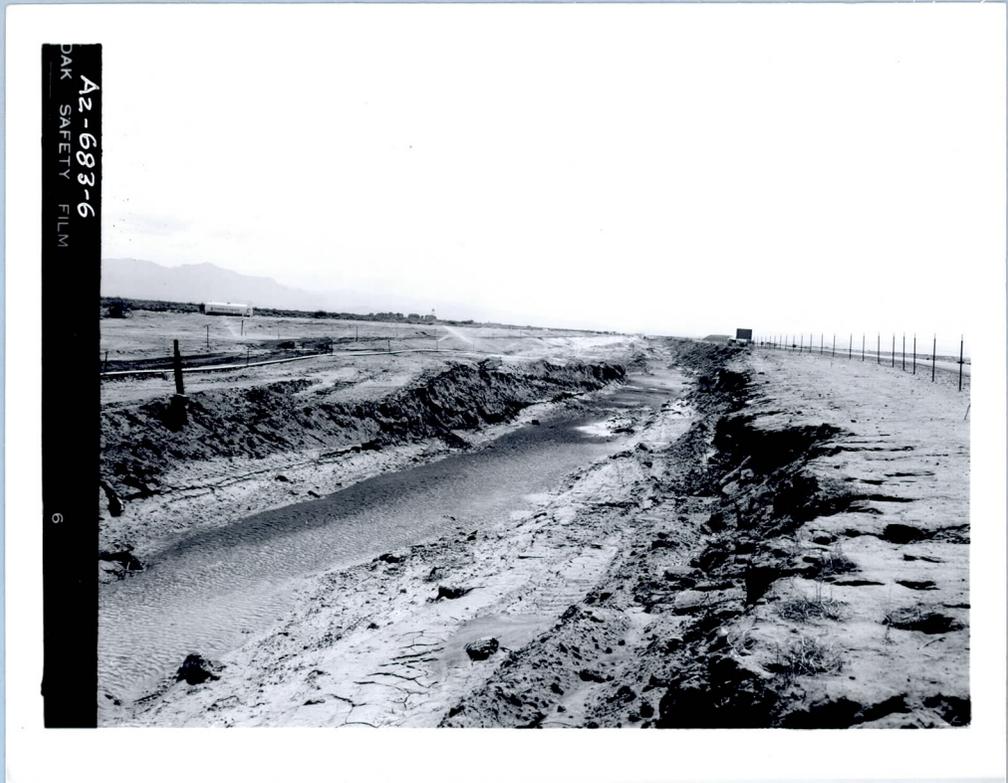
Powerline Floodway after  
clearing and grubbing  
operation and prior to  
excavation north of  
W.A.F.B.

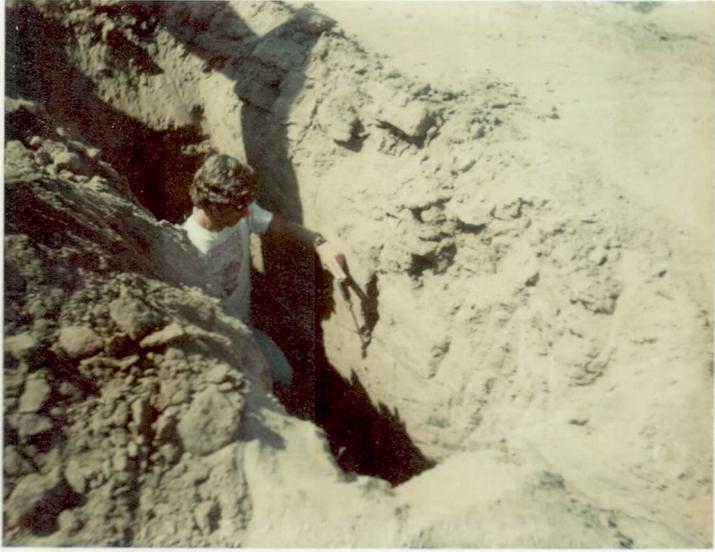
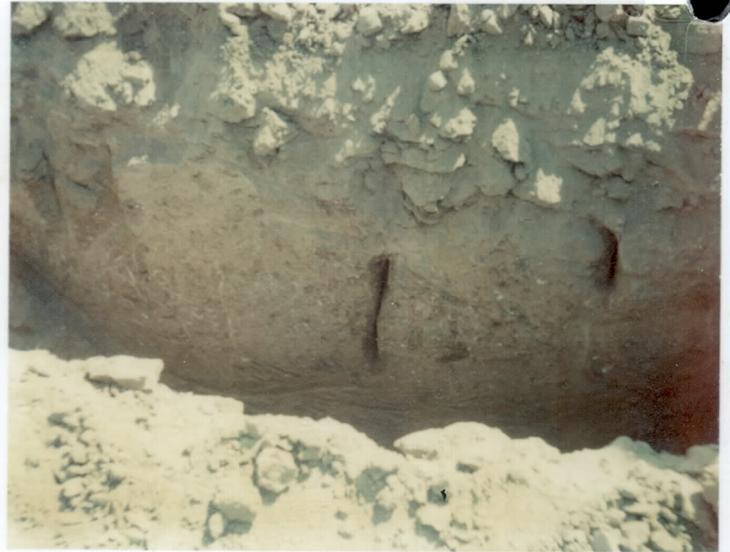
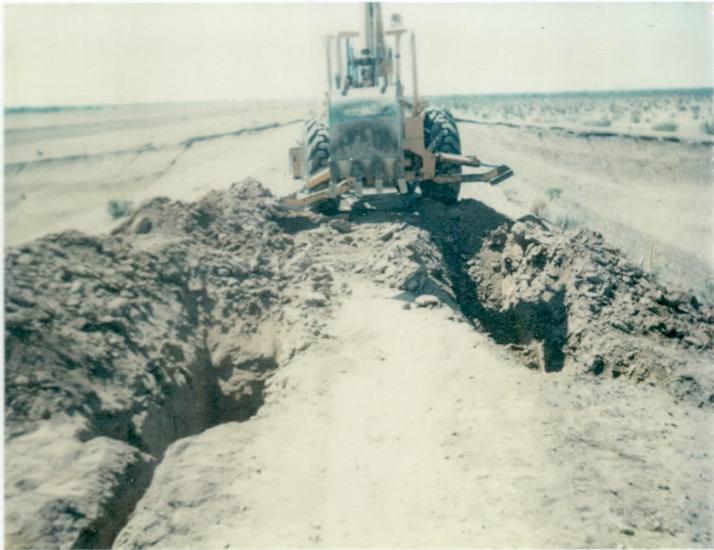
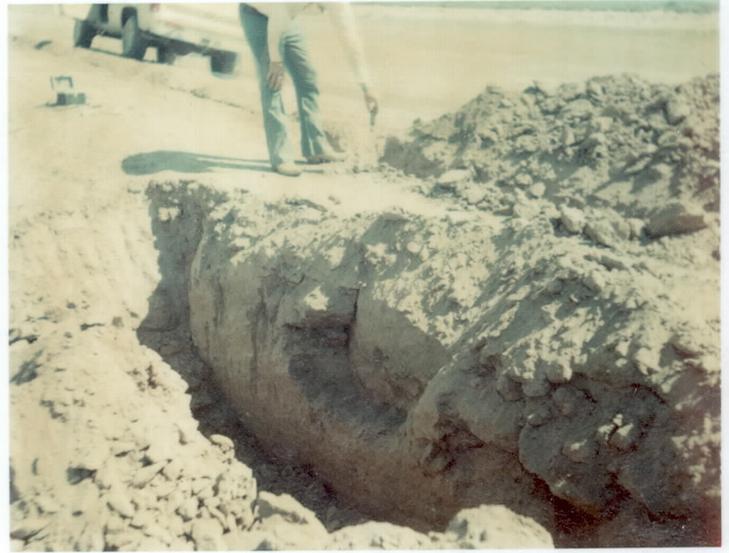
Station 98+38 - Excavation started in the centerline of the dam. The depth of the cut is  $5\frac{1}{2}$ ' , width  $3\frac{1}{2}$ ' , length 11' . We found transverse crack. Determined that the crack goes down 4' below the crest and was about  $\frac{1}{4}$ " wide. There was another transverse crack in this excavation 3' north of the crack just described. This crack we determined goes down 2' below the crest and is about  $\frac{1}{4}$ " wide. A longitudinal crack exists in the north wall of excavation,  $\frac{1}{4}$ " wide. Another cut was made at this same Station, but on the downstream hinge point. This cut is 9' deep, 5' wide and 18' long. Transverse crack was traced down 5' on both ends of the cut. This crack ranged in width from  $\frac{1}{4}$ " to  $\frac{1}{2}$ " . The moisture is still present below the point where we lost evidence of the crack.

In summary, in both excavations at this Station, the transverse crack discontinued at 4' from the cut in the centerline. In the cut on the downstream hinge point the crack discontinued at 5' below the crest. Moisture still present in the bottom of both excavations.

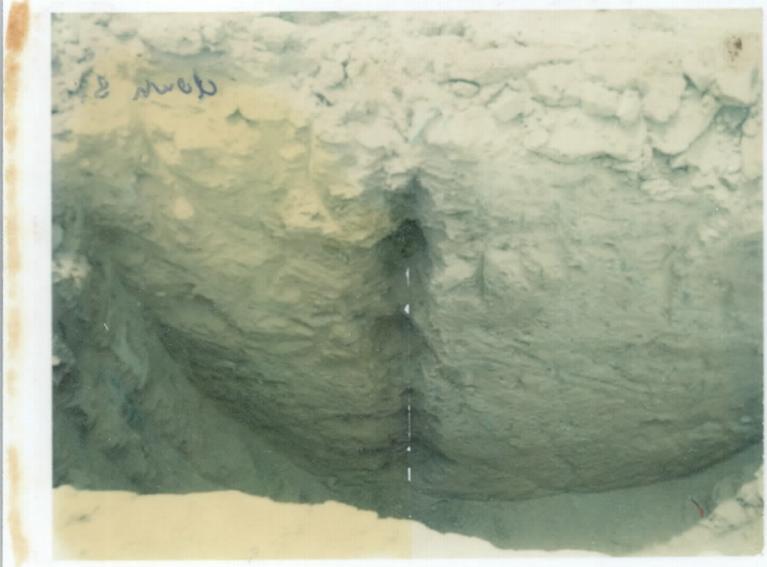
Rittenhouse Flood Retarding Structure - April 26, 1977  
Station 97+20

Excavation on centerline of dam crest. The cut is 4' wide, 12' long and 7½' deep. From the top of the crest to 4' below, crack is about ½" wide; below 4' the transverse crack is full of silt but still present and turns into a hairline that I was able to trace down 6' below the crest. Moisture still present in the bottom of excavation.

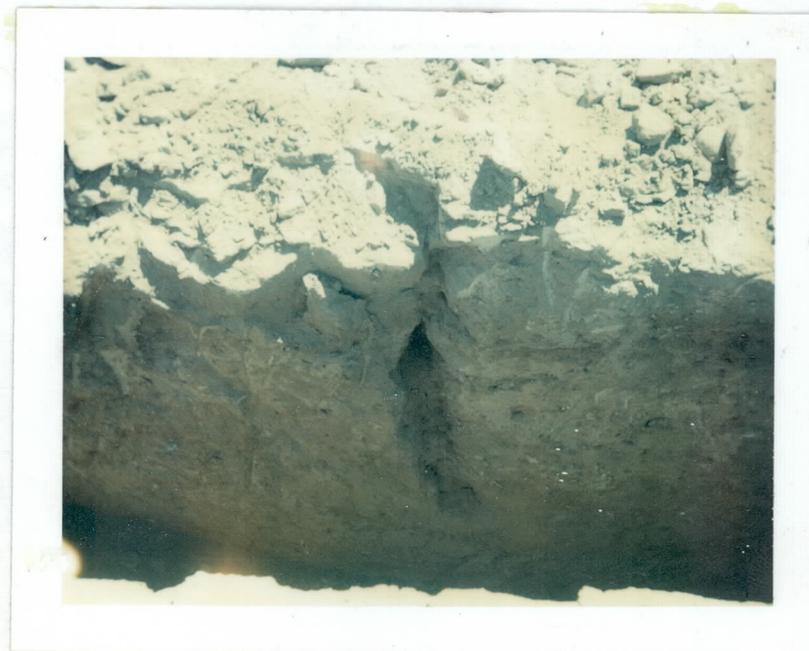
Downstream side

Rittenhouse Flood Retarding Structure - Thursday, April 28, 1977  
Station 89+93 - Digging started at centerline of the dam. On the downstream side of the cut transverse crack was traced down 2' and then discontinued. This crack is just a hair line. On the upstream side of the cut transverse crack was traced down 5' before it discontinued. At 2' down below the crest crack is  $\frac{1}{4}$ " wide. Below that the crack is just a hair line. The excavation goes as follows: 13' long, 3' wide,  $6\frac{1}{2}$ ' deep.

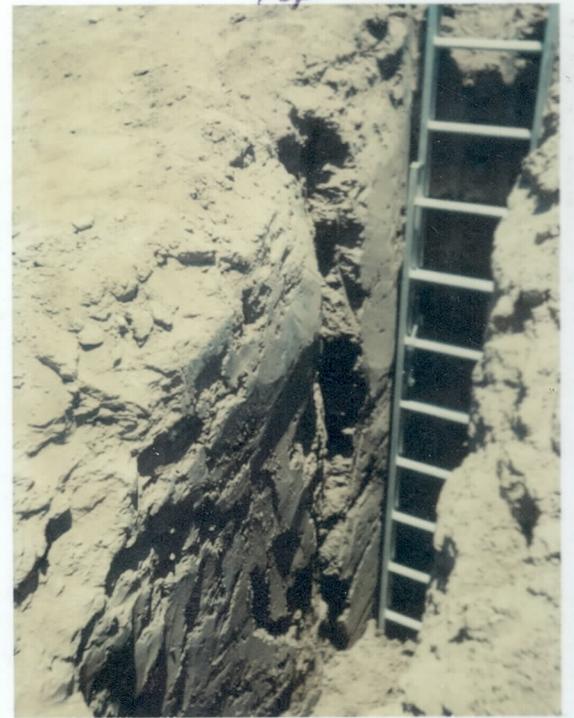
North End

Excavated a cut on centerline and parallel to centerline 9 feet deep and 9 feet long. The transverse crack opening to a one inch width on the upstream face of the excavation extended down to a five foot depth from crest elevation. A second transverse crack on the upstream face was observed beginning three feet below crest and extended another three feet and discontinuing in a small sandy-gravelly layer toward bottom of excavation. Both transverse cracks terminated near bottom of hole at  $5\frac{1}{2}$  feet below crest elevation. The transverse crack on the downstream face of the excavation was not definitely defined and appeared to discontinue in sandy-gravelly pockets and layers above and below a  $3\frac{1}{2}$  foot layer of compacted heavy clay. A longitudinal crack in the end of the centerline excavation was observed opened up to a width of  $\frac{1}{2}$ - $\frac{3}{4}$  inch. This crack was evident in starting three feet below crest and extended another three feet in length along the end face of the excavation.
