Various Project Photos of Maricopa County Flood Control Projects 1970 thru 1977

Various Project Photos of Maricopa County Flood Control Projects

1970 thru 1977

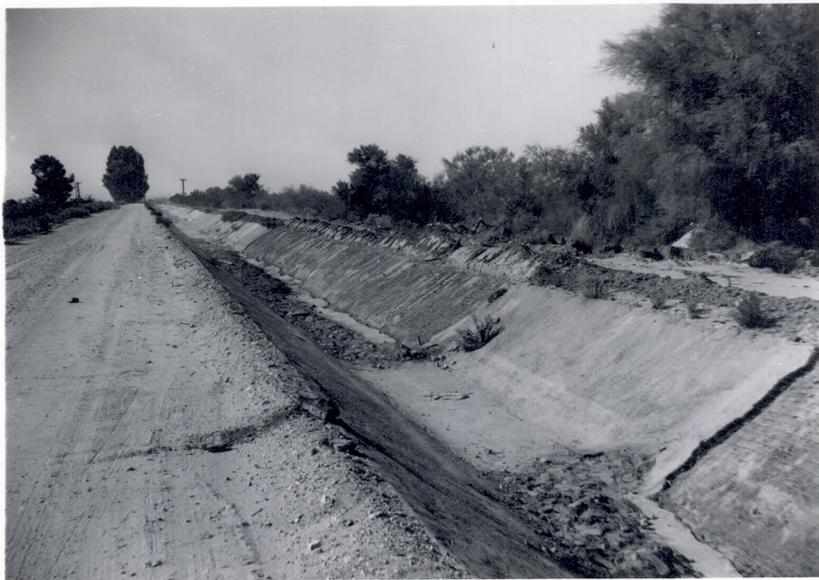
Repair work on Beardsley Canal
north of Camelback Rd. 9-16-70

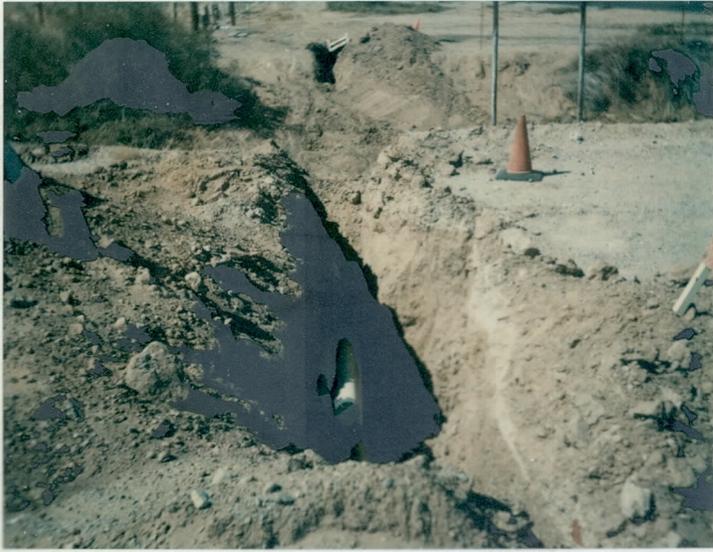
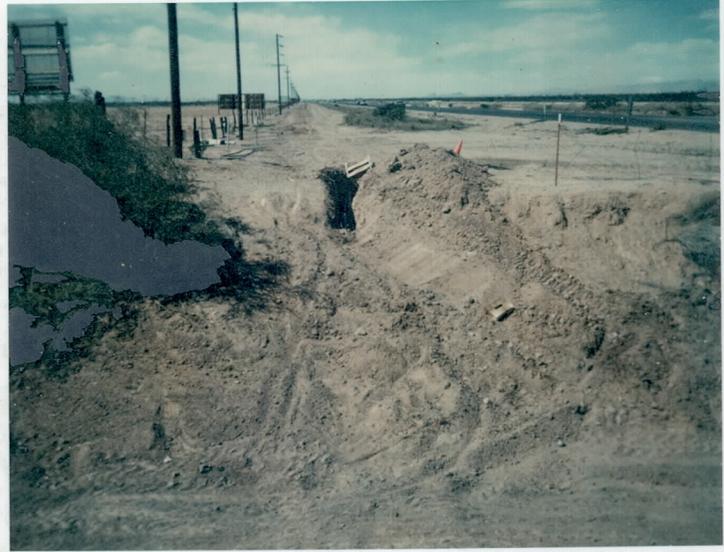
Buckeye #1. Between Palo Verde and Johnson Rd. Long crck on Highway side along toe. 8-4-76

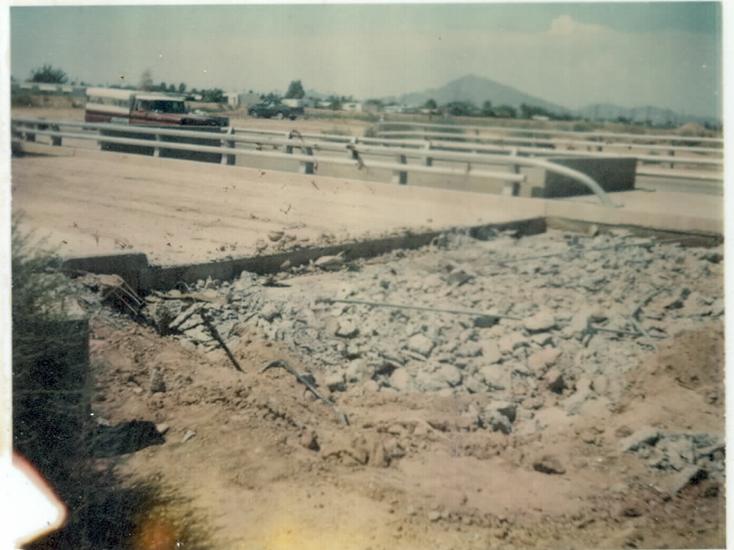
Indian Bend Wash. McKellips Rd. Bridge. Approximate slab demolition southeast corner of bridge.

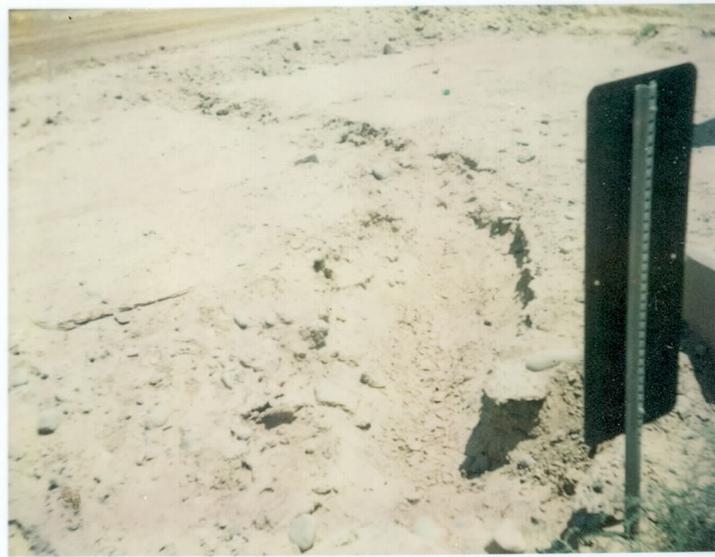
Indian Bend Wash. View of settlement in Mountain Bell Telephone cable trench at corner of bridge. 5-27-76

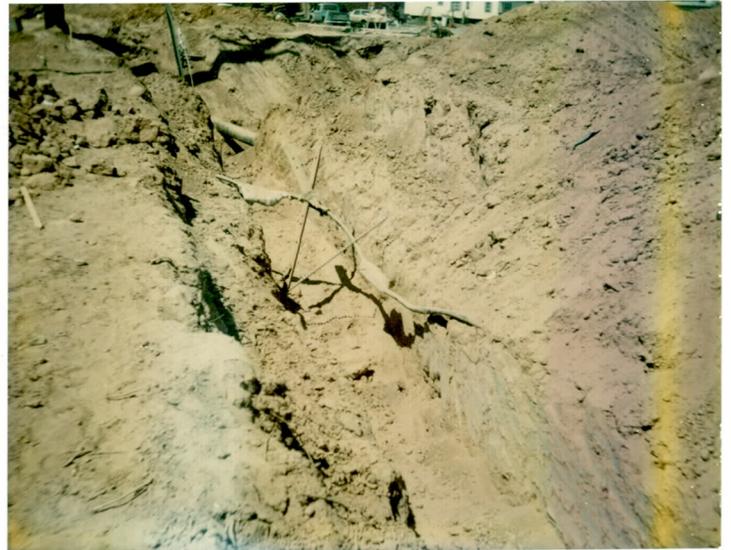
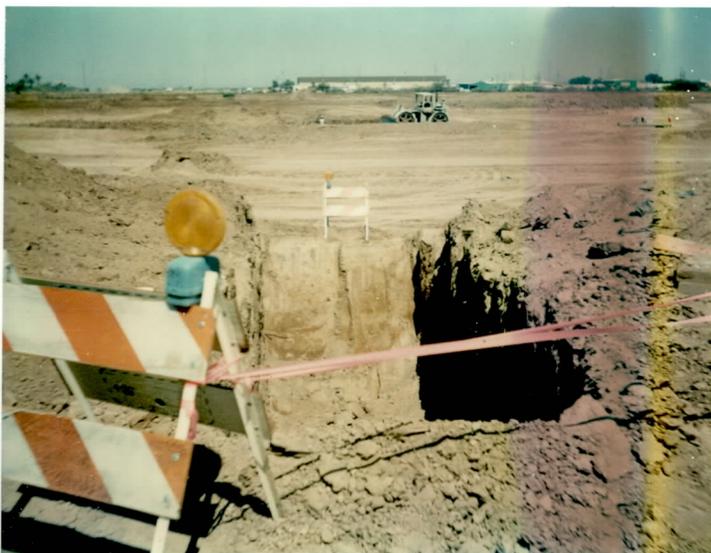
Indian Bend Wash. View of telephone cable crossing 18" storm drain from catch basin in corner of Princess & Miller- Cable covering damaged during initial excavation & cut into during 2nd Excavation shown in this photo. 6-8-76

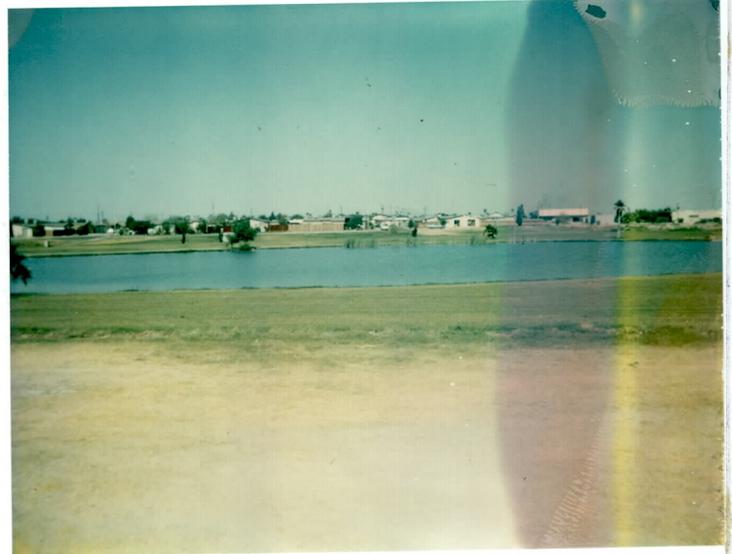
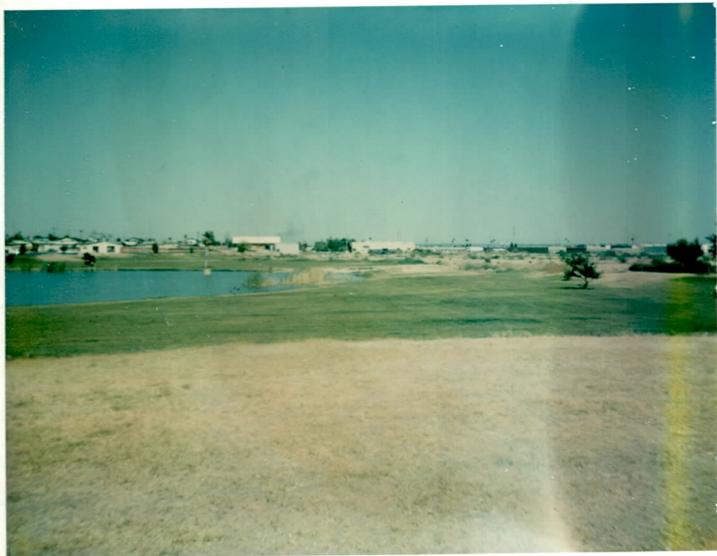
Indian Bend Wash. View of existing lake east of Yavapai School-looking east from rear of school showing landscape. condition. 6-8-76

Indian Bend Wash. View of existing lake east of Yavapai School- looking east from rear of school showing landscape condition. 6-8-76

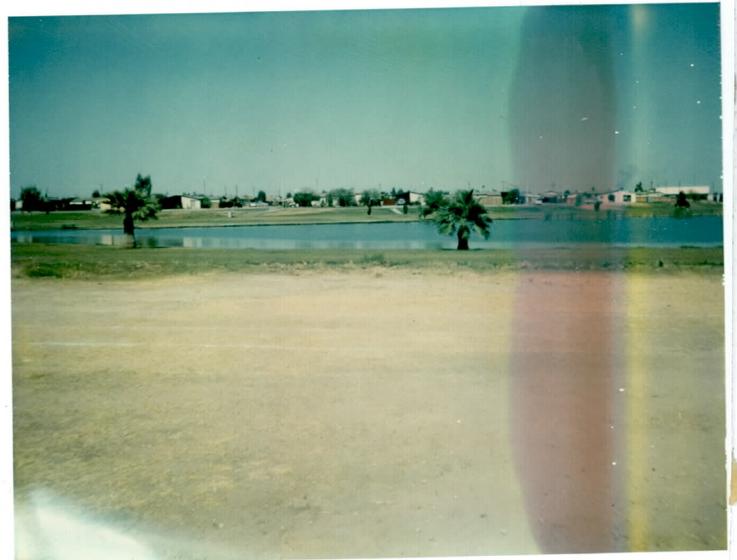
Indian Bend Wash. View of existing lake east of Yavapai School - looking east showing landscape. 6-8-76

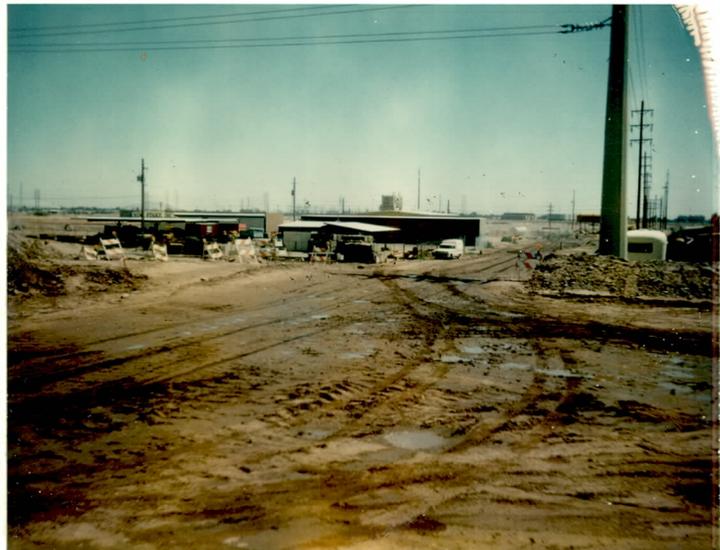
Indian Bend Wash. View of water ponding south of ramp to Nina Stake Co. at Princess & Miller. 8-3-76

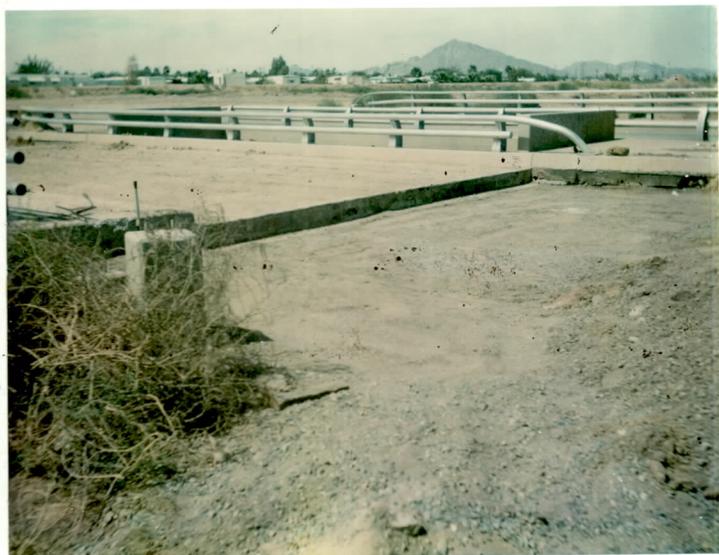
Indian Bend Wash. View of reworked back fill under approach slab east and of McKellips Bridge. 9-14-76

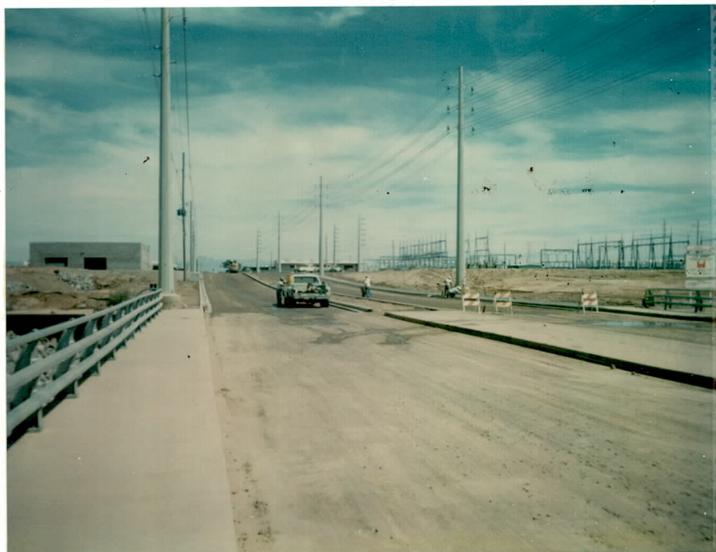
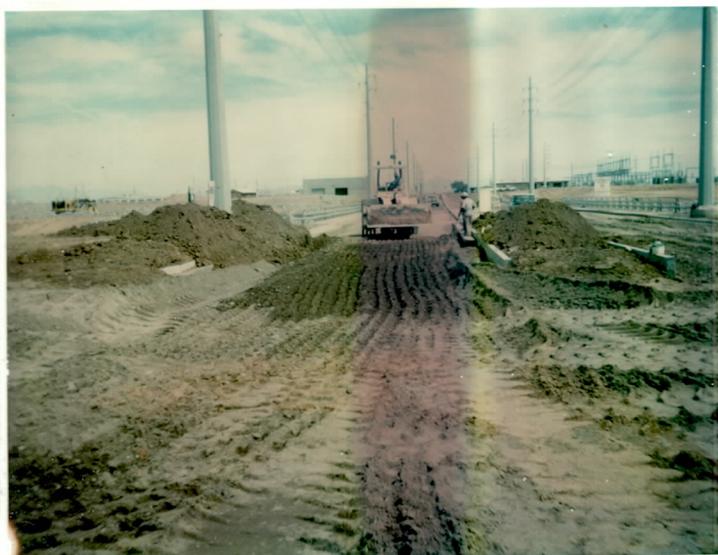
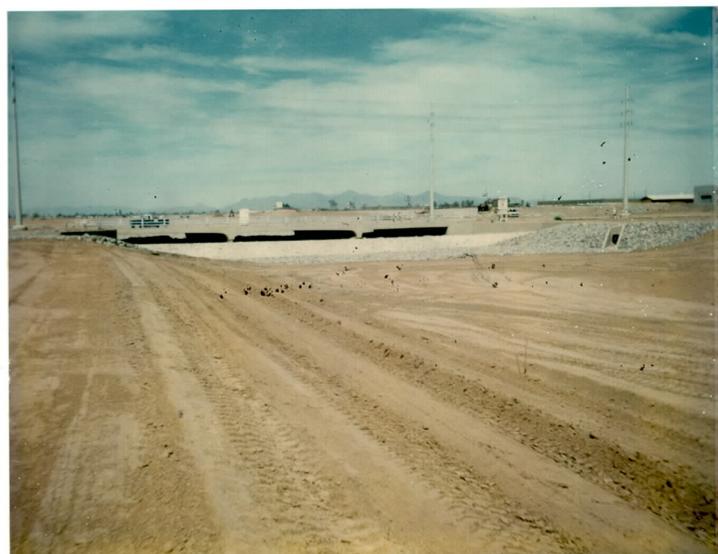
Indian Bend Wash. View of wet area being recompactified- west end of Princess St, bridge. 9-14-76

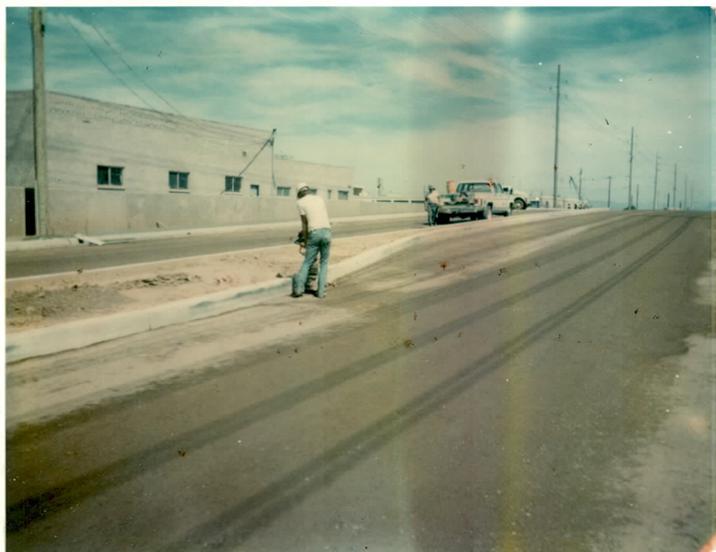
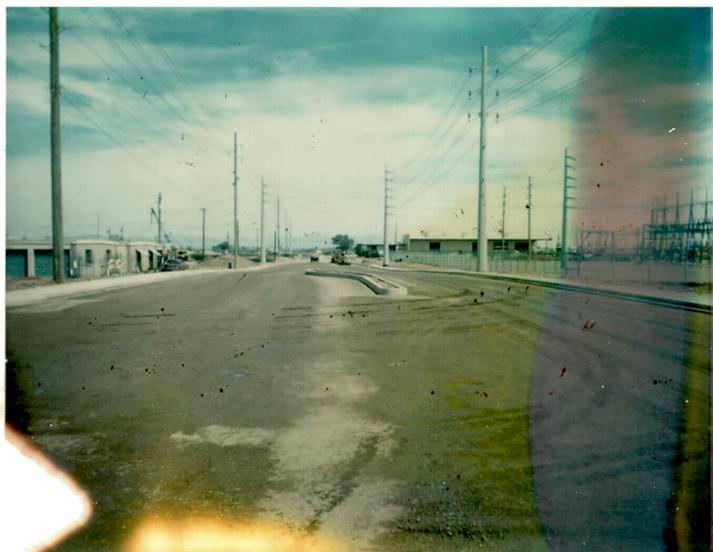
Indian Bend Wash. View of reworked back fill under approach slab west end of McKellips Bridge. 9-14-76

Indian Bend Wash. View of recompacted material - close-up in corner of approach - slab foundation material - west end of McKellips Bridge. 9-14-76

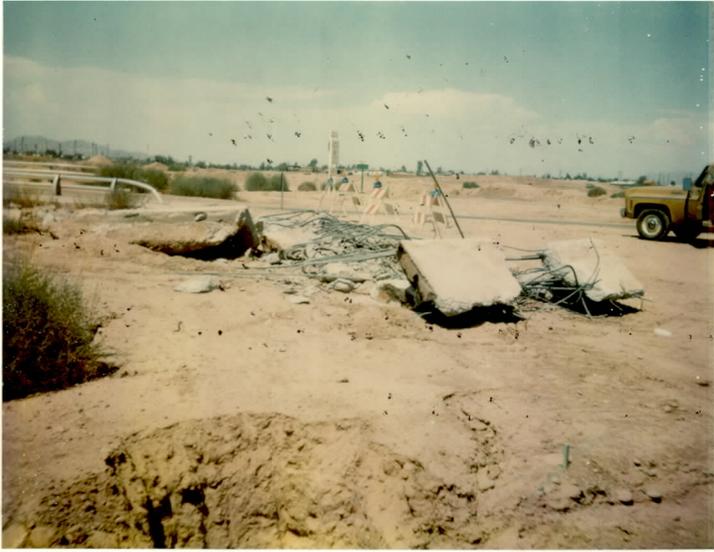
Indian Bend Wash. McKellips Rd. Bridge. View of subgrade material after removal of approach slab. Southwest corner.

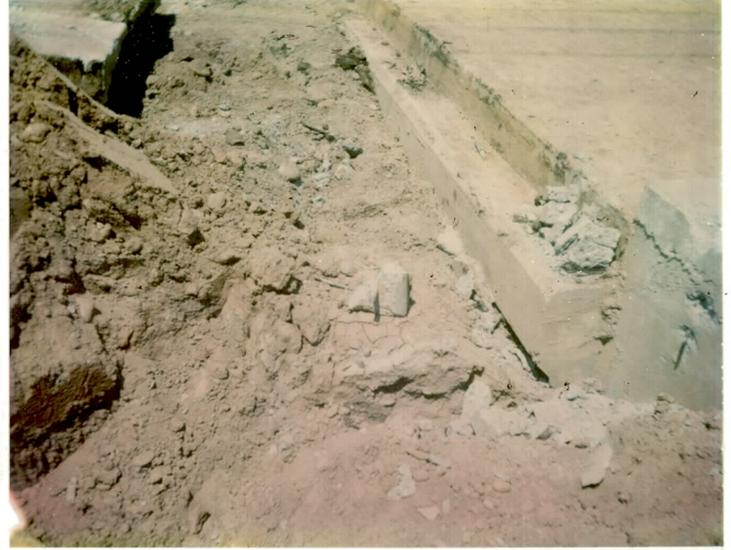
Indian Bend Wash. McKellips Rd. Bridge. View of subgrade material after removal of approach slab. (Southwest slab)

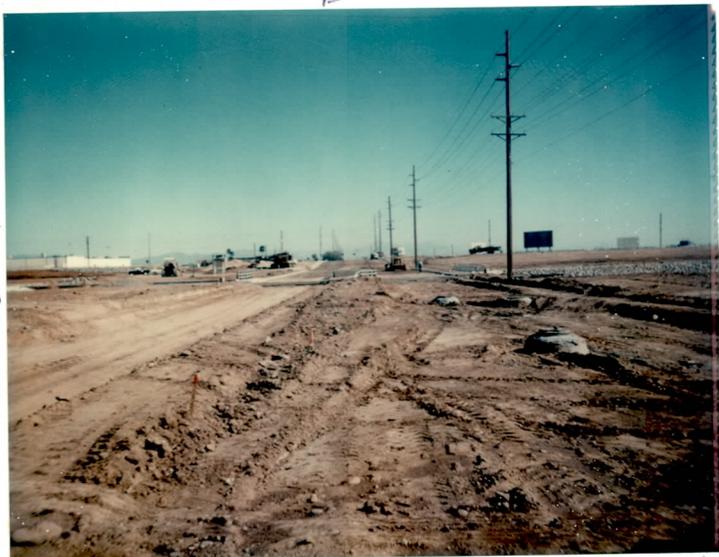
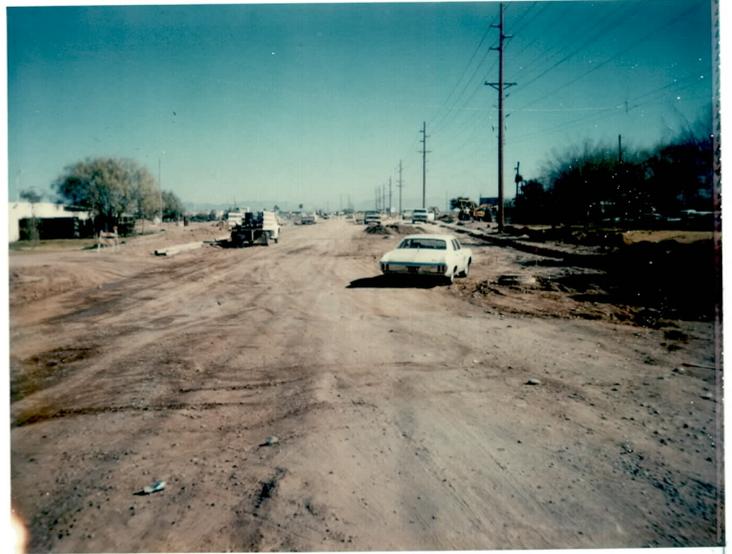
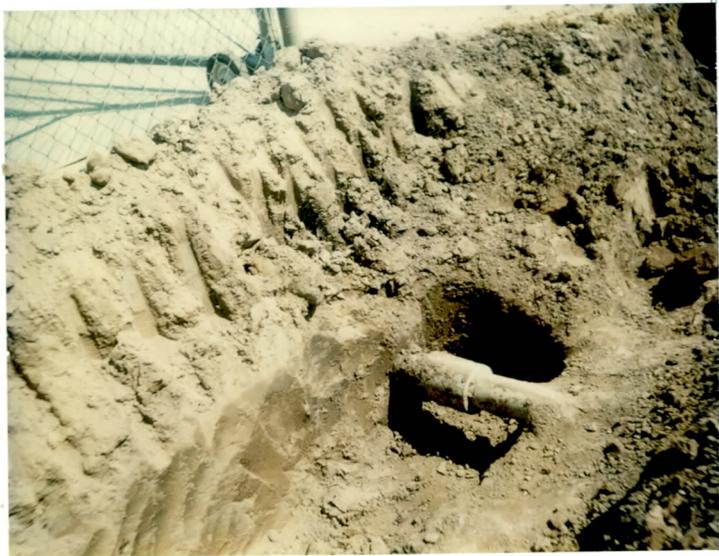
Indian Bend Wash. View of transite pipe serving small business at Princess and Miller - live belonging to Benny Cadena. 9-22-76

Indian Bend Wash. View of transite pipe coupling southeast corner of chain link fence where Mr. Cadena's 4 inch waterline runs north in front of business places. 9-22-76

Indian Bend Wash. View of trench for temporary 1 inch rolled plastic waterline to serve Cadena & business customers . 9-22-76

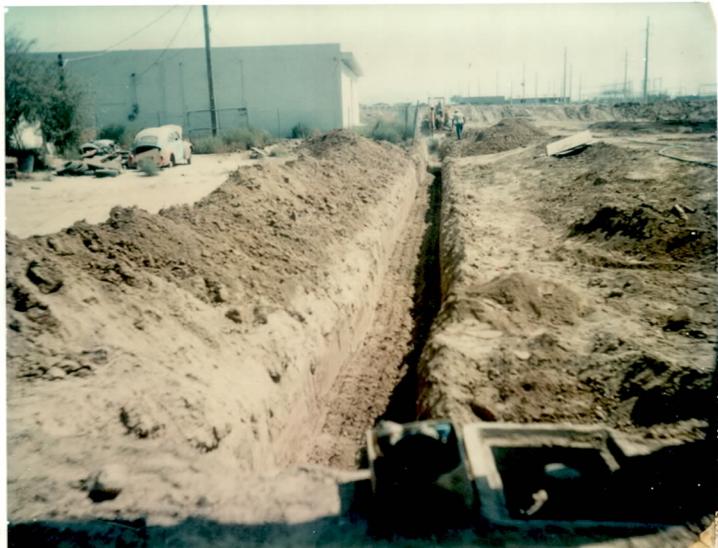
Indian Bend Wash. View of temporary support of 12 inch waterline while installing storm drain line. 11-22-76

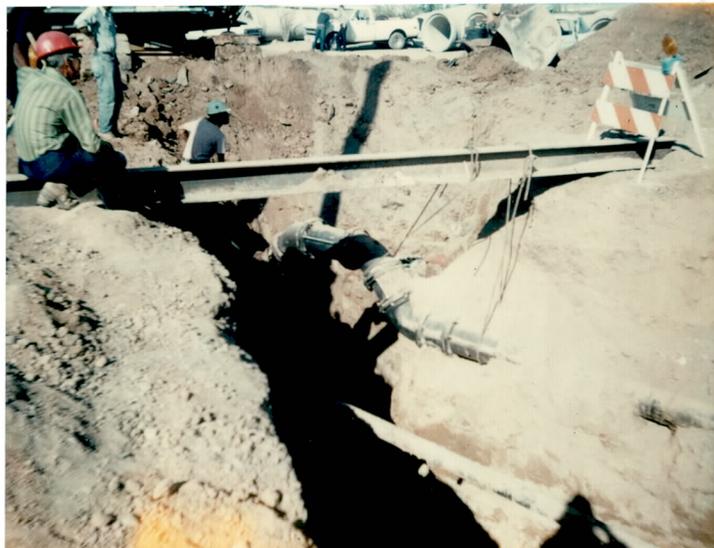
Indian Bend Wash. View of 12 inch waterline modified to fit storm drain installation near City of Tempe Well # 6. 11-22-76

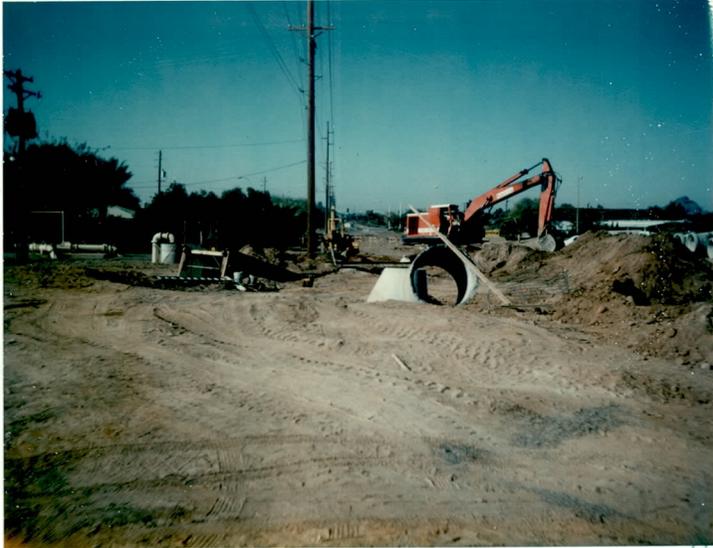
Indian Bend Wash. McKellips Rd. View of new man hole and sewer line from City of Tempe Well # 6 and portion of excavation for storm drain at intersection with 12 inch waterline. 11-22-76

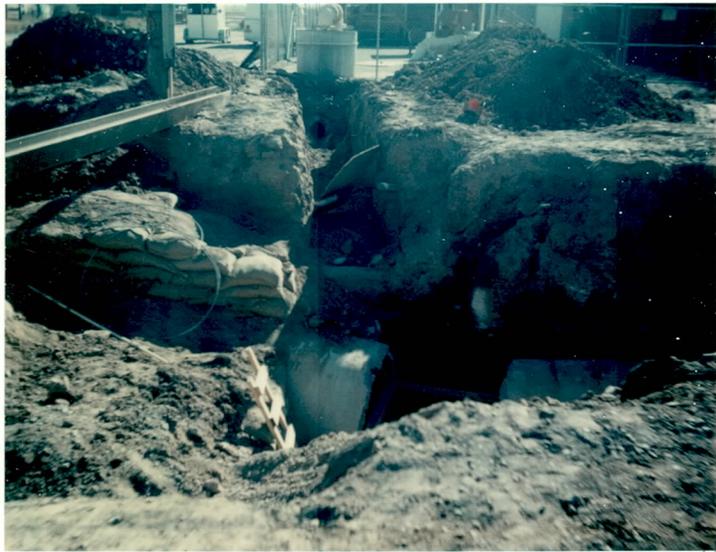
Indian Bend Wash. View showing temporary anchor Lee Construction is using to hold 12 inch water line in place while laying storm drain. 12-1-76

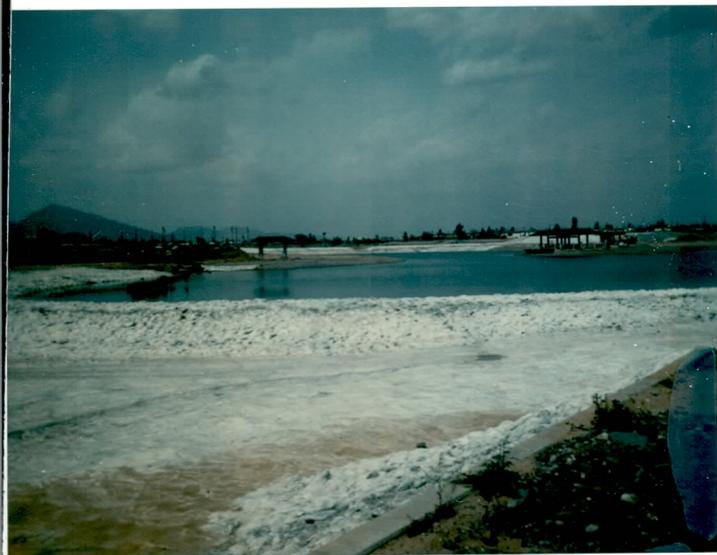
Indian Bend Wash. View of McKellips
Lake inlet stone protection. Grouting
in progress. 3-21-77

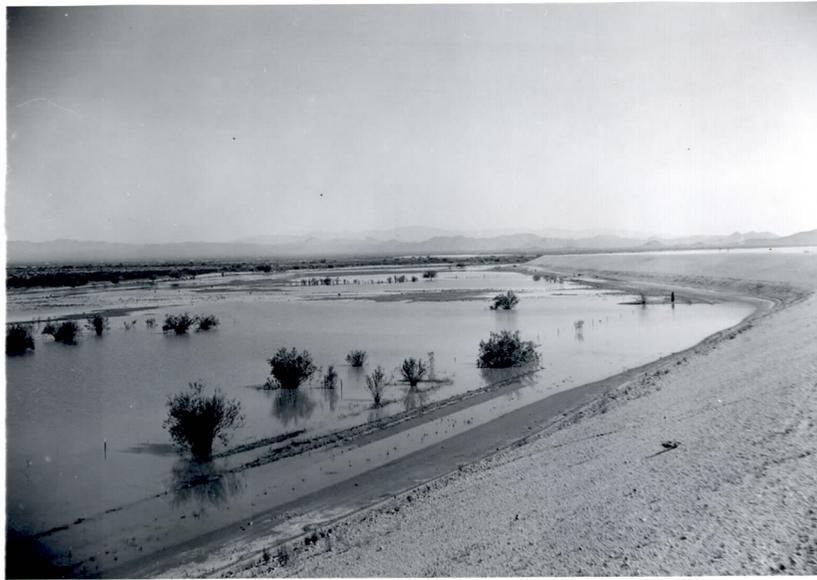
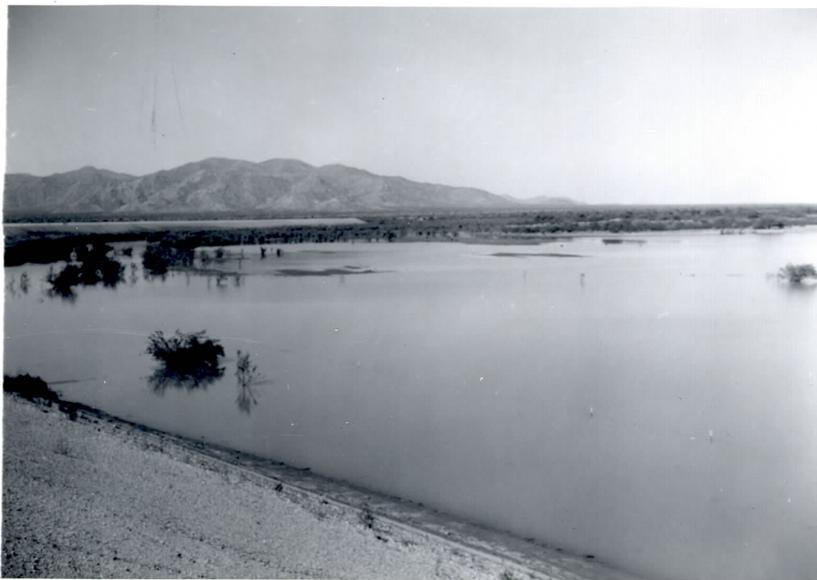
McMicken Dam. Water was 15'
from top of dam. 9-16-70
(Both pictures)

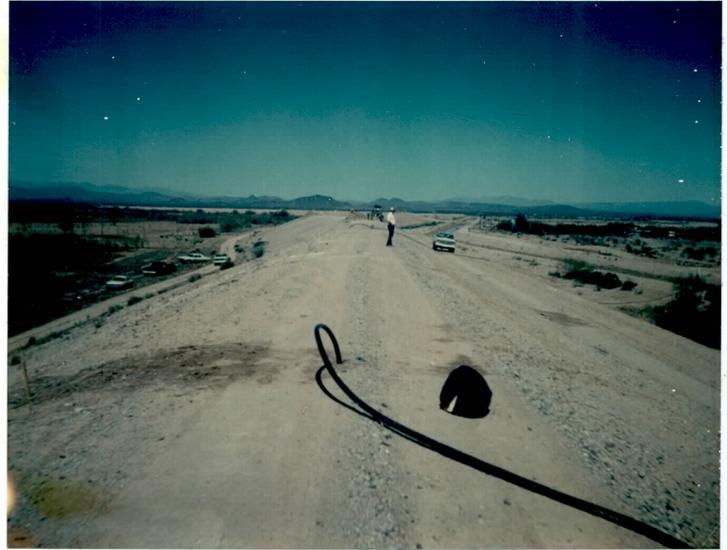
McMicken Dam. Station 456+10.
View looking downstream to
upstream showing Eric inspecting
cracking on upstream slope
just over upstream shoulder.
4-4-77

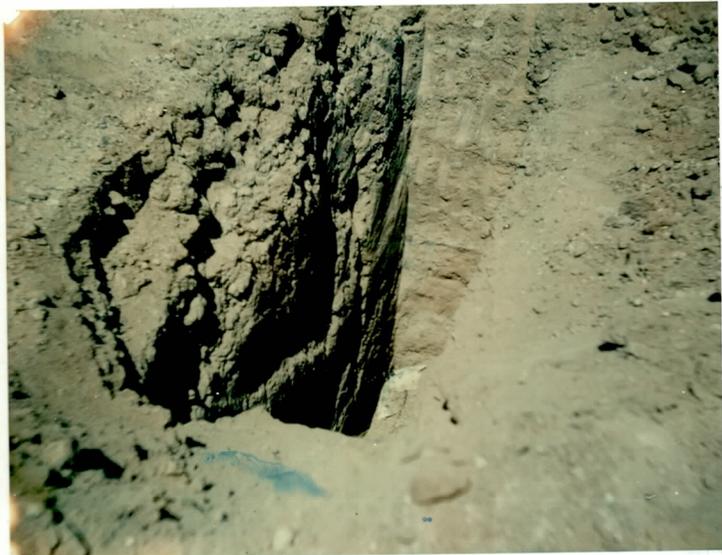
McMicken Dam. Station 460+18.
View of upstream cut looking
north to south. 4-4-77

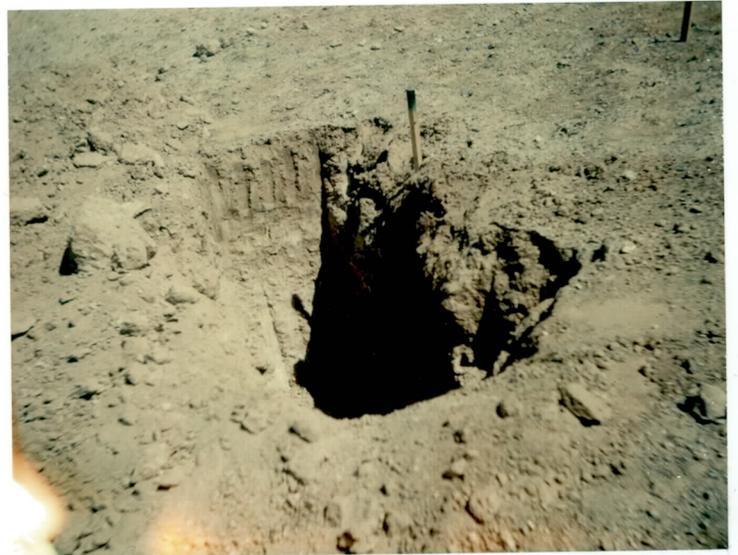
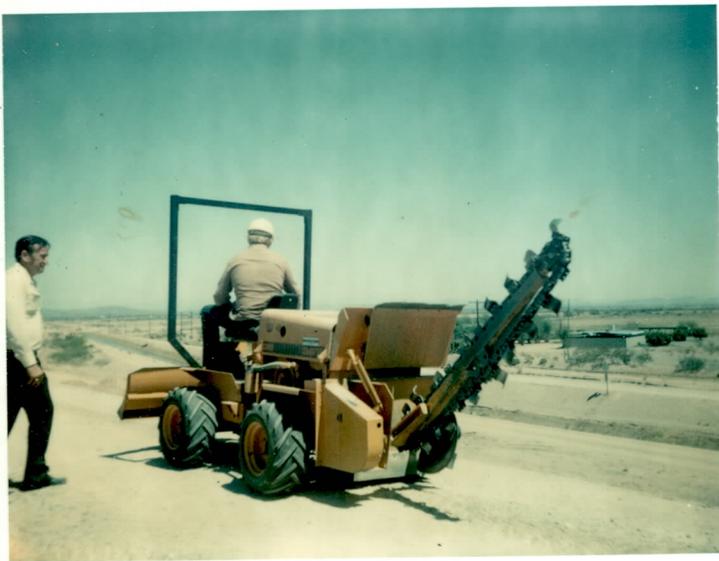
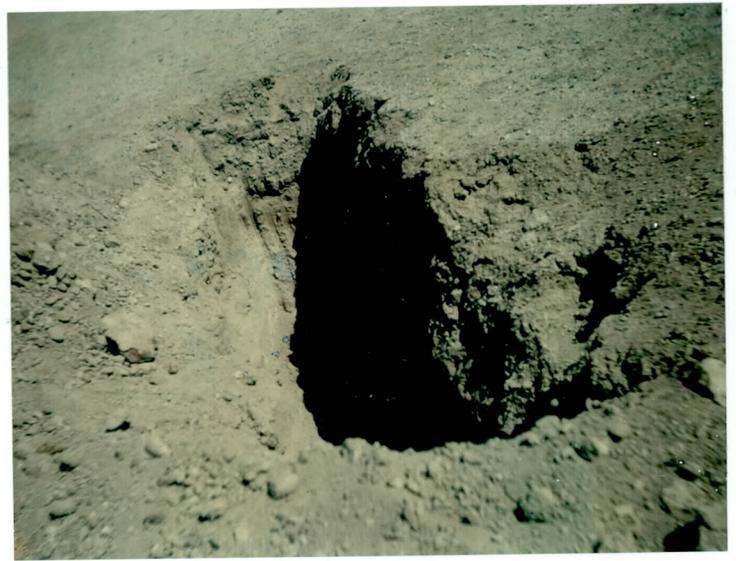
McMicken Dam. Station 458+57.
upstream cut. View looking from
south to north. 4-4-77

View of excavation for crack inspection at station 456+18.
4-4-77

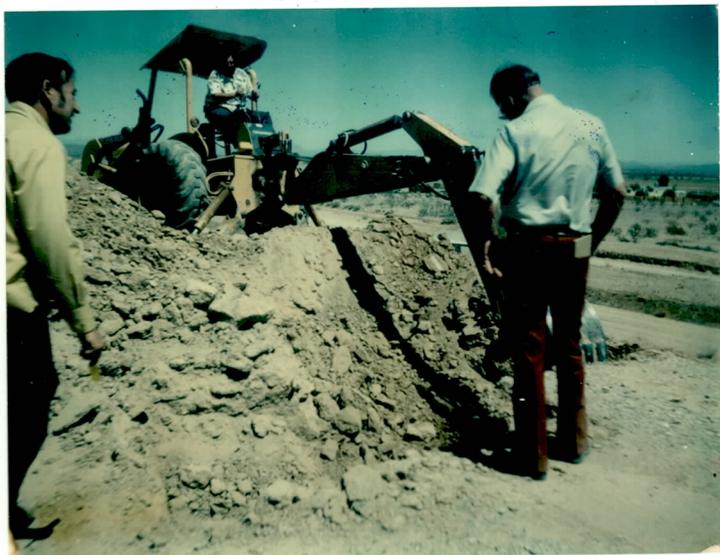
McMicken Dam. Station 460+18.
View of excavation on crest
looking south to north into
hole. 4-4-77

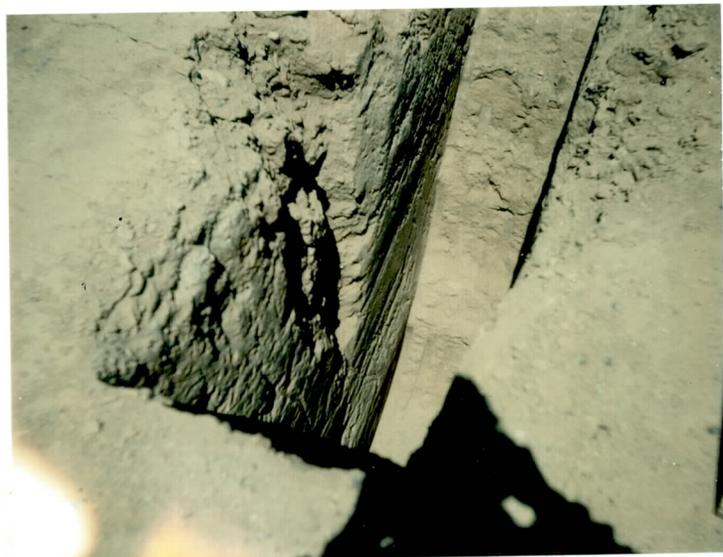
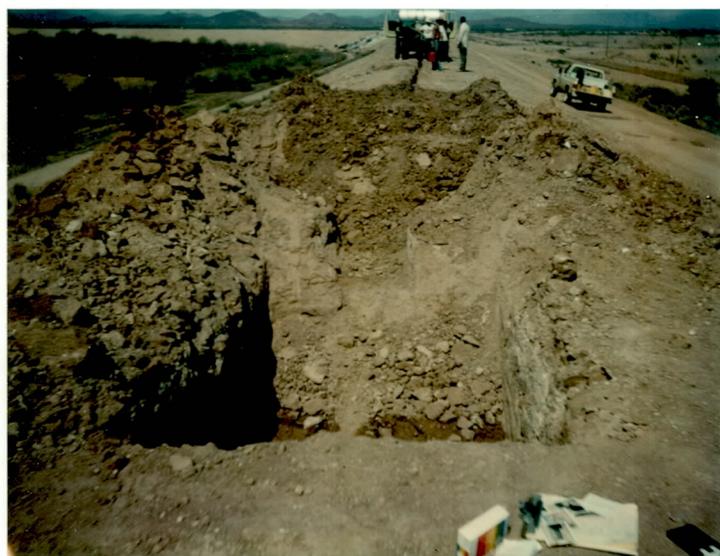
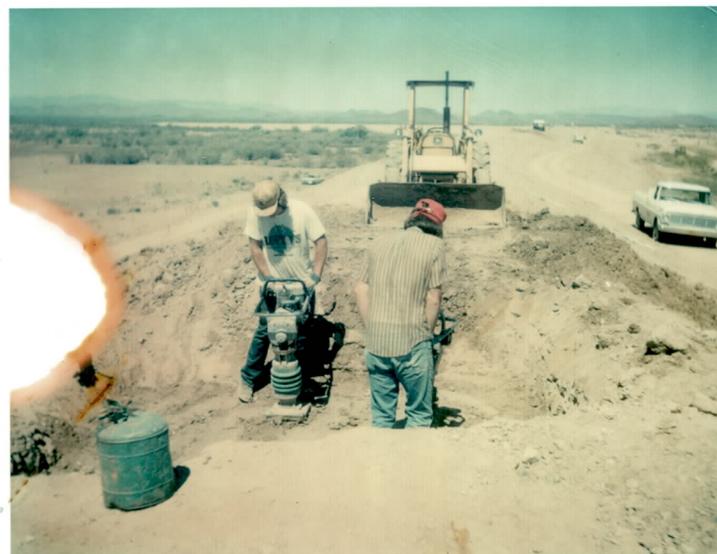
McMicken Dam. View of excavation
for cracks at stations 465+79 &
465+85 looking south to north.
Watering cracks in trench in
foreground. 4-5-77

McMicken Dam. Back fill
operations on dam crest
after inspection at station
460+90. 4-5-77

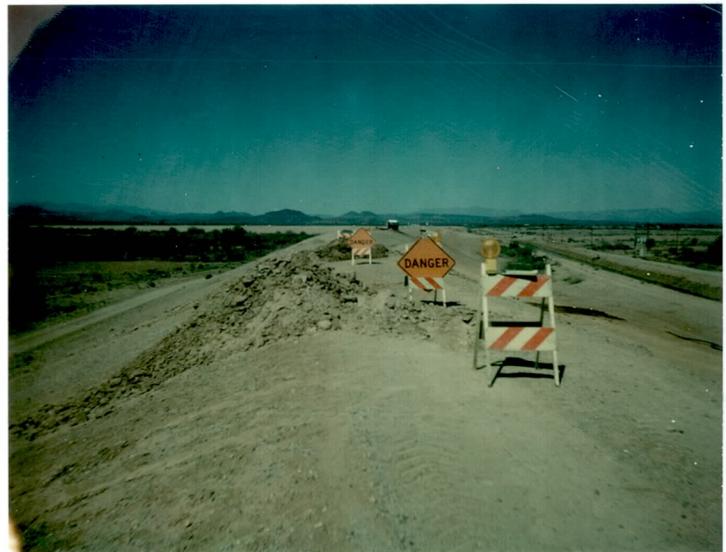
McMicken Dam. View of typical
barricading of excavations on
dam crest. 4-5-77

McMicken Dam. View of back fill
in progress made on crest of dam
at station 456+10. Bob Wately
Contractor. 4-8-77

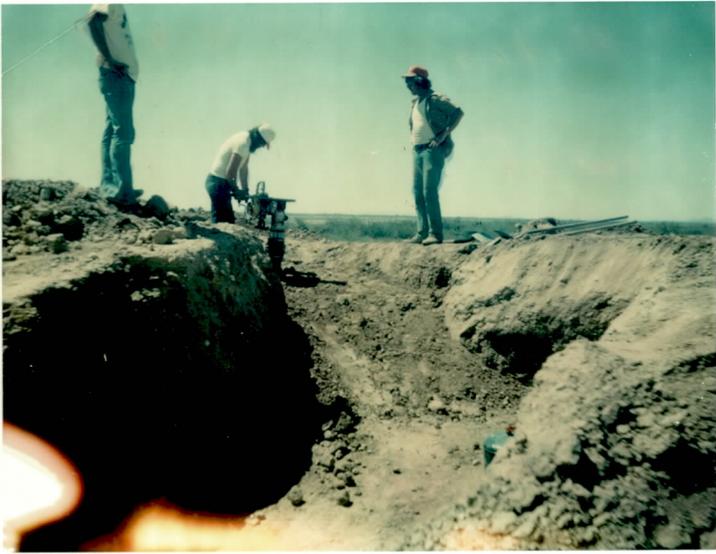
McMicken Dam. Station 458+57
Wateleys J P model # 510
excavation to additional depth
on previously excavated trench.
4-8-77

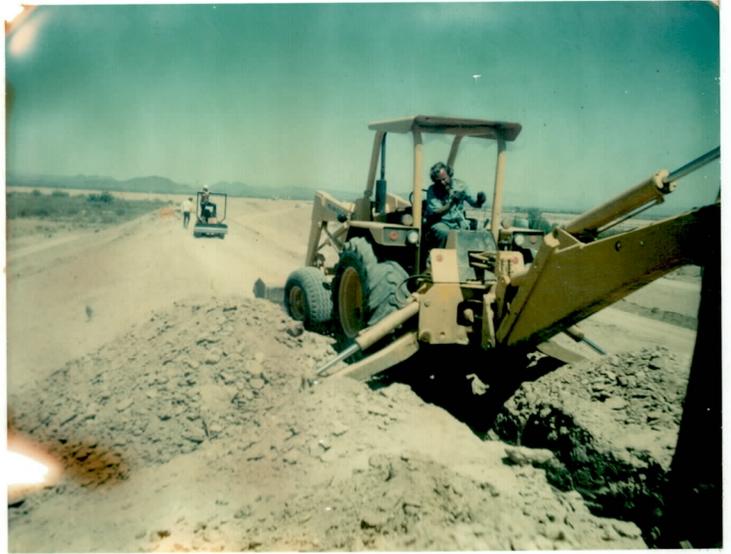
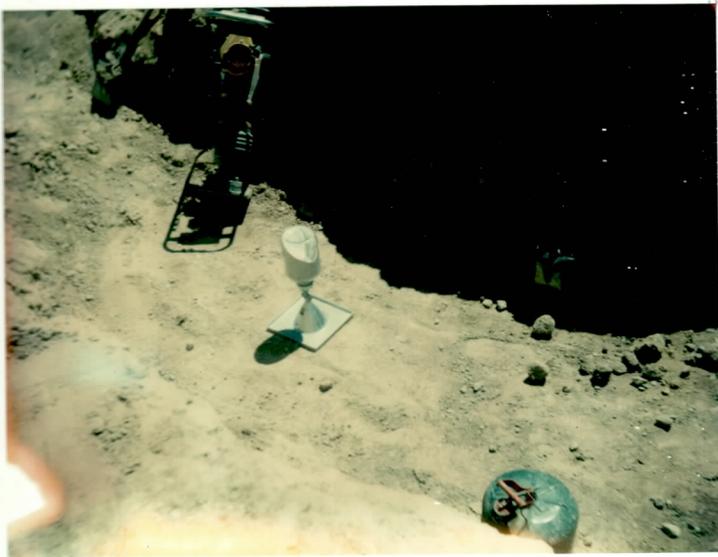
McMi ken Dam. View of density being
taken with sand core at station
456+10. 4-8-77

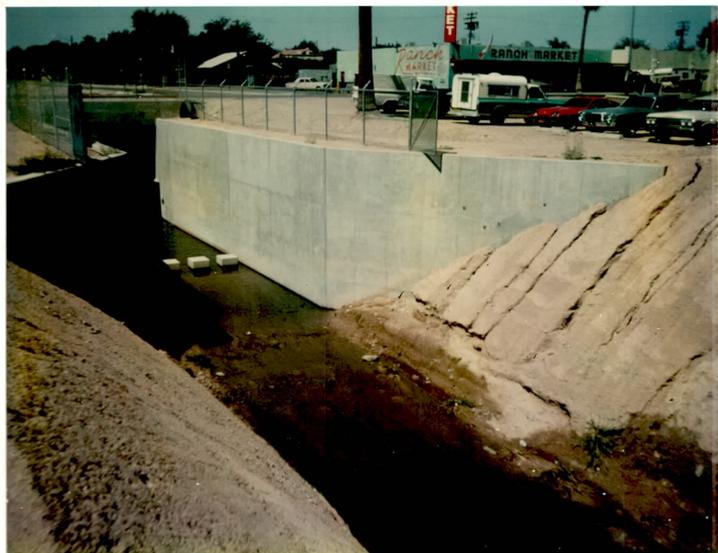
Old Cross Cut Canal. View of erosion (typical) at downstream wing walls of drop structure. (At Van Buren)
8-3-76

Typical erosion at downstream chute wing walls. Drop at trailer court north of Pierce St.
8-3-76

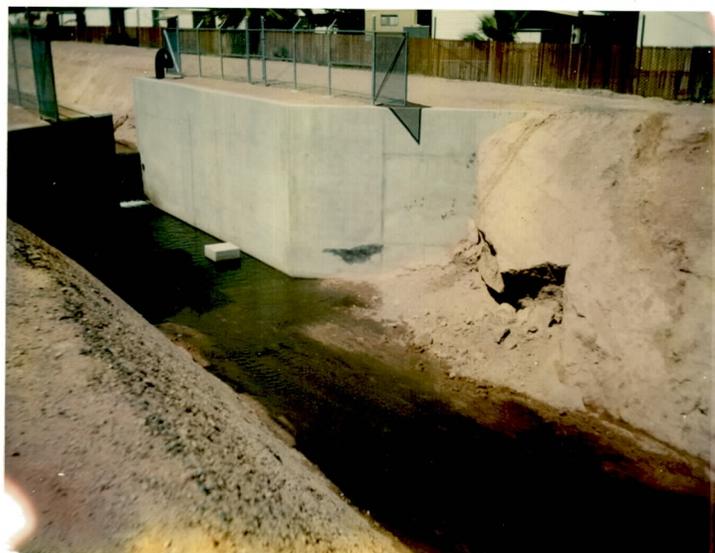
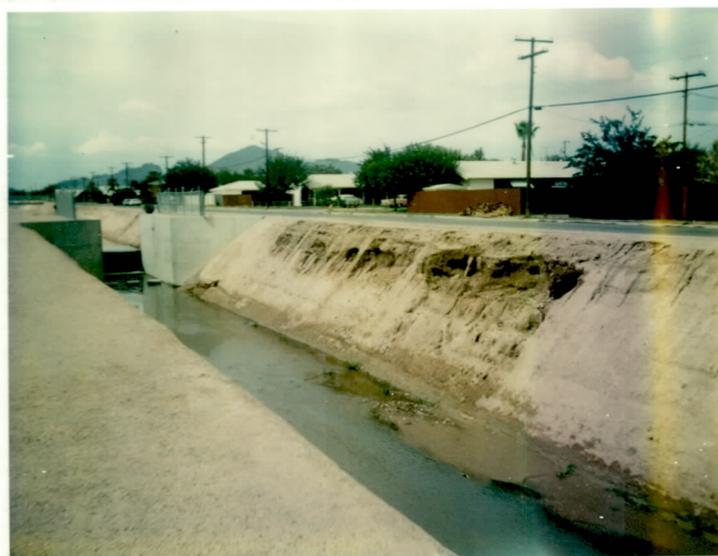
Old Cross Cut Canal. View of erosion along canal after construction.

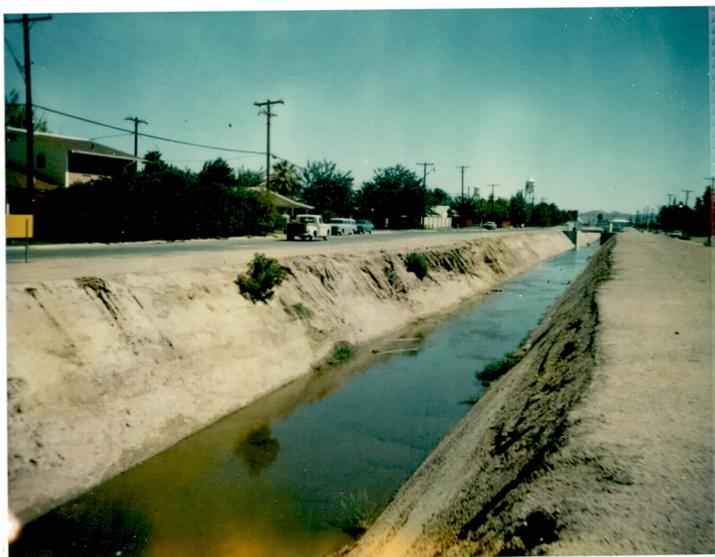
Old Cross Cut Canal. Bank (E) erosion at Pierce and 46th St. 8-3-76

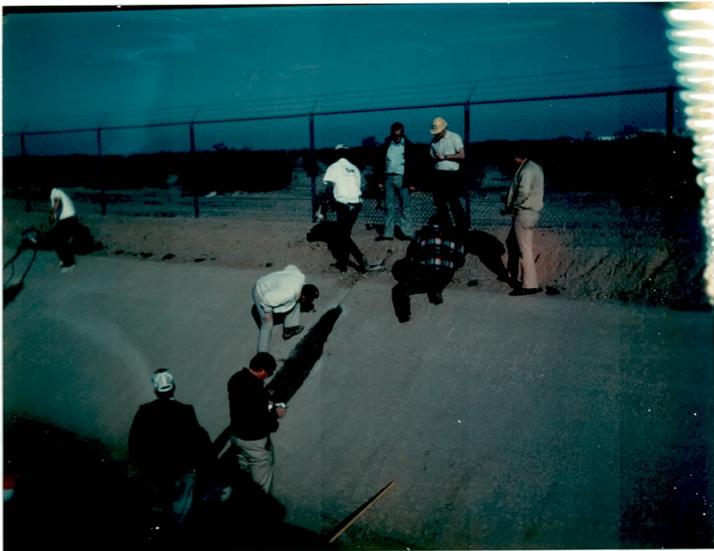
Powerline Floodway. Peterson-SCS
Monville-SCS
Leavitt-FCD
Inspection of core along line
#15-#16. 1-27-77

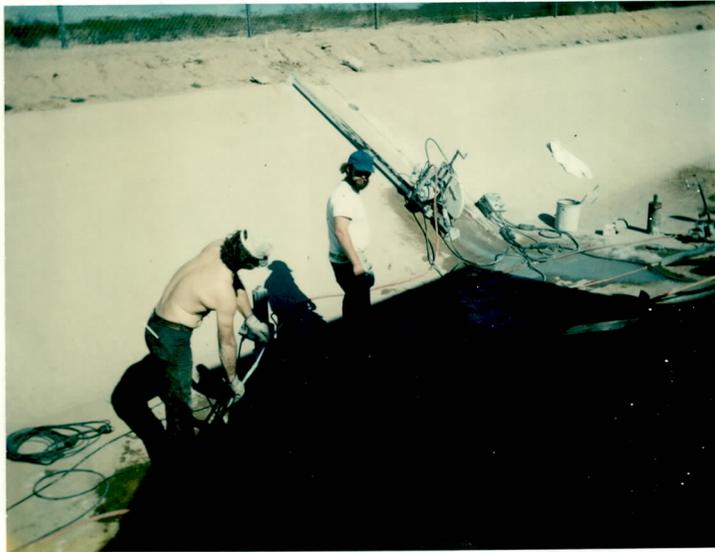
Powerline Floodway. View of core extraction along Exp. & Contr. joint #15-#16. 1-27-77

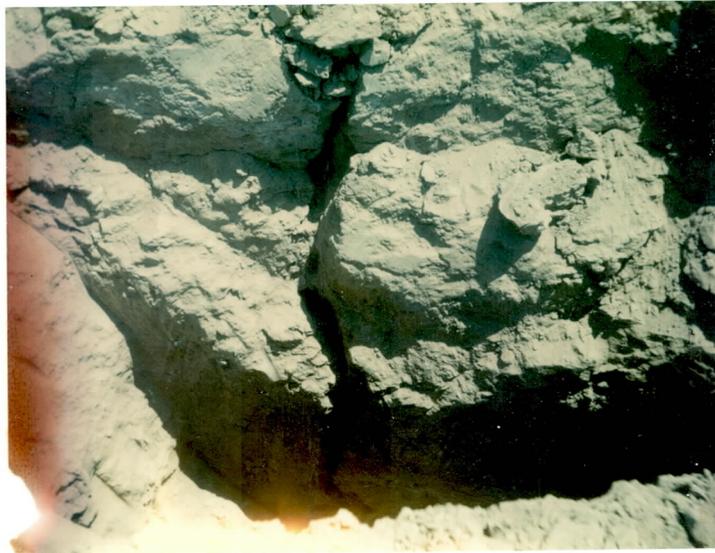
Rittenhouse. View of fracture on upstream
face of cut made in line with downstream
shoulder. Station 98+38. 4-26-77

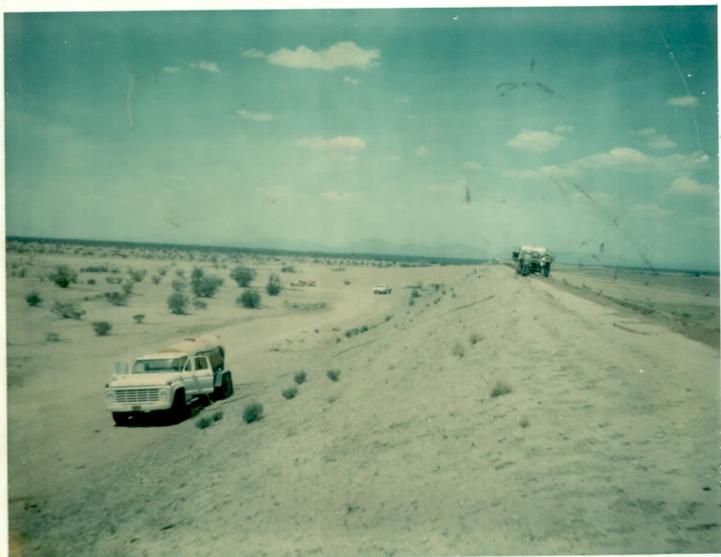
Rittenhouse. Overall view of watering trenches and cracks.
4-26-77

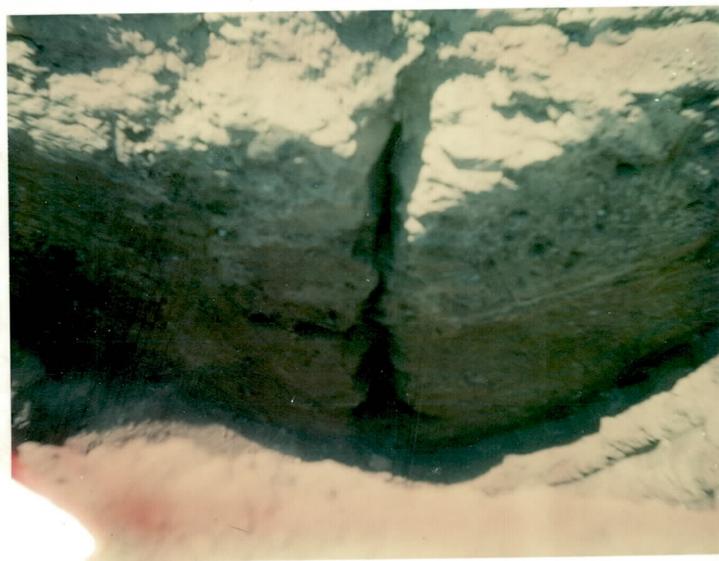
Rittenhouse. View of watering crew testing trench for cracks vicinity of station 93+15.
4-26-77

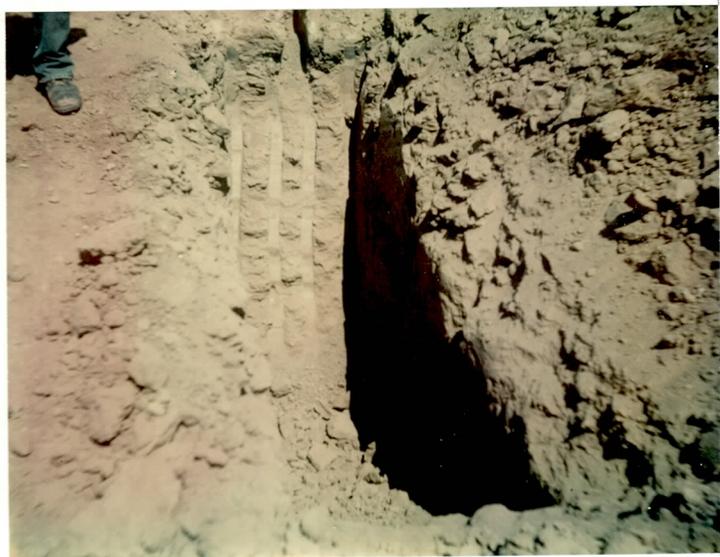
Rittenhouse. View of excavation
in crest at station 98+38. 4-26-77

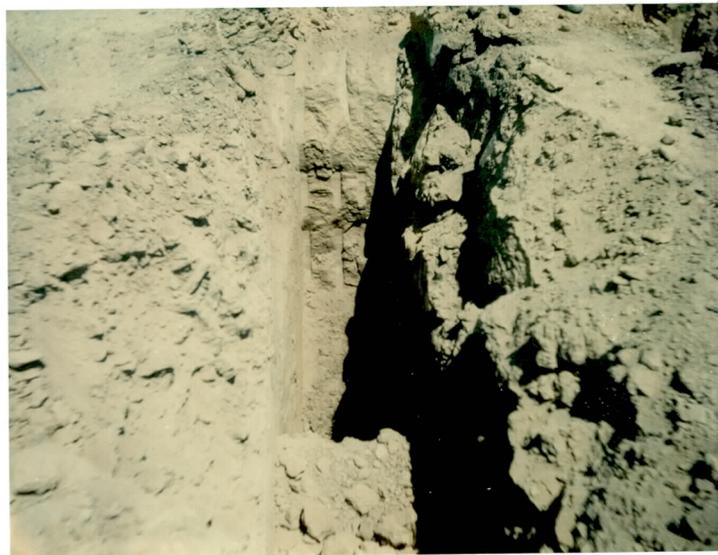
Rittenhouse. View of excavation
on line of downstream shoulder
at station 98+38. 4-26-77

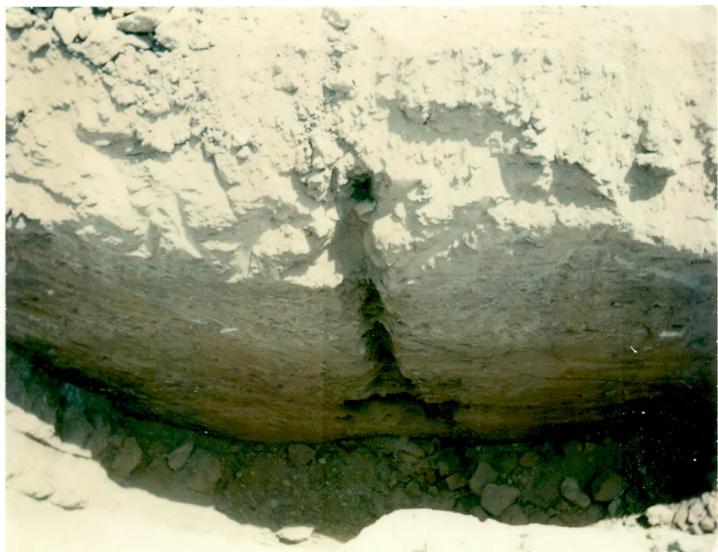
Rittenhouse. FRS station 97+08.
upstream side of cut. 4-27-77
