Various Project Photos of Maricopa County Flood Control Projects 1970 thru 1977

Various Project Photos of Maricopa County Flood Control Projects

1970 thru 1977

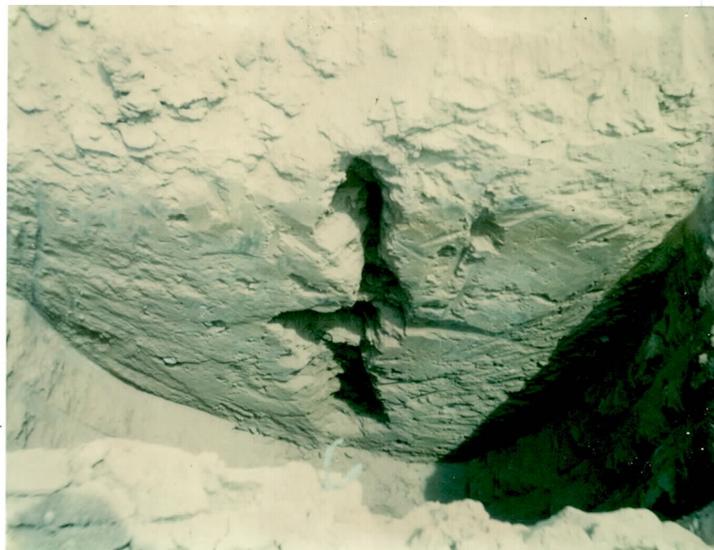
Station 89+26. Upstream side of
cut. 4-27-77

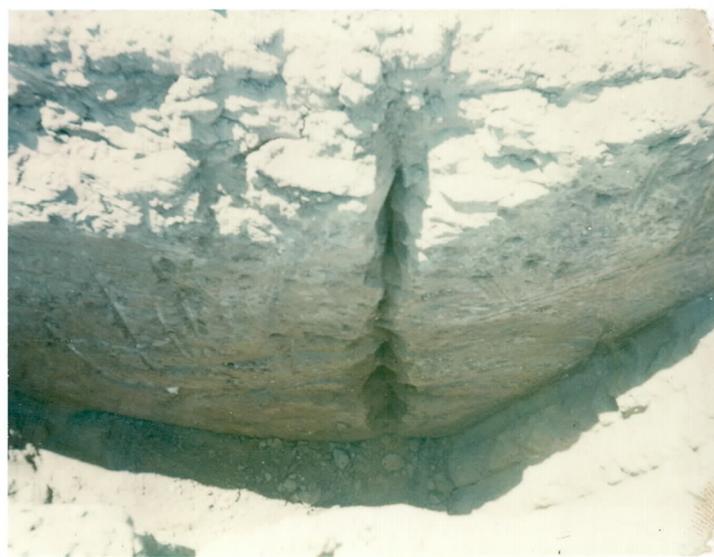
Rittenhouse. View of fracture on
upstream face of cut made on centerline
of crest. Station 98+38. 4-26-77
