FINAL REPORT TO CONGRESS

**THE STREAMBANK EROSION CONTROL
EVALUATION AND DEMONSTRATION ACT OF 1974
SECTION 32, PUBLIC LAW 93-251**

Appendix G - Demonstration Projects on Other Streams, Nationwide Volume 2 of 2

APPENDIX G DEMONSTRATION PROJECTS ON OTHER STREAMS, NATIONWIDE

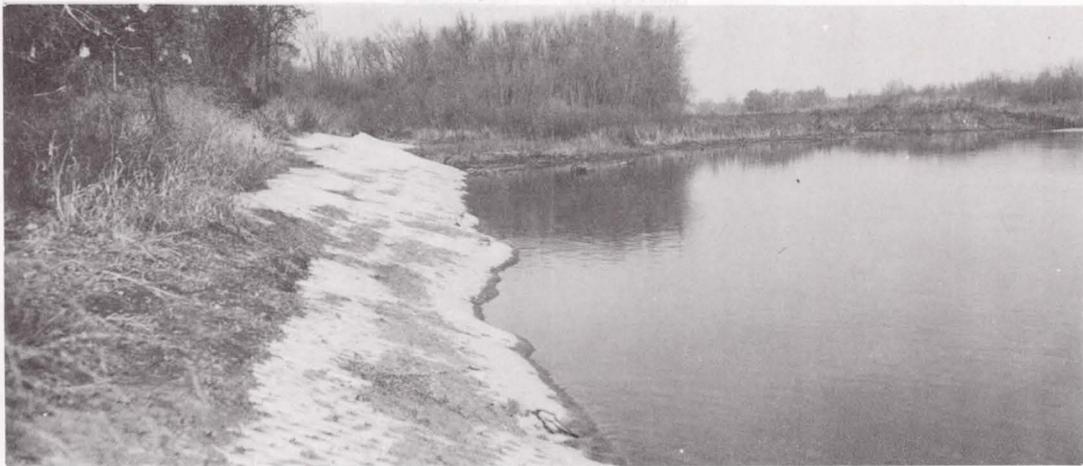
PHOTO 9. STA 12+00 LOOKING UPSTREAM AT CONCRETE MAT.
14 NOVEMBER 1979.

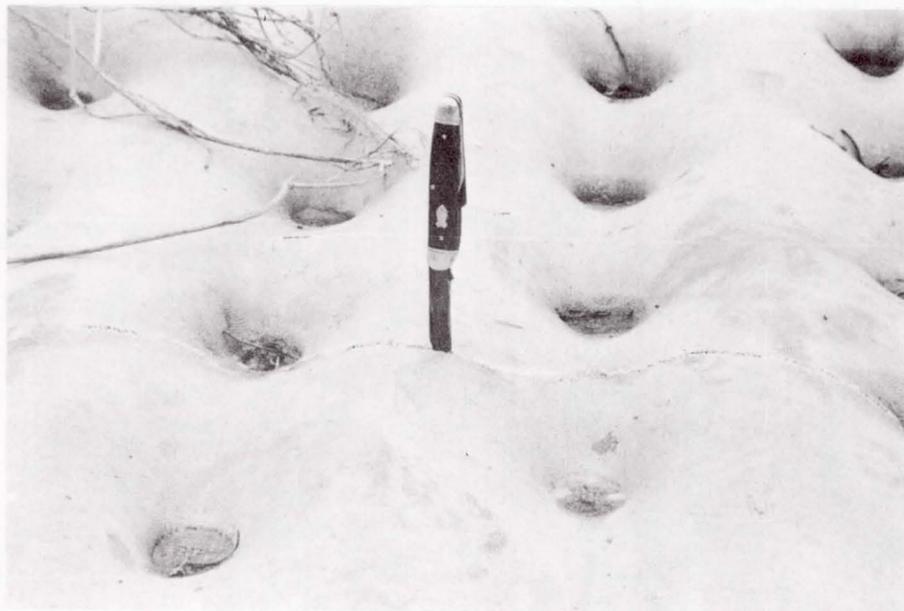
PHOTO 14. BREAK IN CONCRETE EROSION CONTROL MAT.

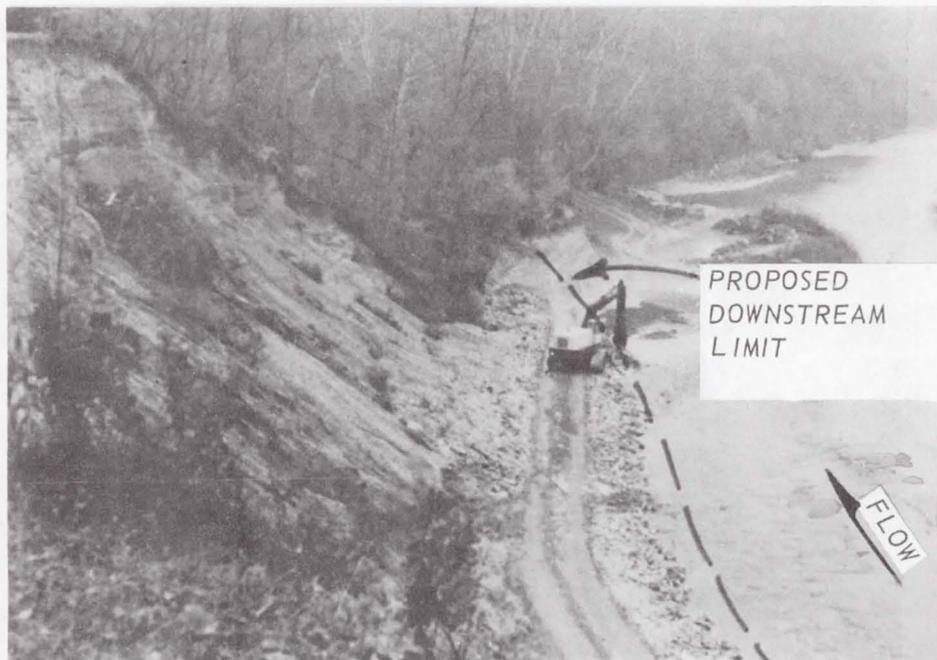
PHOTO NO. 2. 9 Nov. 78. Under construction; downstream portion of project.

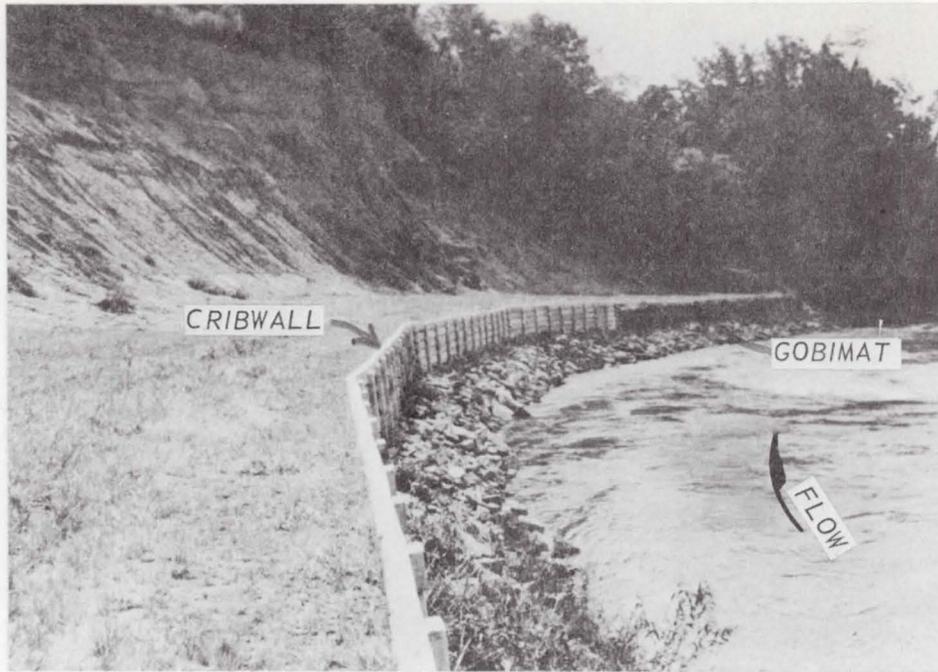
PHOTO NO. 3. 5 May 80. Completed project.

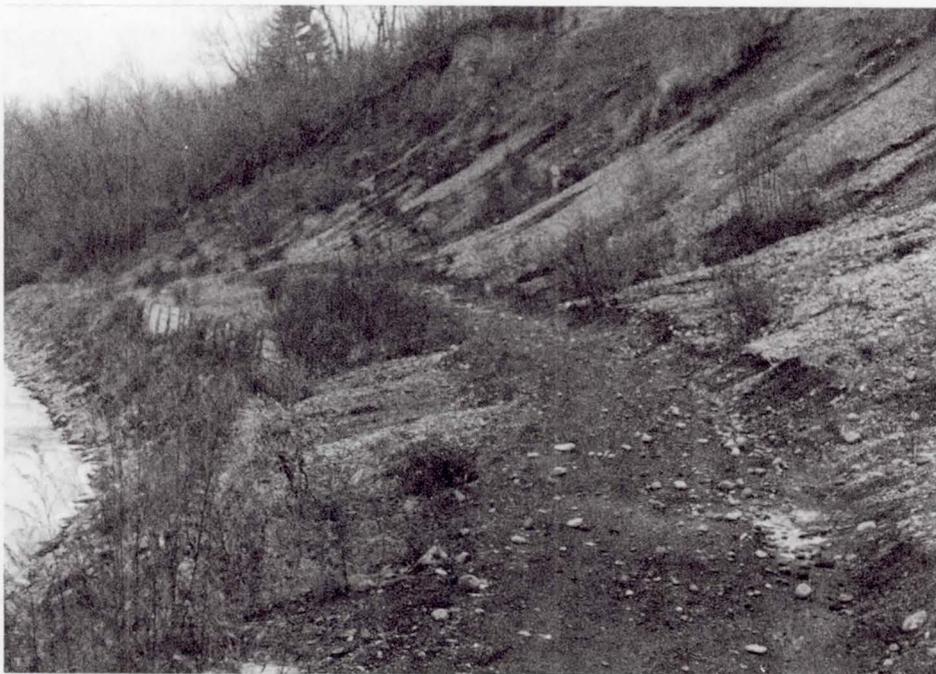
PHOTO NO. 8. Jan. 81. Note side of material from upper bank onto berm area. Some vegetation, mostly weeds, also occurring.

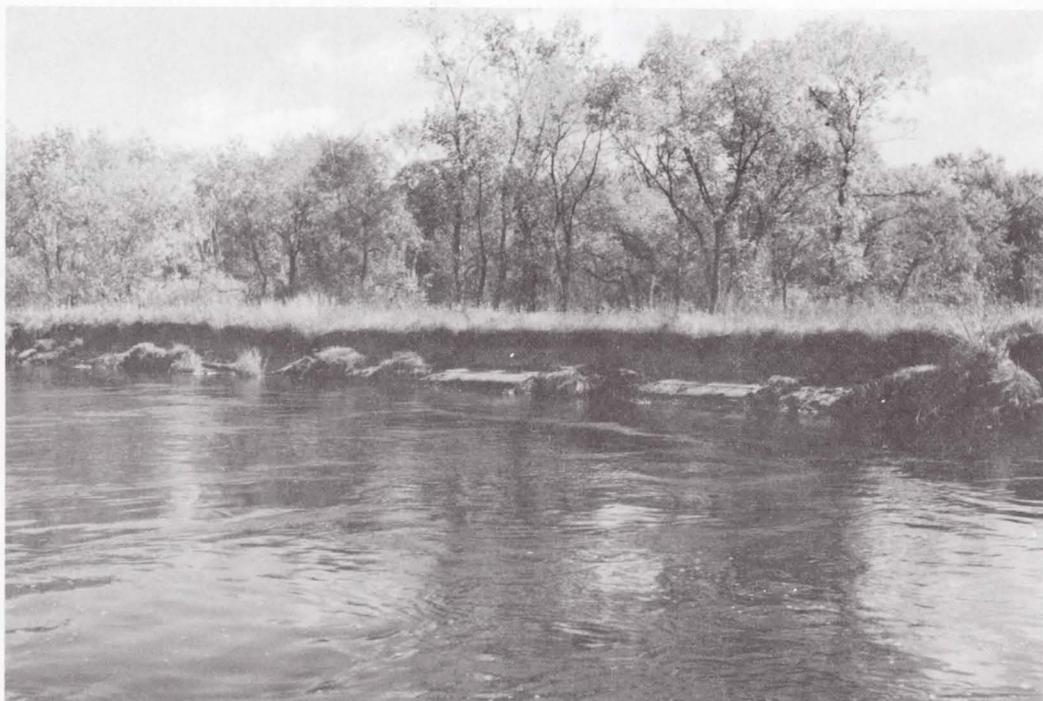
4. Problem Resume. Erosion along the Lower Chippewa River is of two types: (1) high bank erosion and (2) low bank erosion. The high bank chosen for protection is more than 100 feet high and is being eroded by undermining of the bank below the normal water surface which causes the material to slide. See photo 1 for typical high bank erosion. Low bank erosion occurs on banks generally 5 to 15 feet high. These banks are eroded in the same manner. Undermining beneath the water surface causes the material to slide while ground cover reinforces the soil at the top of the bank. This soil becomes cantilevered as erosion progresses and eventually breaks away. See photo 2 for typical low bank erosion.

Erosion of the banks below the water surface is primarily caused by the river current acting against the banks and by fluctuations in the water surface resulting from releases for hydropower. These fluctuations

tend to saturate a narrow band of the silty sand banks during the higher stage. When the stage drops, the return seepage results in loss of strength in the first few inches of the surface soils causing minor sloughing or flow of material which allows the current to slowly carry or move it into the stream. These repeated actions steepen the bank causing failure.

PHOTO 2. SITE NO. 2 - LOW, DOWNSTREAM SUBREACH, DOWNSTREAM TO RIGHT, BANK ABOUT 7 FEET HIGH, 25 SEPTEMBER 1980.

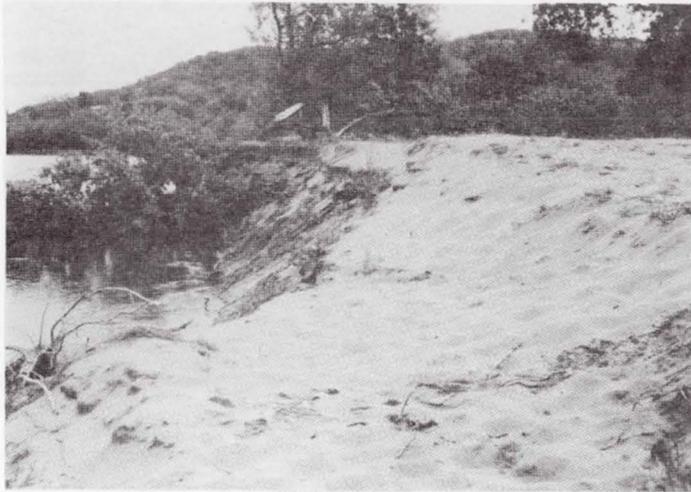
PHOTO 3

PHOTO 3. SECTION 1 LOOKING DOWNSTREAM BEFORE CONSTRUCTION. 27 AUGUST 1980.

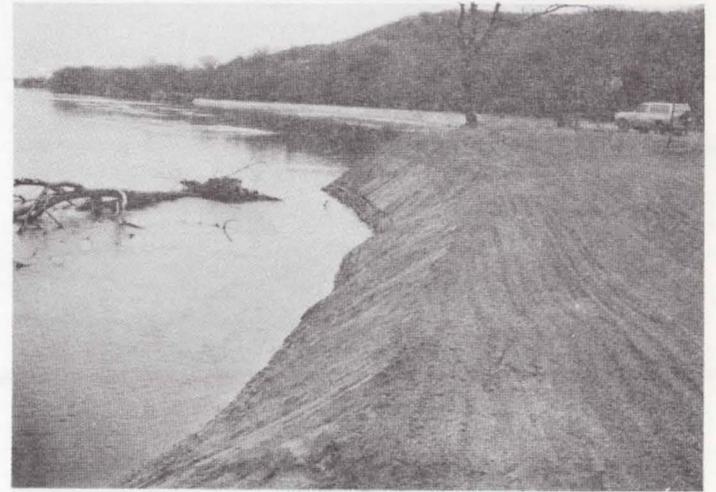
PHOTO 4

PHOTO 4. SECTION 1 LOOKING UPSTREAM AFTER CONSTRUCTION. 17 NOVEMBER 1980.

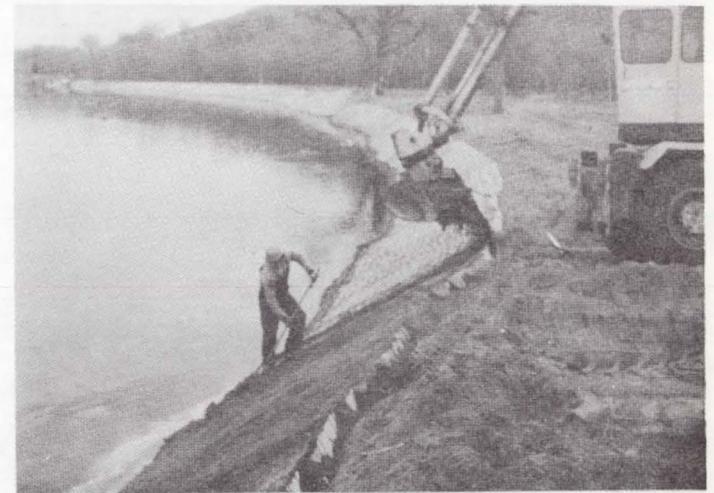
PHOTO 5

PHOTO 5. SECTION 2 LOOKING UPSTREAM DURING CONSTRUCTION.

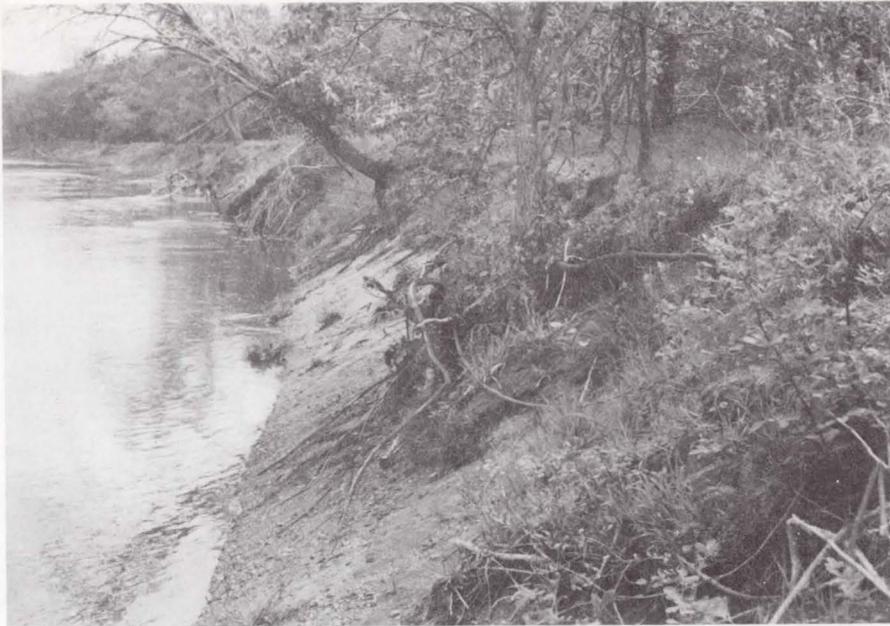
PHOTO 6. SECTION 4 LOOKING UPSTREAM BEFORE CONSTRUCTION.
27 AUGUST 1980.

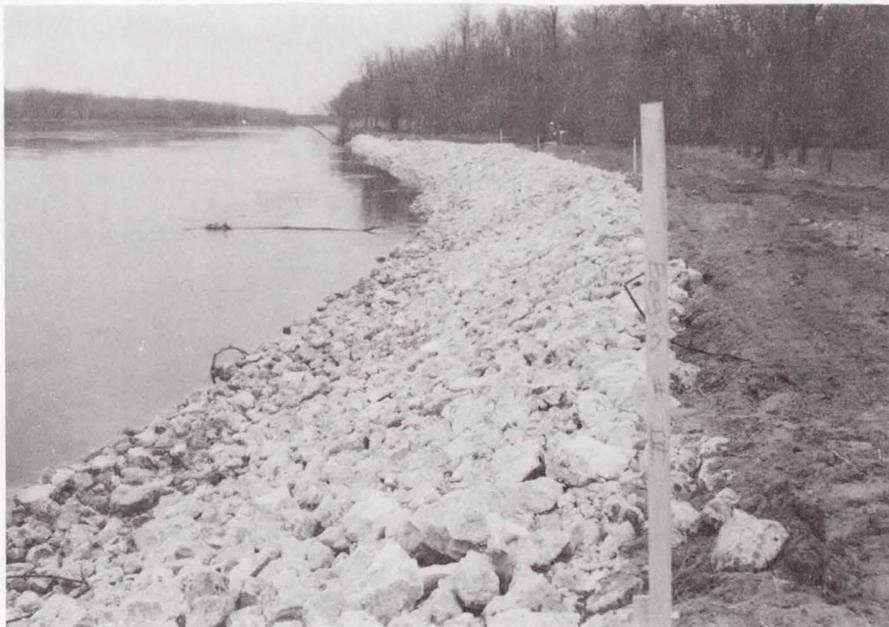
PHOTO 7. SECTION 4 LOOKING UPSTREAM AFTER CONSTRUCTION.
17 NOVEMBER 1980.

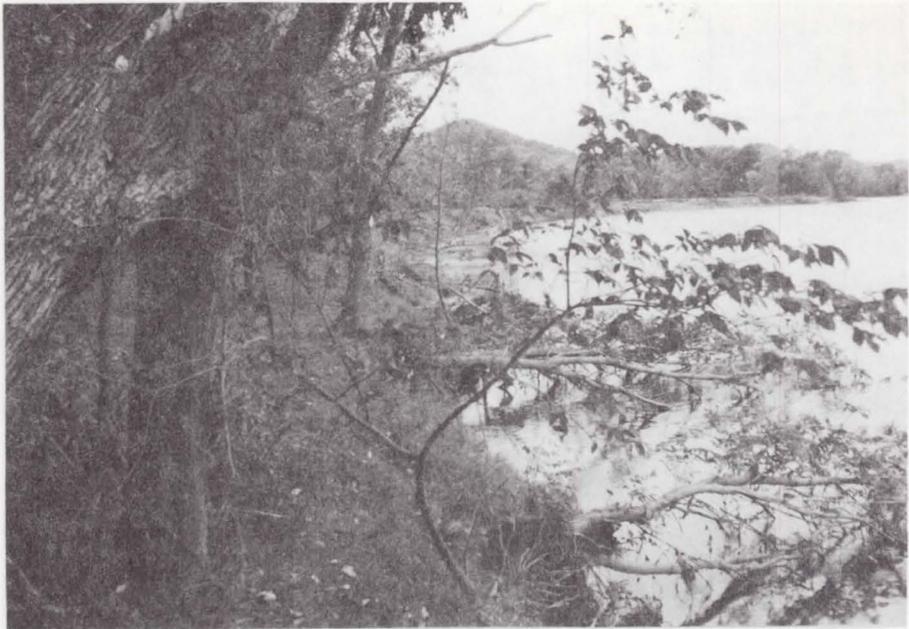
PHOTO 8. SECTION 5 LOOKING DOWNSTREAM BEFORE
CONSTRUCTION. 27 AUGUST 1980.

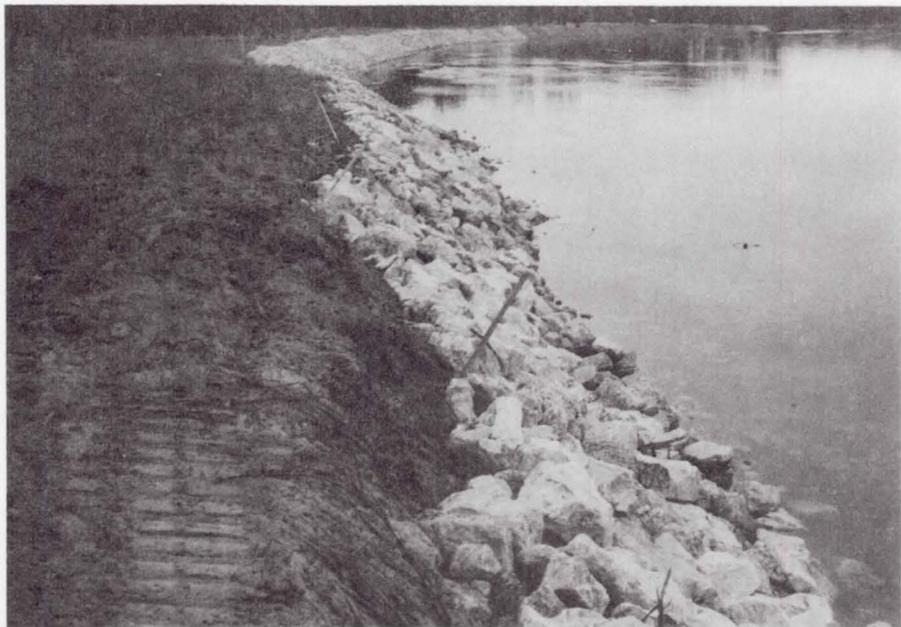
PHOTO 9. SECTION 5 LOOKING DOWNSTREAM AFTER CONSTRUCTION.
17 NOVEMBER 1980.

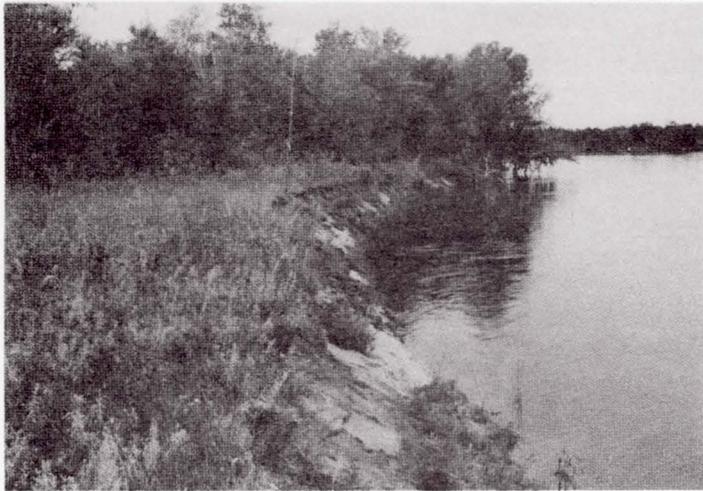
PHOTO 10

PHOTO 10. SECTION 1 LOOKING DOWNSTREAM BEFORE CONSTRUCTION. 27 AUGUST 1980.

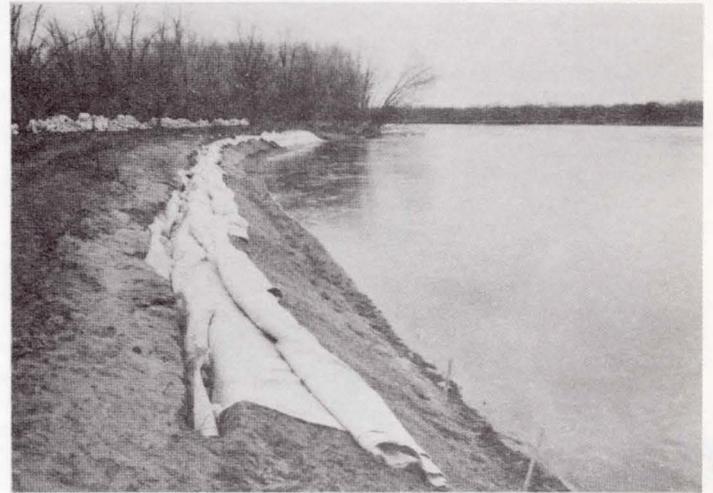
PHOTO 11

PHOTO 11. SECTION 1 LOOKING DOWNSTREAM DURING CONSTRUCTION. 17 NOVEMBER 1980.

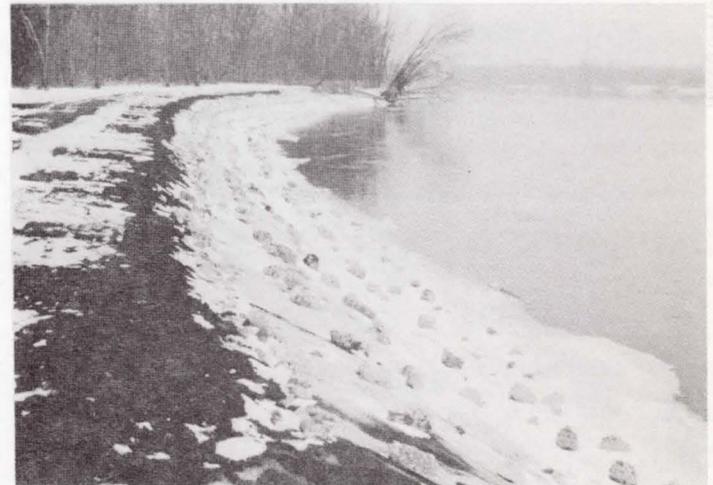
PHOTO 12

PHOTO 12. SECTION 1 LOOKING DOWNSTREAM AFTER CONSTRUCTION. 5 DECEMBER 1980.

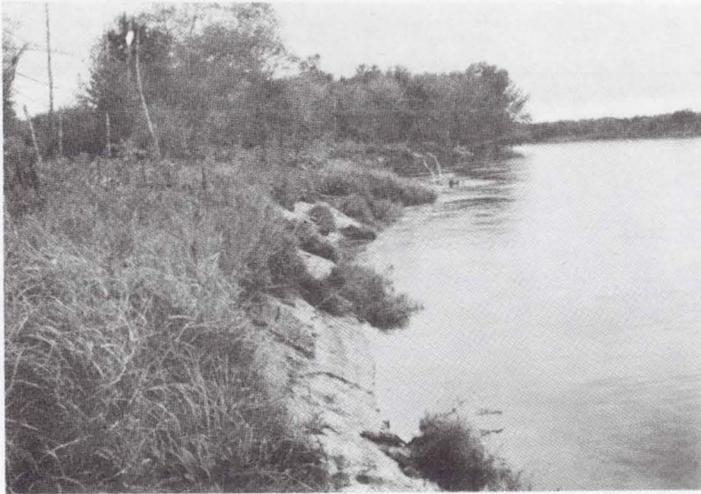
PHOTO 13

PHOTO 13. SECTION 3 LOOKING DOWNSTREAM BEFORE CONSTRUCTION. 27 AUGUST 1980.

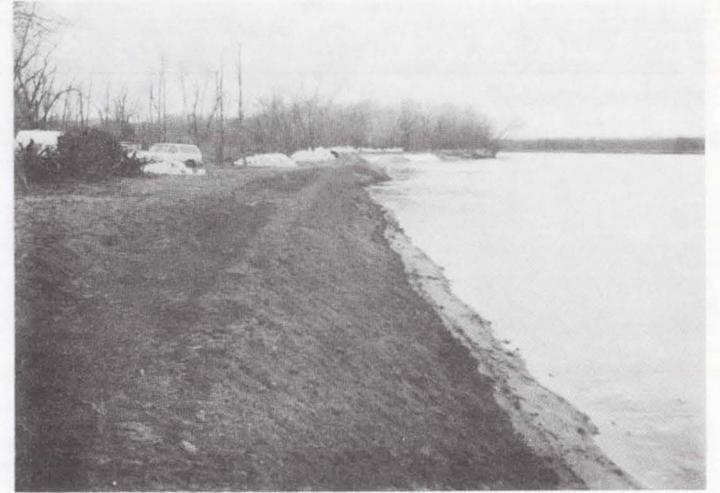
PHOTO 14

PHOTO 14. SECTION 3 LOOKING DOWNSTREAM DURING CONSTRUCTION. 17 NOVEMBER 1980.

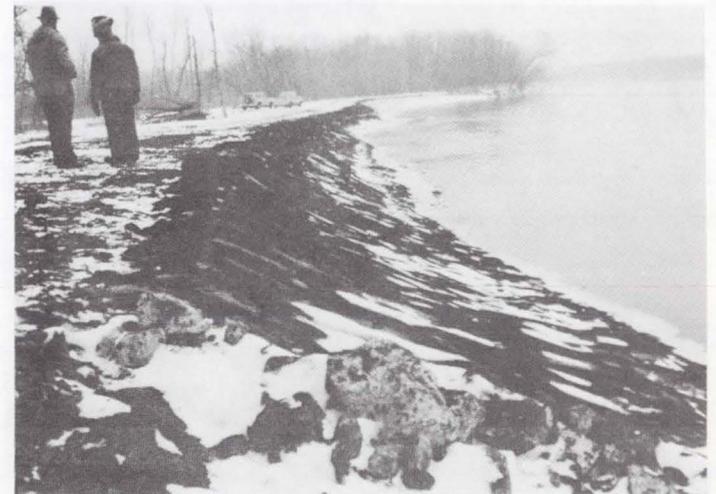
PHOTO 15

PHOTO 15. SECTION 3 LOOKING DOWNSTREAM AFTER CONSTRUCTION. 5 DECEMBER 1980.

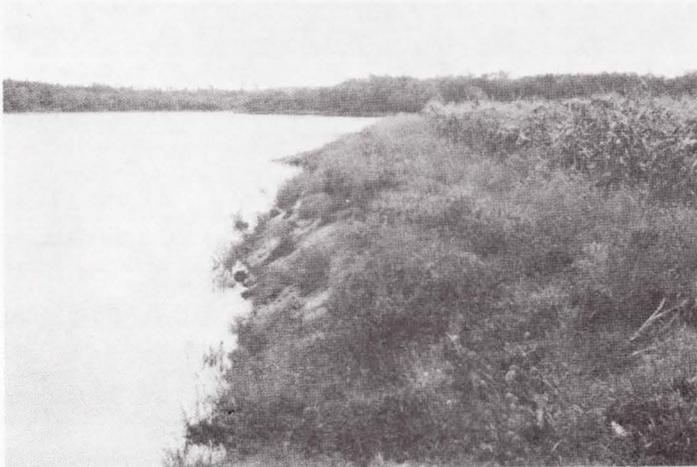
PHOTO 16

PHOTO 16. SECTION 4 LOOKING UPSTREAM BEFORE CONSTRUCTION. 27 AUGUST 1980.

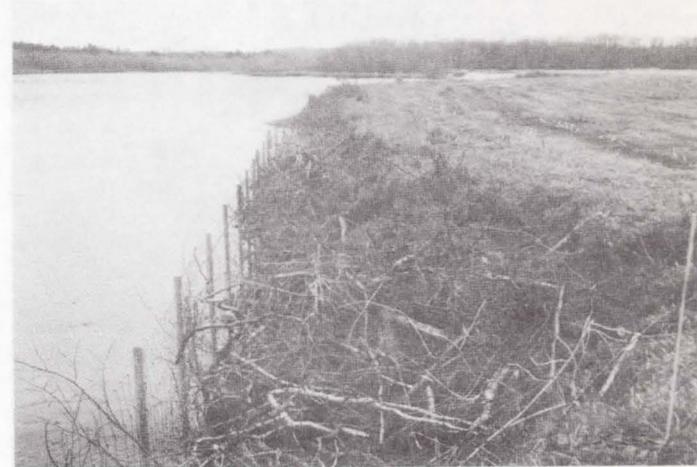
PHOTO 17

PHOTO 17. SECTION 4 LOOKING UPSTREAM DURING CONSTRUCTION. 17 NOVEMBER 1980.

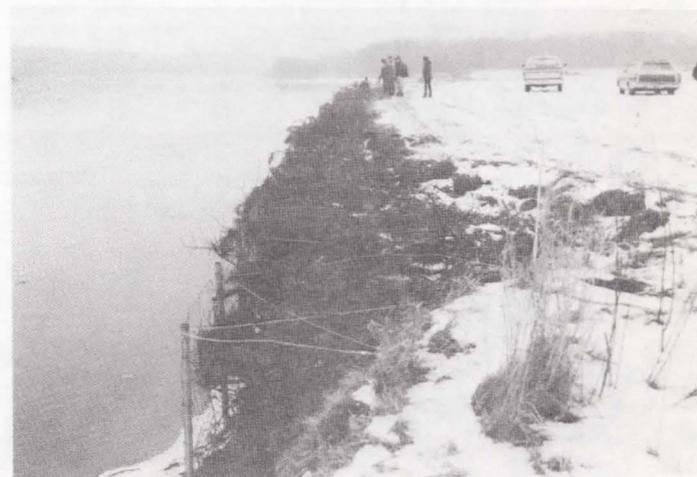
PHOTO 18

PHOTO 18. SECTION 4 LOOKING UPSTREAM AFTER CONSTRUCTION. 5 DECEMBER 1980.

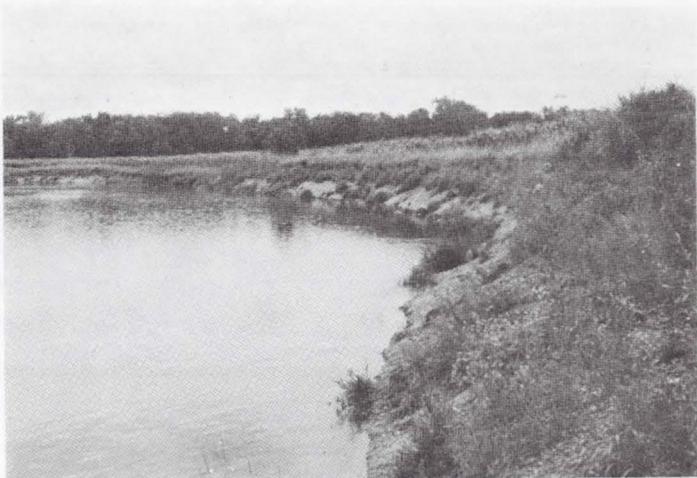
PHOTO 19

PHOTO 19. SECTION 6 LOOKING UPSTREAM BEFORE CONSTRUCTION. 27 AUGUST 1980.

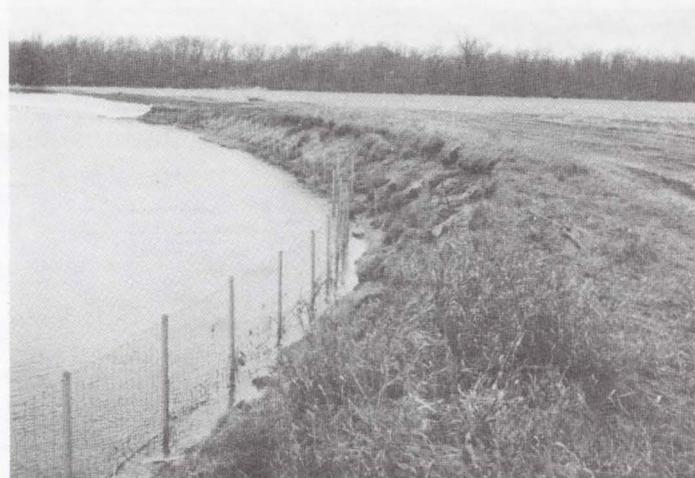
PHOTO 20

PHOTO 20. SECTION 6 LOOKING UPSTREAM DURING CONSTRUCTION. 17 NOVEMBER 1980.

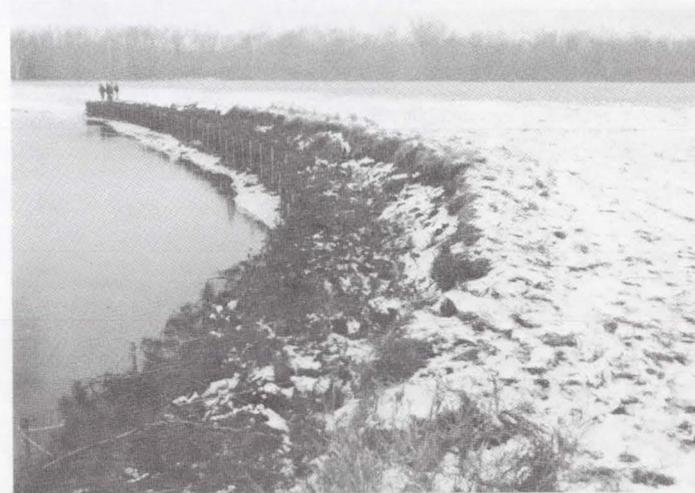
PHOTO 21

PHOTO 21. SECTION 6 LOOKING UPSTREAM AFTER CONSTRUCTION. 5 DECEMBER 1980.

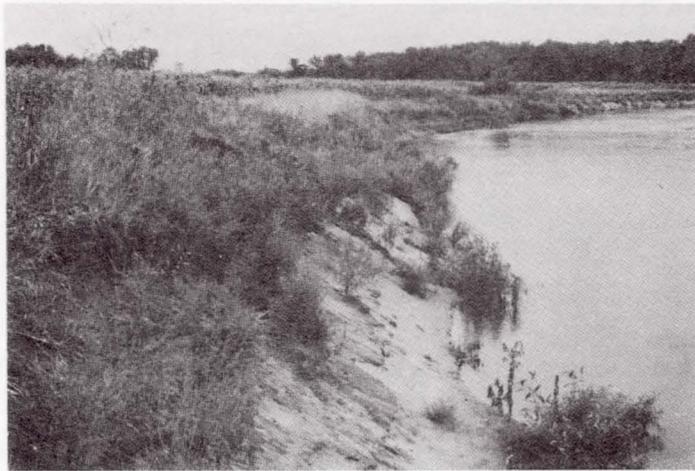
PHOTO 22

PHOTO 22. SECTION 7 LOOKING DOWNSTREAM BEFORE CONSTRUCTION. 27 AUGUST 1980.

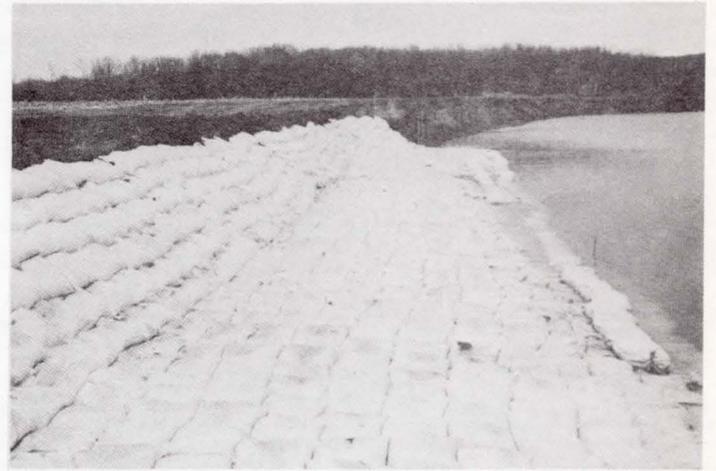
PHOTO 23

PHOTO 23. SECTION 7 LOOKING DOWNSTREAM DURING CONSTRUCTION. 17 NOVEMBER 1980.

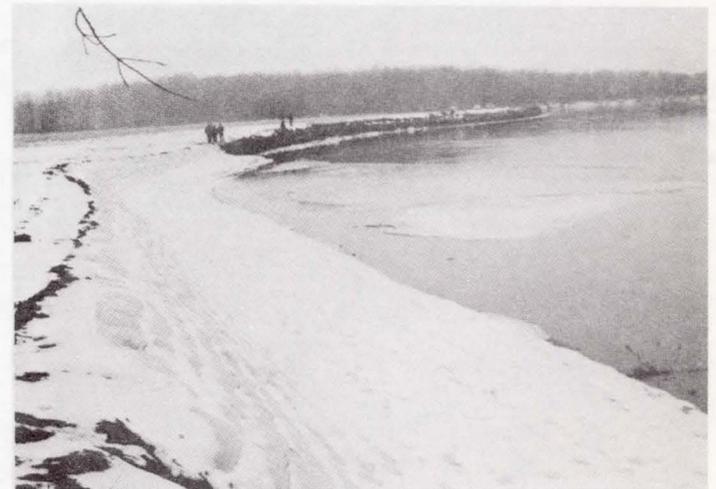
PHOTO 24

PHOTO 24. SECTION 7 LOOKING DOWNSTREAM AFTER CONSTRUCTION. 5 DECEMBER 1980.

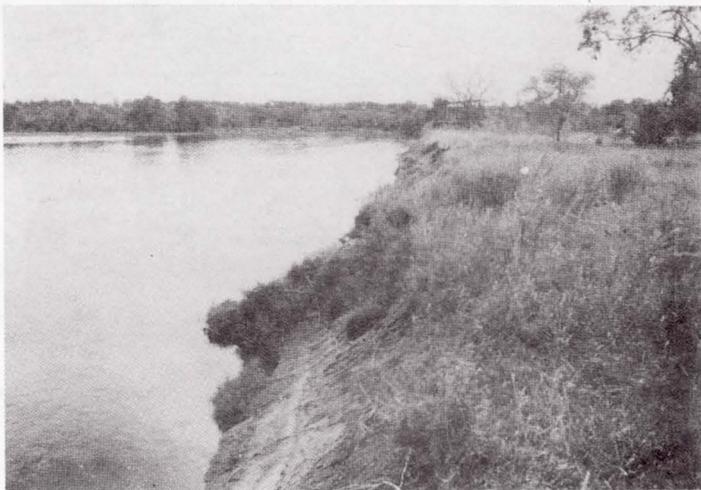
PHOTO 26

PHOTO 26. SECTION 1 LOOKING DOWNSTREAM BEFORE CONSTRUCTION. 27 AUGUST 1980.

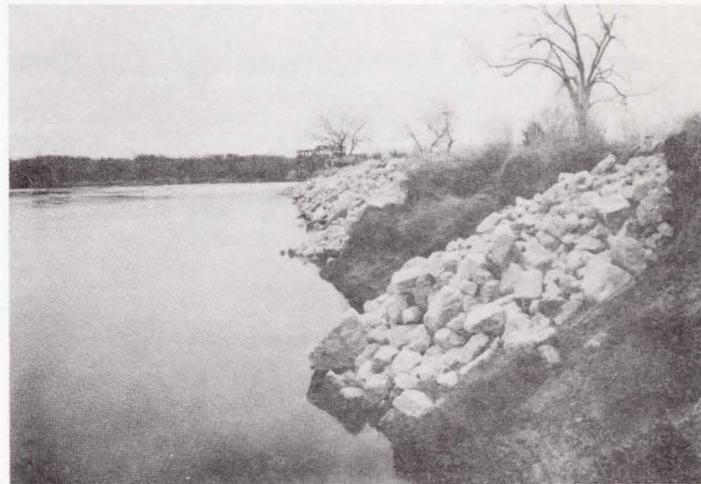
PHOTO 27

PHOTO 27. SECTION 1 LOOKING DOWNSTREAM DURING CONSTRUCTION. 17 NOVEMBER 1980.

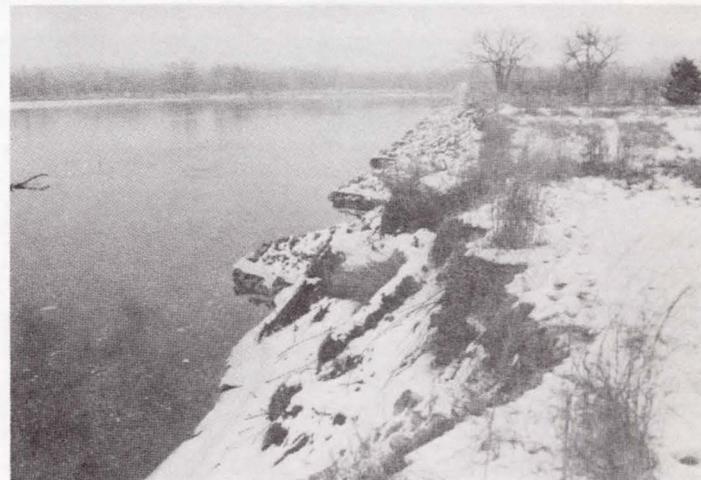
PHOTO 28

PHOTO 28. SECTION 1 LOOKING DOWNSTREAM AFTER CONSTRUCTION. 5 DECEMBER 1980.

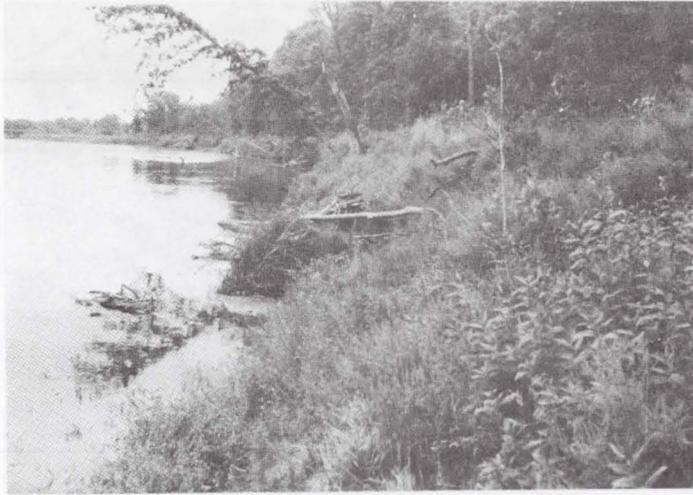
PHOTO 29

PHOTO 29. SECTION 2 LOOKING DOWNSTREAM BEFORE CONSTRUCTION. 27 AUGUST 1980.

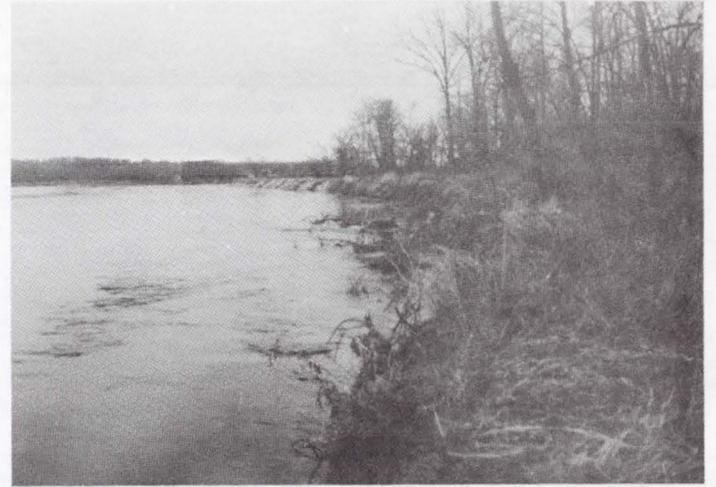
PHOTO 30

PHOTO 30. SECTION 2 LOOKING DOWNSTREAM DURING CONSTRUCTION. 17 NOVEMBER 1980.

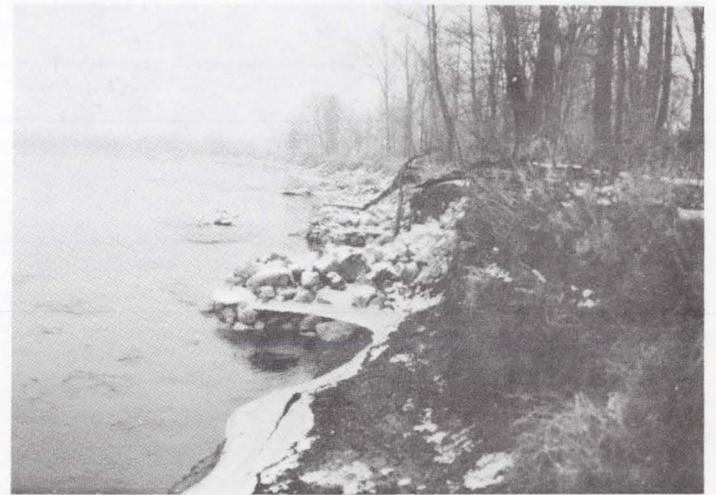
PHOTO 31

PHOTO 31. SECTION 2 LOOKING DOWNSTREAM AFTER CONSTRUCTION. 5 DECEMBER 1980.

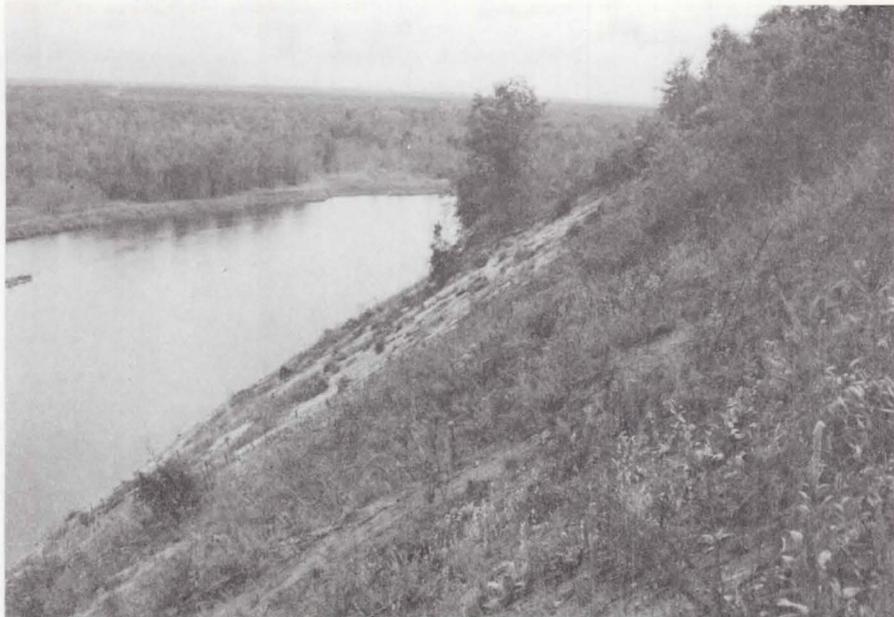
PHOTO 33. LOOKING DOWNSTREAM BEFORE CONSTRUCTION.
27 AUGUST 1980.

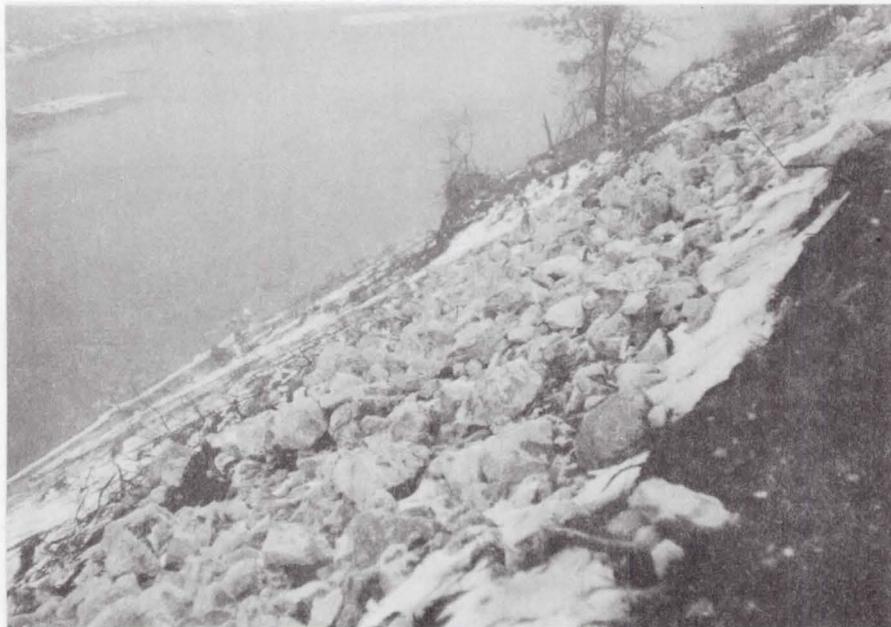
PHOTO 34. LOOKING DOWNSTREAM AFTER CONSTRUCTION.
5 DECEMBER 1980.

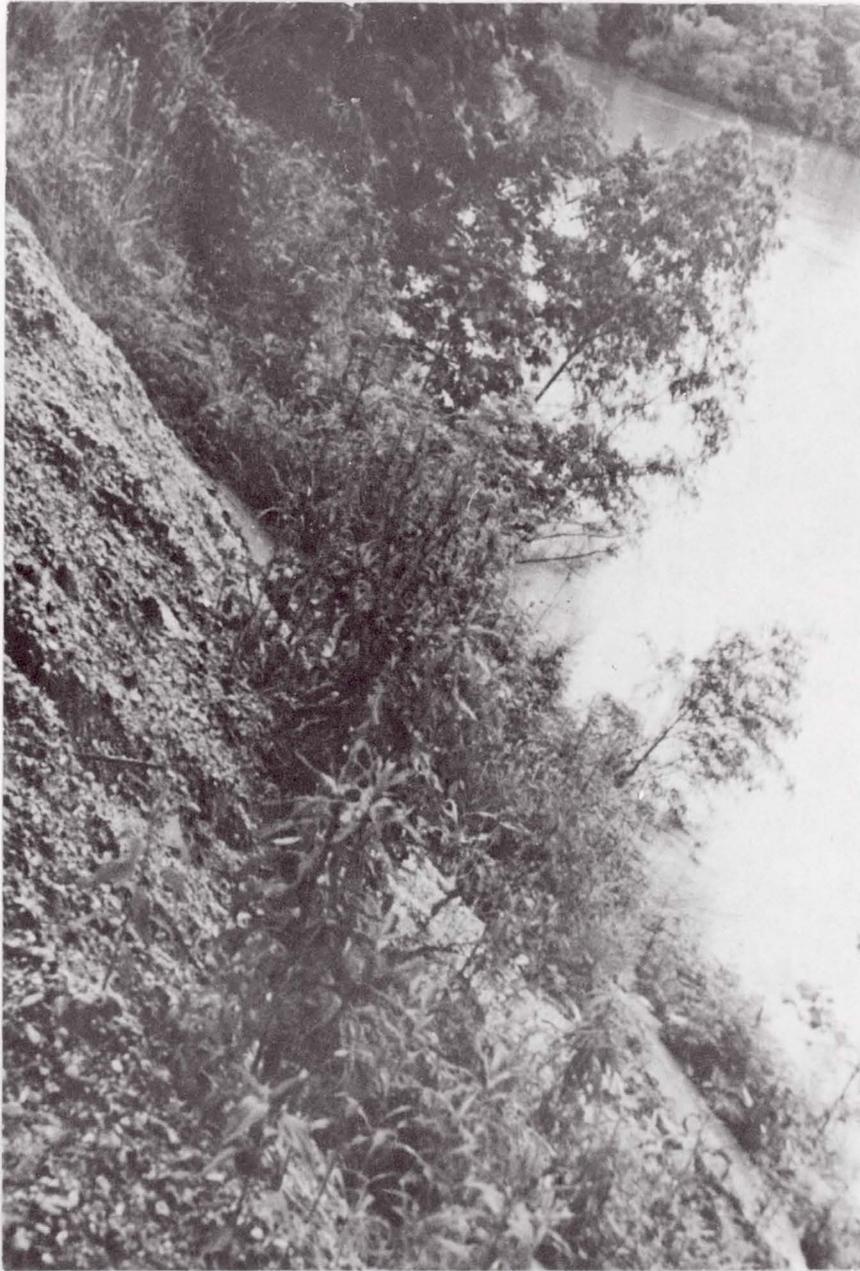
PLATE 10

BEFORE CONSTRUCTION, MAY 1980. NOTE UPSTREAM VIEW,
TOP OF BANK, APPROXIMATELY 200 FEET N.G.V.D., 19 FEET
ABOVE WATER SURFACE.

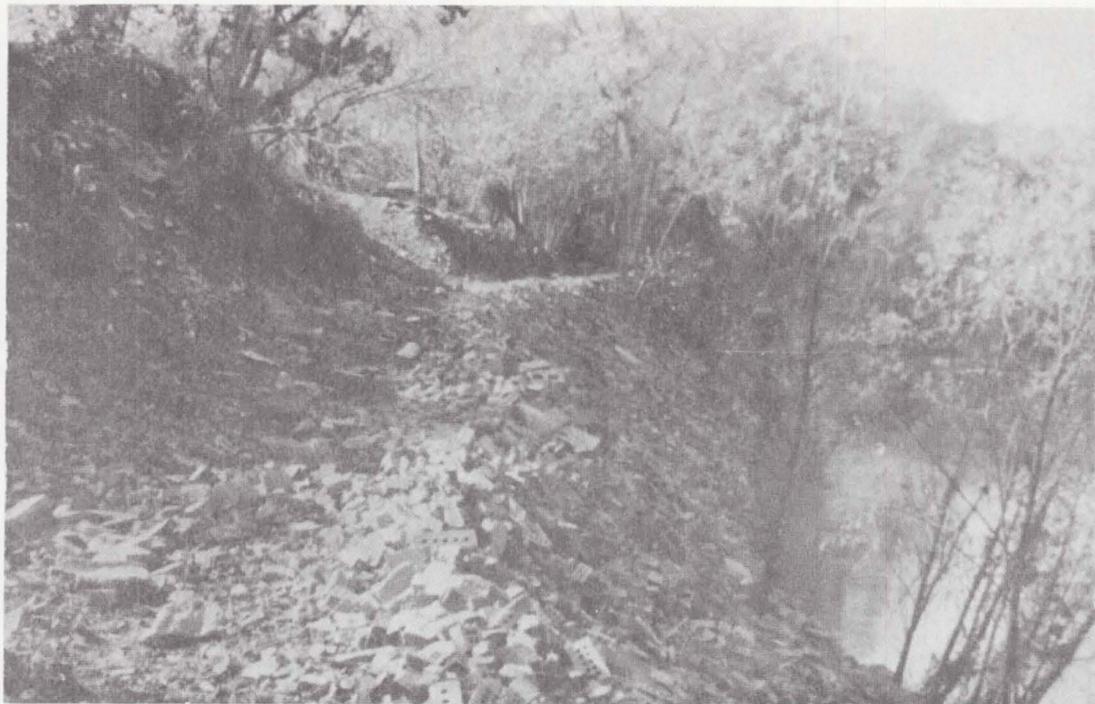
AFTER CONSTRUCTION, DECEMBER 1980. NOTE UPSTREAM VIEW, TOP OF RUBBLE, 190 FEET N.G.V.D., 23 FEET ABOVE WATER SURFACE.

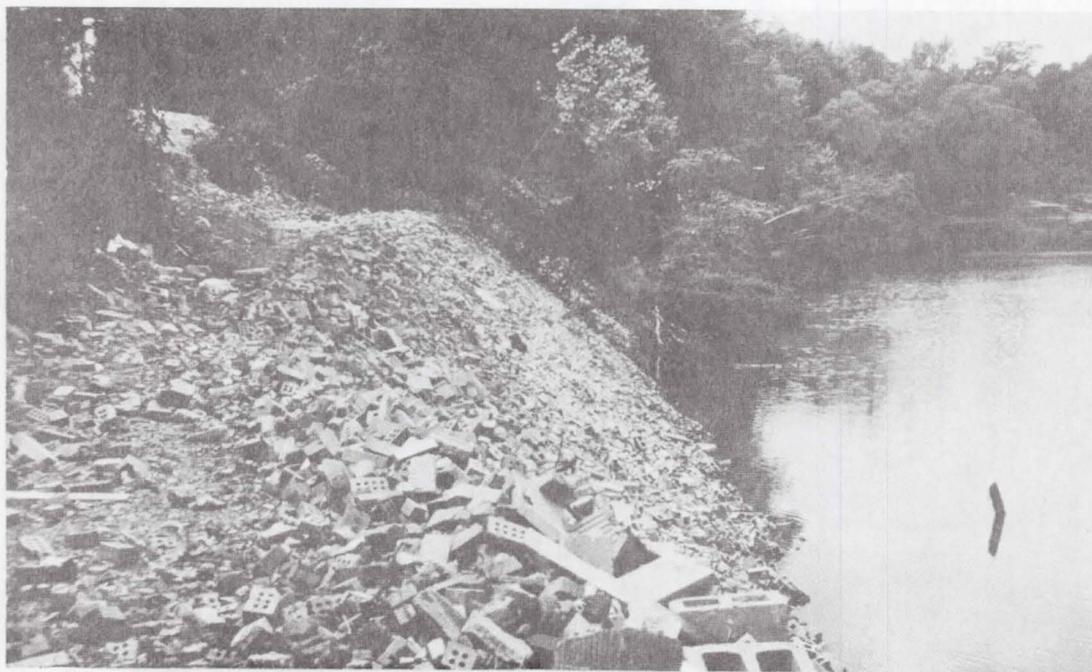
14. Conclusions. The "final inspection" after construction was made in early December 1980. This trip concluded the construction phase and initiated the monitoring effort. During late April 1981 a minor flood occurred at Monticello. After this flood, a site visit was made to monitor and note any damage. Except for minor erosion at the toe of Site 3, all three sites appeared to be in excellent condition and have halted the erosion, to date, at each location.

AFTER FLOOD OF MAY 1981. NOTE UPSTREAM VIEW, TOP OF RUBBLE 190 FEET N.G.V.D., 18 FEET ABOVE WATER SURFACE.

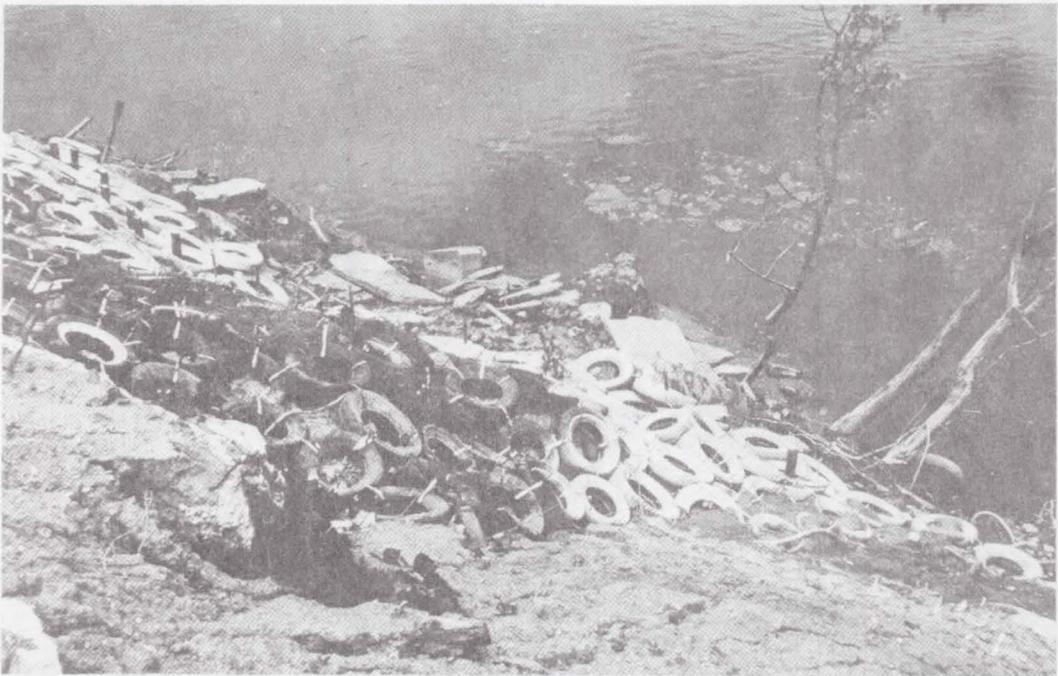
AFTER FLOOD OF MAY 1981. NOTE FLOW TO THE RIGHT, TOP OF STRUCTURE 190 FEET N.G.V.D., 18 FEET ABOVE WATER SURFACE.

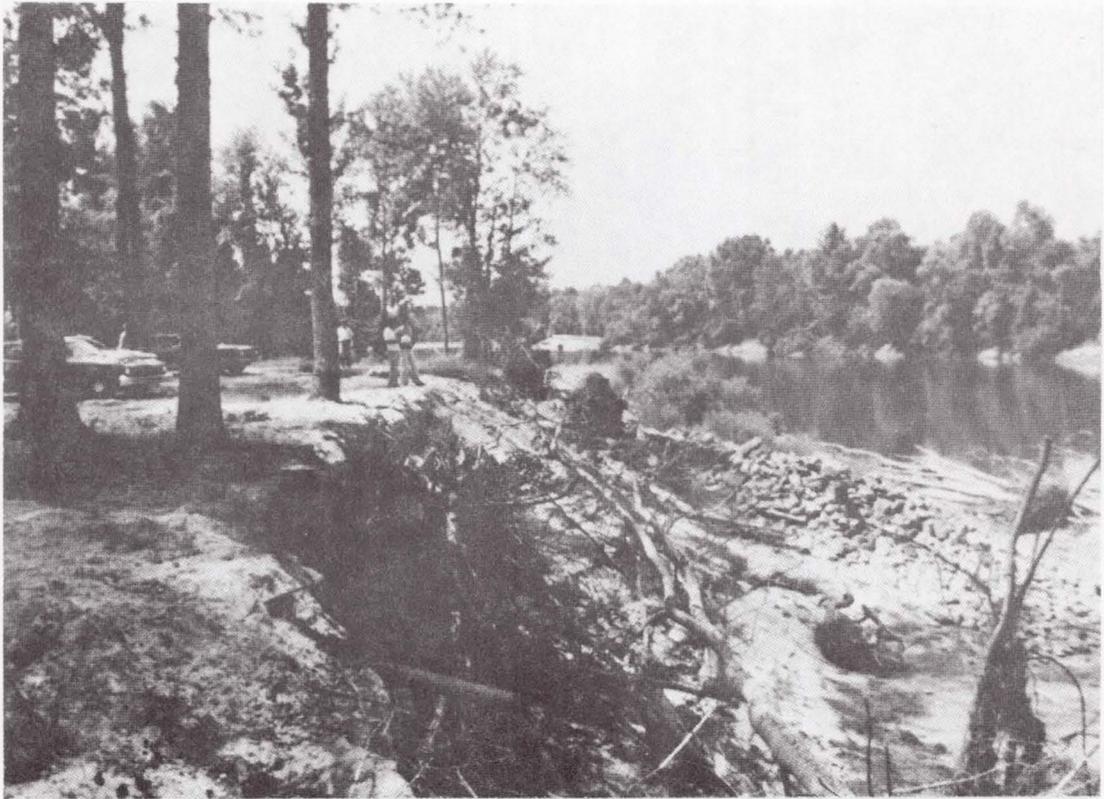
PLATE 14

BEFORE CONSTRUCTION, MAY 1980. NOTE DOWNSTREAM VIEW, TOP OF BANK APPROXIMATELY 185 FEET N.G.V.D., 10 FEET ABOVE WATER SURFACE.

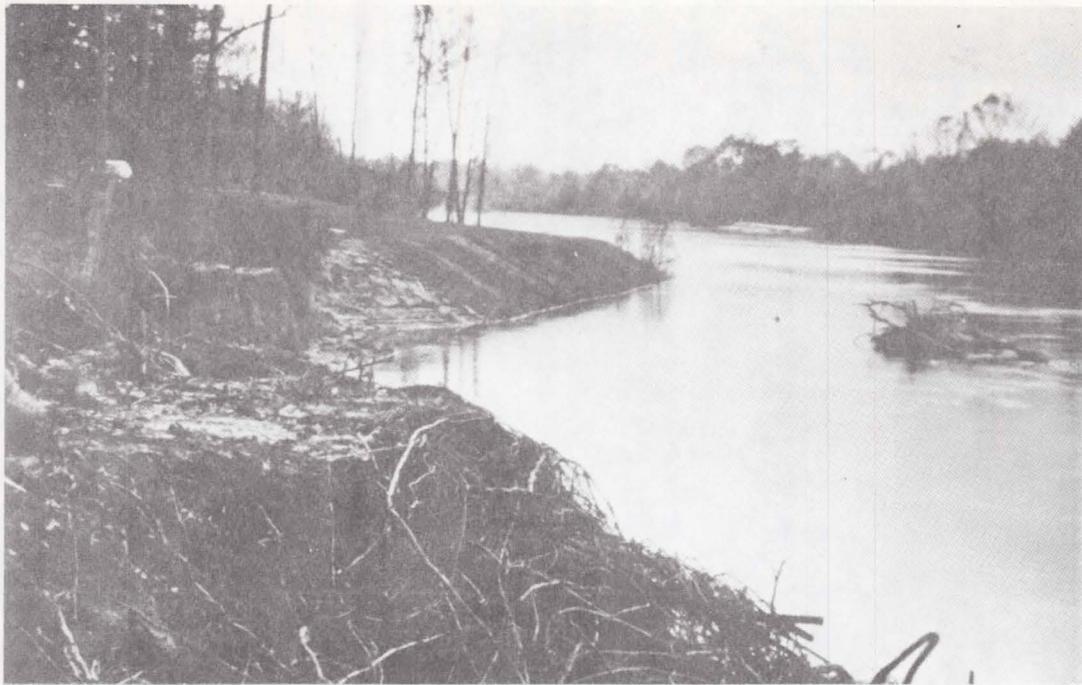
AFTER CONSTRUCTION, DECEMBER 1980. NOTE DOWNSTREAM VIEW, TOP OF STRUCTURE 180 FEET N.G.V.D., 8 FEET ABOVE WATER SURFACE.

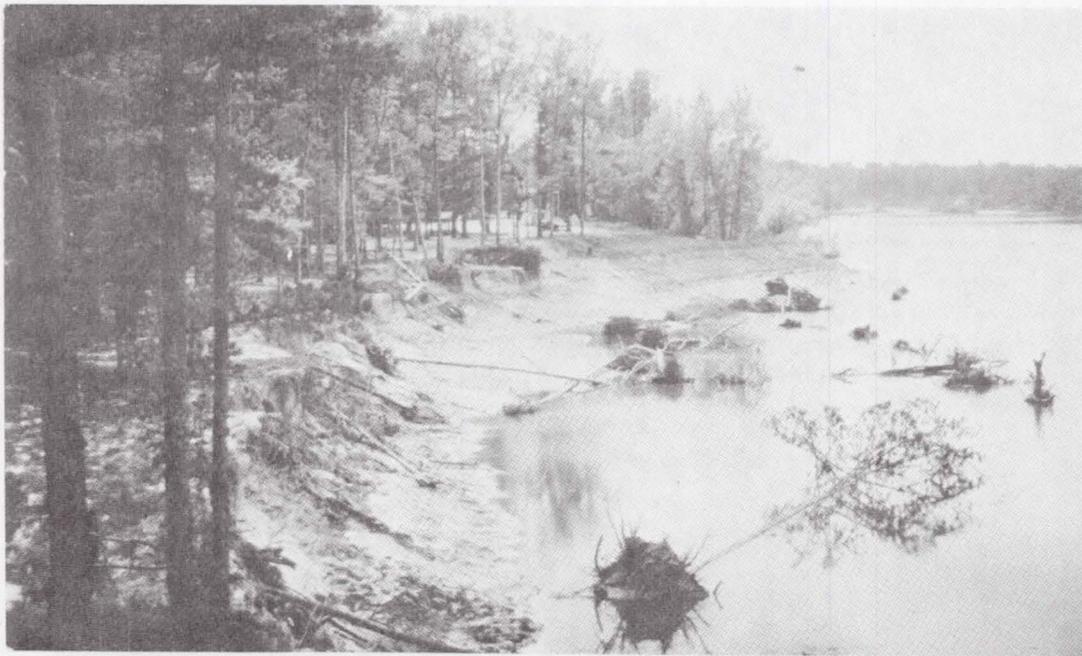
AFTER FLOOD OF MAY 1981. NOTE DOWNSTREAM VIEW, TOP OF STRUCTURE 180 FEET N.G.V.D., 13 FEET ABOVE WATER SURFACE.

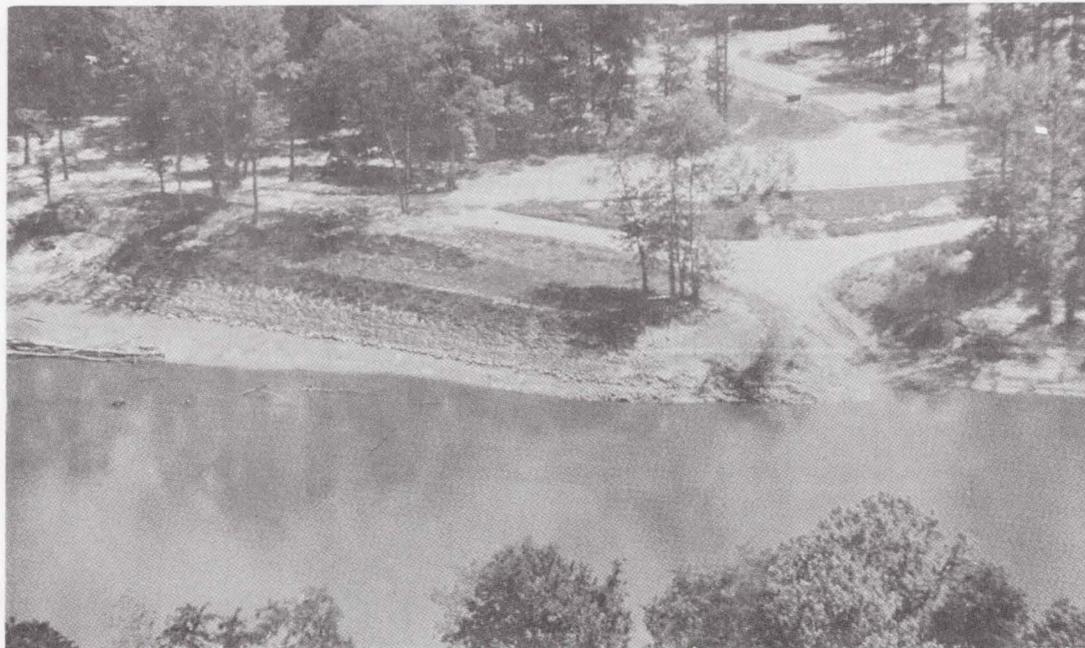
SITE 3, MAY 1981. NOTE FLOW TO THE RIGHT, TOP OF BANK APPROXIMATELY 185 FEET N.G.V.D., 18 FEET ABOVE WATER SURFACE.
