FINAL REPORT TO CONGRESS

**THE STREAMBANK EROSION CONTROL
EVALUATION AND DEMONSTRATION ACT OF 1974
SECTION 32, PUBLIC LAW 93-251**

Appendix G - Demonstration Projects on Other Streams, Nationwide Volume 2 of 2

APPENDIX G DEMONSTRATION PROJECTS ON OTHER STREAMS, NATIONWIDE

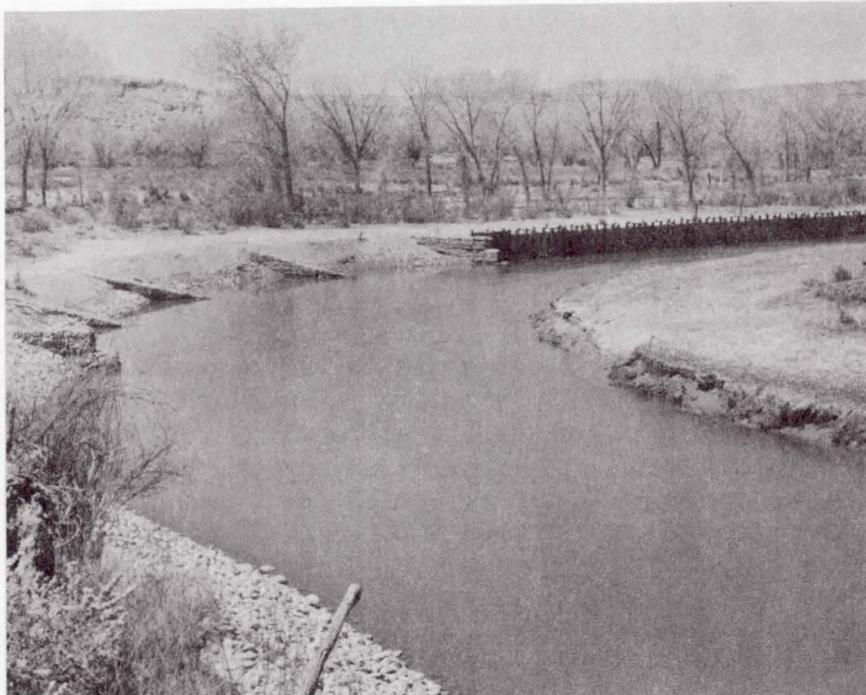
PHOTO 2 LOOKING UPSTREAM AFTER CONSTRUCTION
DATE: APRIL 1981

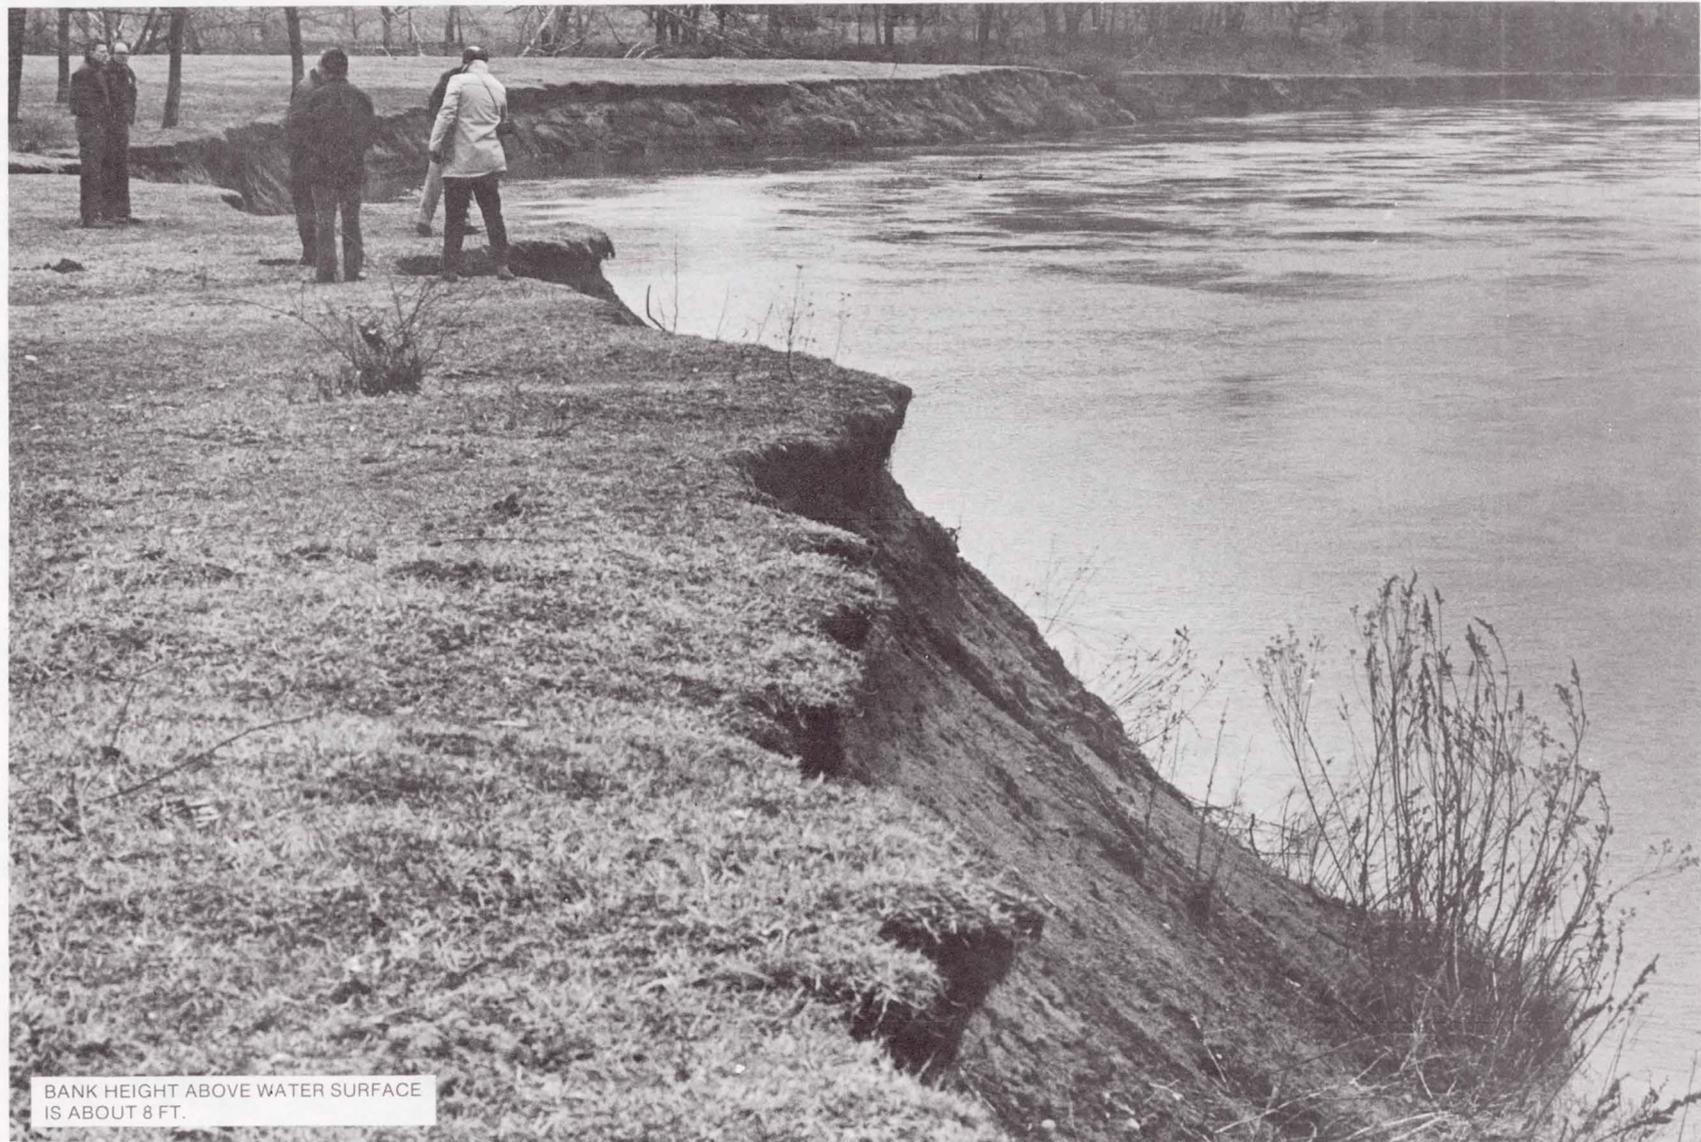
PHOTO 1

PHOTO 1. Site A, Station 7+00, downstream 16 Mar 78

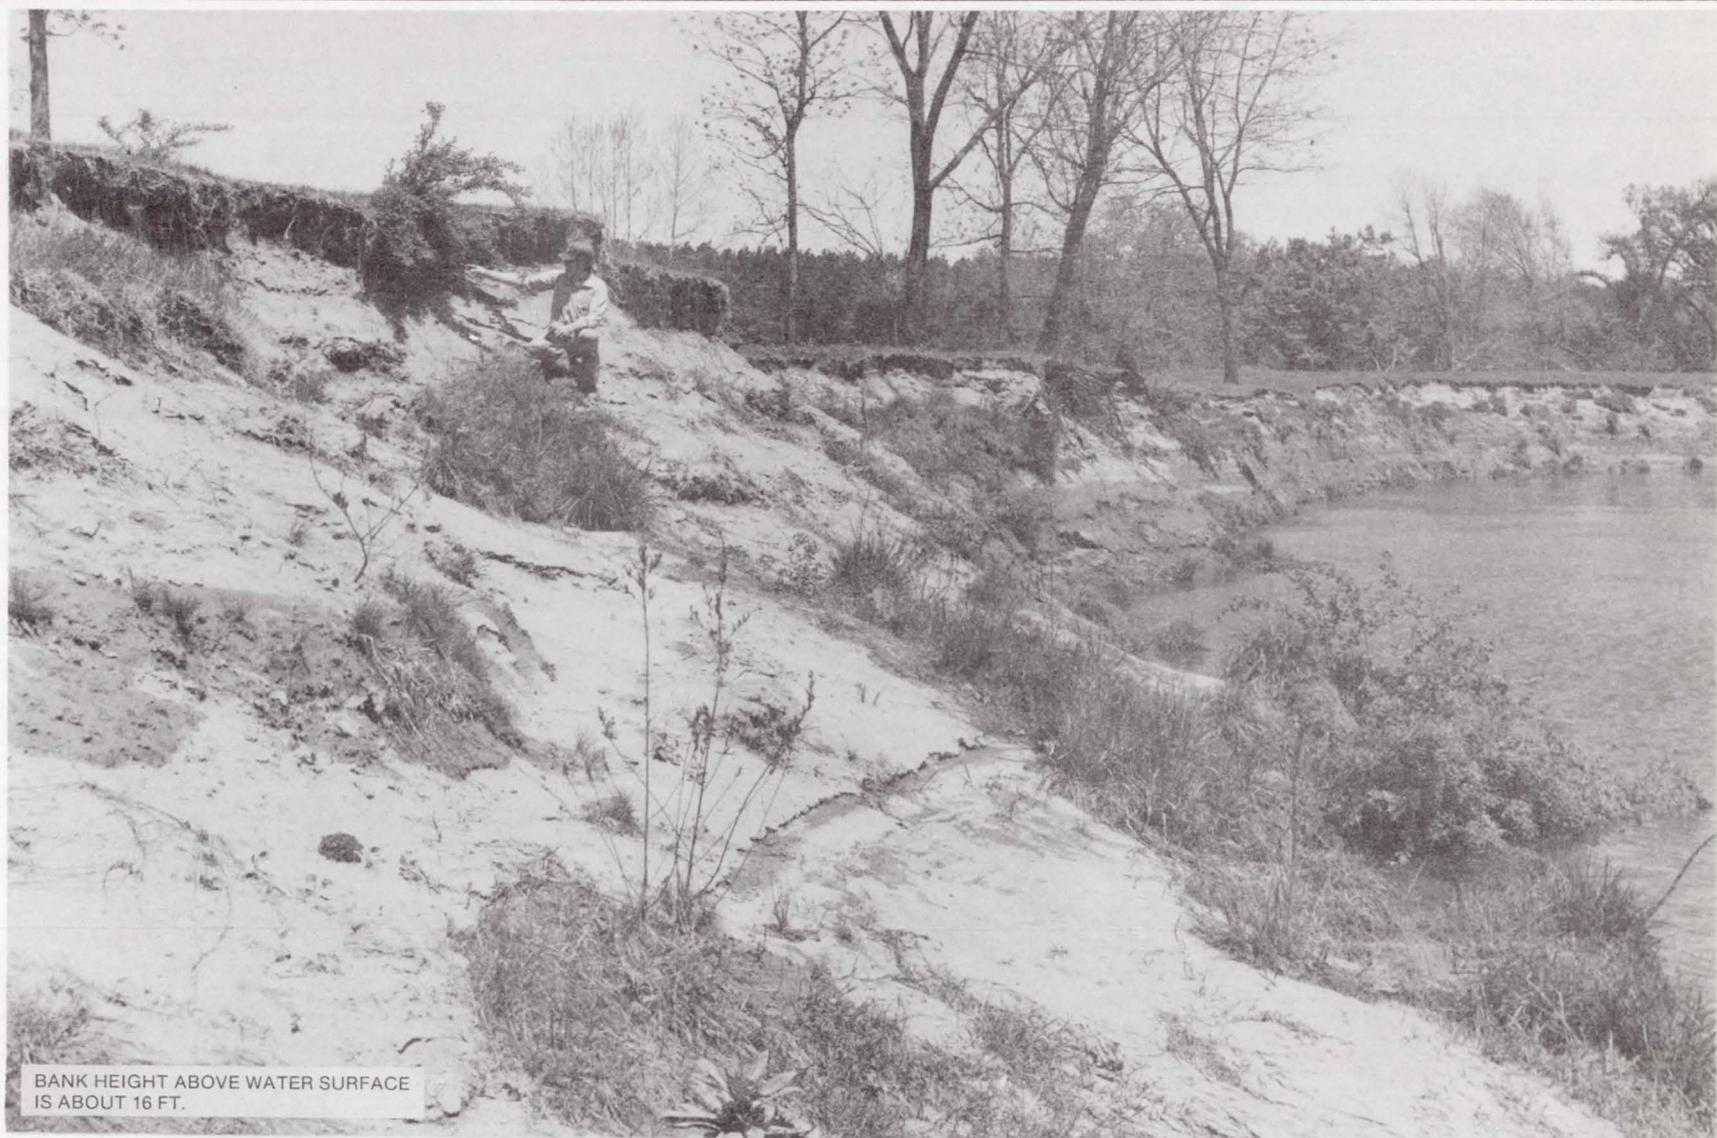
PHOTO 4

PHOTO 4. Site A, Station 5+00, downstream 1 May 79

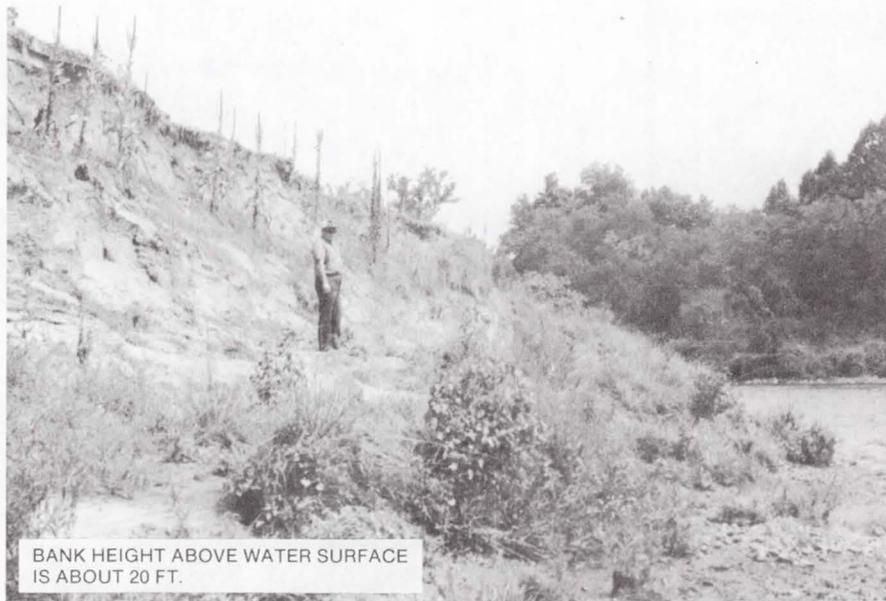
PHOTO 10. Site A, Station 2+50, downstream 3 Sep 80

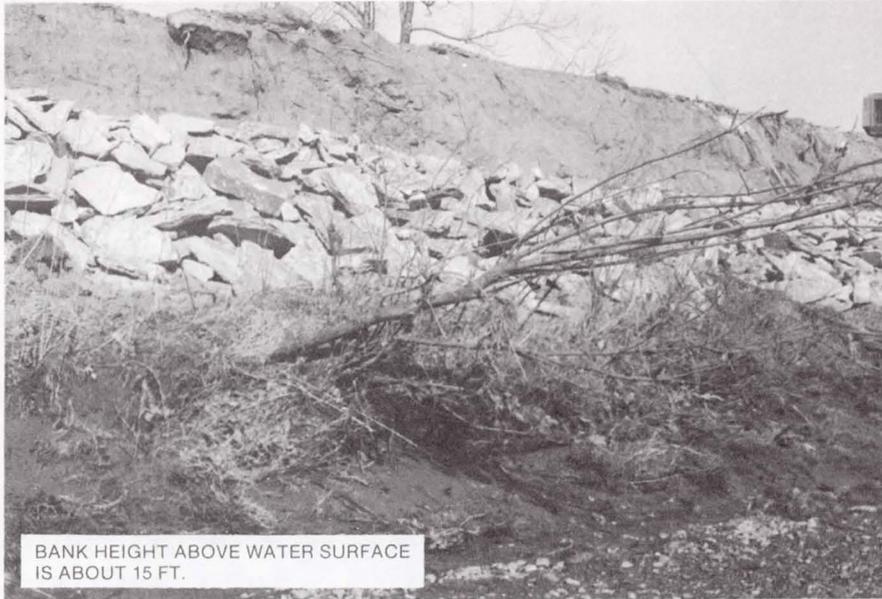
PHOTO 13. Site A, Station 3+50, view of bank, stone rubble method 5 Jan 81

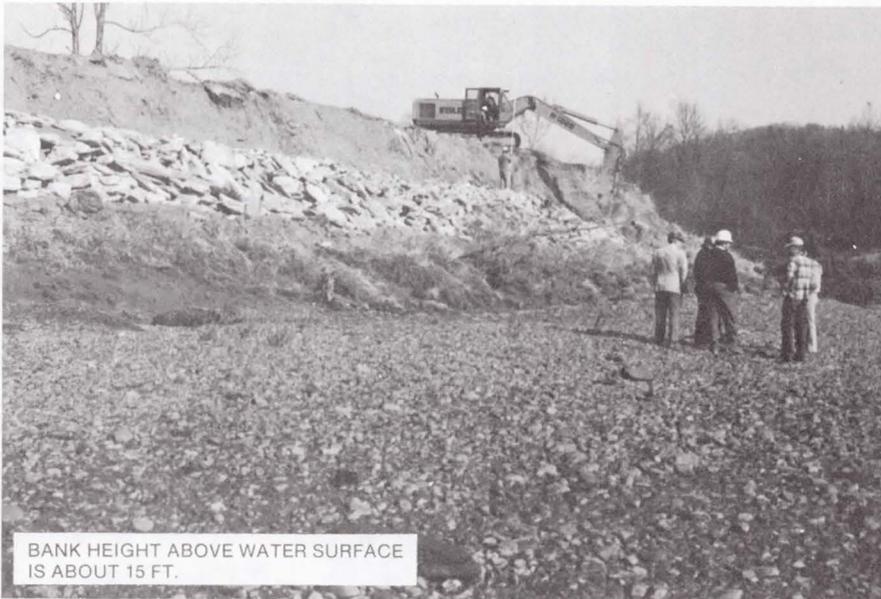
PHOTO 14. Station 3+50, downstream, stone rubble method 5 Jan 81

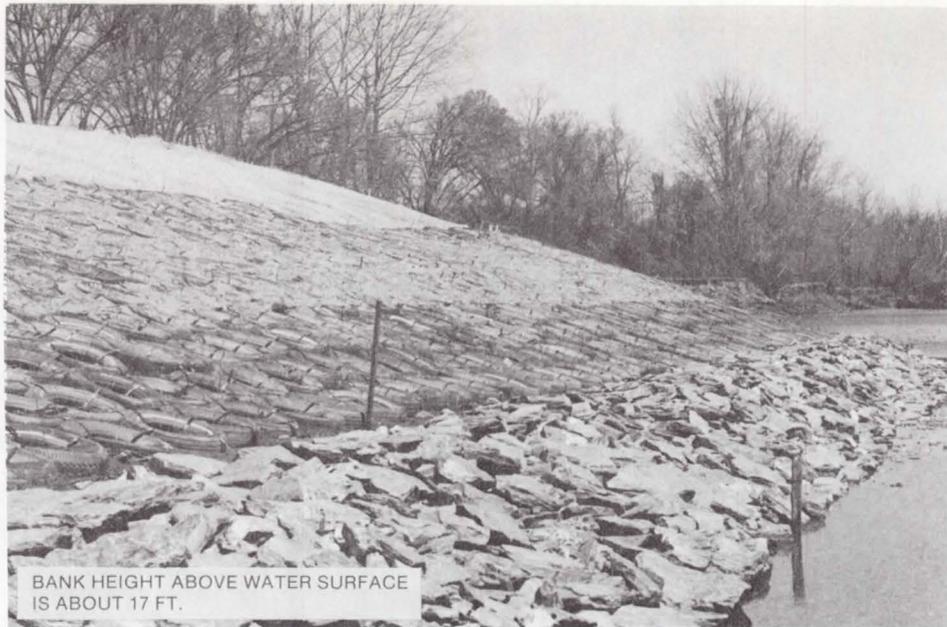
PHOTO 18. Site A, about Station 9+00. View of rubber tire mattress - rock toe immediately after construction. 21 Mar 81

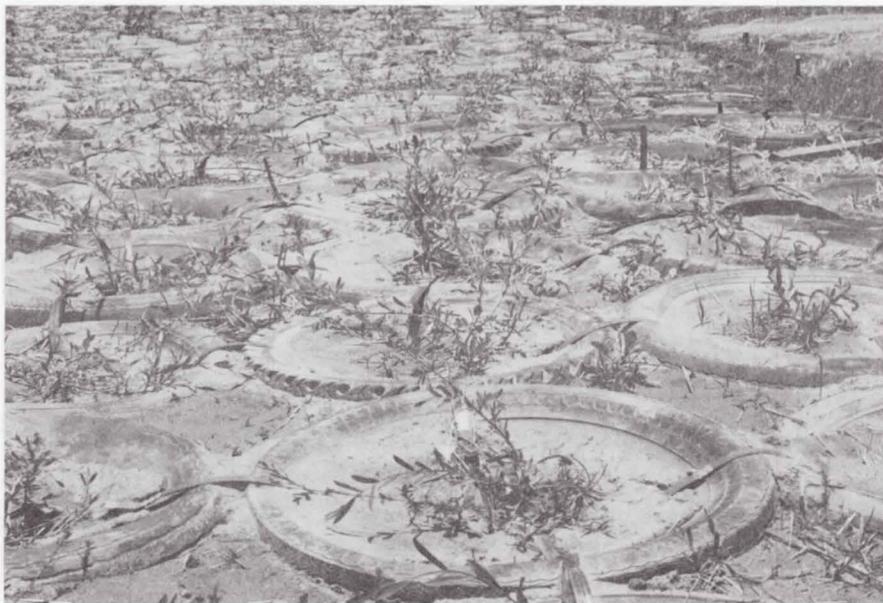
PHOTO 23. Site A, close-up of rubber tire mattress 2 months after construction. 21 May 81

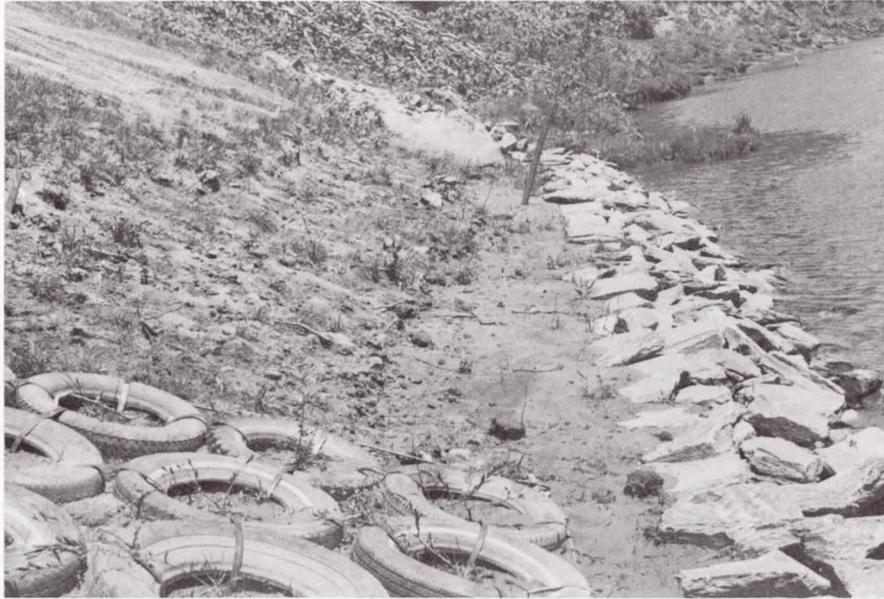
PHOTO 24. Site A, downstream view, Station 12+50 to 13+00 showing lower 50 feet of project that received only rock toe and grass cover (no tires). 21 May 81

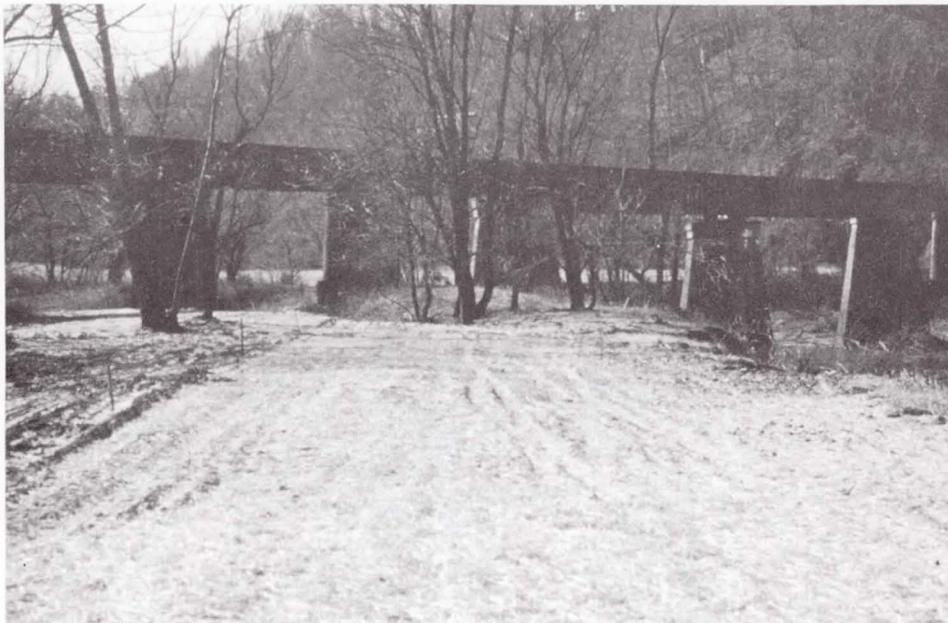
PHOTO 25. Site C, stone windrow method. Upstream view from Station 3+00 to 0+00. River on right. Immediately after construction. 21 May 81

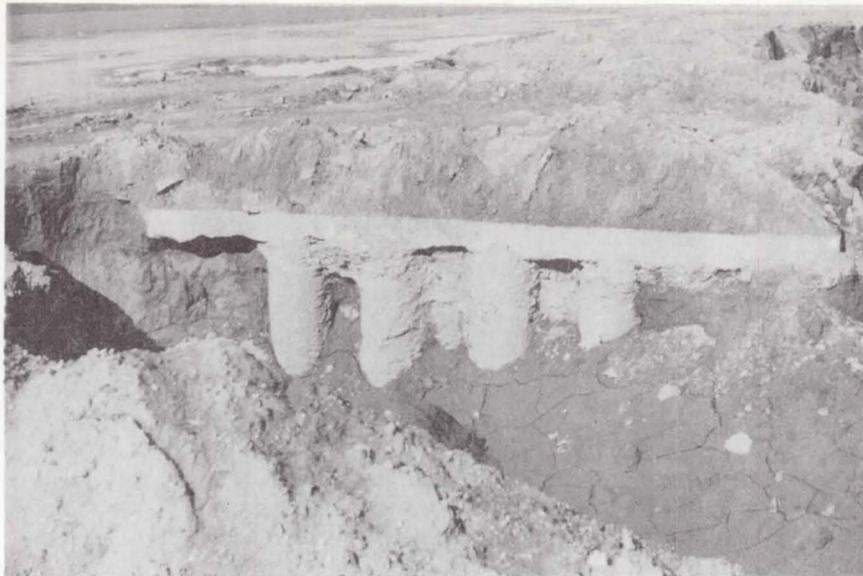
AFTER CONSTRUCTION

Station 18+20 - Looking at downstream side of groin
Number 14 - Erosion to a depth of 10 feet (April 1981)

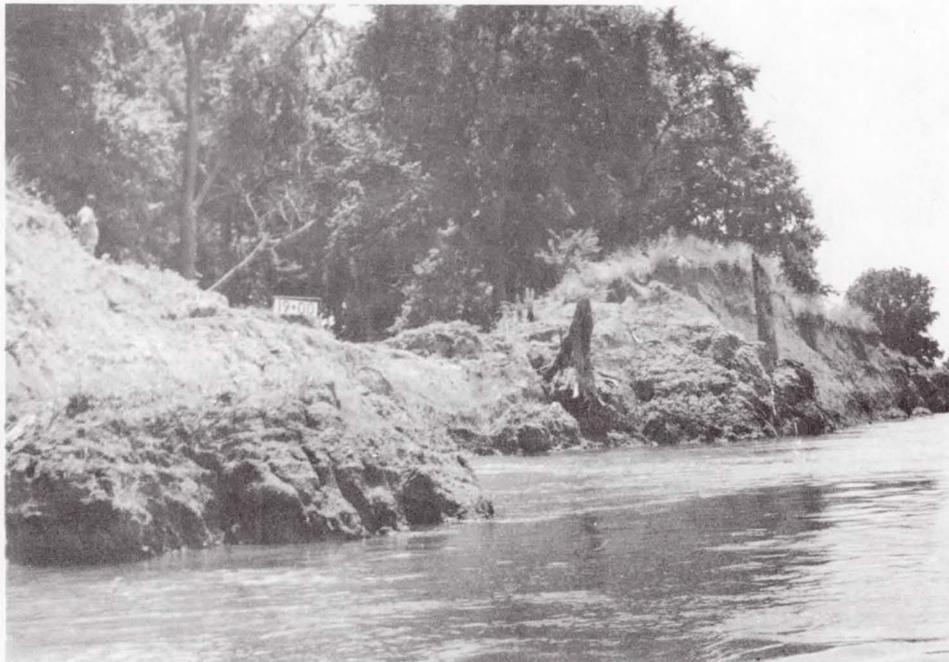
PHOTO 2

STA 11+00

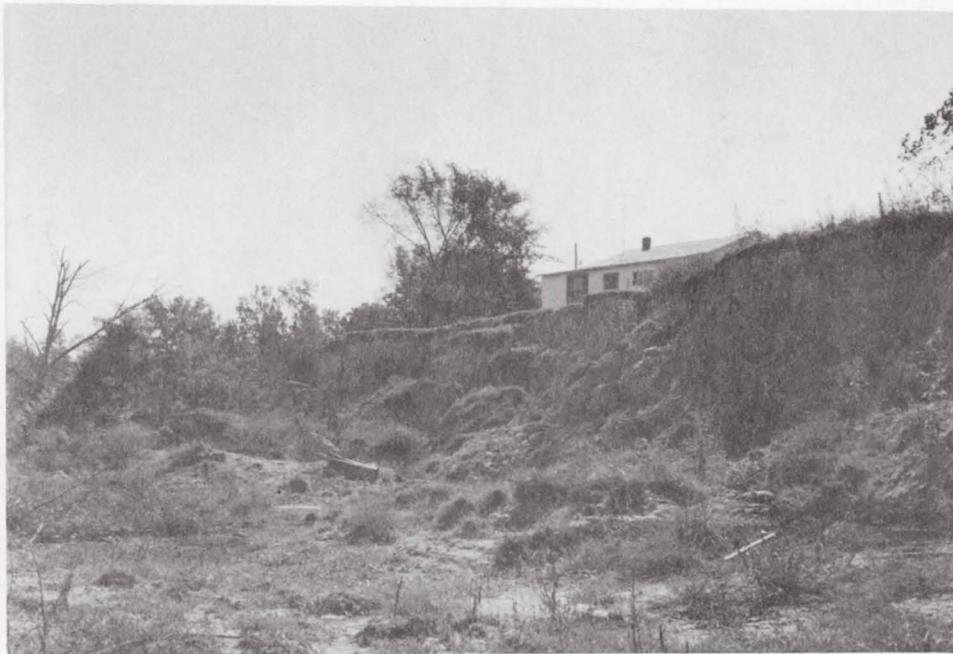
PHOTO 3

PRE-PROJECT CONDITIONS

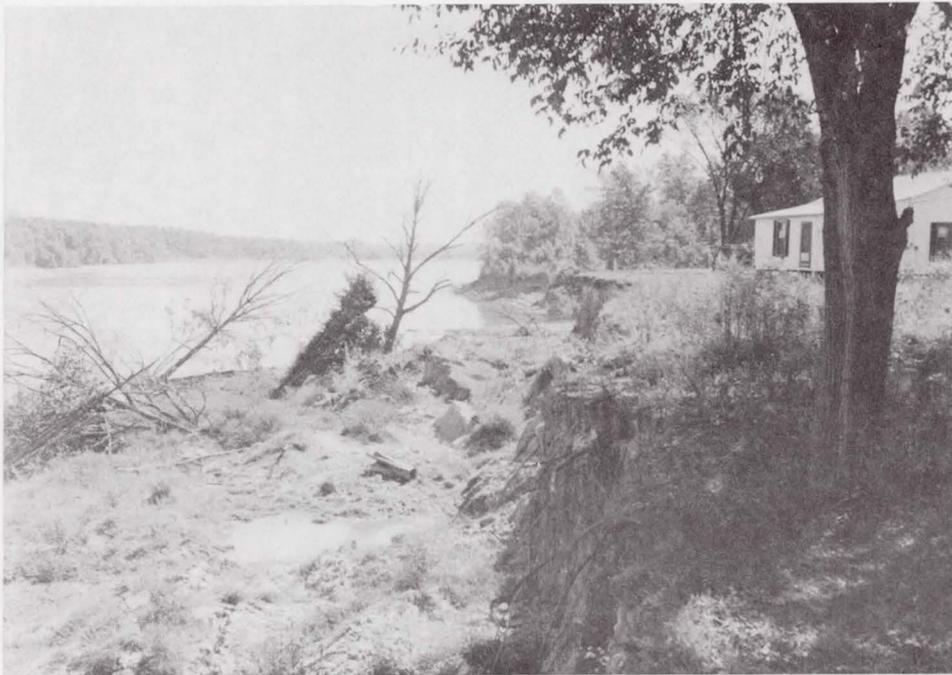
PHOTO 4

PRE-PROJECT CONDITIONS

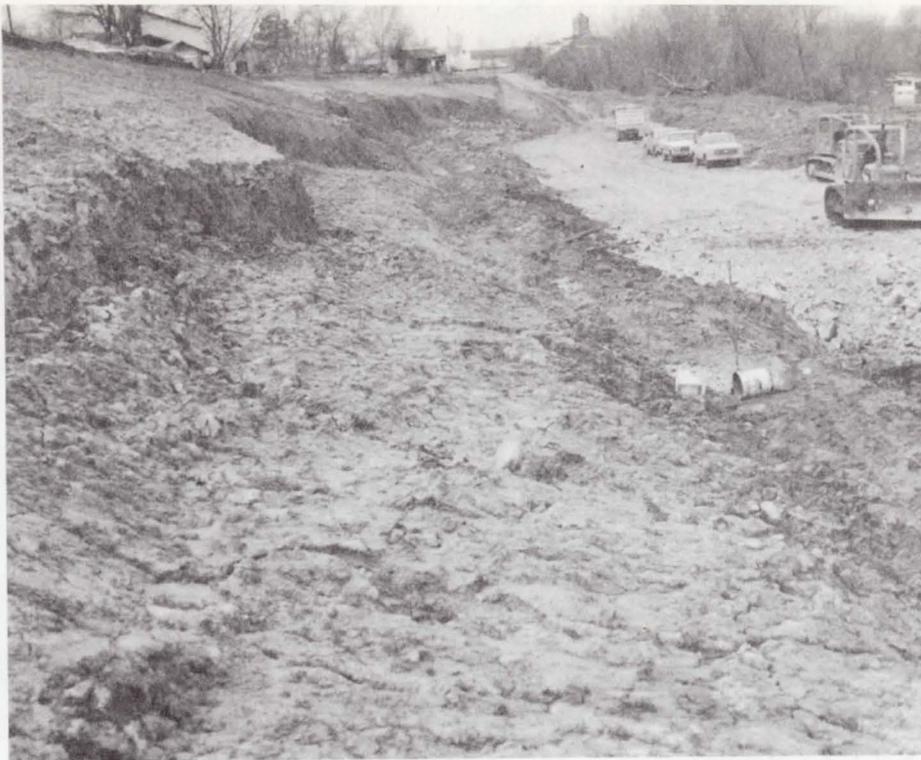
PHOTO 5

VIEW UPSTREAM

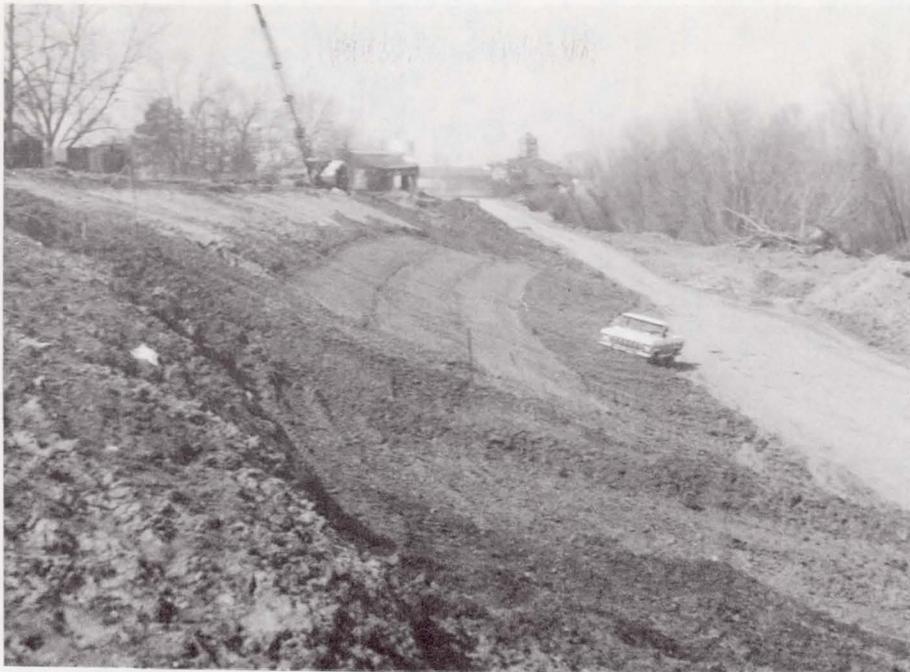
PHOTO 7

VIEW UPSTREAM

REPLACING FAILED BANK MATERIAL WITH
SEMI-COMPACTED CLAY GRAVEL

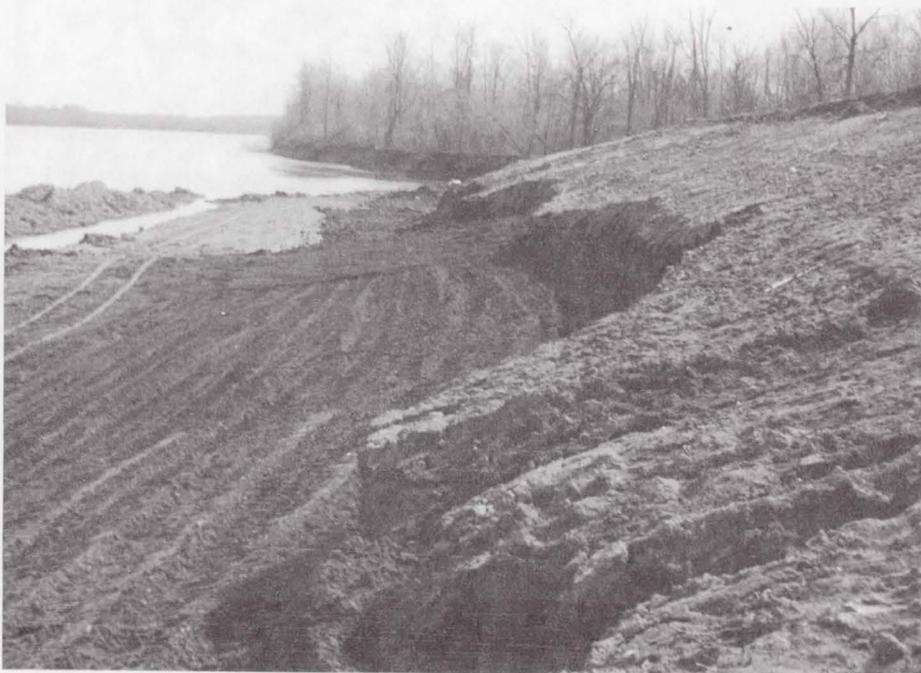
PHOTO 8

VIEW DOWNSTREAM

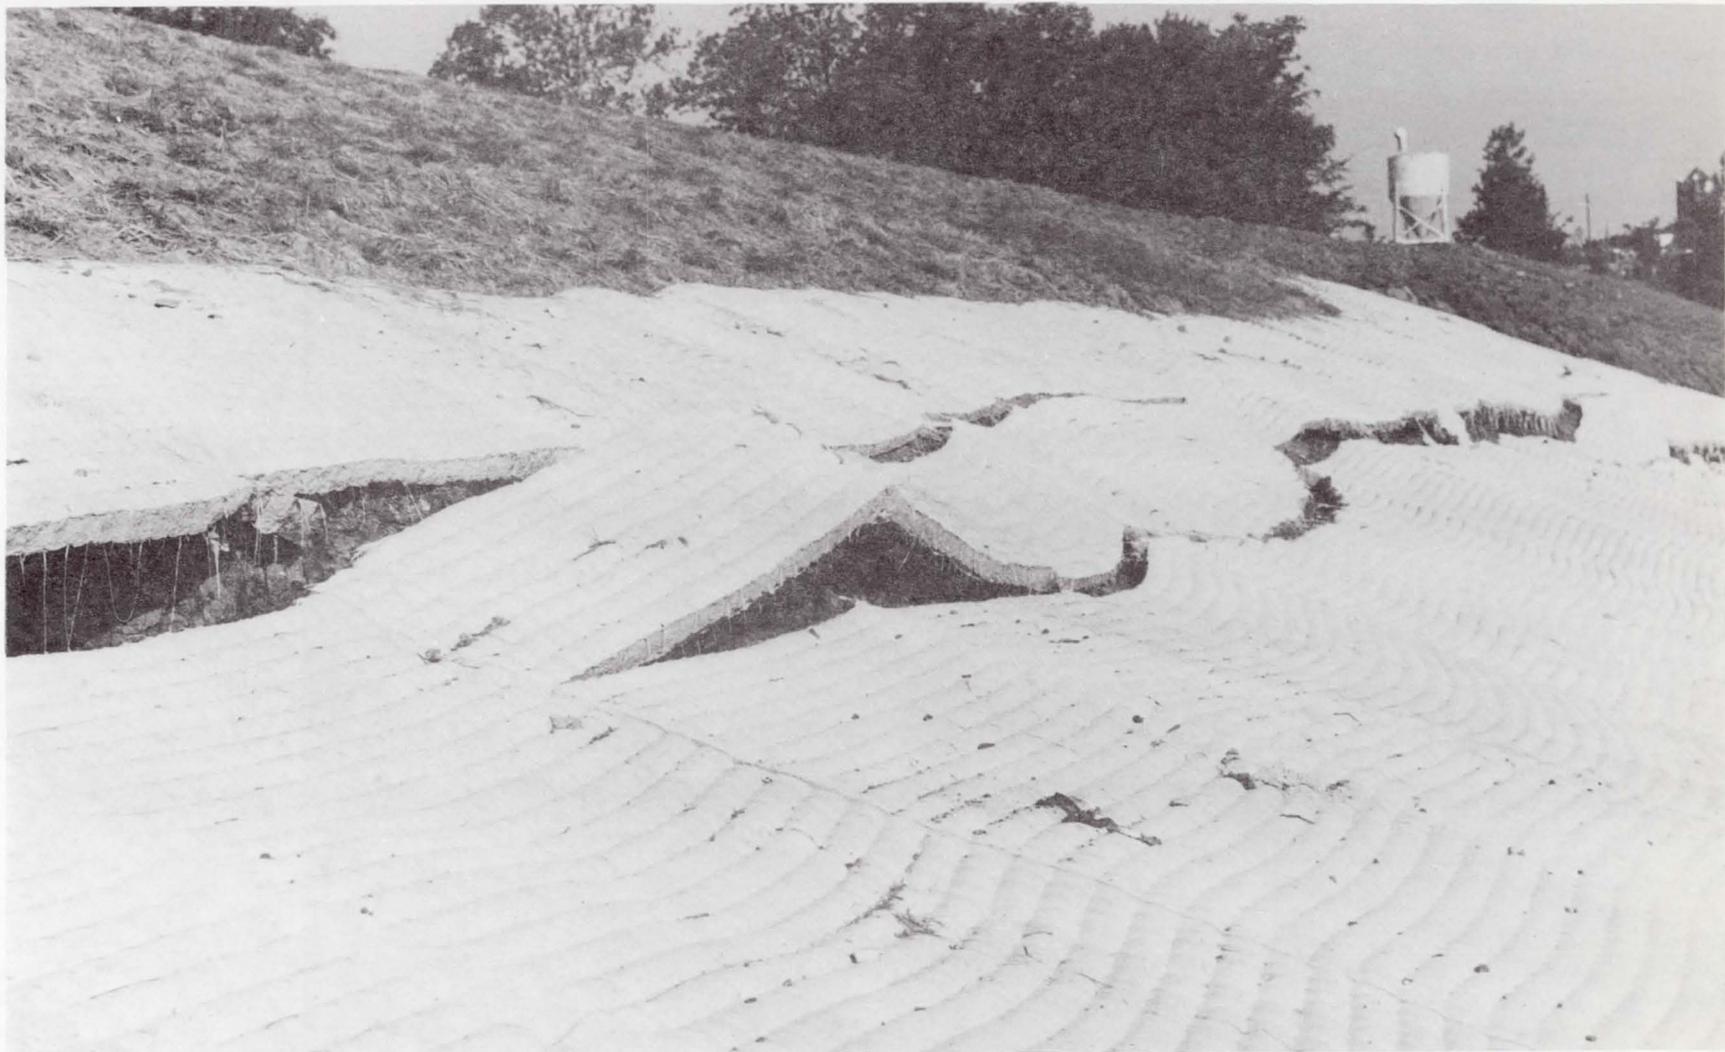
PHOTO 13

GROUT-FILLED MATTRESS 2 MONTHS AFTER CONSTRUCTION
BREAKAGE AND SEPARATION DUE TO SUBGRADE MOVEMENT

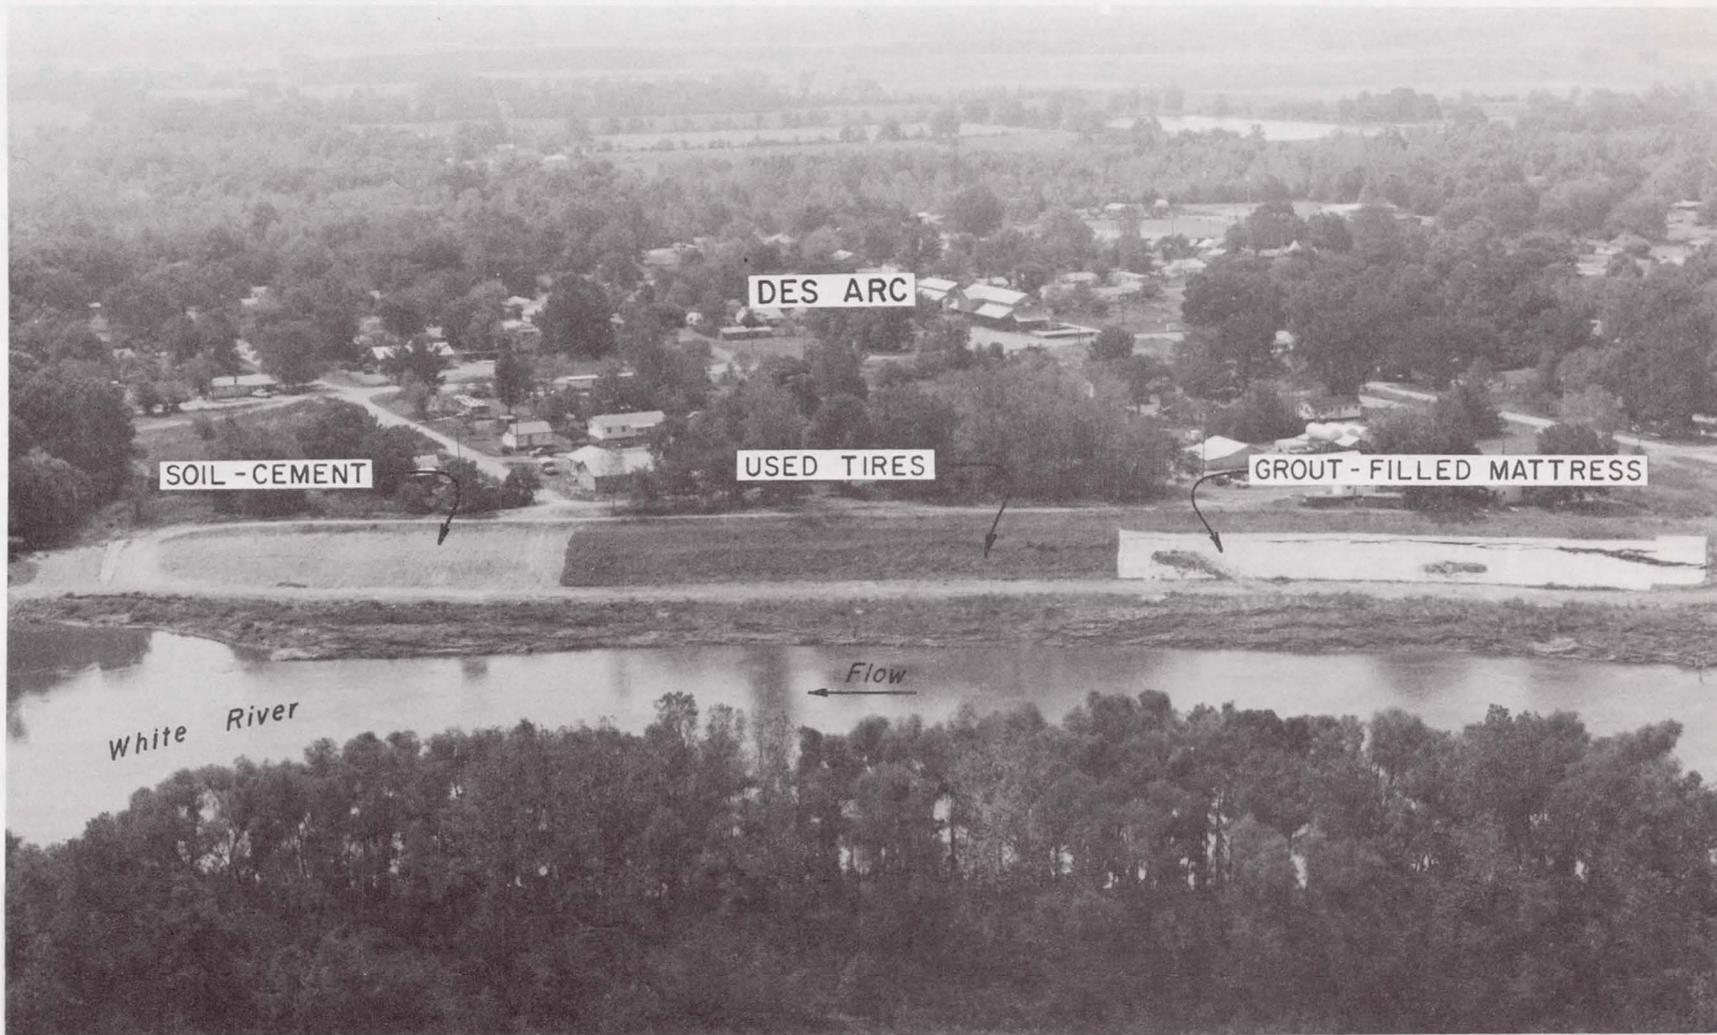
PHOTO 14

VIEW OF COMPLETED PROJECT SHOWING
3 TYPES OF BANK PROTECTION

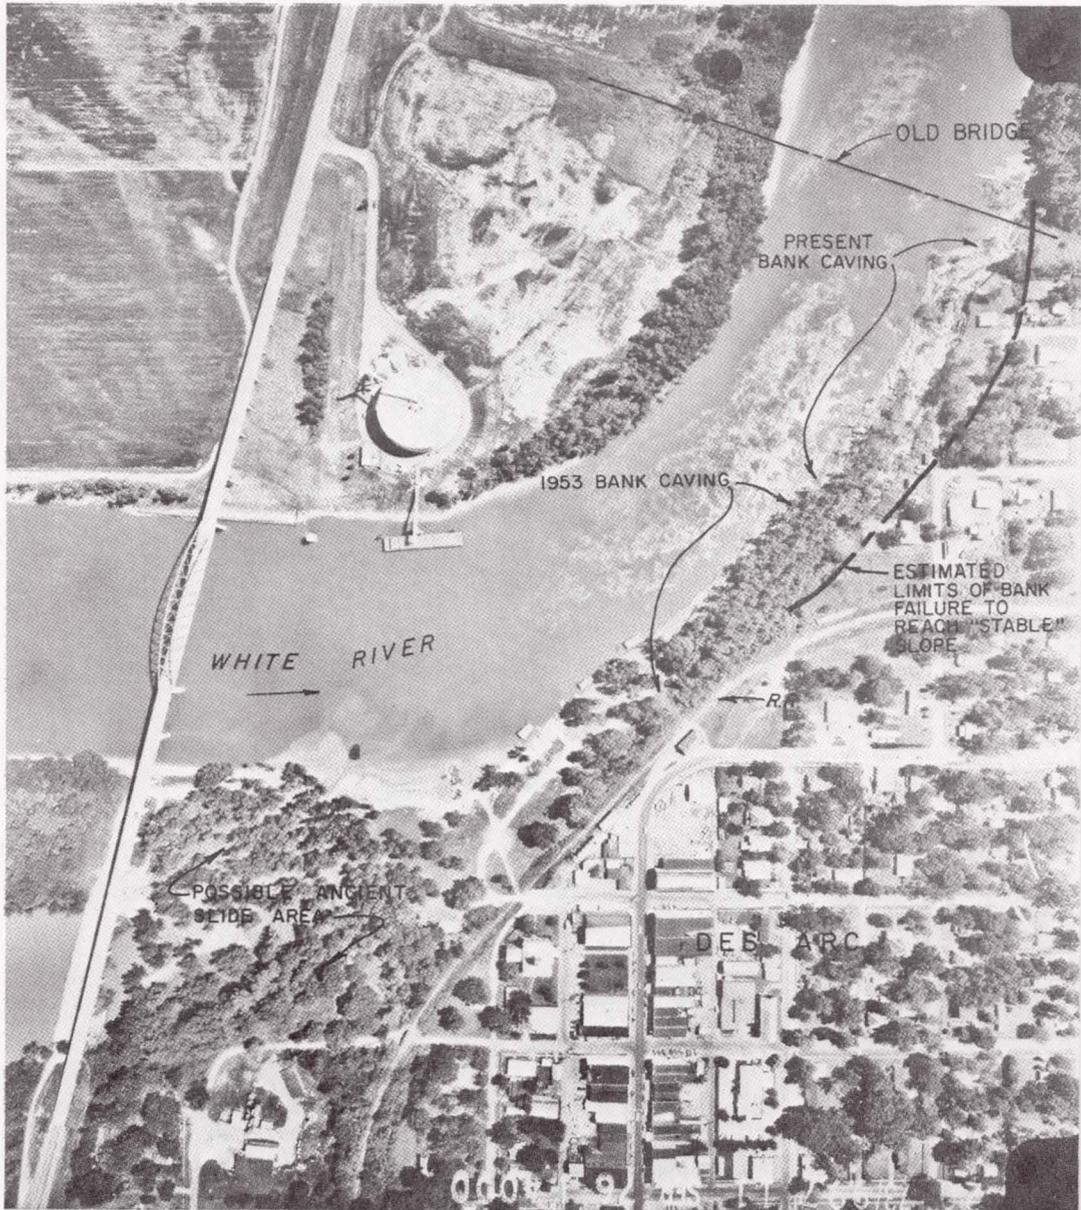
INCLOSURE 4

crystals while the lower six to eight inches of the surfaces were covered with a thin sheen of water which was free of ice crystals, indicating that movement had occurred just prior to the inspection. Several dead trees, leaning at various angles, were observed out in the river, indicating that the talus extended for some distance past the waters edge. Sketches of the failure section are included. (Inclosures 1 and 2). The location of the failure is shown on Inclosure 3 and 4.

6. As stated, the bank caving should continue until an equilibrium condition is reached. The limits to which caving may be expected is shown on Inclosure 4. It should be noted that the location of the limits are nothing more than a guess on our part. On reaching a slope of equilibrium it cannot be assumed that the banks are permanently stabilized. With the recurrence of erosion at the toe of the talus, the failure mechanism may be again generated. This is not an unlikely event but rather an expected natural occurrence.
