# Individual Structures Assessment Report

Spook Hill FRS  
Signal Butte FRS  
Apache Junction FRS

## Structures Assessment Program - Phase 1

FCD No. 98-41/PCN PLAN.01.00

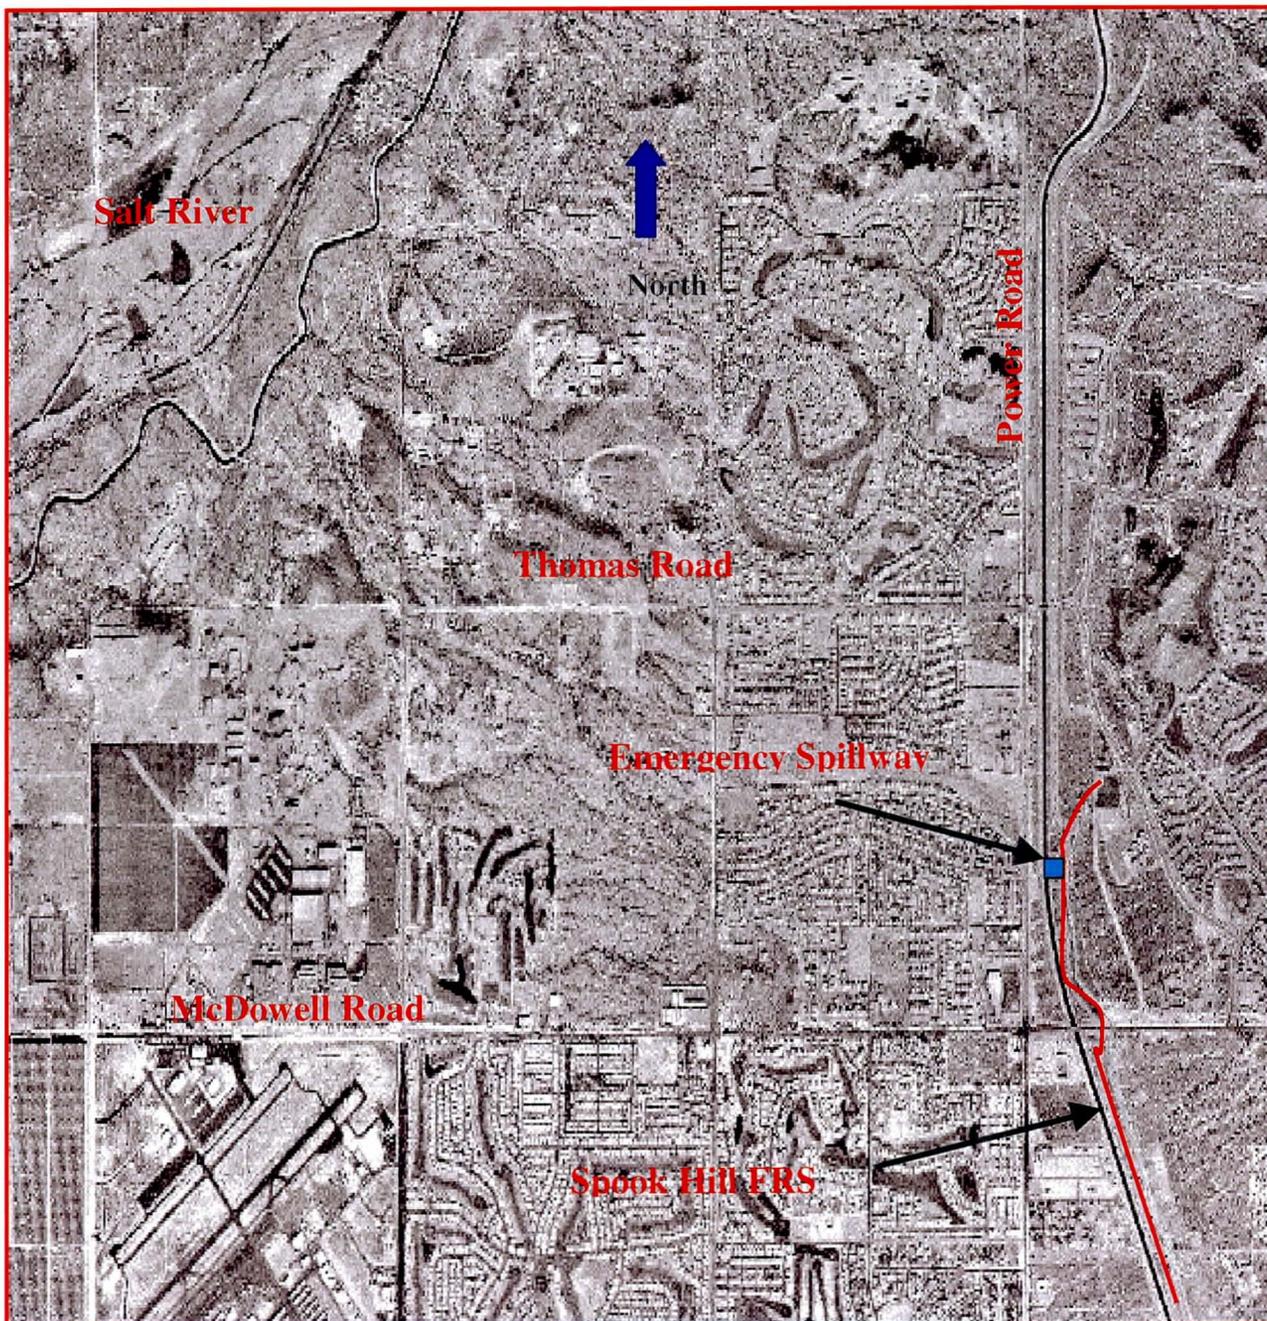
**Figure 2-2. Aerial photograph of Spook Hill FRS showing urbanization encroachment downstream of the dam and emergency spillway.**

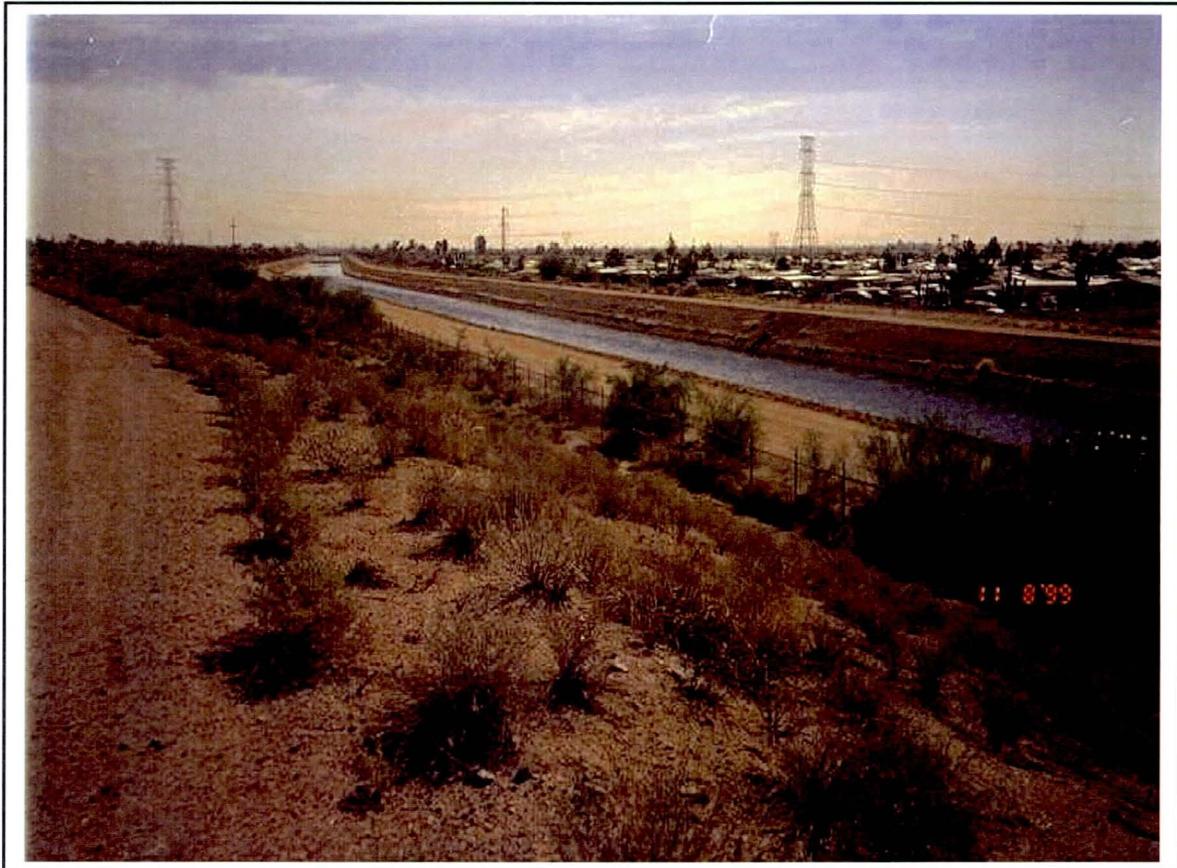
**Figure 2-3. Ground level photograph downstream of Spook Hill FRS showing homes built adjacent to downstream toe of dam and the Central Arizona Project.**

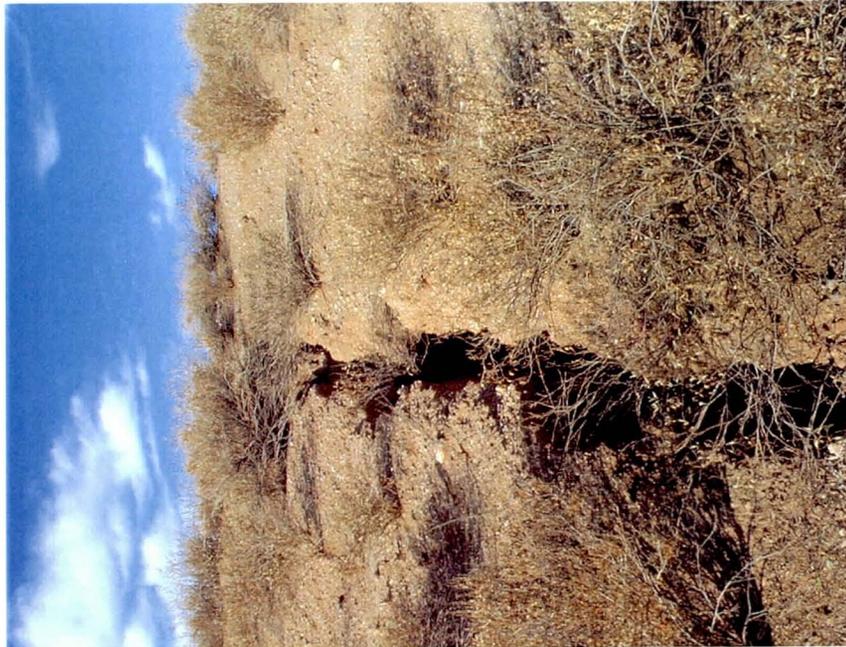
Spook Hill FRS. Downstream slope rill erosion Station 115+50.

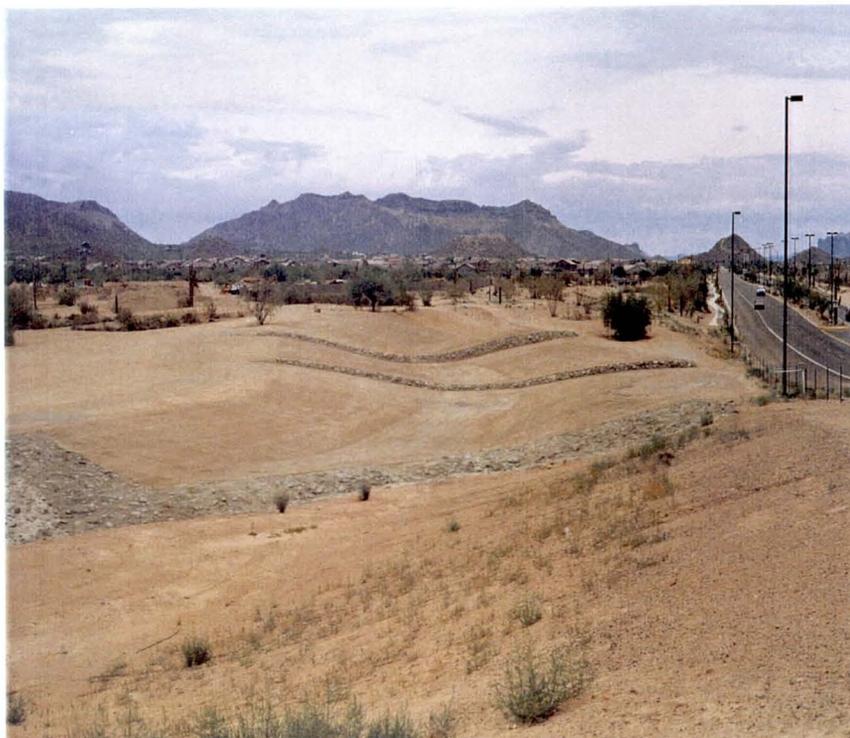
Spookhill FRS. Station 274+50. Looking on west side of McDowell Road in pool area. Newly graded channel and drop structures in channel.

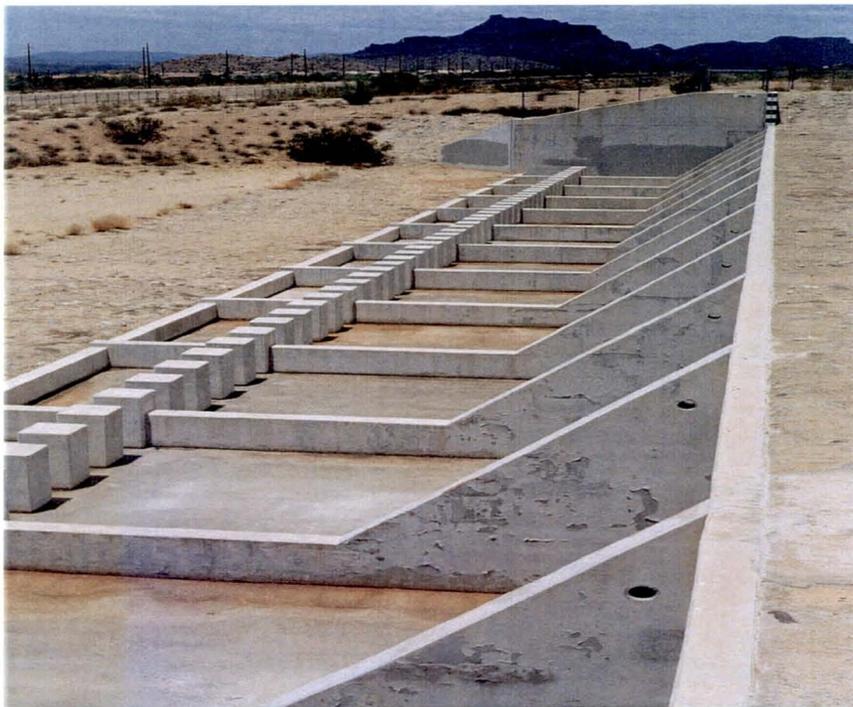
Spookhill FRS. Emergency Spillway looking north from left wingwall. Reinforced drop structure with bay and baffle block dissipators.

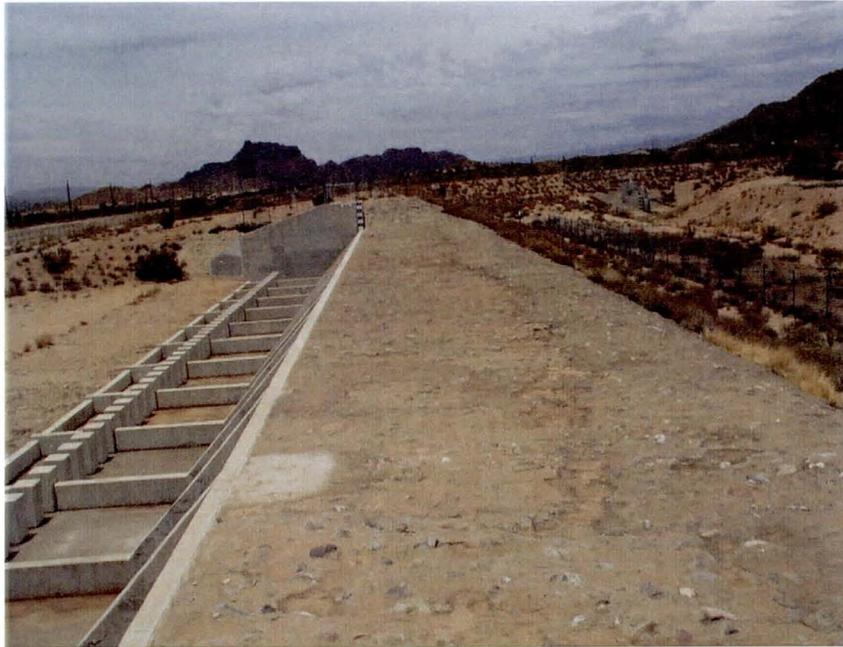
Spookhill FRS. Looking right at emergency spillway crest.

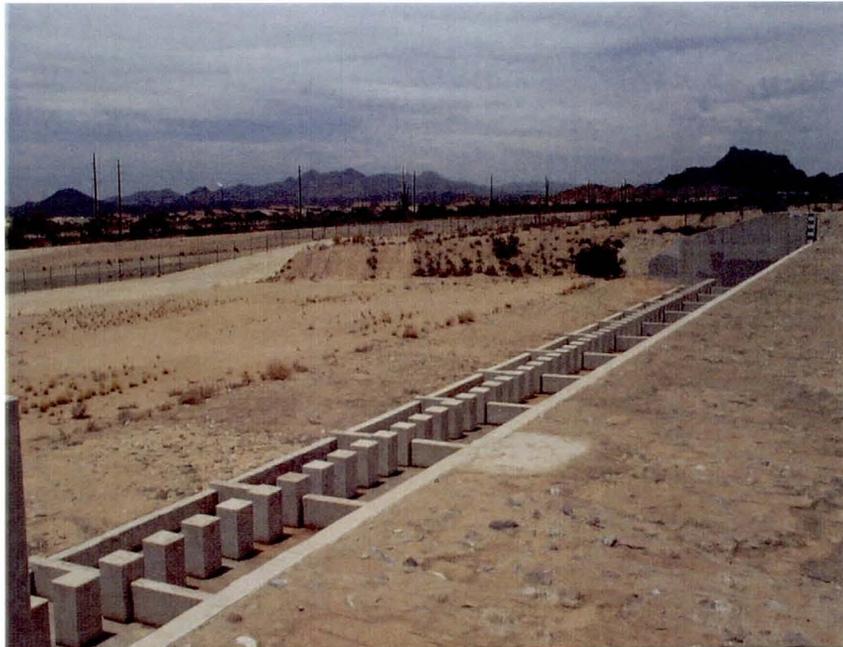
Spookhill FRS. Looking downstream from emergency spillway crest towards Central Arizona Project canal.

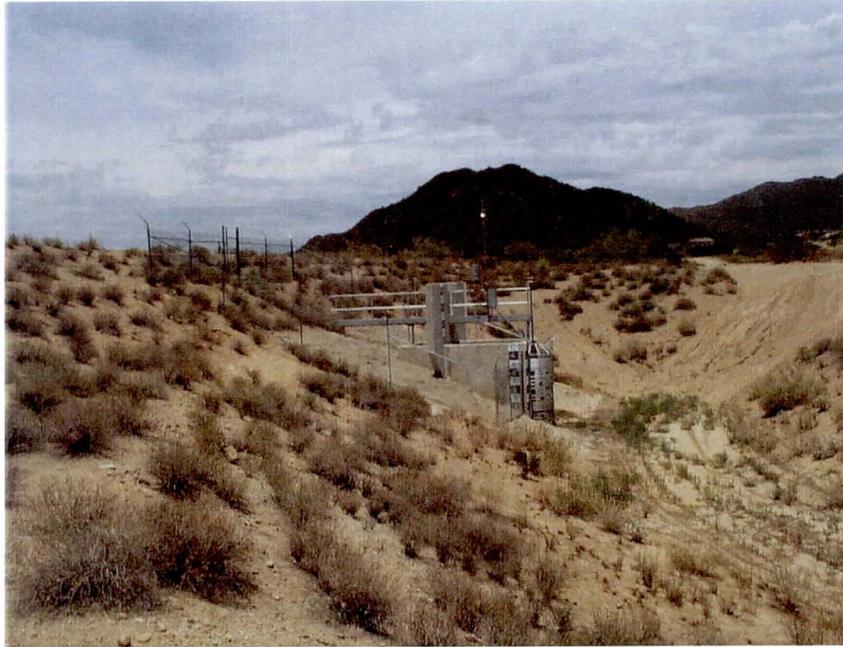
Spookhill FRS. Principle spillway inlet and approach channel.

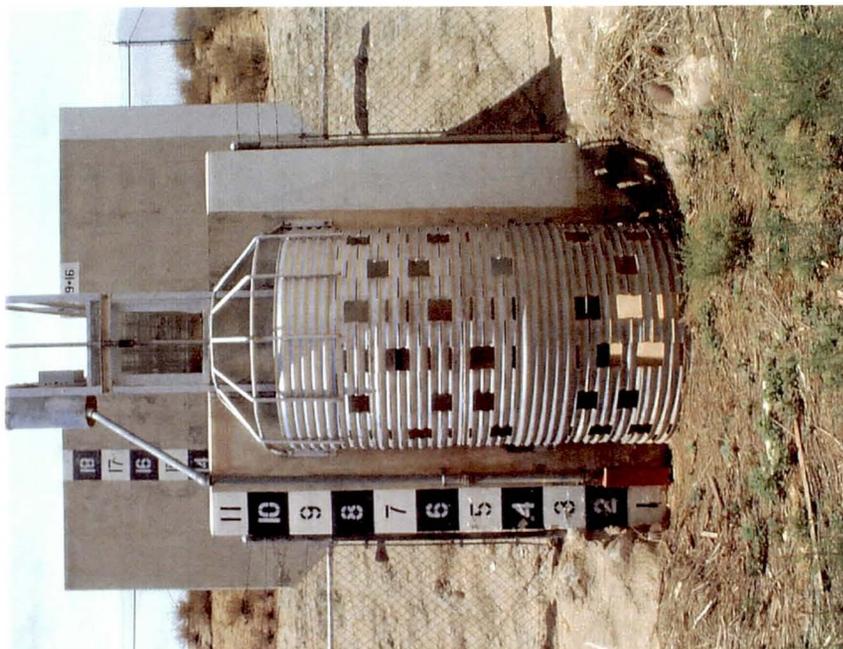
Spookhill FRS. Principal Spillway inlet tower.

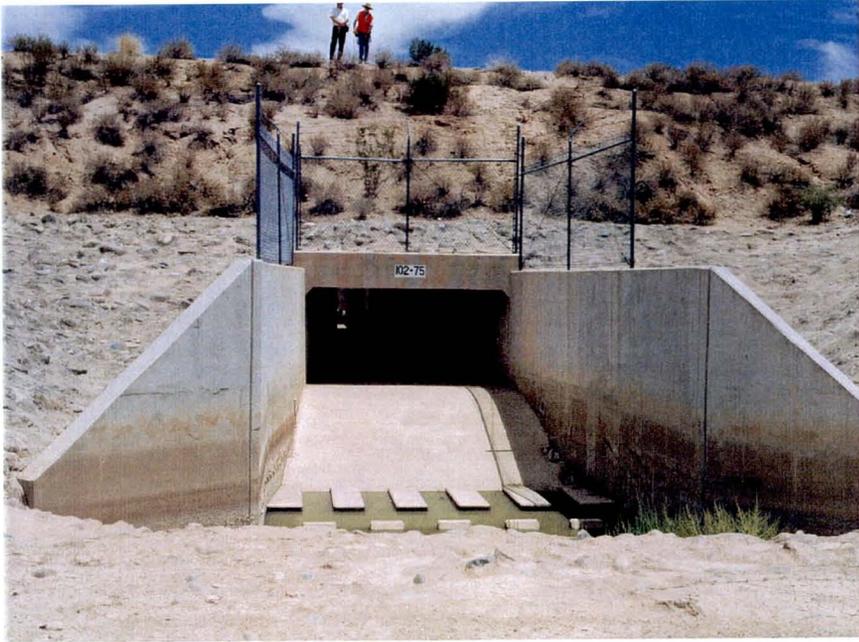
Spookhill FRS. Principal spillway outlet structure and energy dissipator.

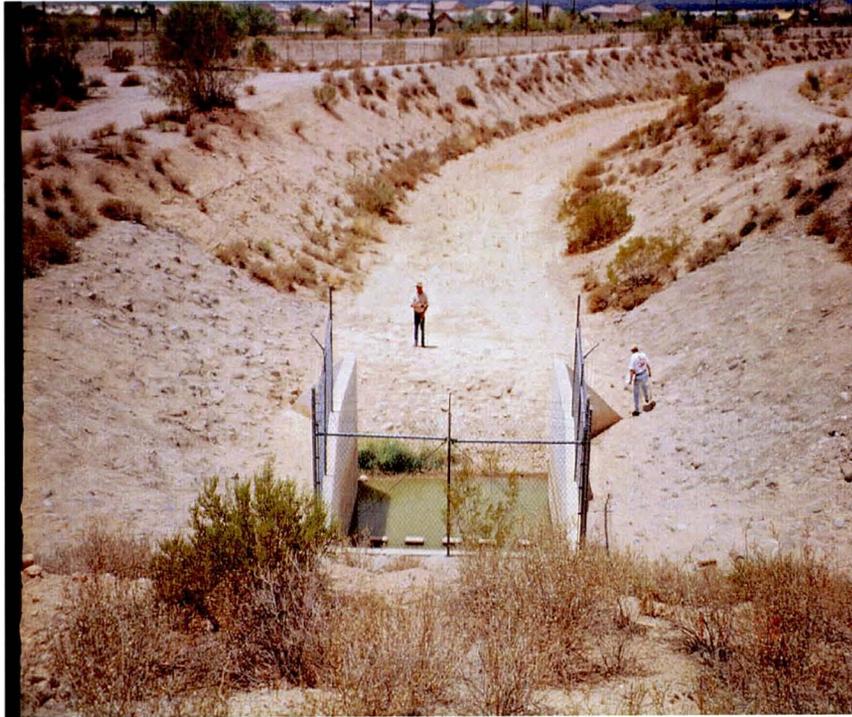
Spookhill FRS. Looking downstream from principal spillway outlet to the Spookhill floodway channel.

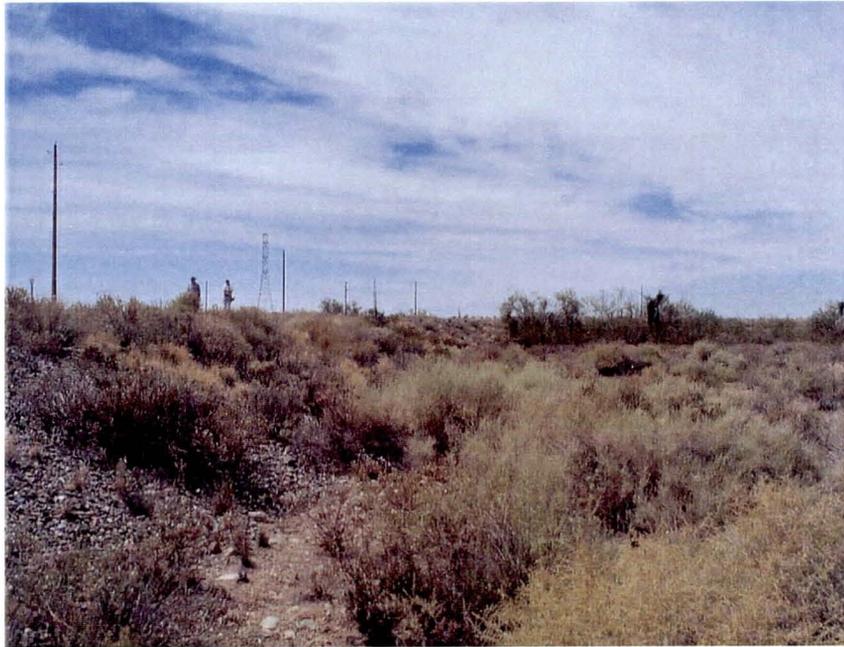
Signal Butte FRS. Left abutment looking right Station 195+00 near Signal Butte extension.

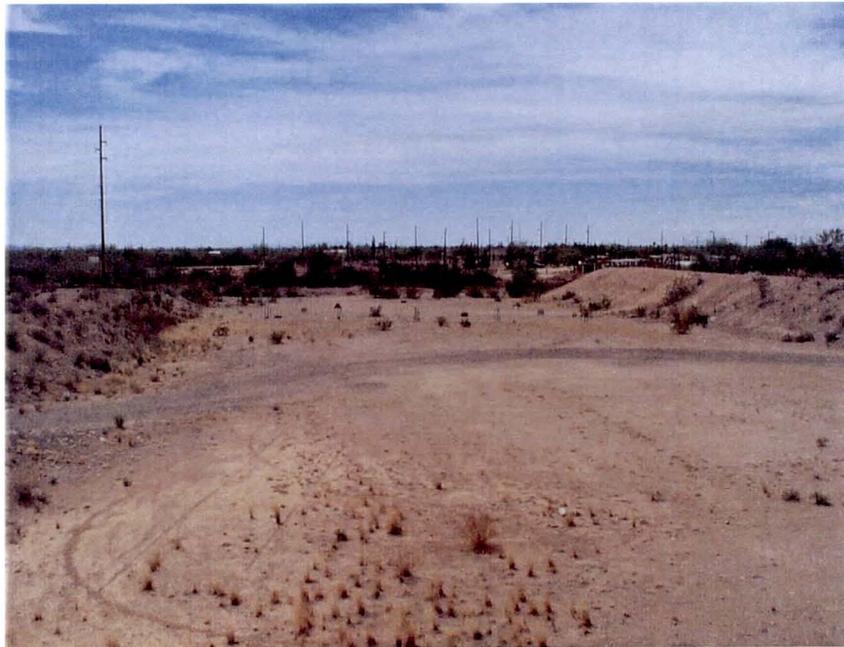
Signal Butte FRS. Looking downstream from emergency spillway Station 205+00. Note horse corral and homes.

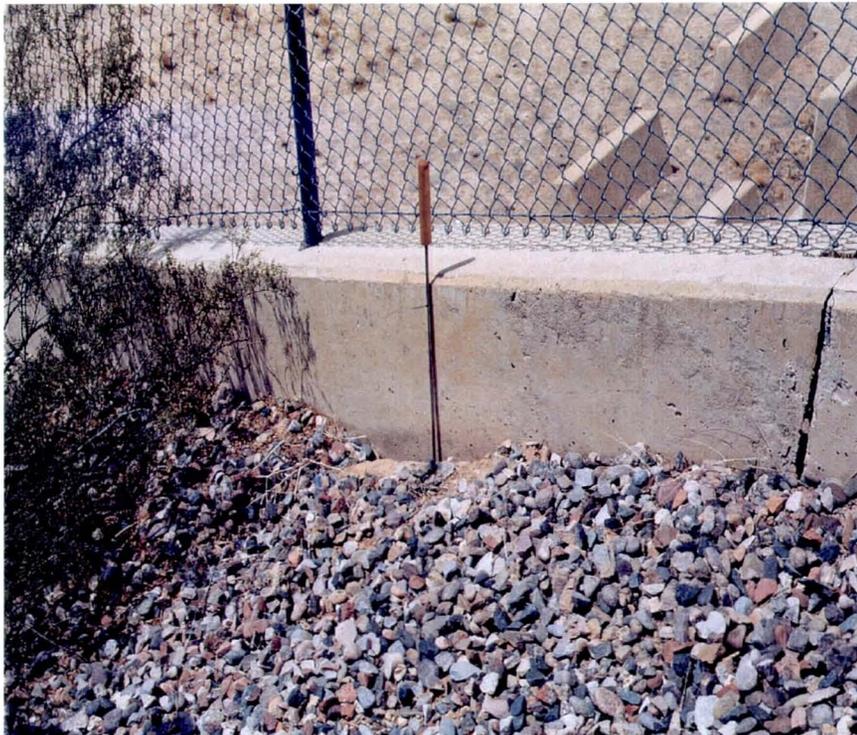
Signal Butte FRS. Left wing contact with embankment. Slight separation from embankment on crest.

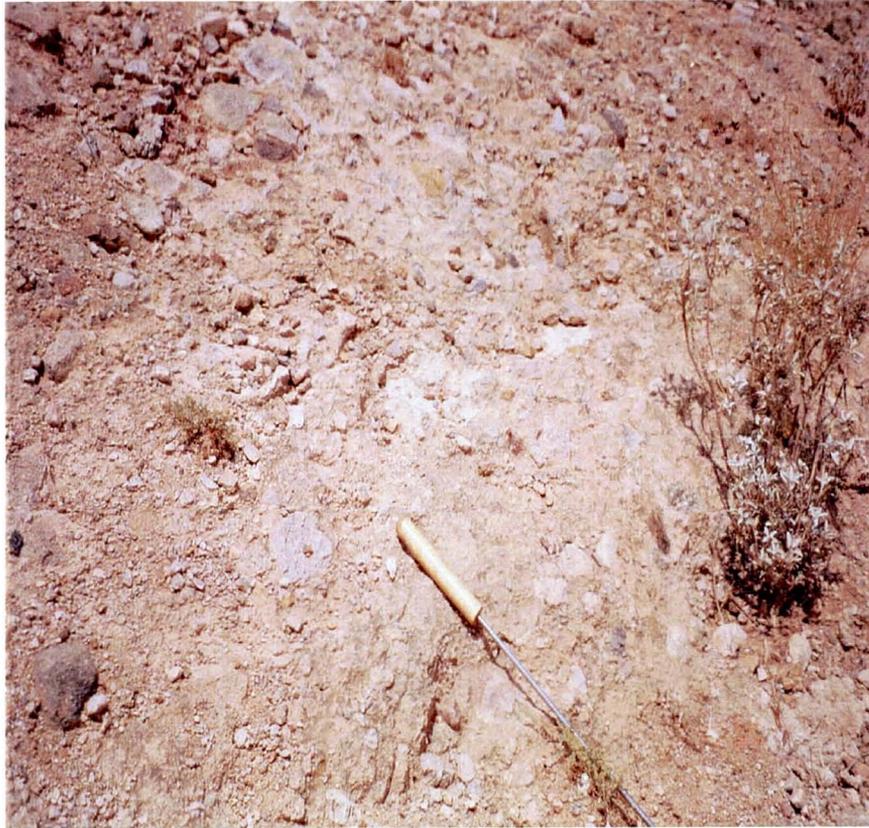
Signal Butte FRS. Exposure of caliche cemented breccia in emergency spillway channel.

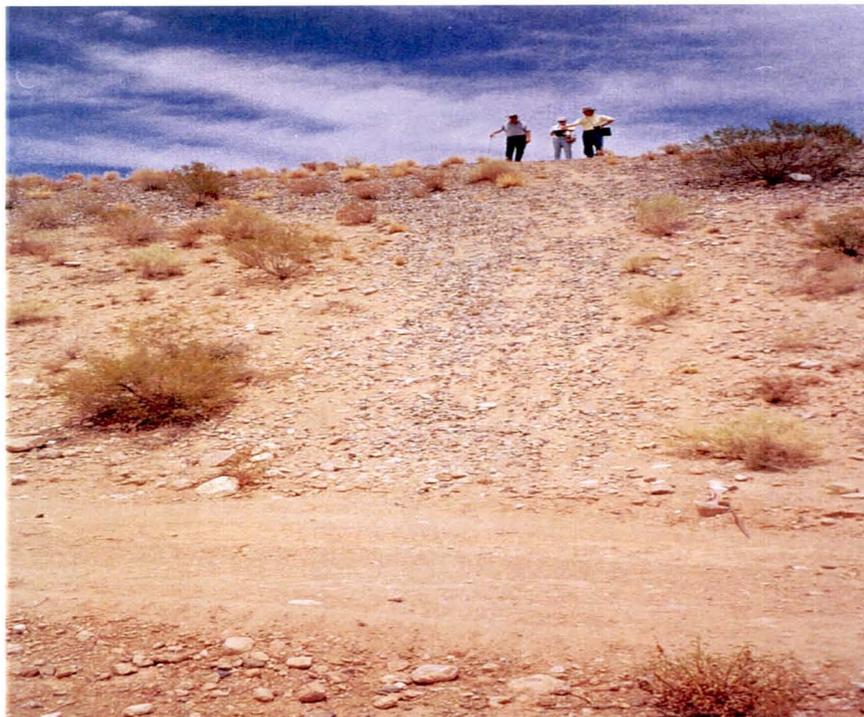
Signal Butte FRS. Station 226+00. Tire tracks up downstream slope. Loss of gravel mulch plating from upper slope.

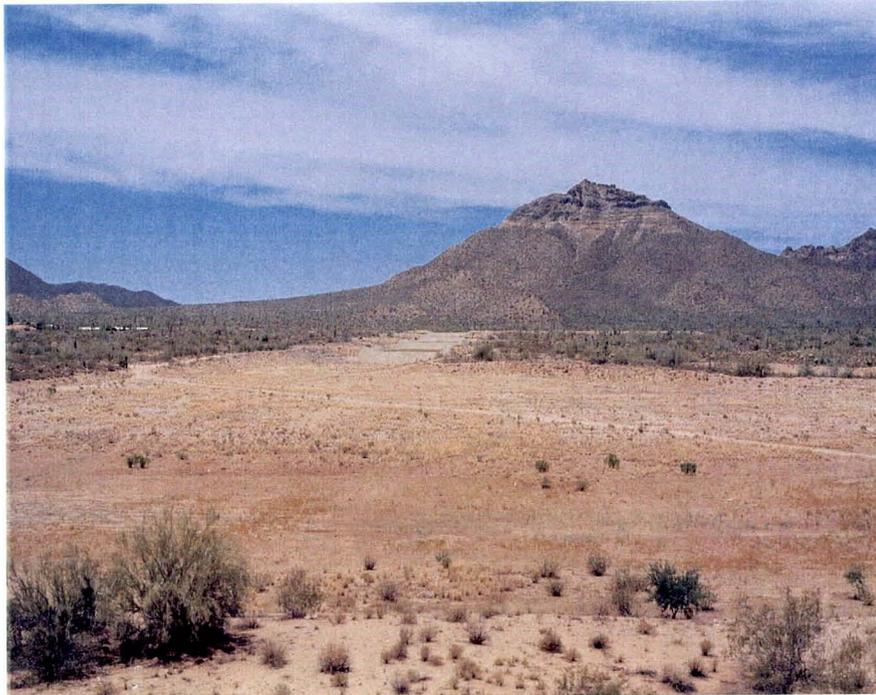
Signal Butte FRS. Station 237+50. Looking north from crest toward Pass Mountain. Note drop structures from Pass Mountain diversion into Signal Butte reservoir.

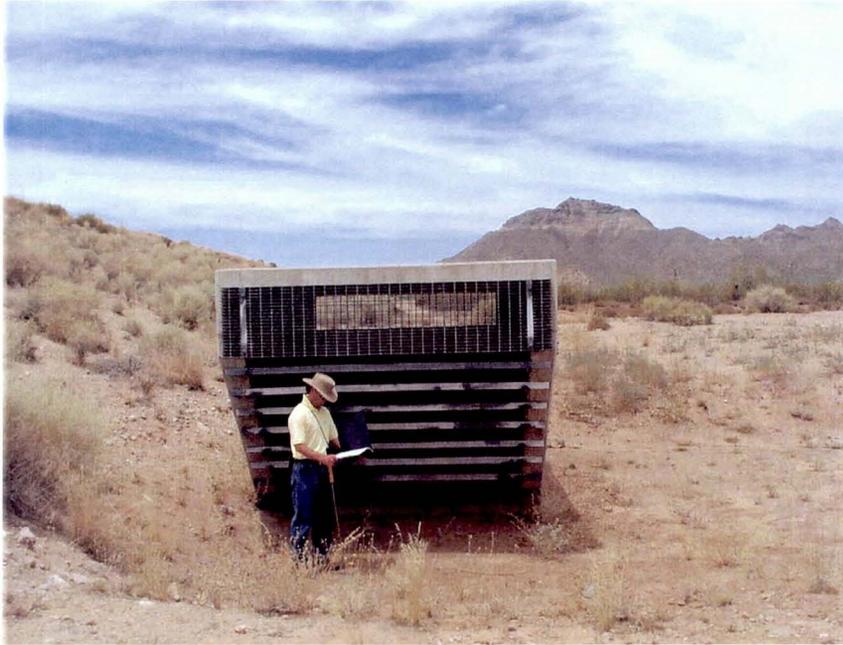
Signal Butte FRS. Principal Spillway inlet structure. Station 249+63.

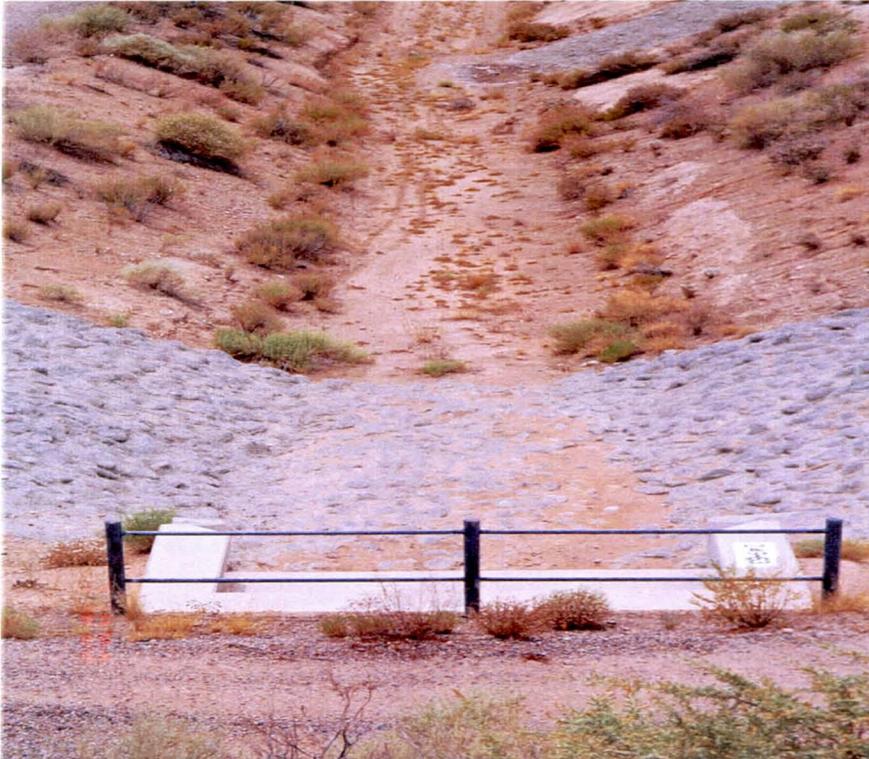
Signal Butte FRS. Principal Spillway outlet structure into Signal Butte floodway.

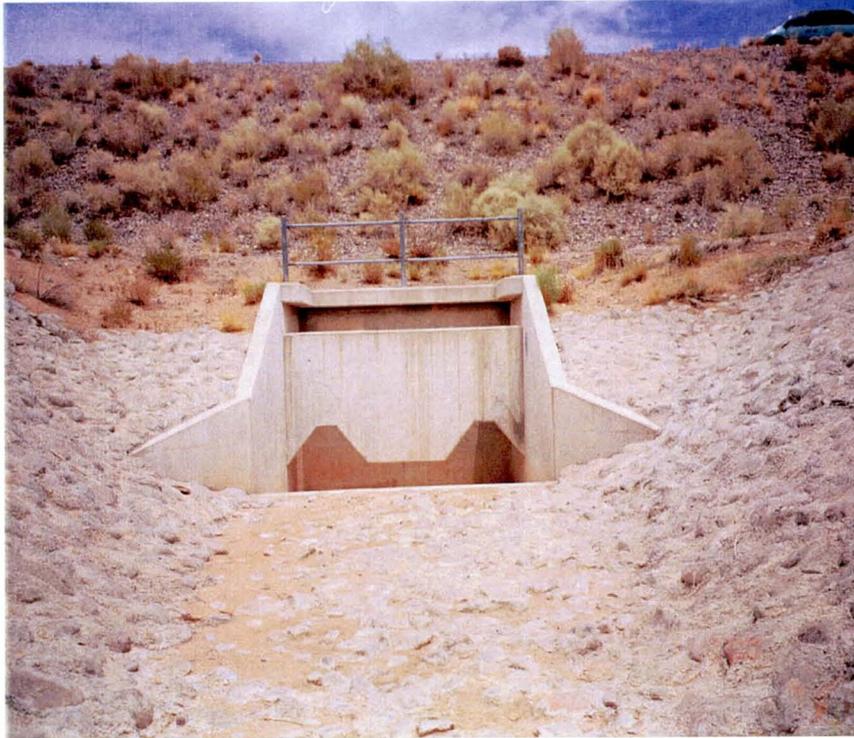
Signal Butte FRS. Principal Spillway outlet structure with energy dissipator.

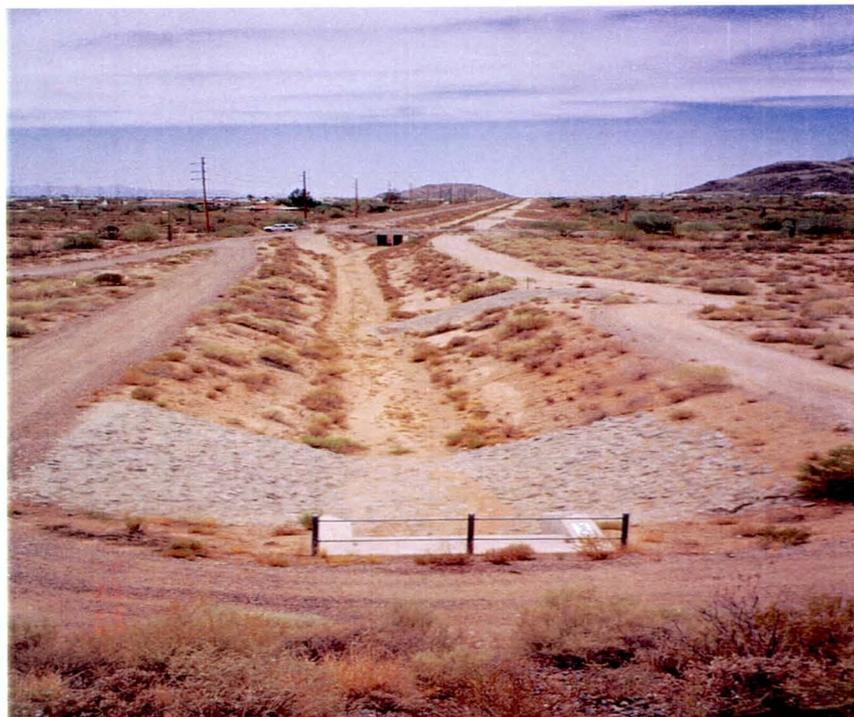
Signal Butte FRS. Looking downstream from top of crest at Station 249+63 at upstream end of Signal Butte floodway.

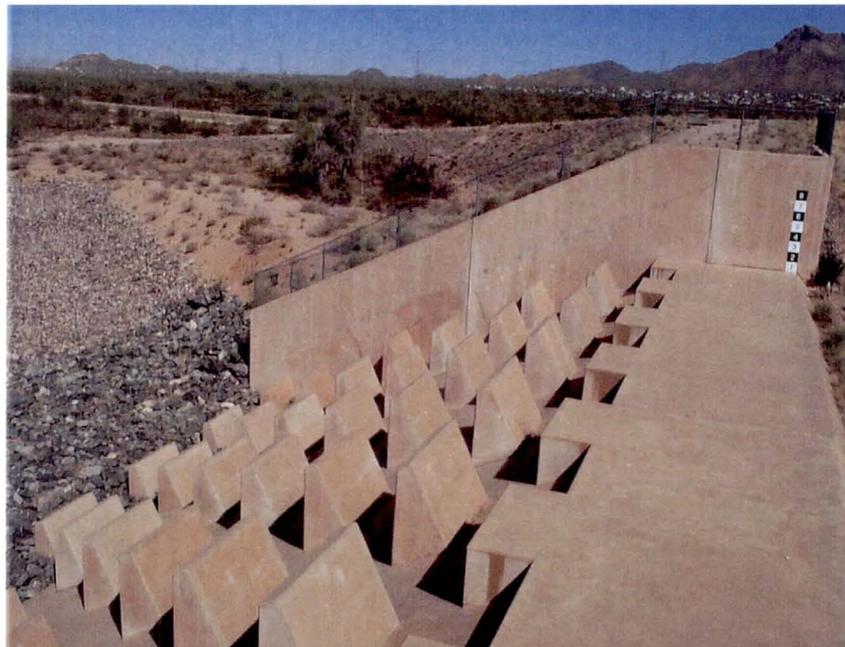
Apache Junction FRS. Left wingwalls of emergency spillway chute slight separation between embankment of concrete walls

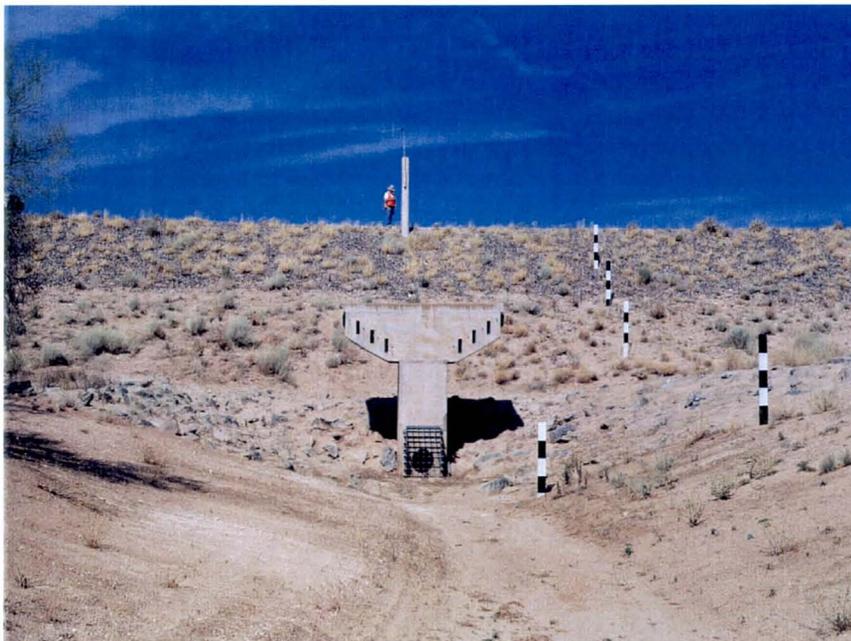
Apache Junction FRS. Baffle block spillway chute for emergency spillway and downstream riprap basin.

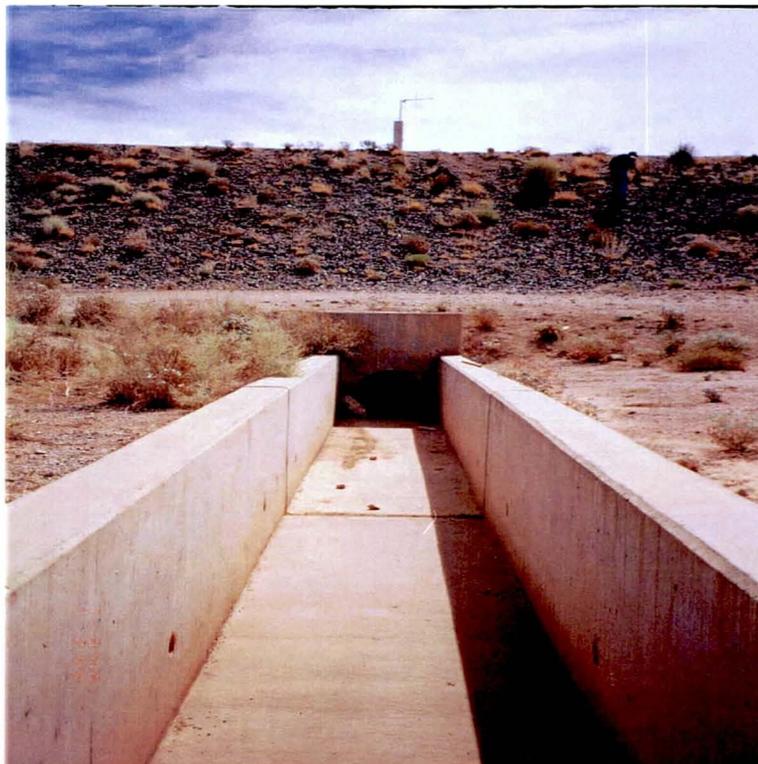
Apache Junction FRS. Outlet into Bulldog Floodway.
