**Golden Eagle
Park Dam
Construction
Photos**

DISK 10

JUNE 2000

Golden Eagle Park Dam Construction of Improvements in 2000

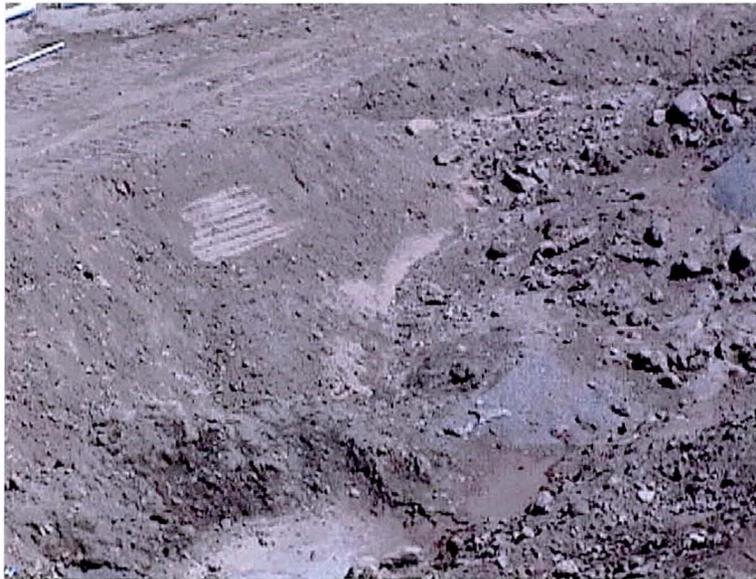
- Date: June, 2000
- Location: upstream end of auxiliary outlet works
- Description: high groundwater exposed during excavation for new box culvert

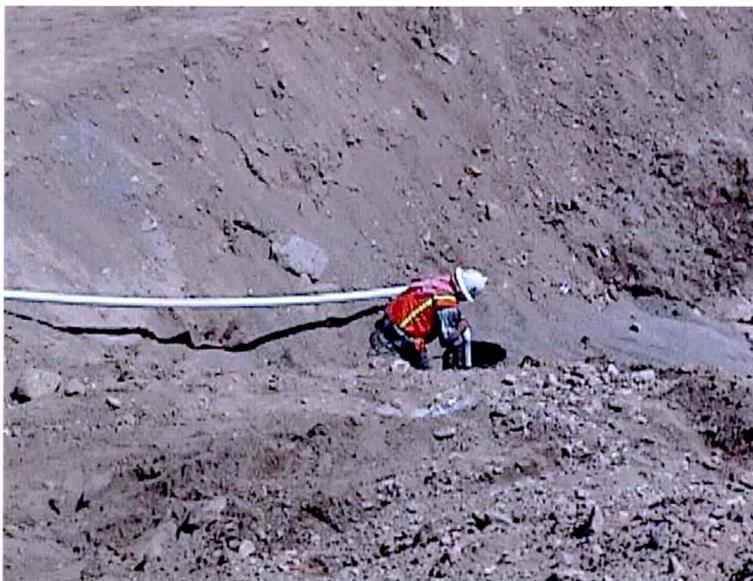
- Date: June, 2000
- Location: upstream end of auxiliary outlet works
- Description: installing dewatering wells

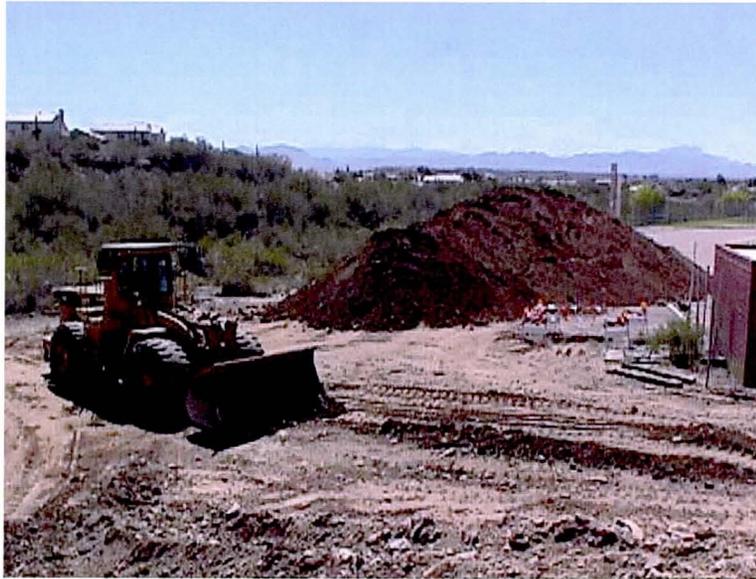
- Date: June, 2000
- Location: northeast side of dam
- Description: stockpiled material from outlet works excavation

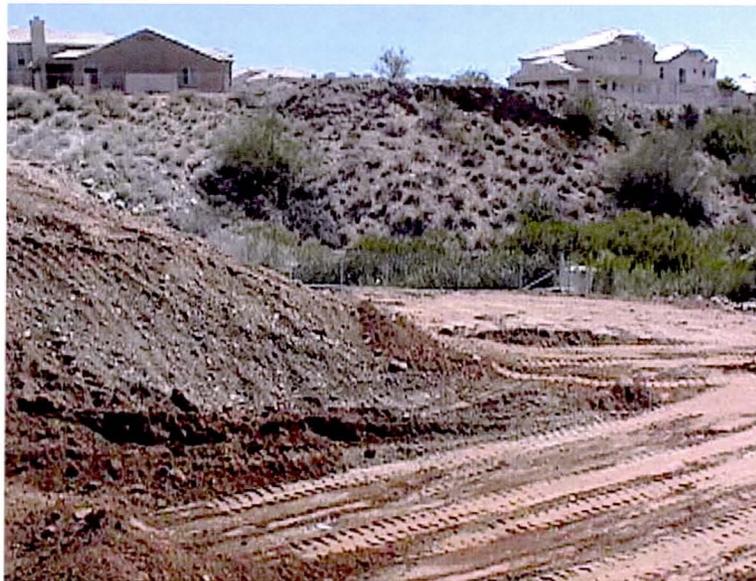
- Date: June, 2000
- Location: auxiliary outlet works
- Description: trench excavation for installation of the new box culvert

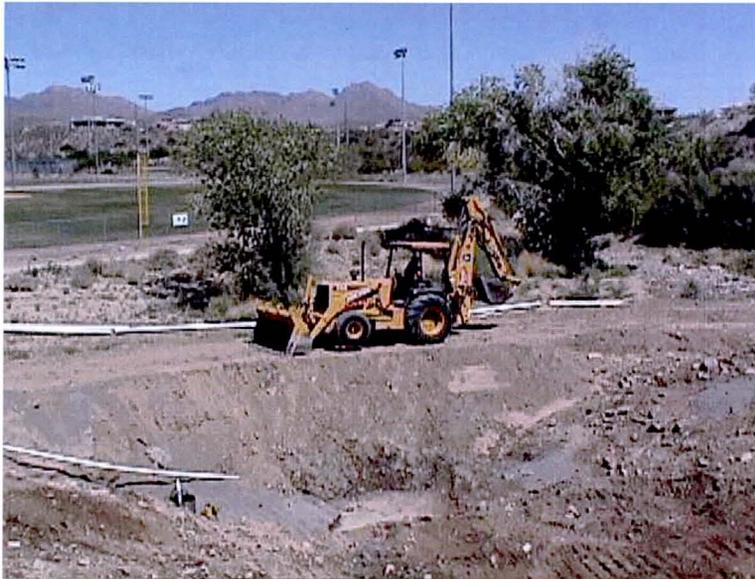
- Date: June, 2000
- Location: upstream end of auxiliary outlet works
- Description: installing dewatering wells

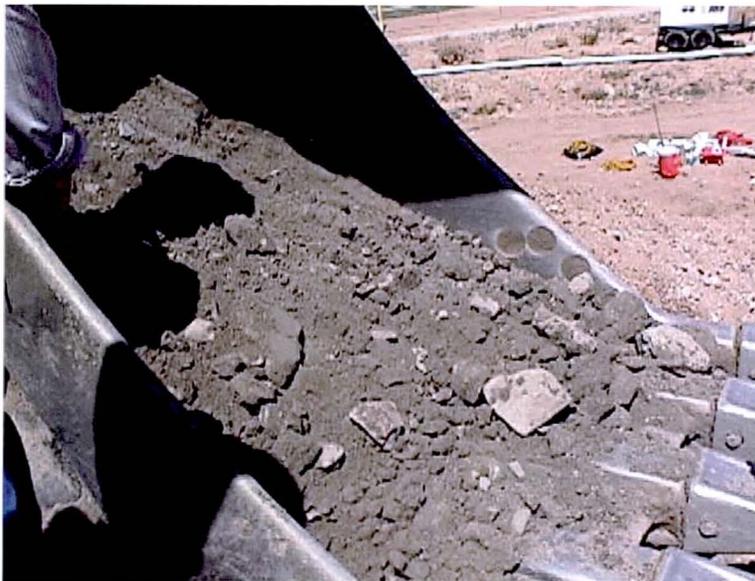
- Date: June, 2000
- Location: auxiliary outlet works
- Description: material excavated from the trench for the new box culvert

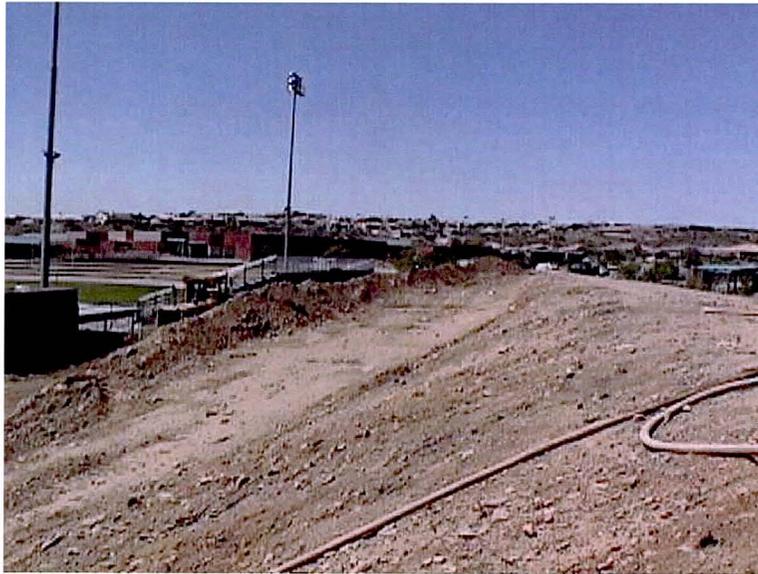
- Date: June, 2000
- Location: north end of dam, looking south
- Description: stockpiled material shown on east side of dam

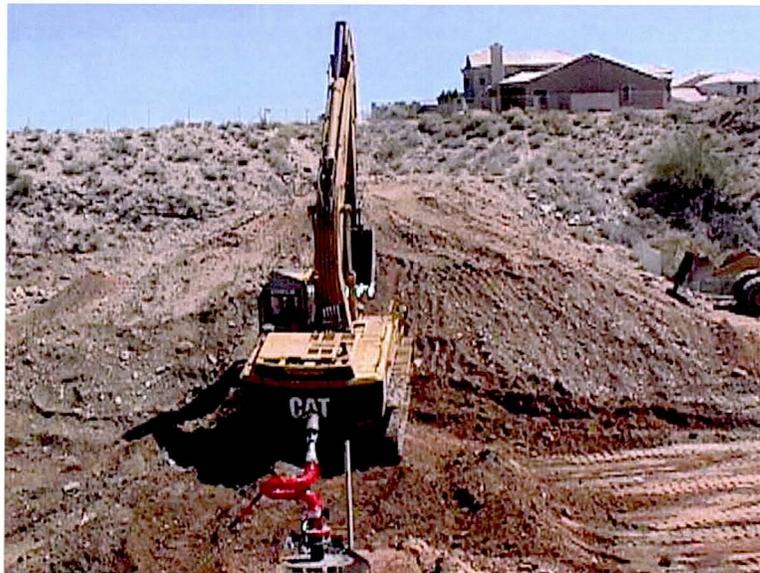
- Date: June, 2000
- Location: north end of dam
- Description: trenching for auxiliary outlet works

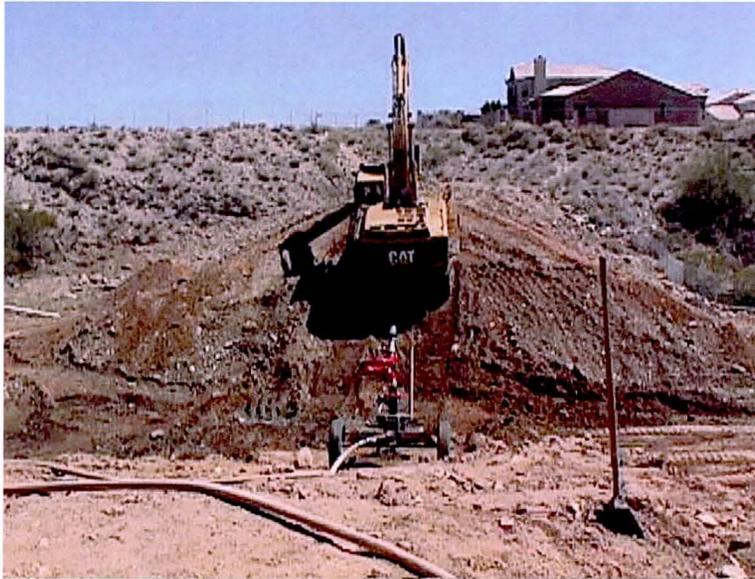
- Date: June, 2000
- Location: north end of dam
- Description: trenching for auxiliary outlet works

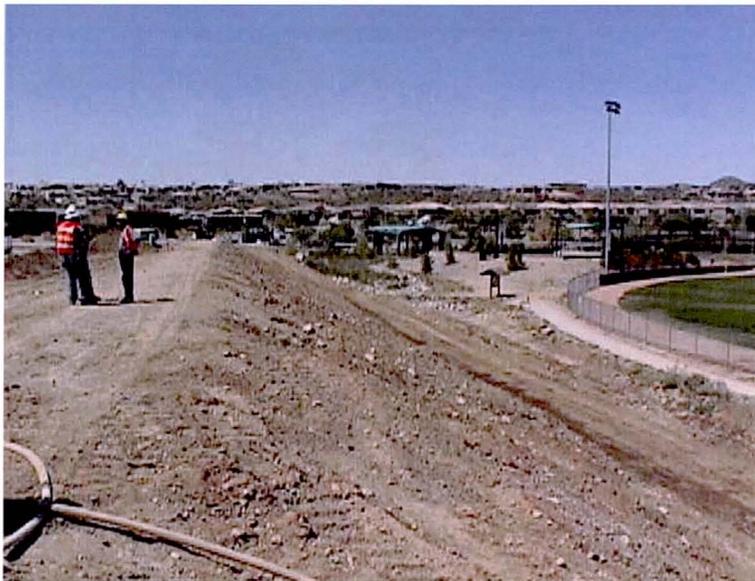
- Date: June, 2000
- Location: north end of dam looking south
- Description: stripped dam embankment

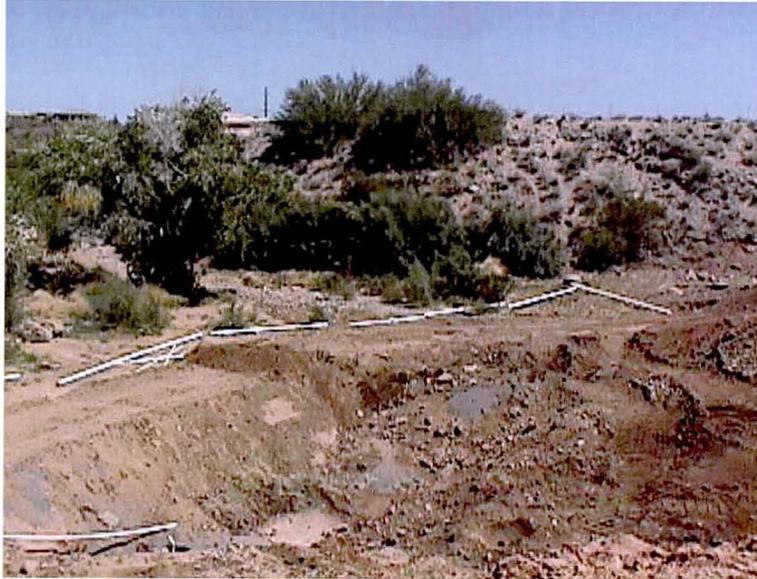
- Date: June, 2000
- Location: north end of dam
- Description: dewatering for auxiliary outlet works

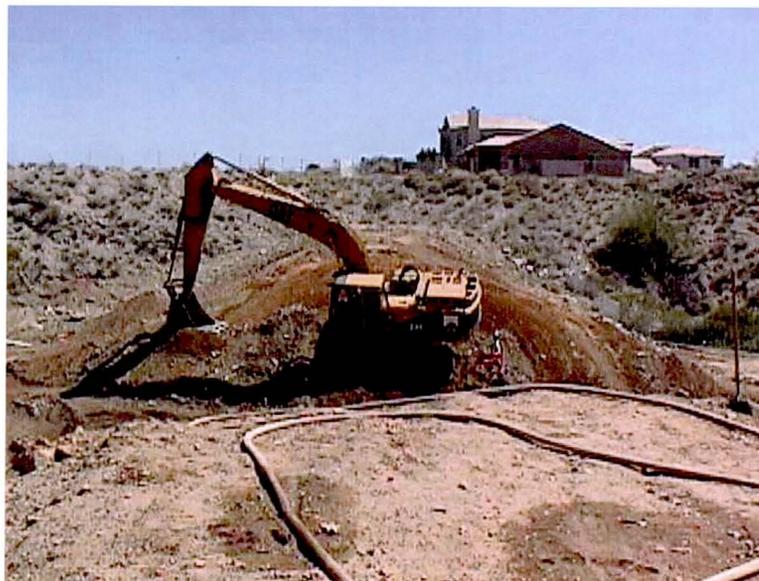
- Date: June, 2000
- Location: north end of dam
- Description: trenching for auxiliary outlet works

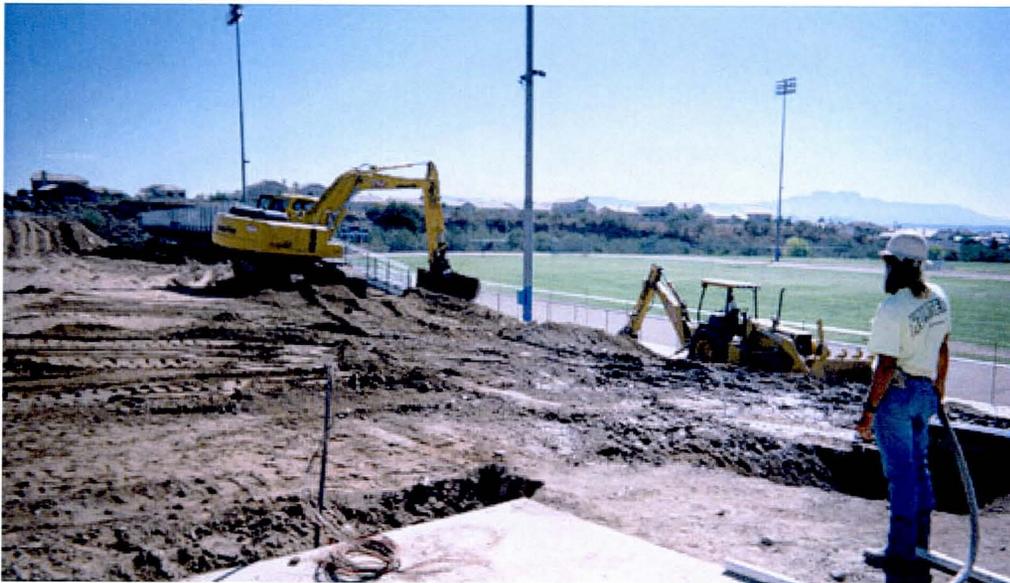
- Date: July 2000
- Location: emergency spillway looking northeast
- Description: excavation

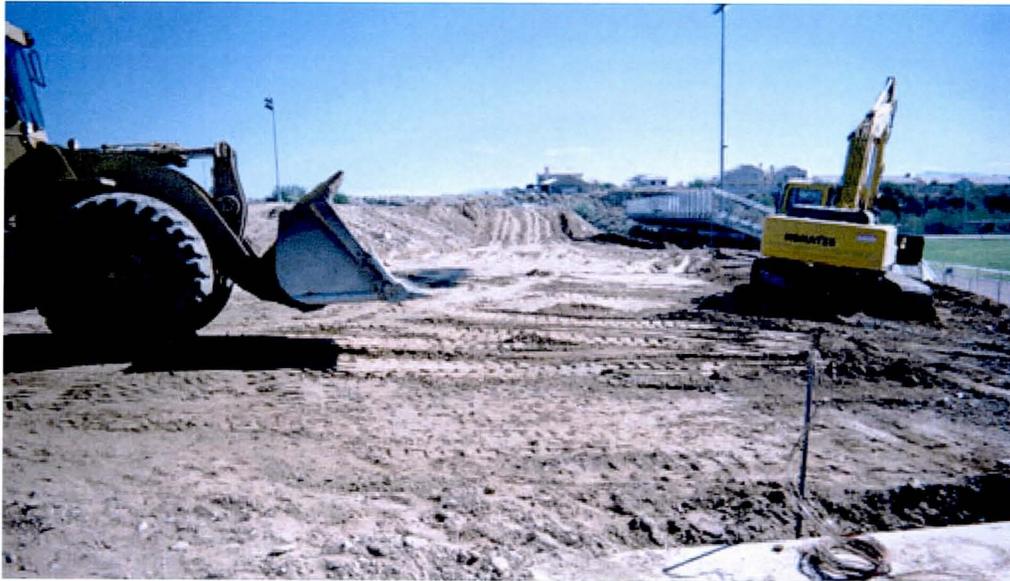
- Date: July 2000
- Location: emergency spillway looking northeast
- Description: excavation

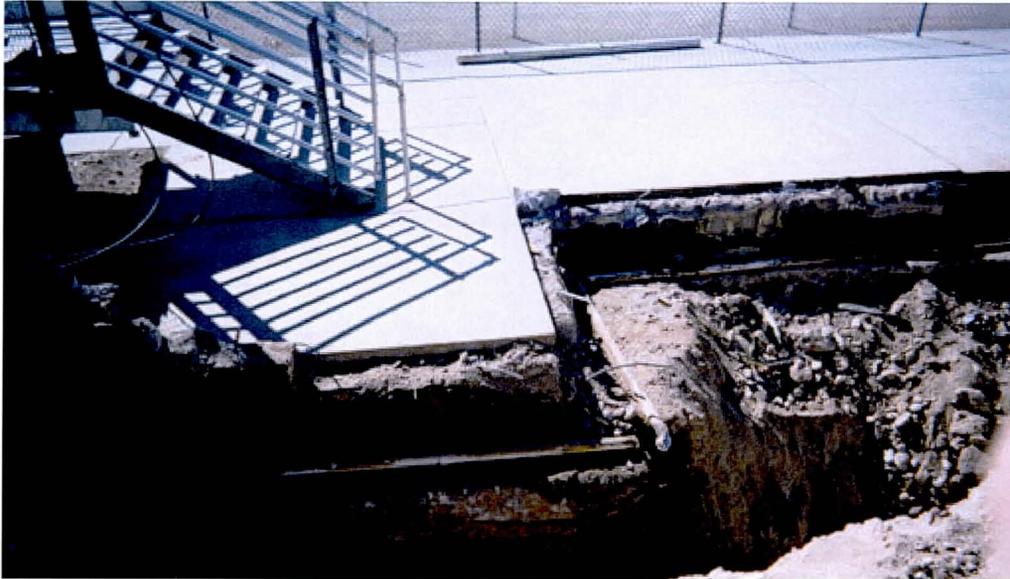
- Date: July 2000
- Location: sidewalk and bleachers at bottom of spillway
- Description: excavation exposing existing waterline to be protected in place

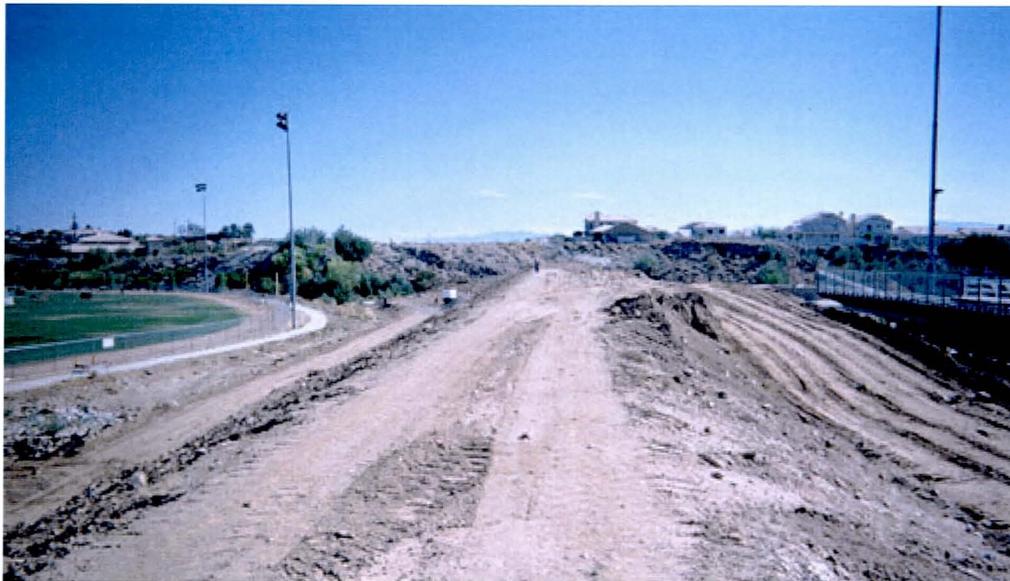
- Date: July 2000
- Location: crest of dam looking north
- Description: dam has been stripped and stockpiled material placed on downstream side behind the bleachers

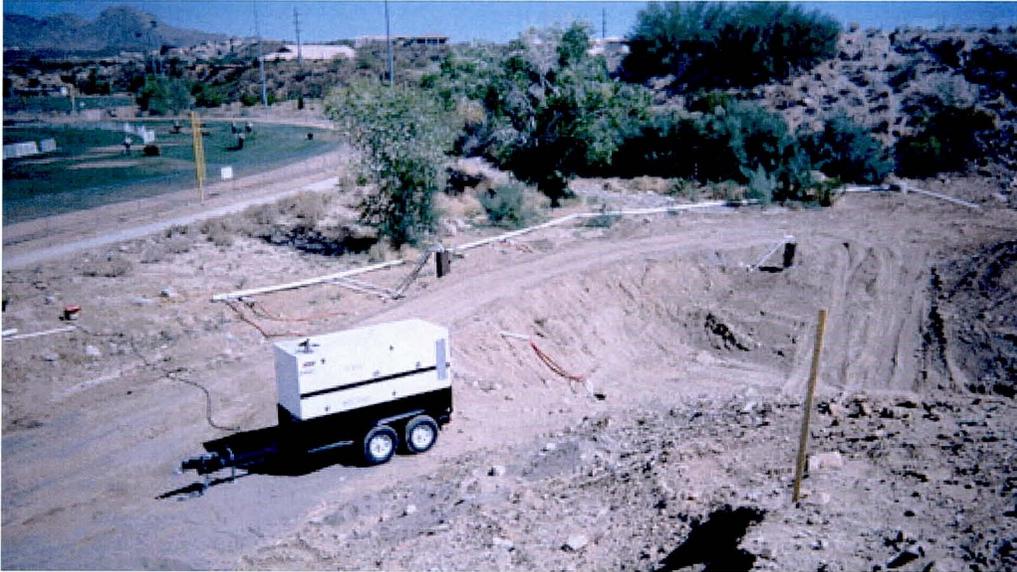
- Date: July 2000
- Location: auxiliary outlet works
- Description: trench excavation and subgrade at upstream end

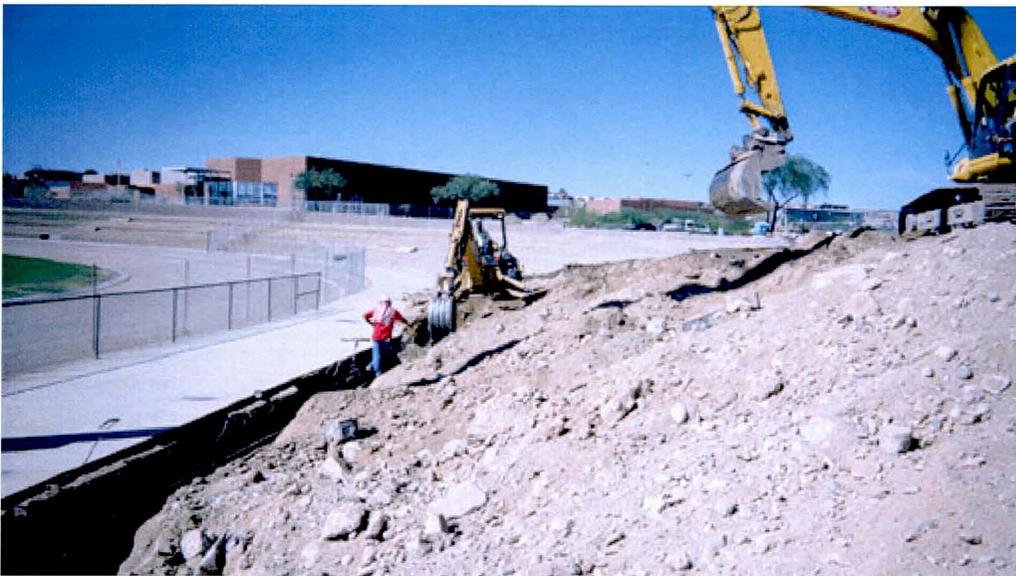
- Date: July 2000
- Location: emergency spillway
- Description: excavation near downstream toe of spillway

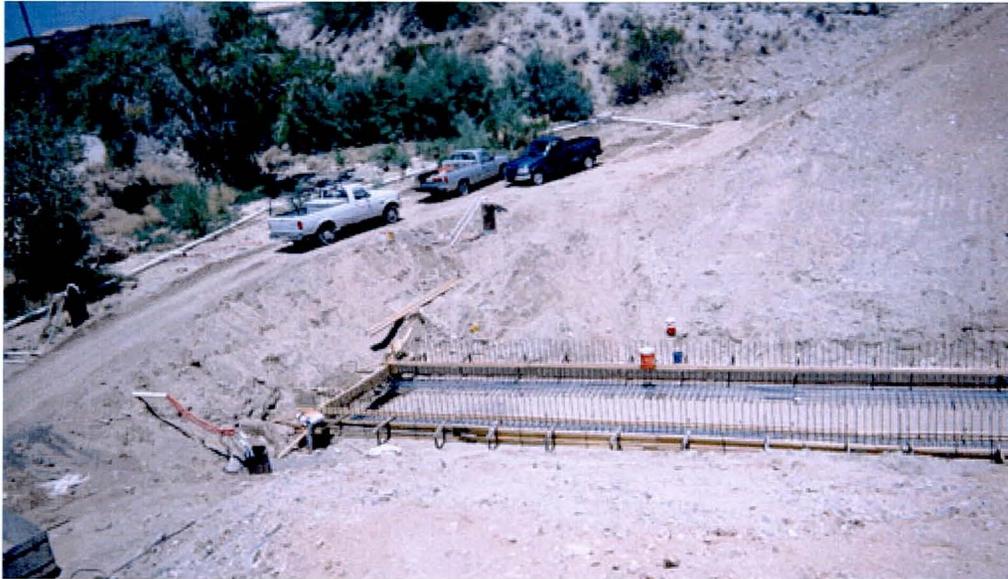
- Date: July 2000
- Location: auxiliary outlet works
- Description: construction of box culvert floor slab

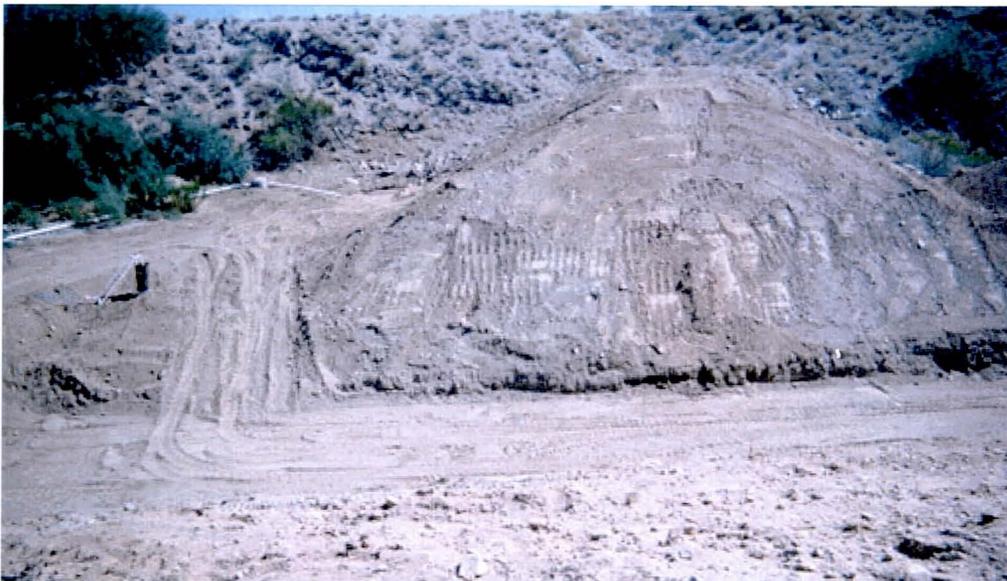
- Date: July 2000
- Location: auxiliary outlet works
- Description: trench excavation and subgrade

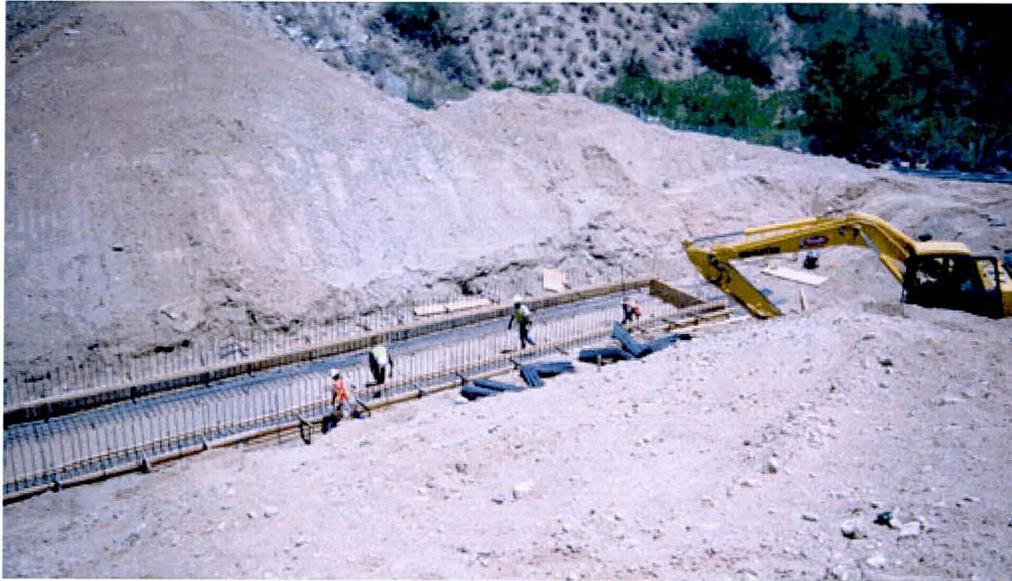
- Date: July 2000
- Location: auxiliary outlet works
- Description: construction of box culvert

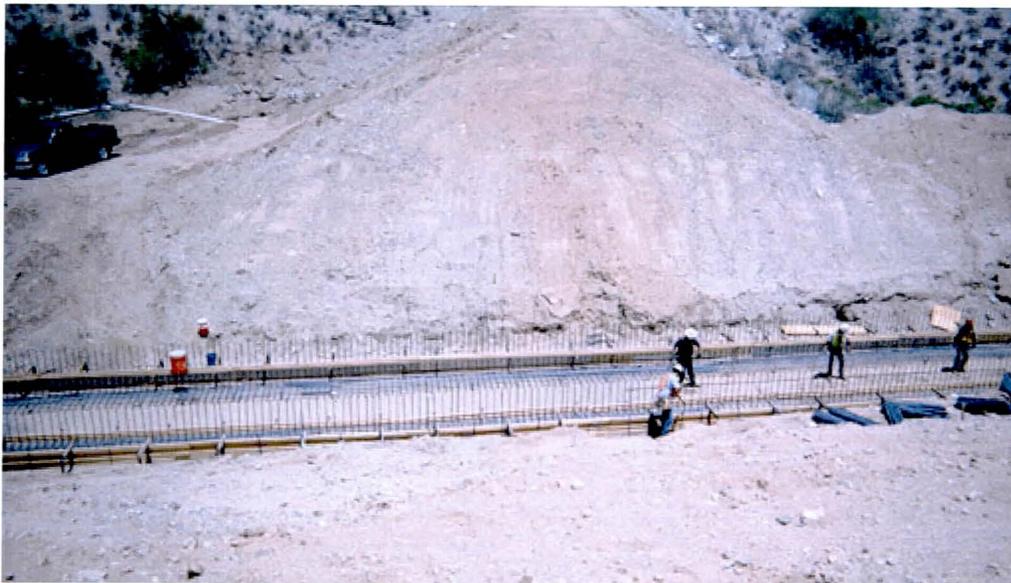
- Date: July 2000
- Location: auxiliary outlet works
- Description: construction of box culvert floor slab

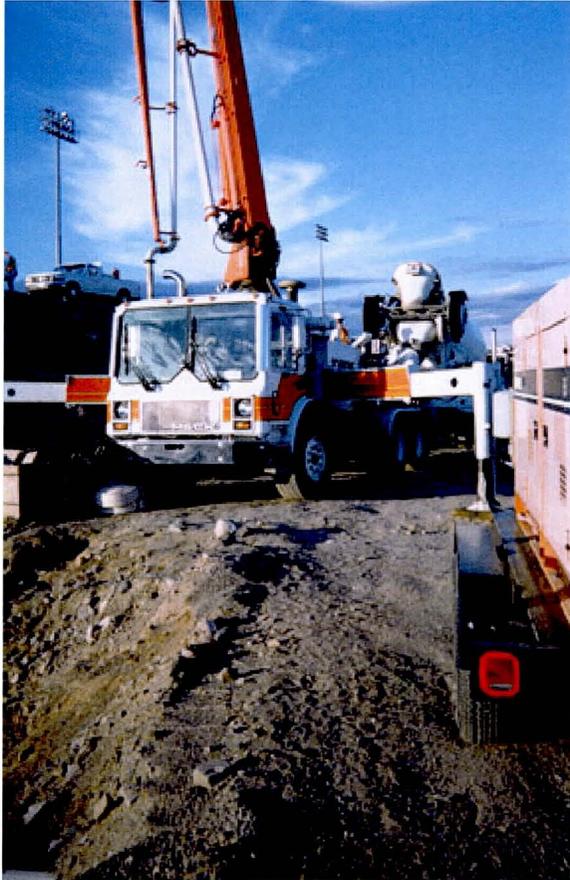
- Date: July 2000
- Location: auxiliary outlet works
- Description: concrete pumper truck

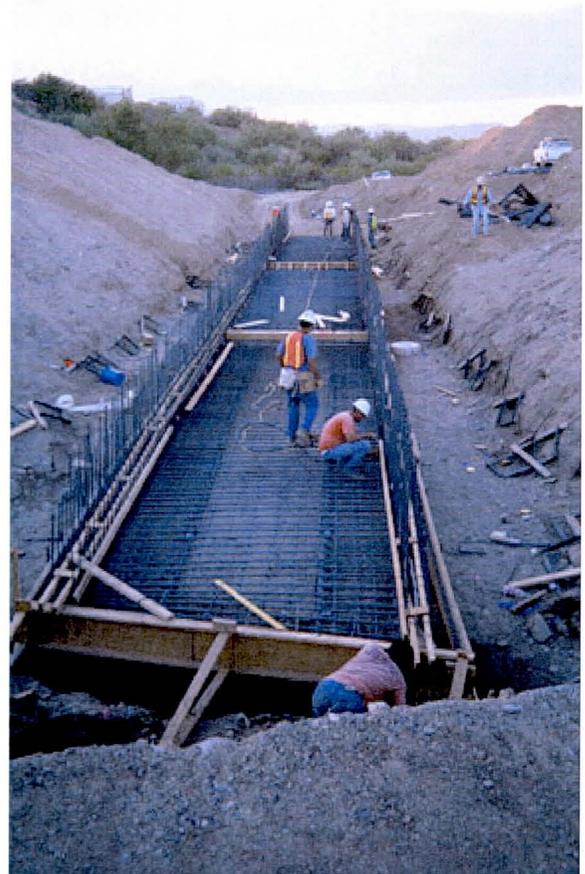
- Date: July 2000
- Location: auxiliary outlet works
- Description: construction of box culvert floor slab

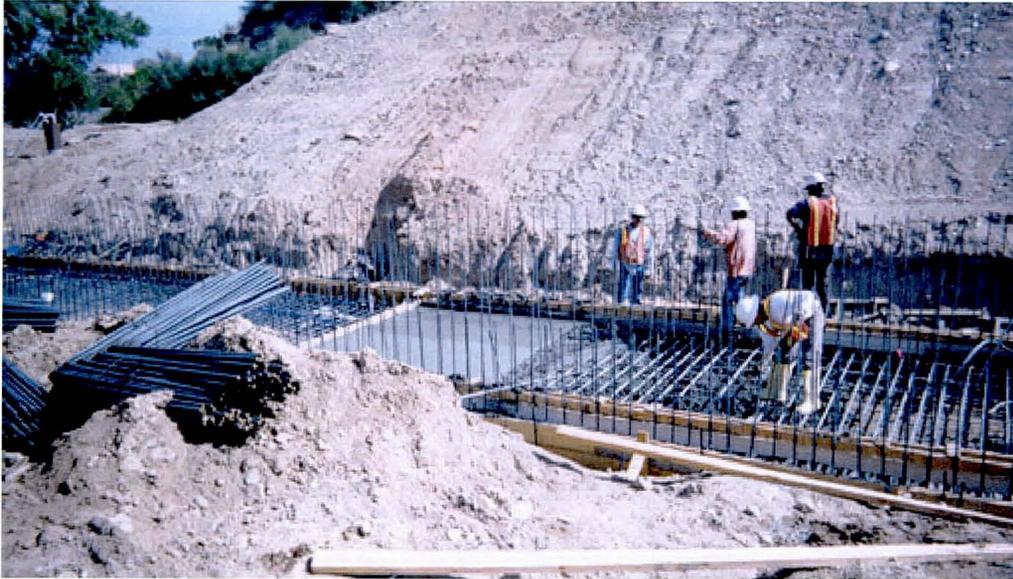
- Date: July 2000
- Location: auxiliary outlet works
- Description: pouring concrete for box culvert floor slab

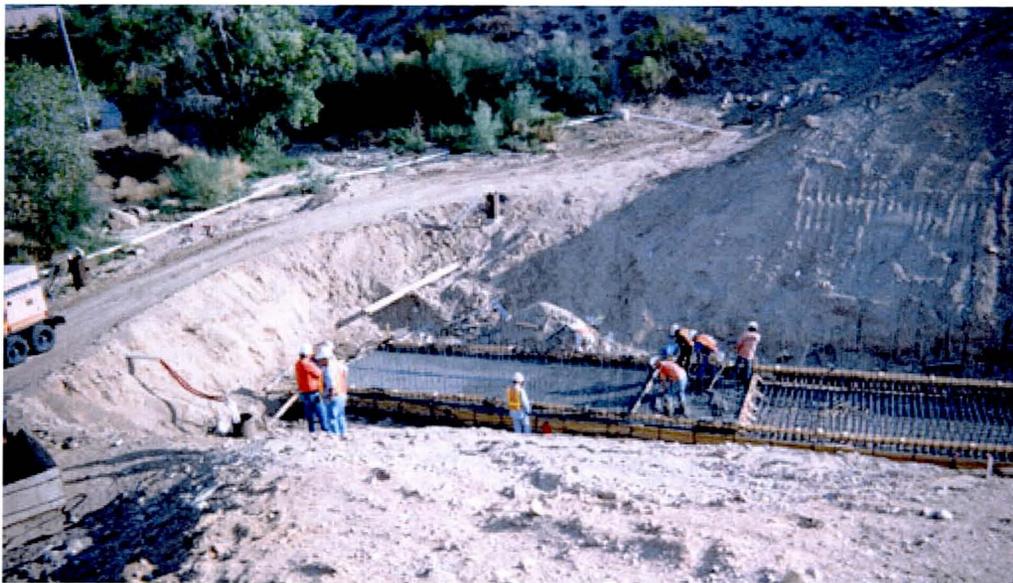
- Date: July 2000
- Location: auxiliary outlet works
- Description: pouring concrete for box culvert floor slab at upstream end

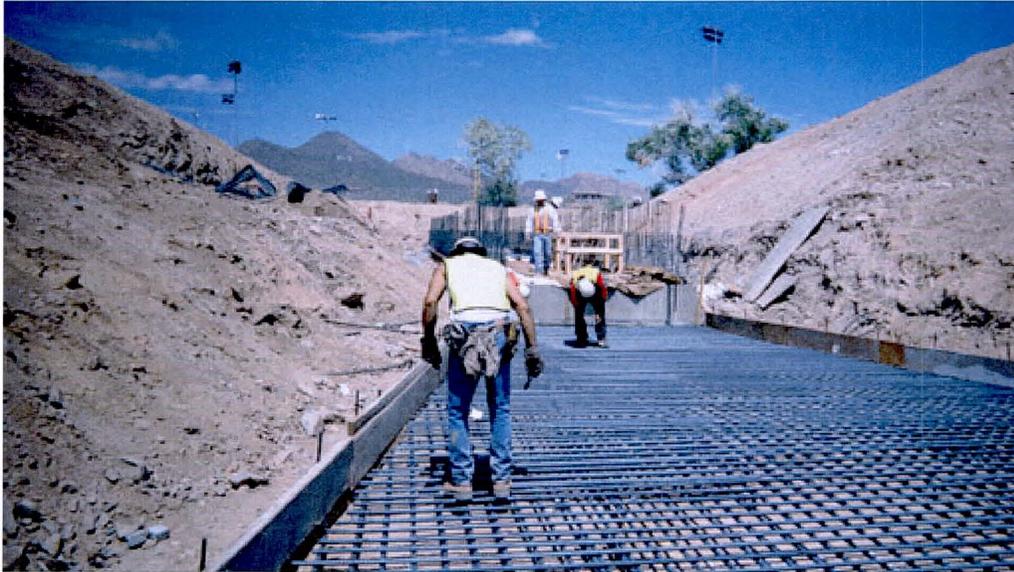
- Date: July 2000
- Location: outlet structure on auxiliary outlet works box culvert
- Description: placing steel for apron

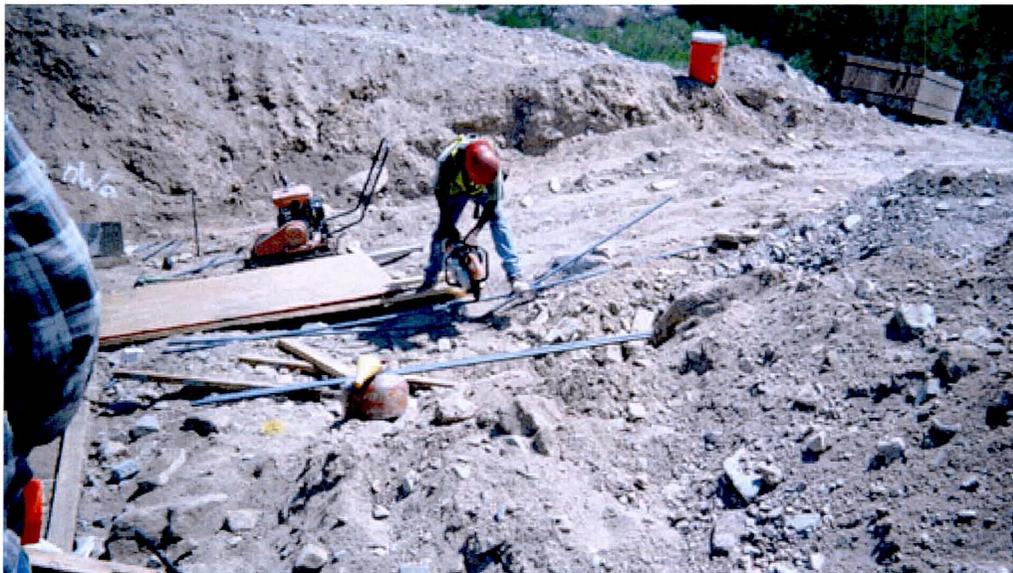
- Date: July 2000
- Location: outlet structure on auxiliary outlet works box culvert
- Description: placing steel for apron, cutting steel with saw

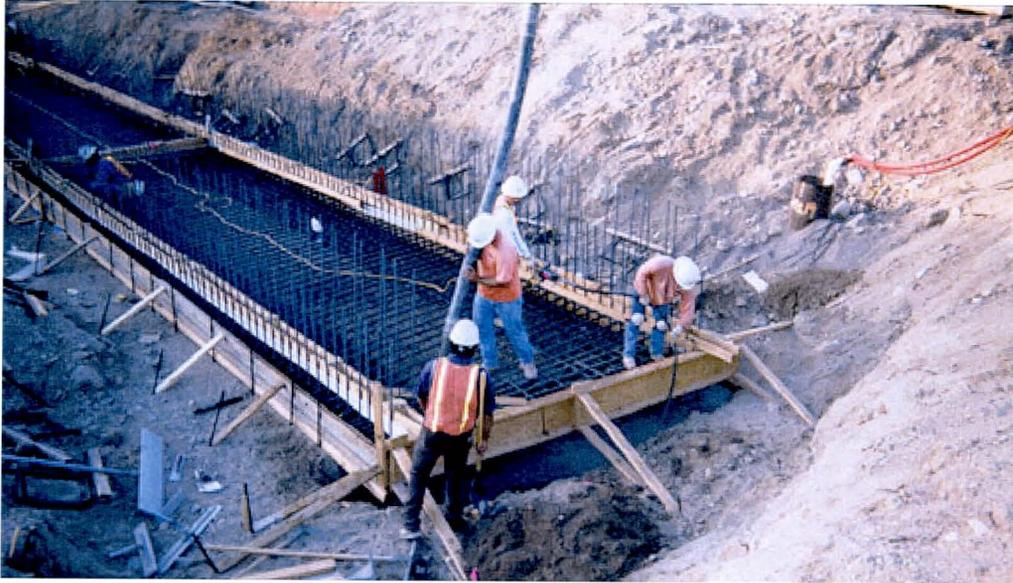
- Date: July 2000
- Location: auxiliary outlet works
- Description: pouring concrete for outlet structure apron at downstream end

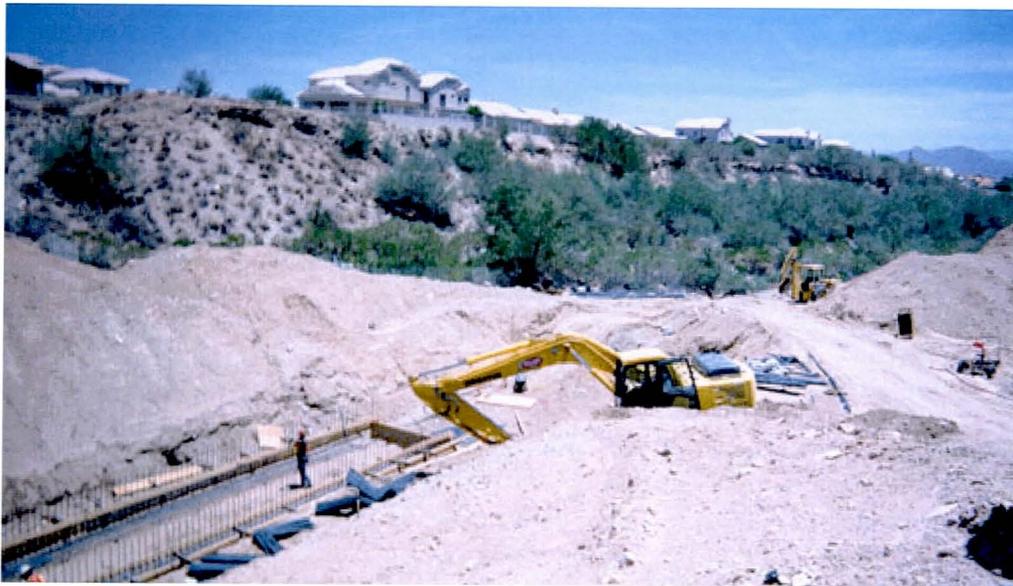
- Date: July 2000
- Location: auxiliary outlet works
- Description: construction of box culvert

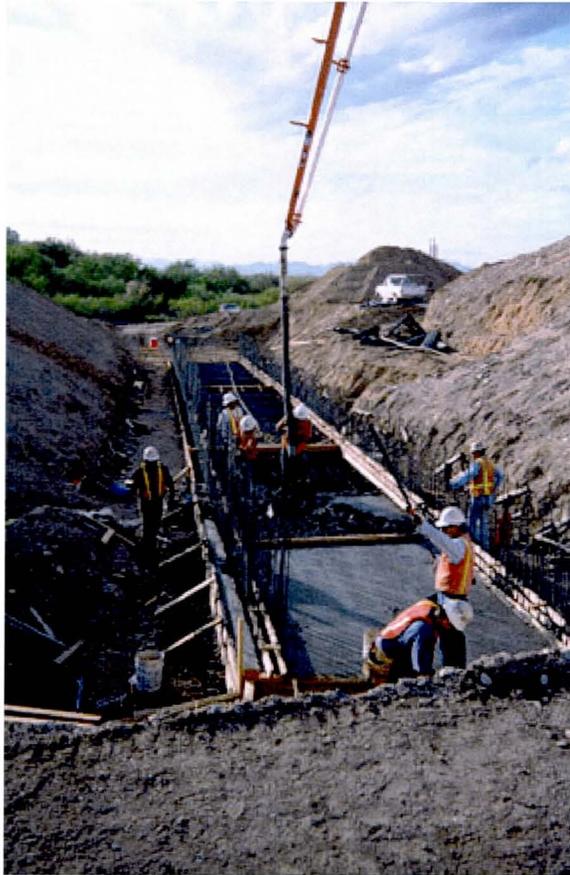
- Date: July 2000
- Location: auxiliary outlet works
- Description: pouring concrete for box culvert floor slab at upstream end

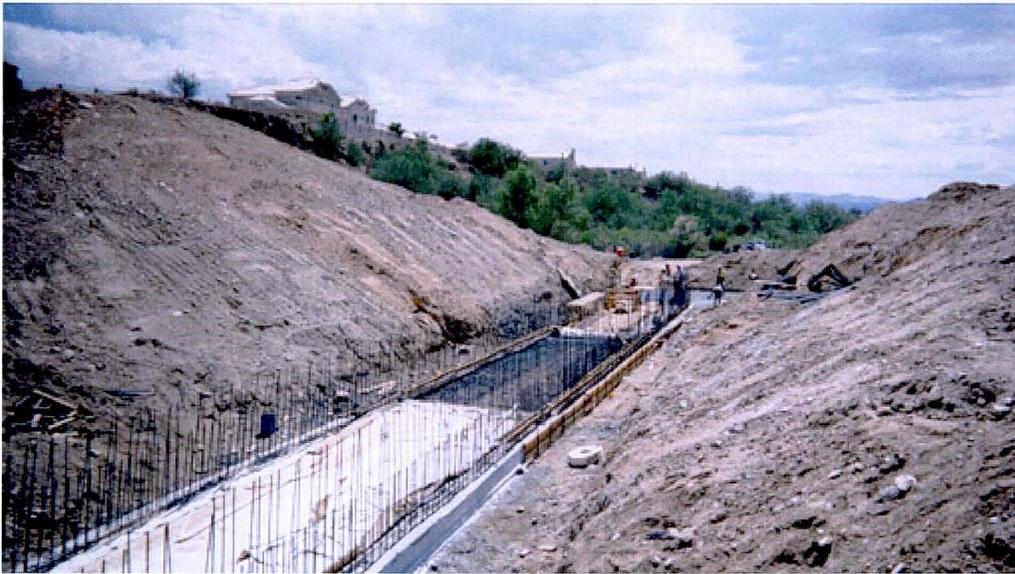
- Date: July 2000
- Location: auxiliary outlet works, looking downstream
- Description: construction of box culvert floor slab

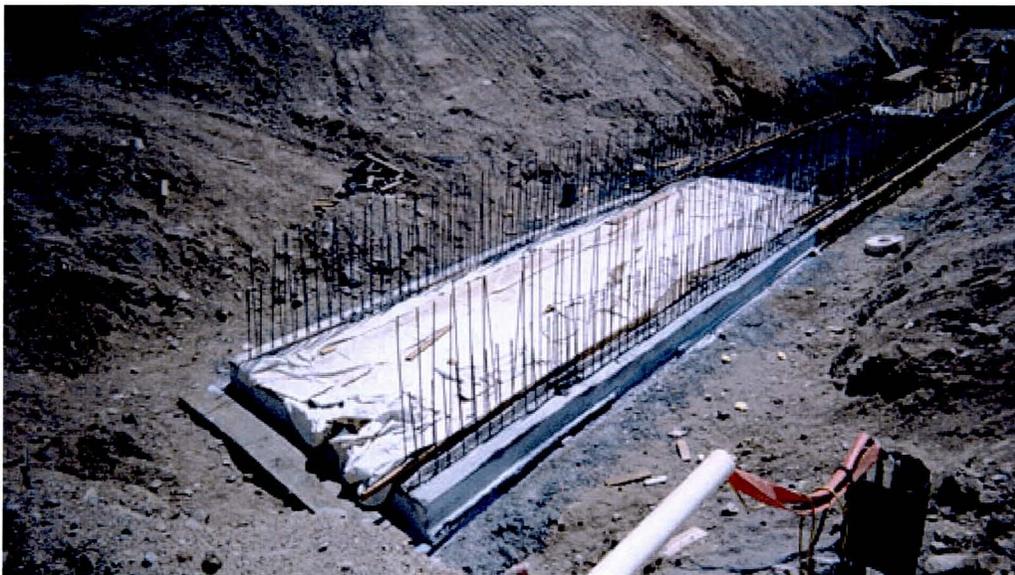
- Date: July 2000
- Location: auxiliary outlet works, upstream end
- Description: box culvert floor slab, wet cured

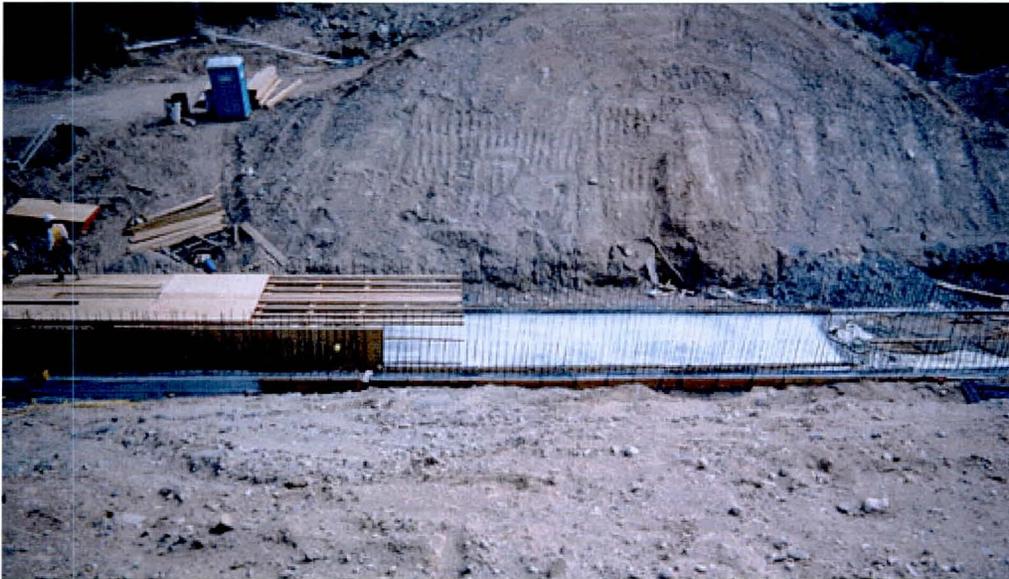
- Date: July 2000
- Location: auxiliary outlet works
- Description: center floor slab of box culvert, just poured and sprayed with curing compound

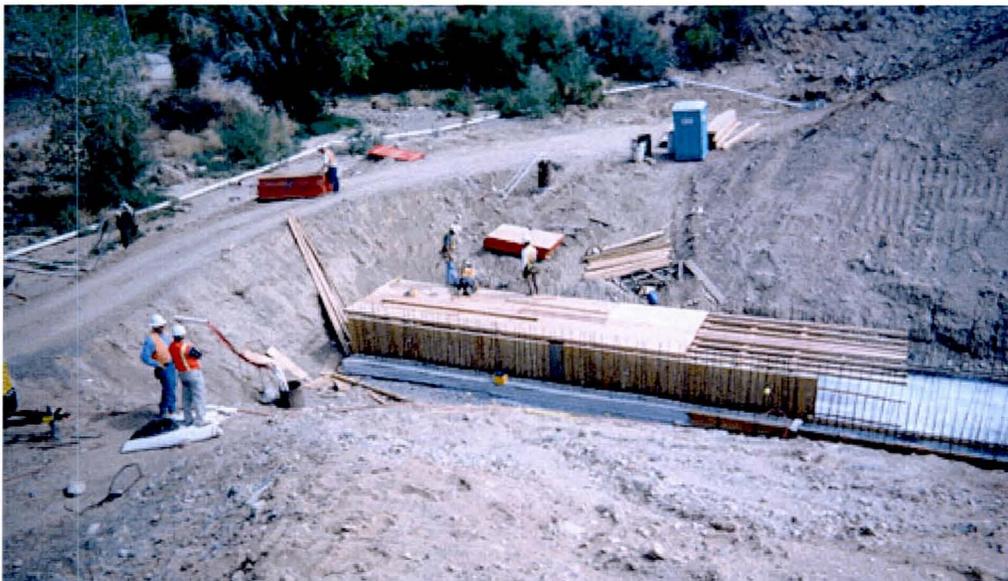
- Date: July 2000
- Location: auxiliary outlet works
- Description: west end of box culvert, beginning forming for walls and deck slab

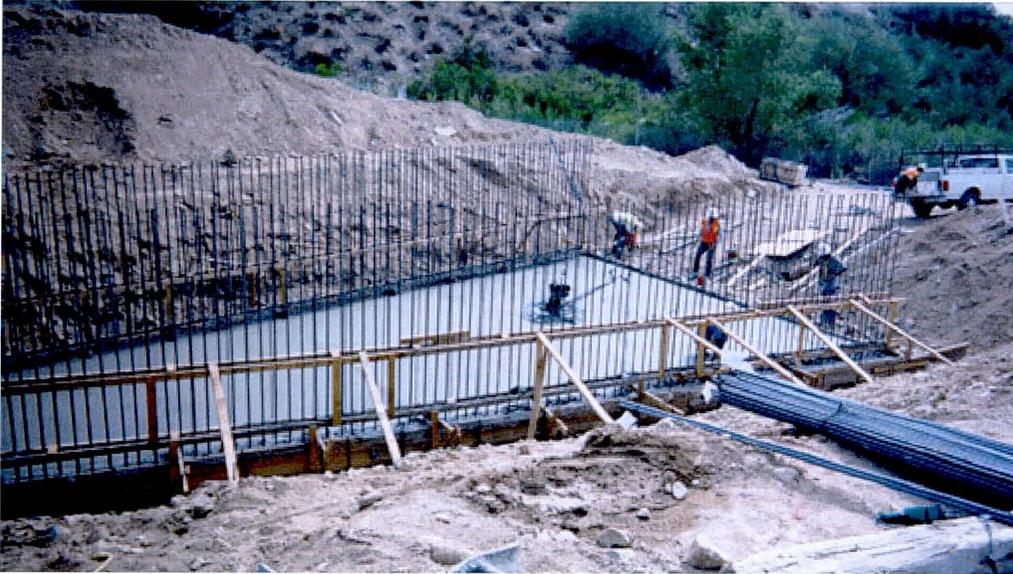
- Date: July 2000
- Location: auxiliary outlet works outlet structure
- Description: pouring and finishing apron

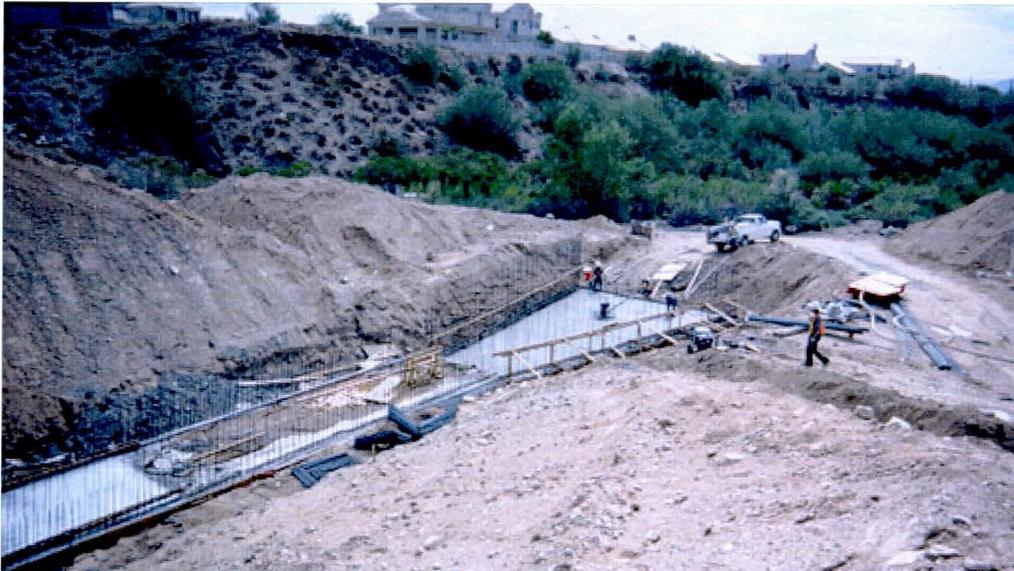
- Date: July 2000
- Location: auxiliary outlet works outlet structure
- Description: pouring and finishing apron

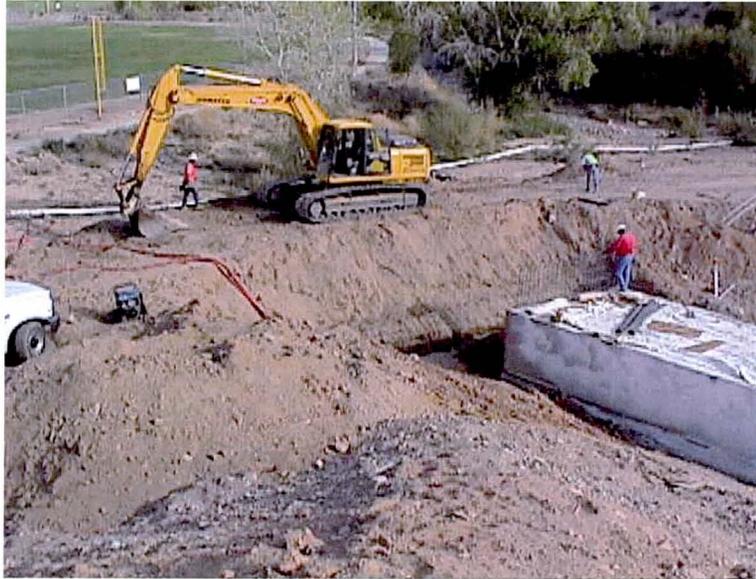
- Date: July 2000
- Location: upstream end of auxiliary outlet works box culvert
- Description: beginning work on inlet structure

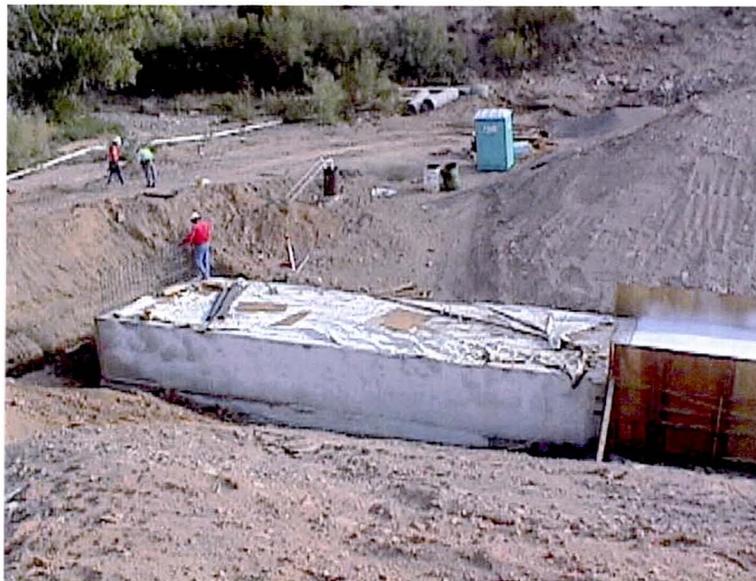
- Date: July 2000
- Location: upstream end of auxiliary outlet works box culvert
- Description: beginning work on inlet structure

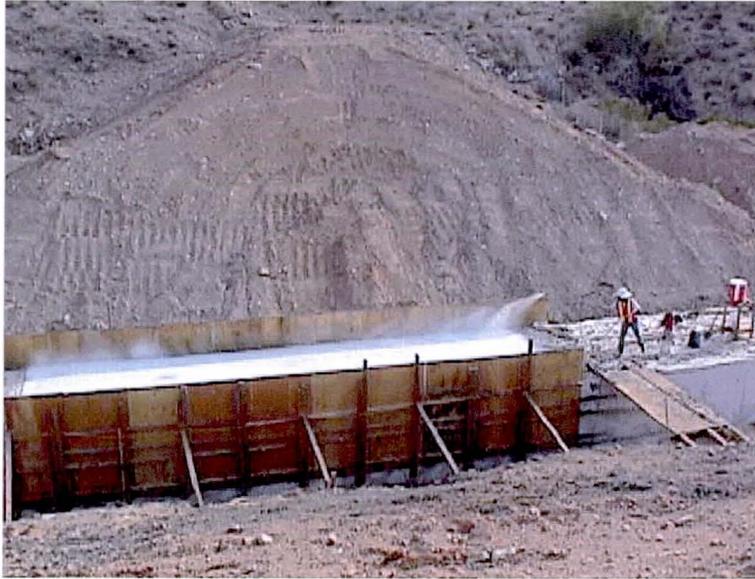
- Date: July 2000
- Location: center of auxiliary outlet works box culvert
- Description: applying curing compound

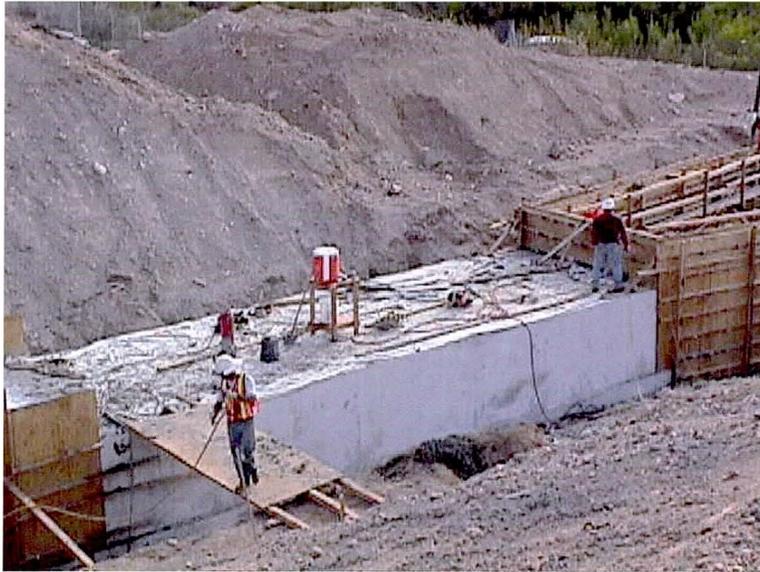
- Date: July 2000
- Location: downstream end of auxiliary outlet works box culvert
- Description: pouring concrete in walls of outlet structure

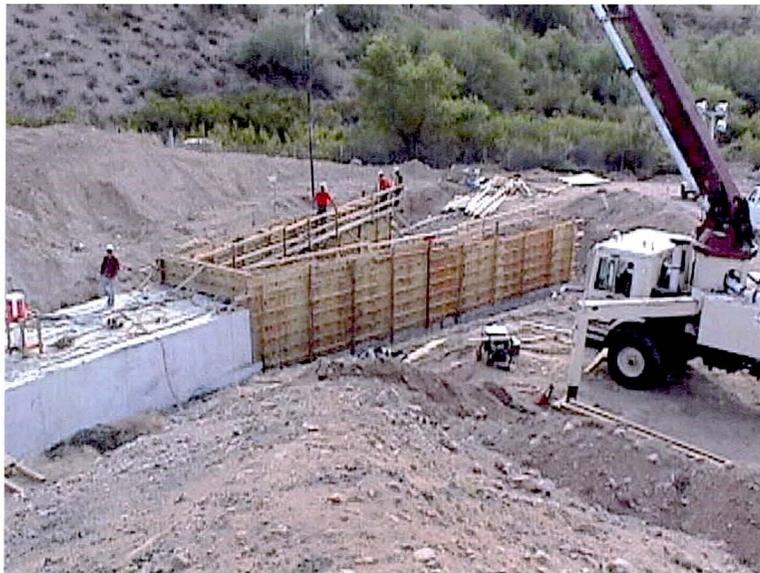
- Date: July 2000
- Location: downstream end of auxiliary outlet works box culvert
- Description: pouring concrete in walls of outlet structure
