**Golden Eagle
Park Dam
Construction
Photos**

DISK 10

JUNE 2000

Golden Eagle Park Dam Construction of Improvements in 2000

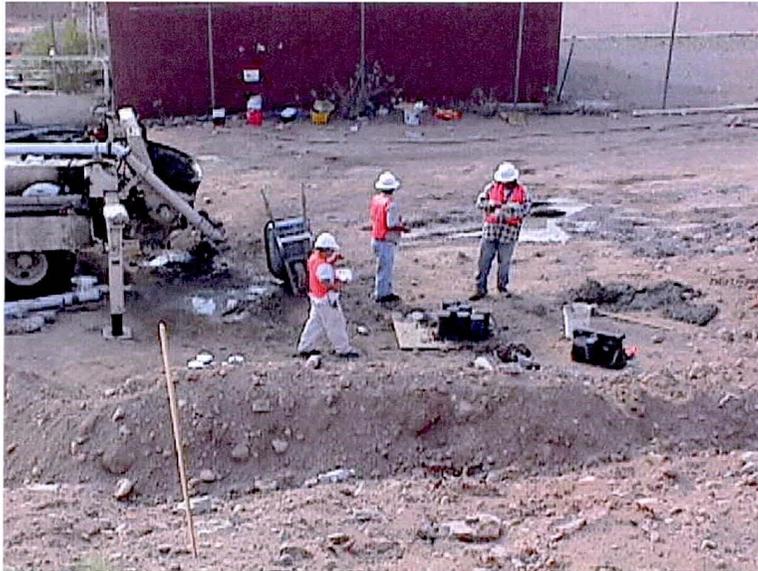
- Date: July 2000
- Location: downstream end of auxiliary outlet works box culvert
- Description: preparing concrete cylinders for testing

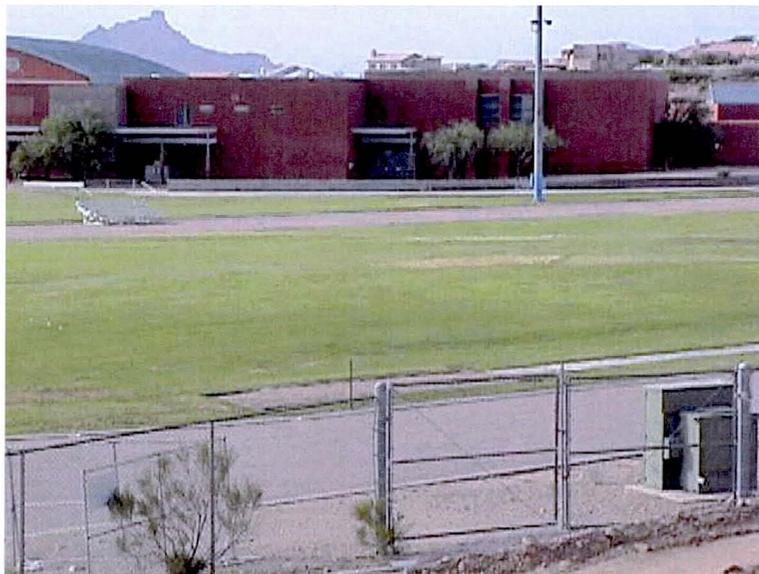
- Date: July 2000
- Location: looking towards gymnasium
- Description: block wall in front of gymnasium is completed

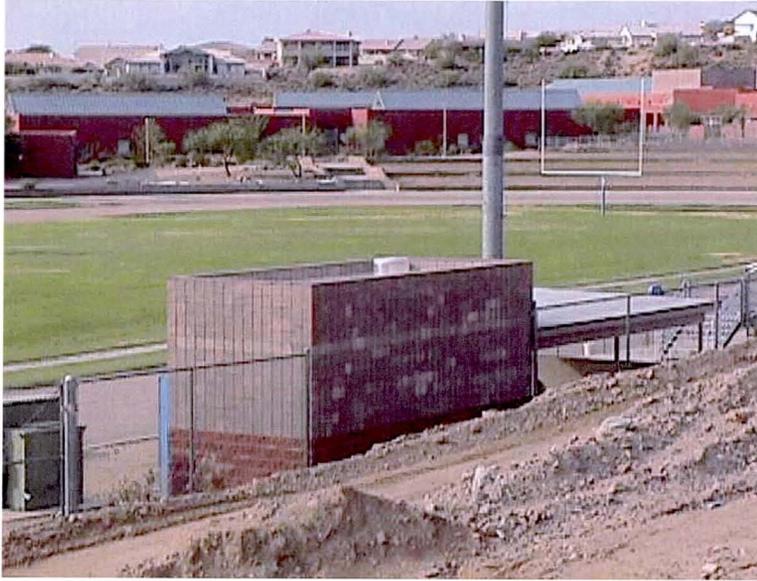
- Date: July 2000
- Location: looking towards gymnasium
- Description: block wall in front of gymnasium is completed

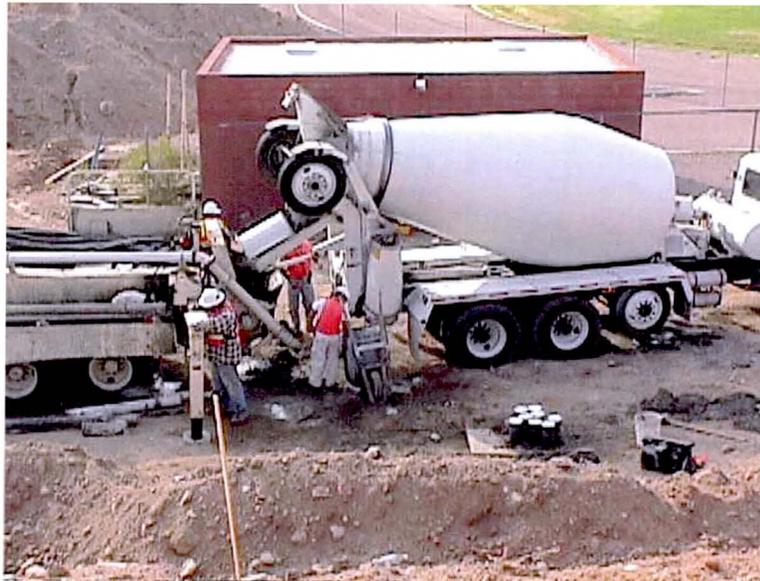
- Date: July 2000
- Location: downstream end of auxiliary outlet works box culvert
- Description: pumping concrete, preparing concrete cylinders for testing

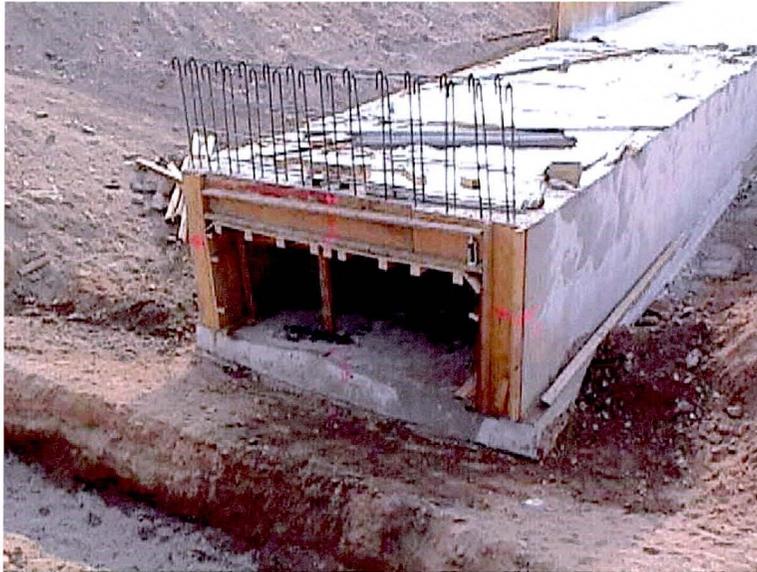
- Date: July 2000
- Location: upstream end of auxiliary box culvert
- Description: subgrade prepared for apron and cutoff

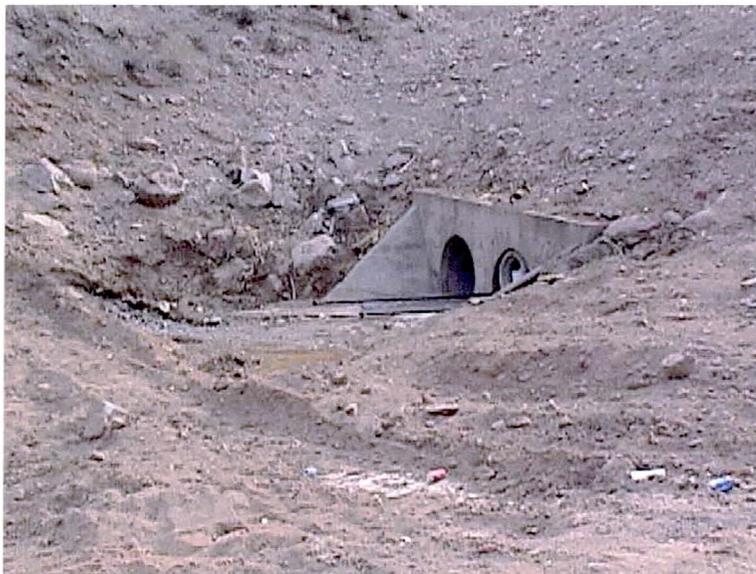
- Date: July 2000
- Location: existing inlet structure to principal outlet works
- Description: casing installed, prior to grouting

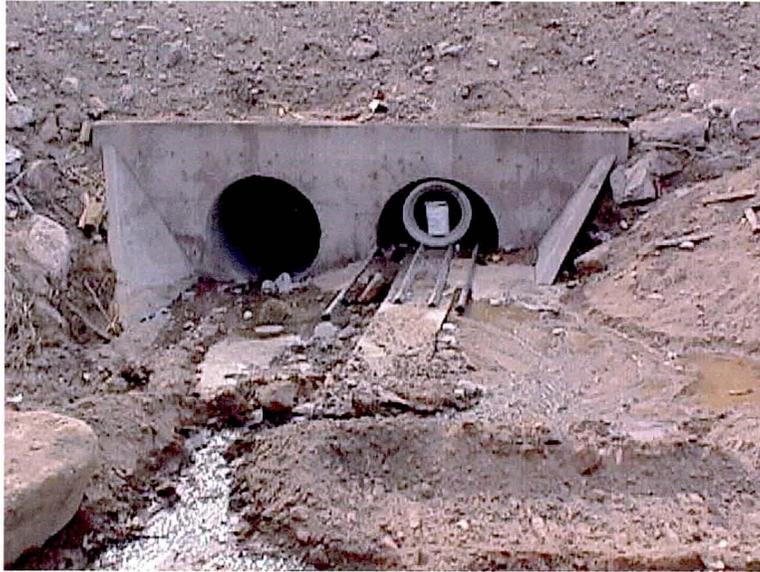
- Date: July 2000
- Location: existing inlet structure to principal outlet works
- Description: casing installed, prior to grouting

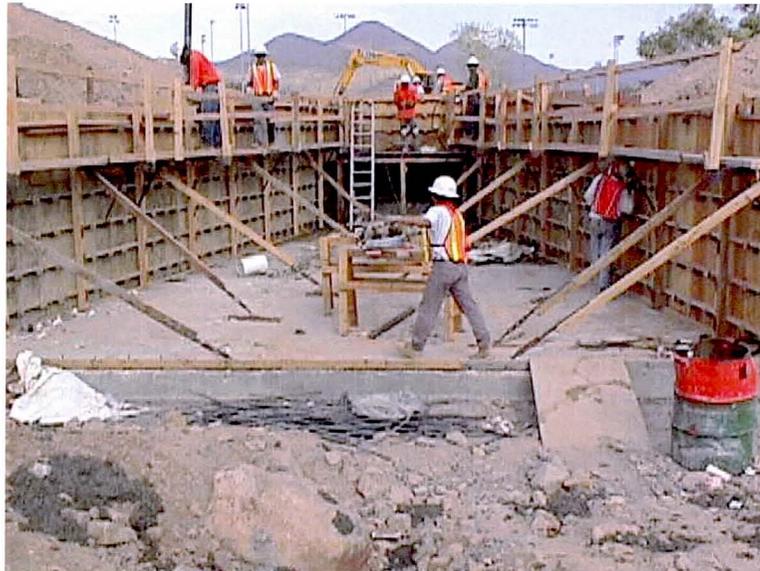
- Date: July 2000
- Location: downstream end of auxiliary outlet works box culvert
- Description: pouring concrete in walls of outlet structure

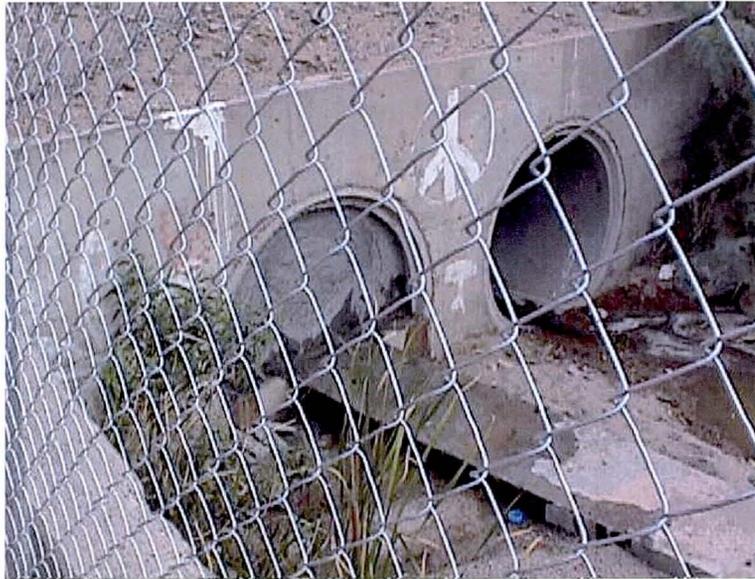
- Date: July 2000
- Location: principal outlet work outlet structure
- Description: plugged 60 inch pipe

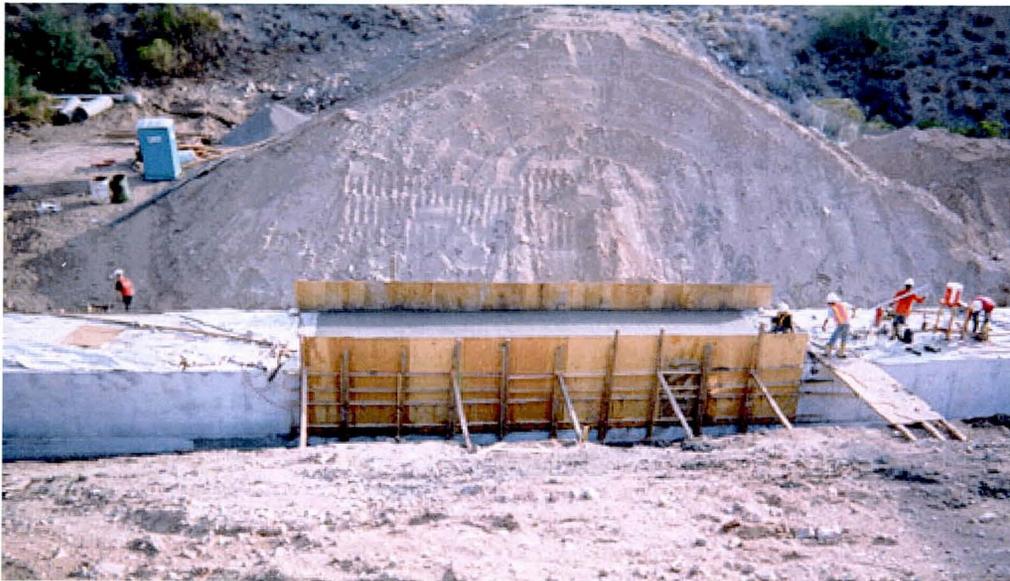
- Date: August 2000
- Location: auxiliary outlet works
- Description: pouring walls and roof deck of center section

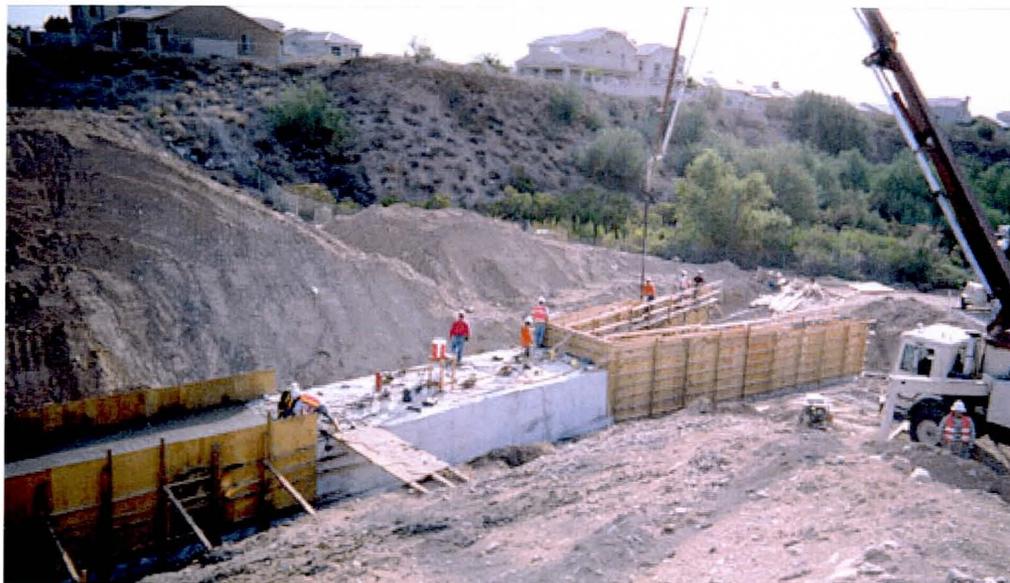
- Date: August 2000
- Location: auxiliary outlet works
- Description: pouring walls of outlet structure

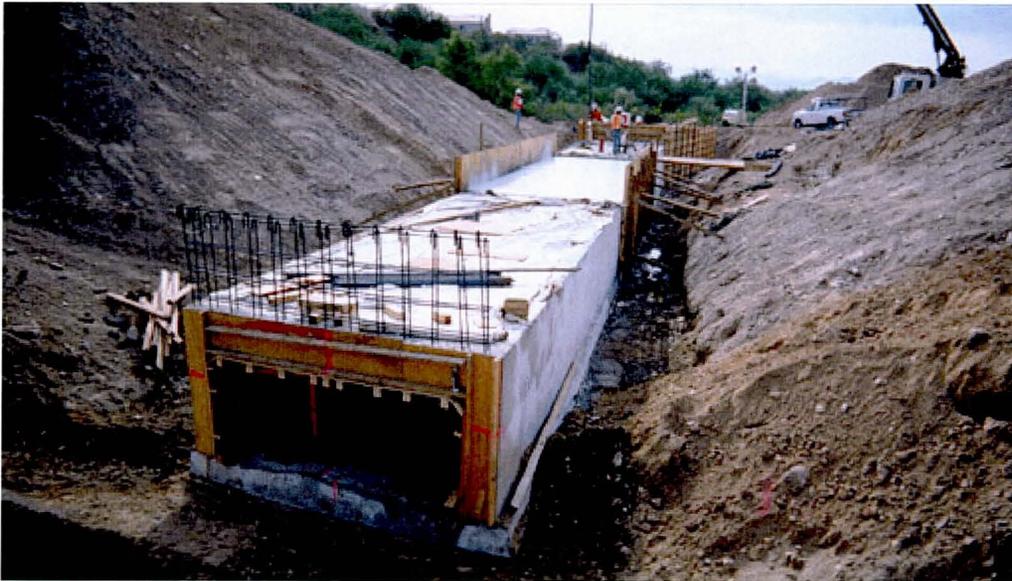
- Date: August 2000
- Location: auxiliary outlet works
- Description: construction of the box culvert

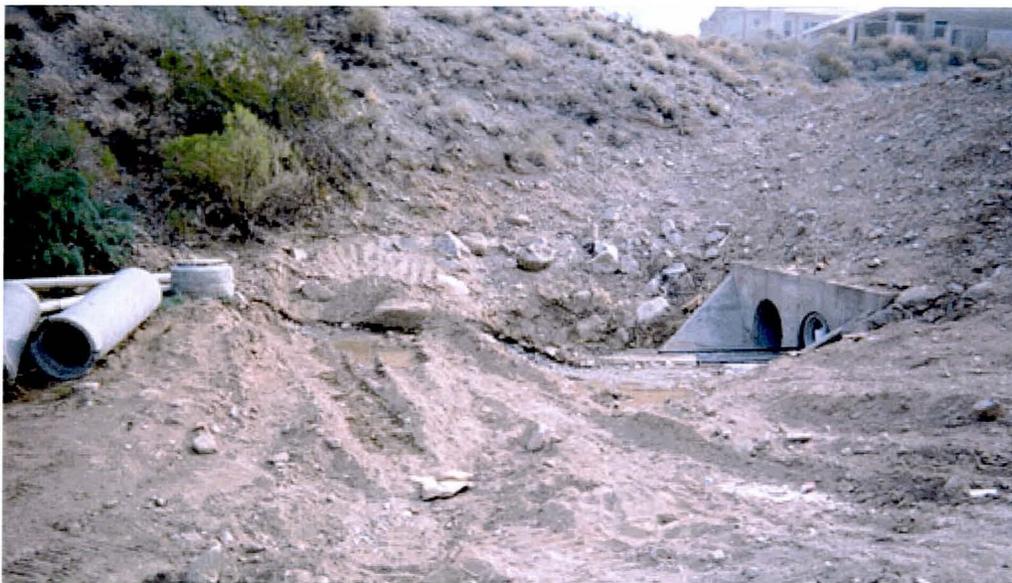
- Date: August 2000
- Location: principal outlet works
- Description: installation of the 24 inch casing inside the 60 inch pipe

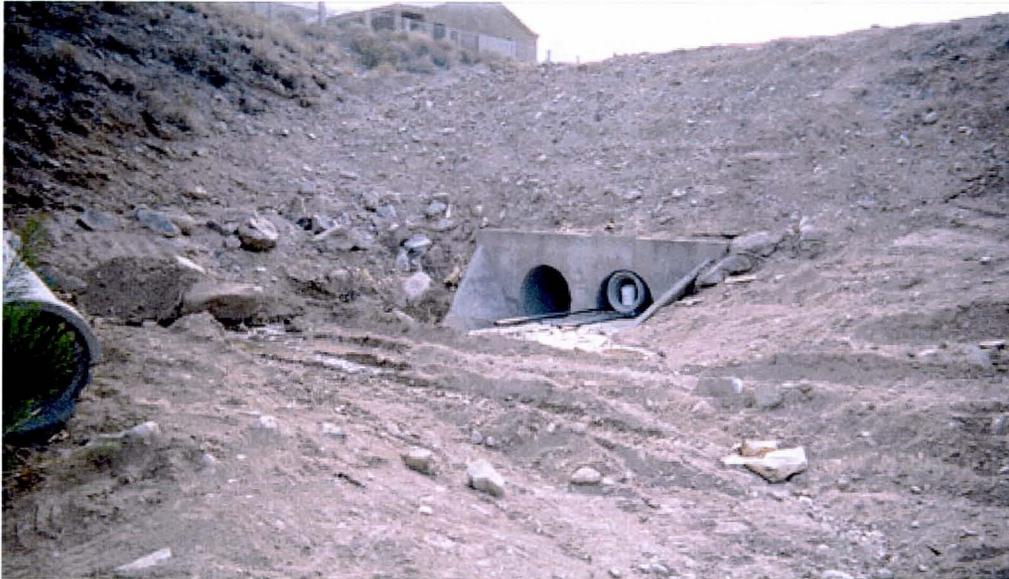
- Date: August 2000
- Location: principal outlet works
- Description: installation of the 24 inch casing inside the 60 inch pipe

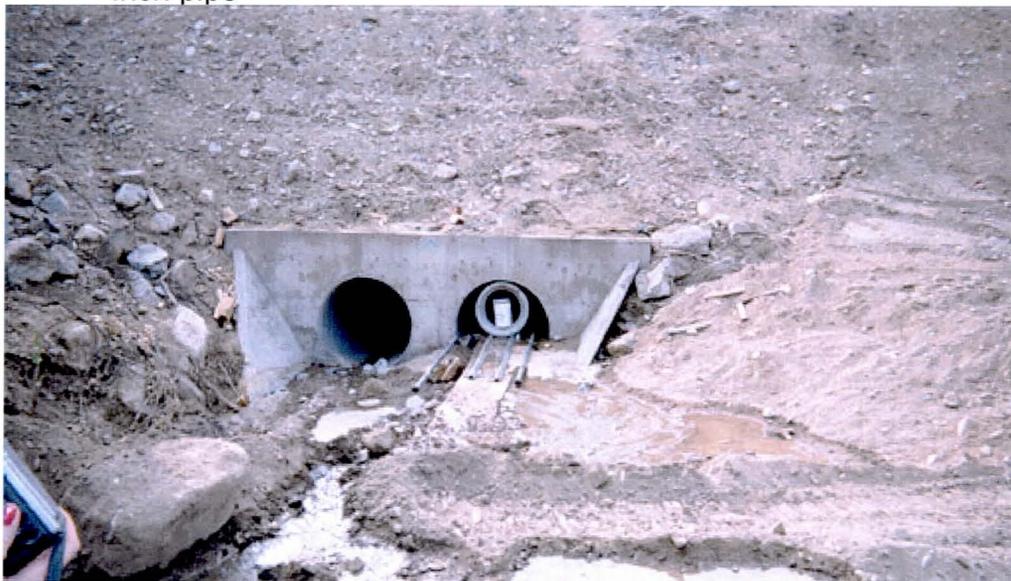
- Date: August 2000
- Location: principal outlet works
- Description: installation of the 24 inch casing inside the 60 inch pipe

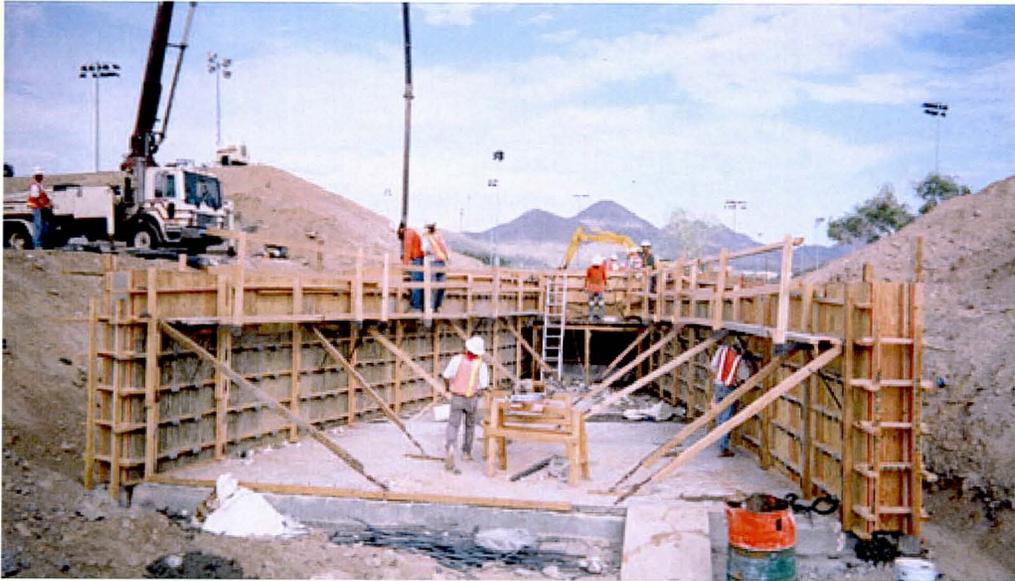
- Date: August 2000
- Location: auxiliary outlet works
- Description: pouring concrete in the outlet structure wing walls

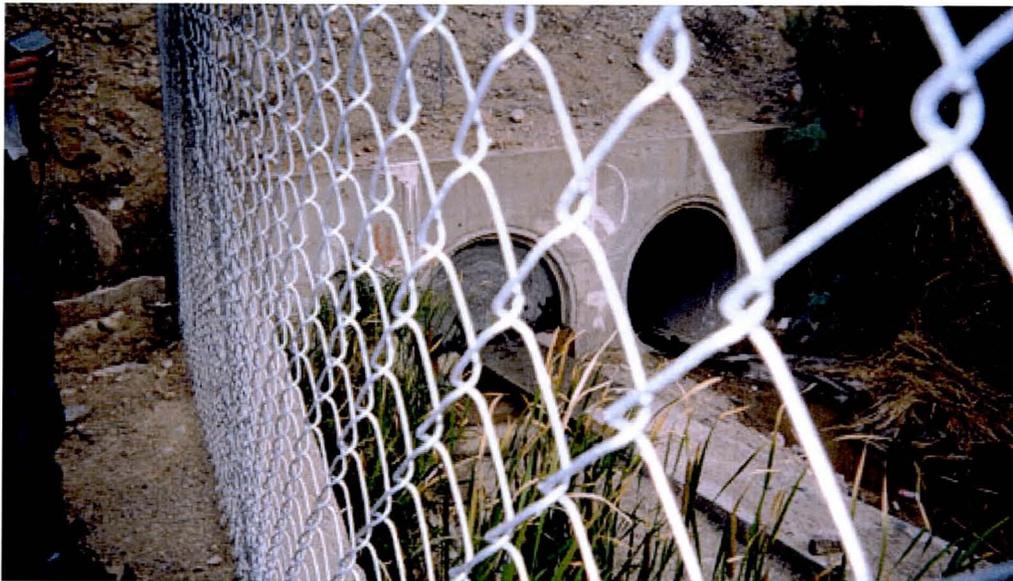
- Date: August 2000
- Location: principal outlet works
- Description: 60 inch pipe plug at downstream end

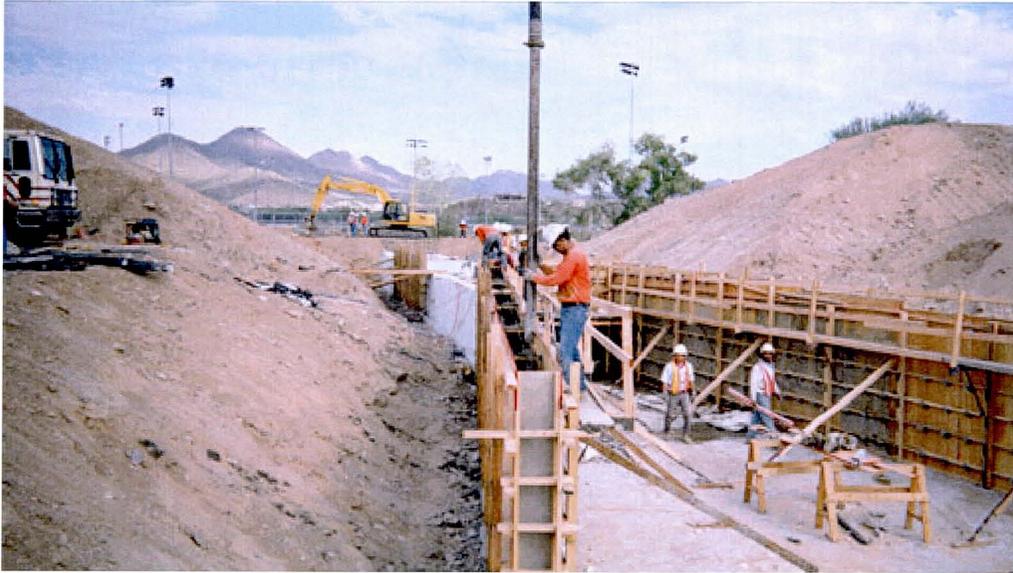
- Date: August 2000
- Location: auxiliary outlet works
- Description: pouring concrete in the outlet structure wing walls

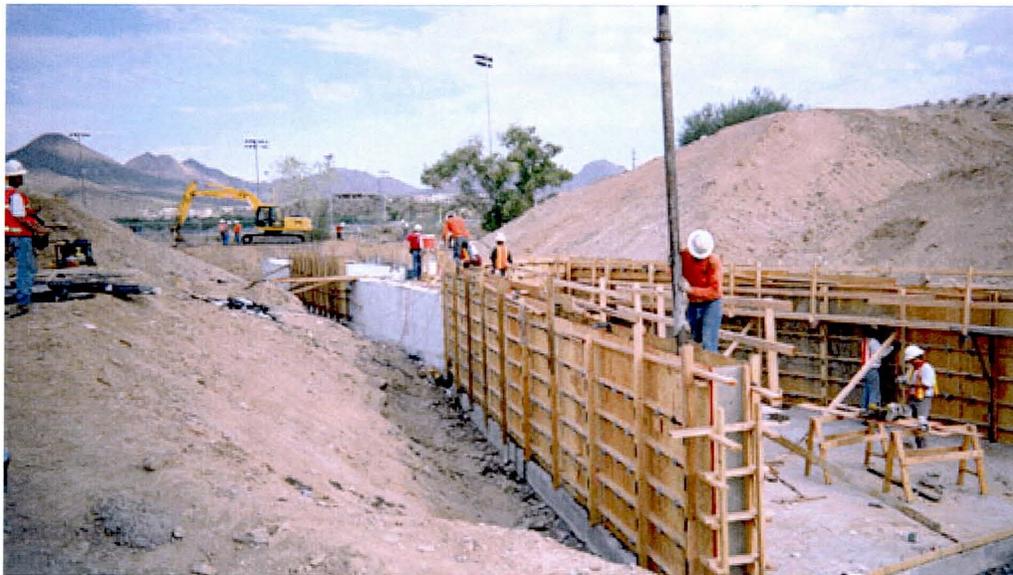
- Date: August 2000
- Location: auxiliary outlet works
- Description: pouring concrete in the outlet structure wing walls

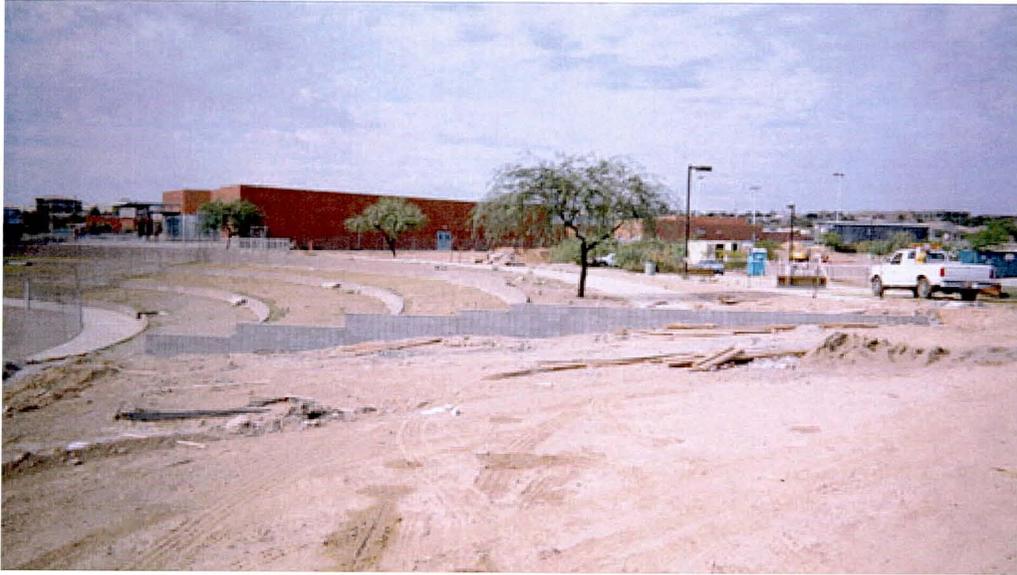
- Date: August 2000
- Location: emergency spillway
- Description: masonry retaining wall completed

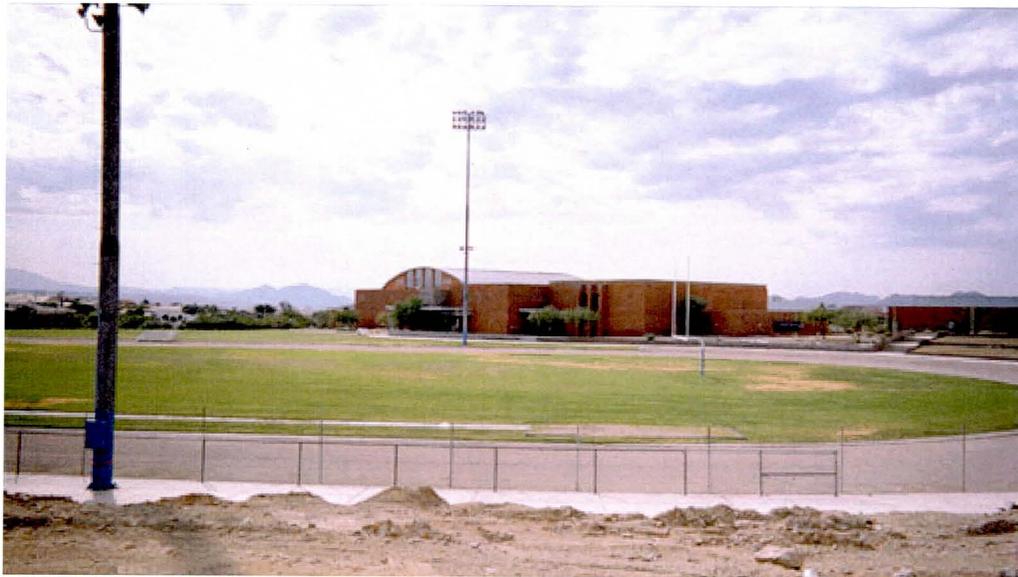
- Date: August 2000
- Location: emergency spillway
- Description: excavation of emergency spillway

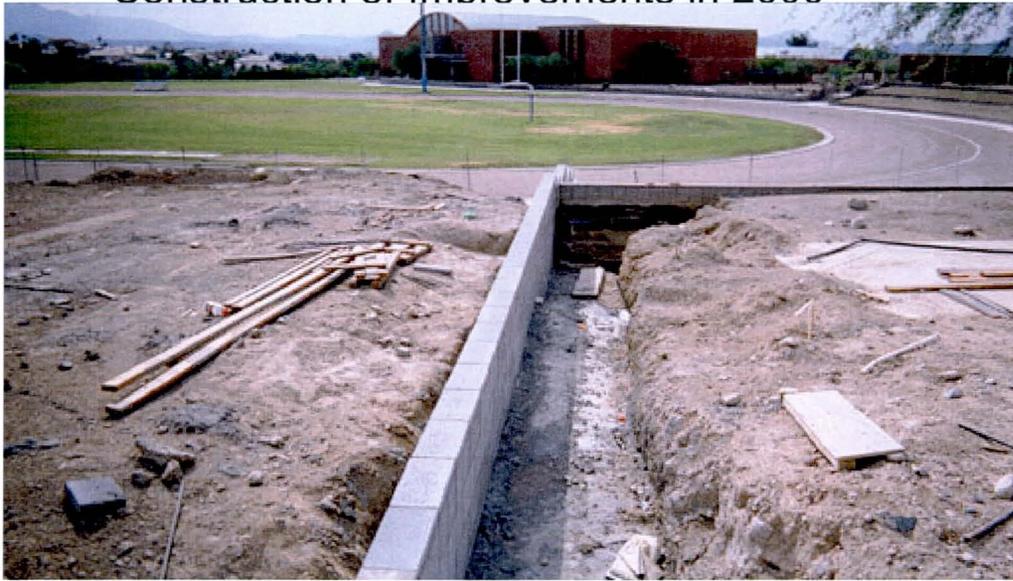
- Date: August 2000
- Location: emergency spillway
- Description: masonry retaining wall

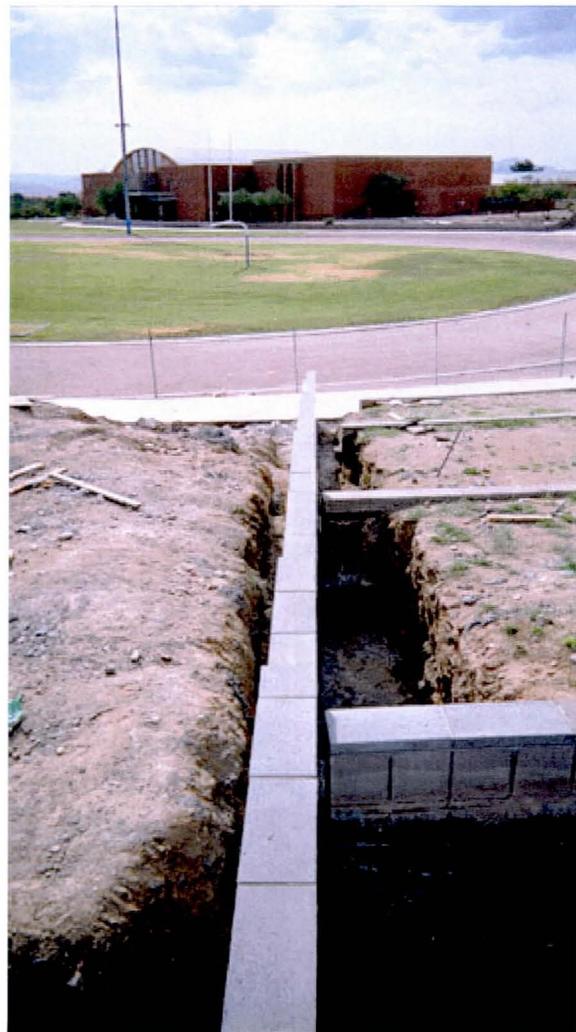
- Date: August 2000
- Location: emergency spillway
- Description: masonry retaining wall

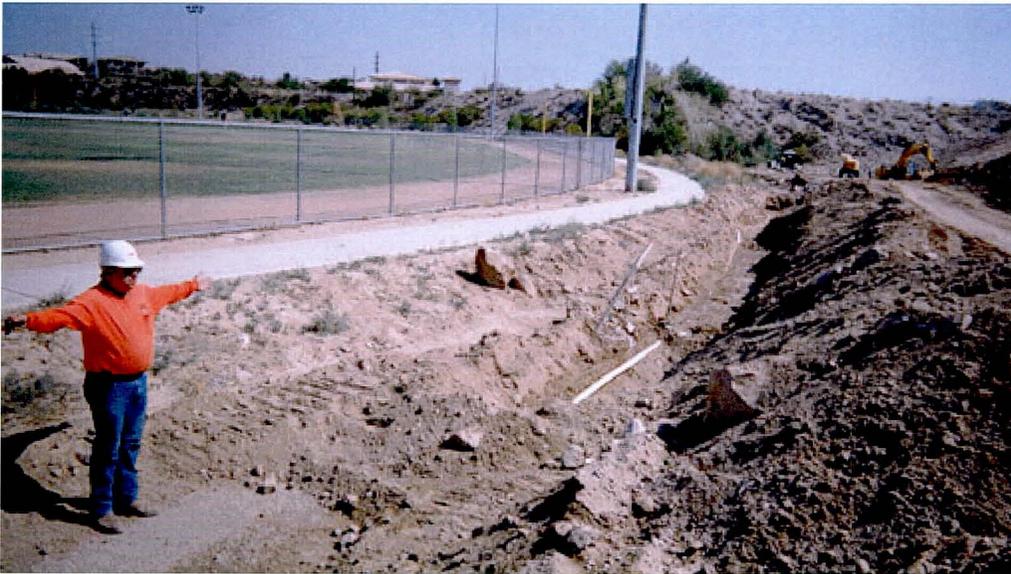
- Date: August 2000
- Location: upstream toe of dam (Cloudburst Wash)
- Description: placement of dam embankment and construction of toe trench for riprap, irrigation lines exposed and relocated

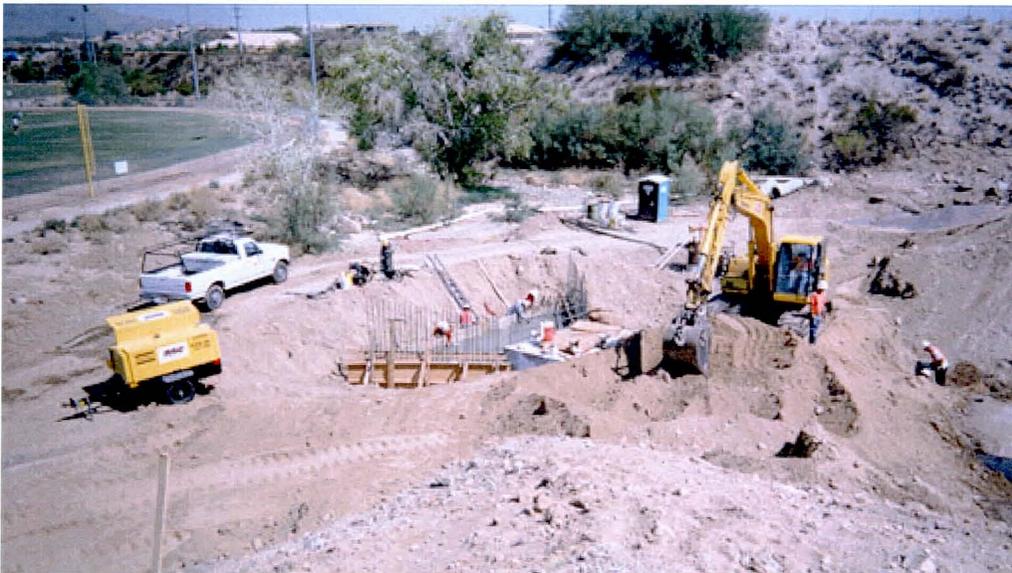
- Date: August 2000
- Location: auxiliary outlet works
- Description: constructing inlet structure

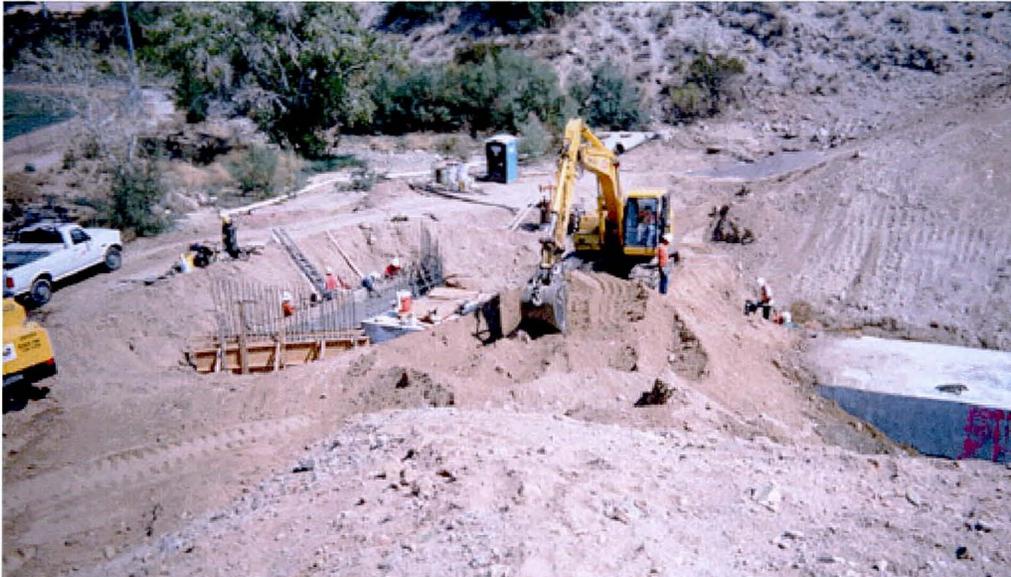
- Date: August 2000
- Location: auxiliary outlet works
- Description: constructing inlet structure, beginning backfill upstream of the core

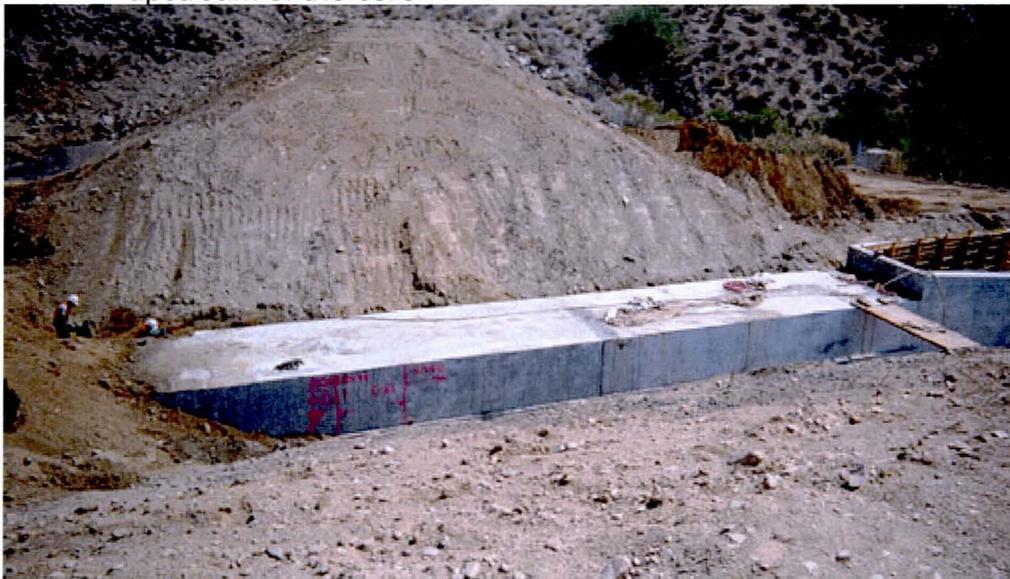
- Date: August 2000
- Location: auxiliary outlet works
- Description: forms stripped, beginning backfill upstream of the core

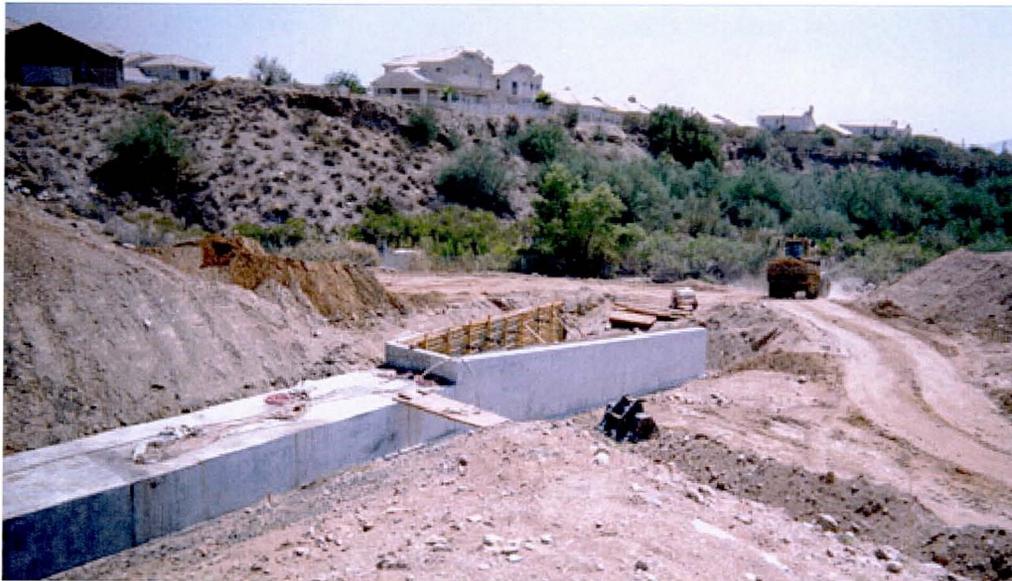
- Date: August 2000
- Location: auxiliary outlet works
- Description: stripping forms, excavating downstream channel

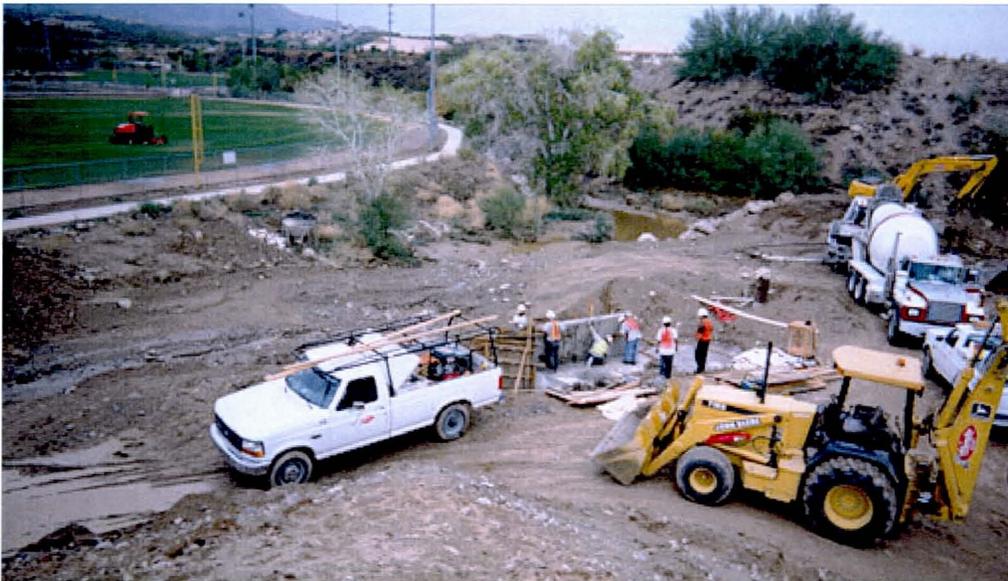
- Date: August 2000
- Location: auxiliary outlet works
- Description: stripping forms on inlet structure, placing concrete at principal inlet structure

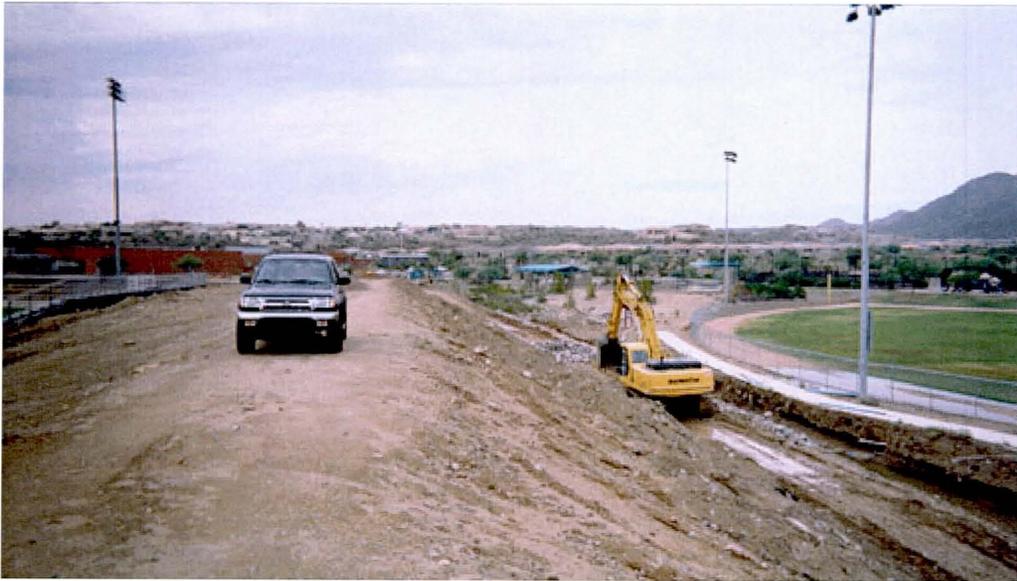
- Date: August 2000
- Location: dam embankment looking south
- Description: placing riprap at toe of dam

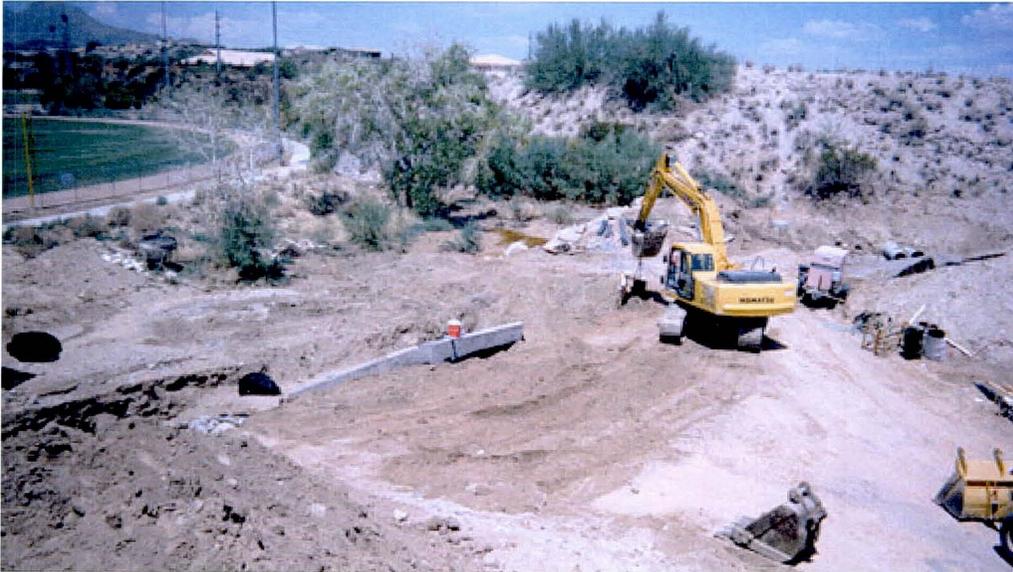
- Date: August 2000
- Location: auxiliary outlet works
- Description: backfilling over box culvert

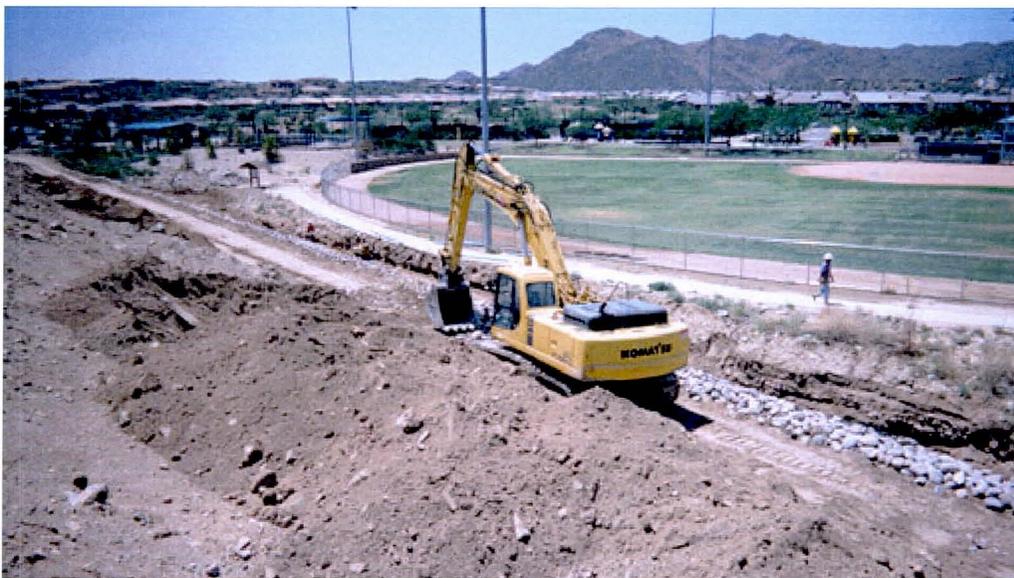
- Date: August 2000
- Location: upstream dam embankment
- Description: placing riprap

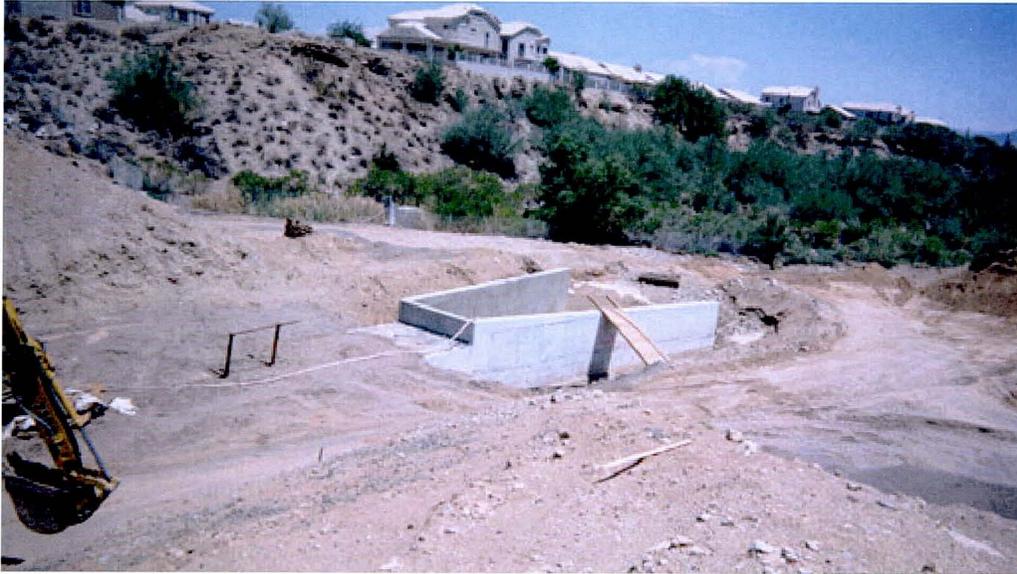
- Date: August 2000
- Location: auxiliary outlet works
- Description: outlet structure

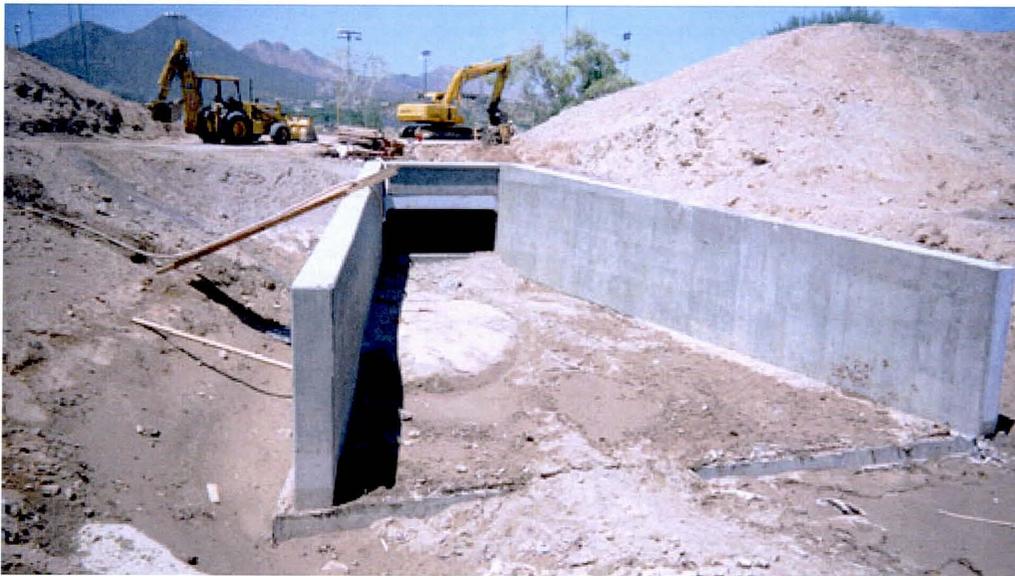
- Date: August 2000
- Location: auxiliary outlet works
- Description: outlet structure filled with sediment from recent rain

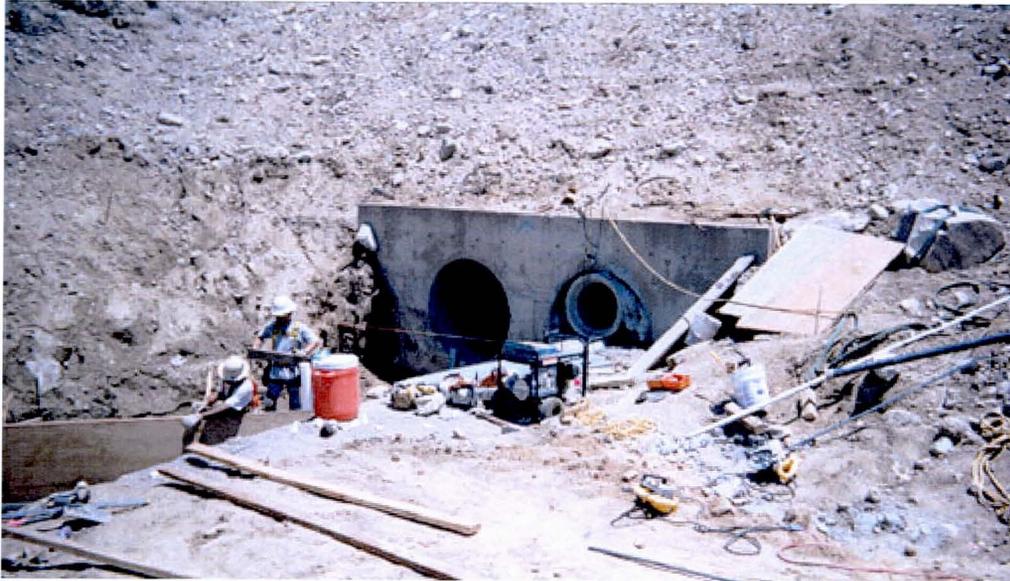
- Date: August 2000
- Location: principal outlet works inlet structure
- Description: forming for the new headwall and apron

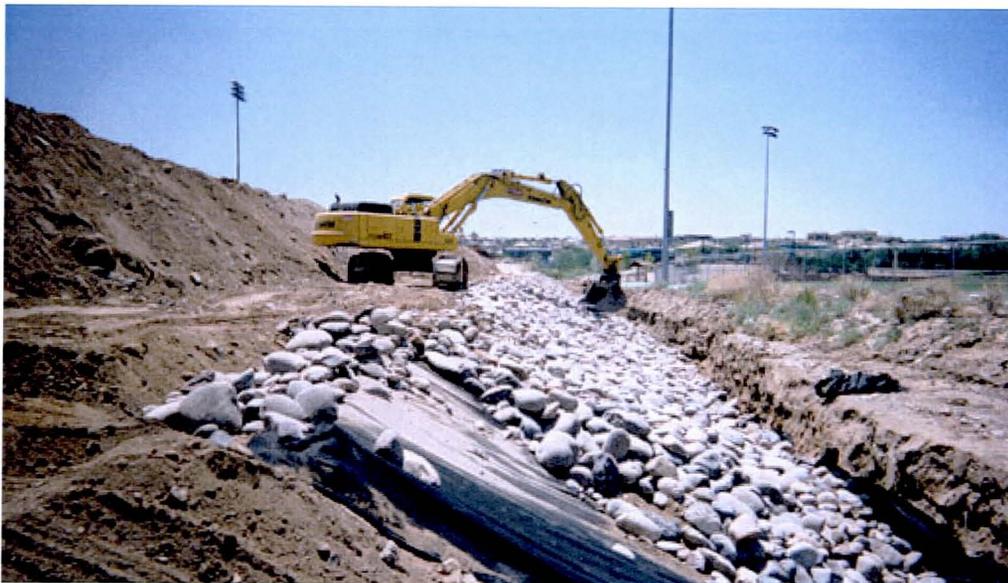
- Date: August 2000
- Location: upstream dam embankment
- Description: placing riprap

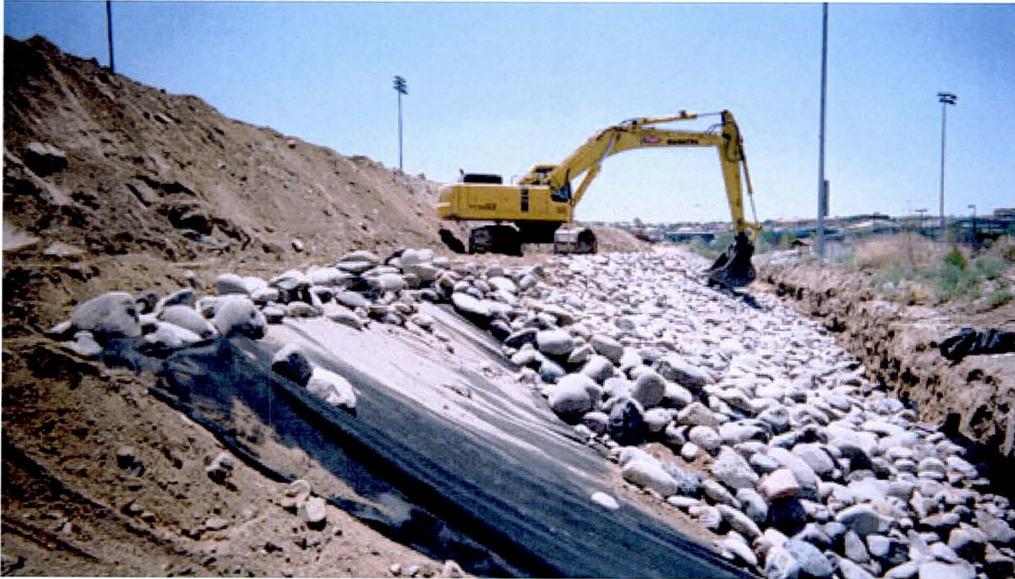
- Date: August 2000
- Location: upstream dam embankment
- Description: placing riprap

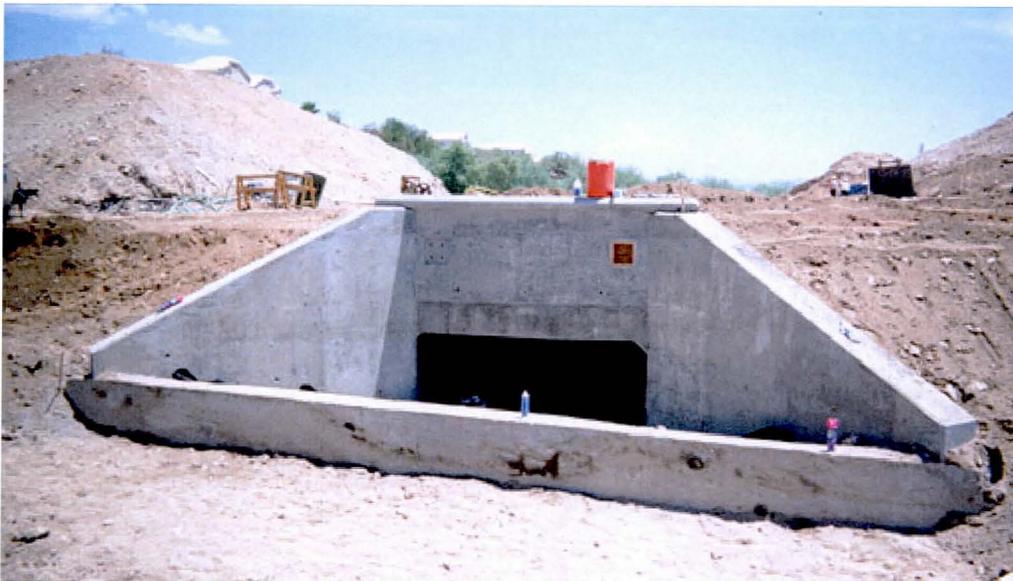
- Date: August 2000
- Location: auxiliary outlet works
- Description: inlet structure

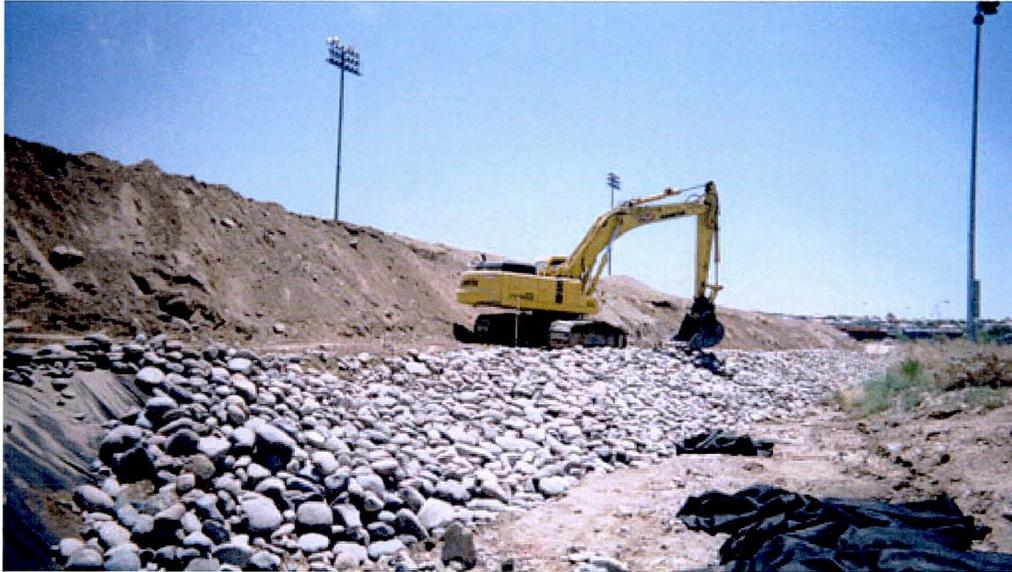
- Date: August 2000
- Location: upstream dam embankment
- Description: placing riprap
