**Golden Eagle
Park Dam
Construction
Photos**

DISK 10

JUNE 2000

Golden Eagle Park Dam Construction of Improvements in 2000

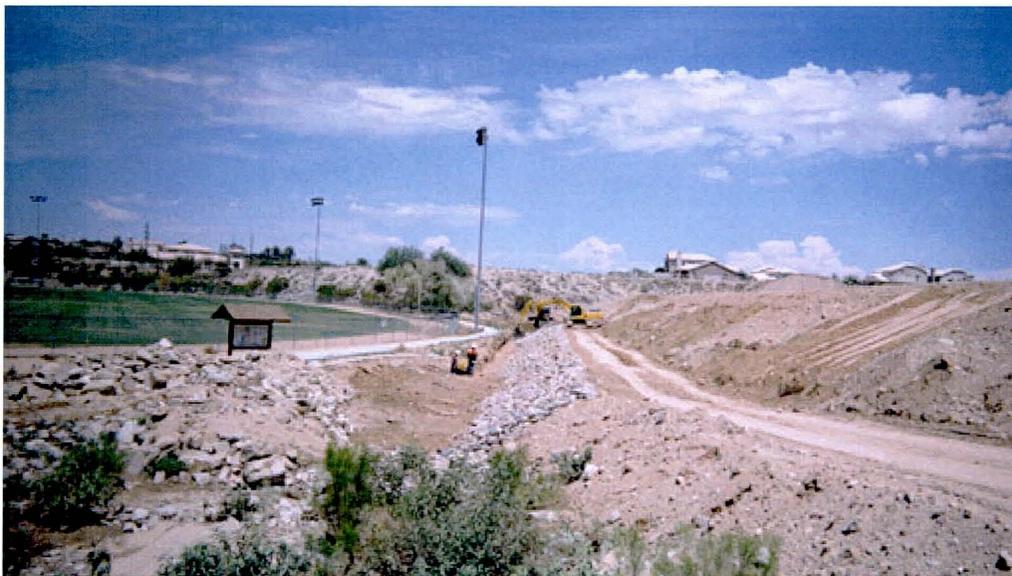
- Date: August 2000
- Location: upstream dam embankment
- Description: placing riprap and backfilling

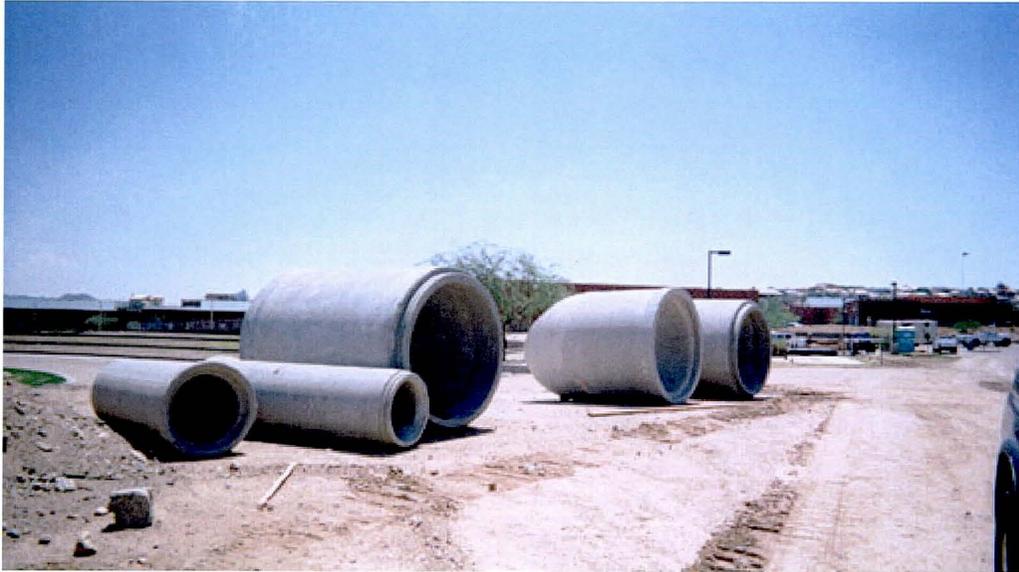
- Date: August 2000
- Location: emergency spillway
- Description: 24" and 60" concrete pipe for installation in the principal outlet works

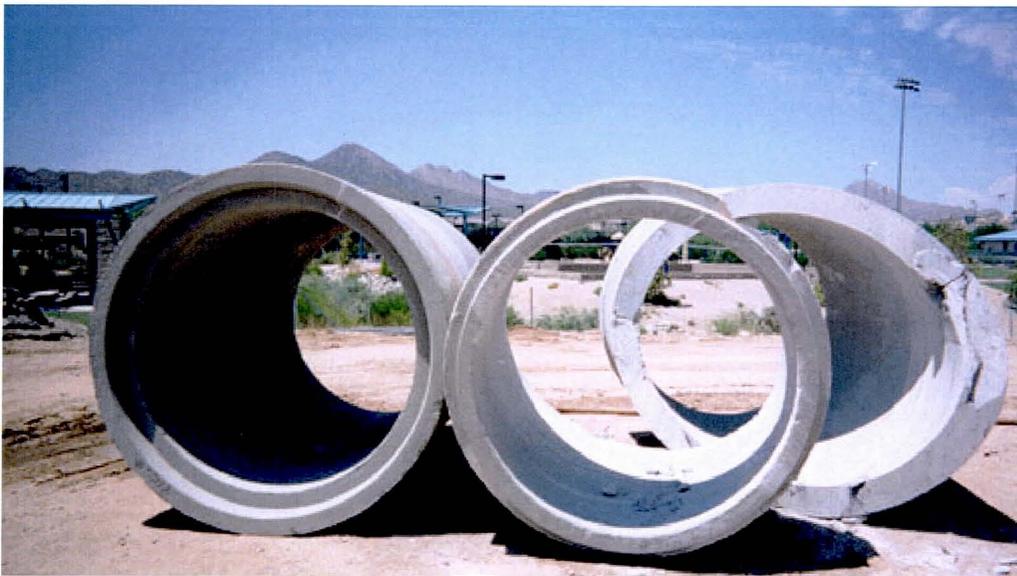
- Date: August 2000
- Location: emergency spillway
- Description: 24" and 60" concrete pipe for installation in the principal outlet works

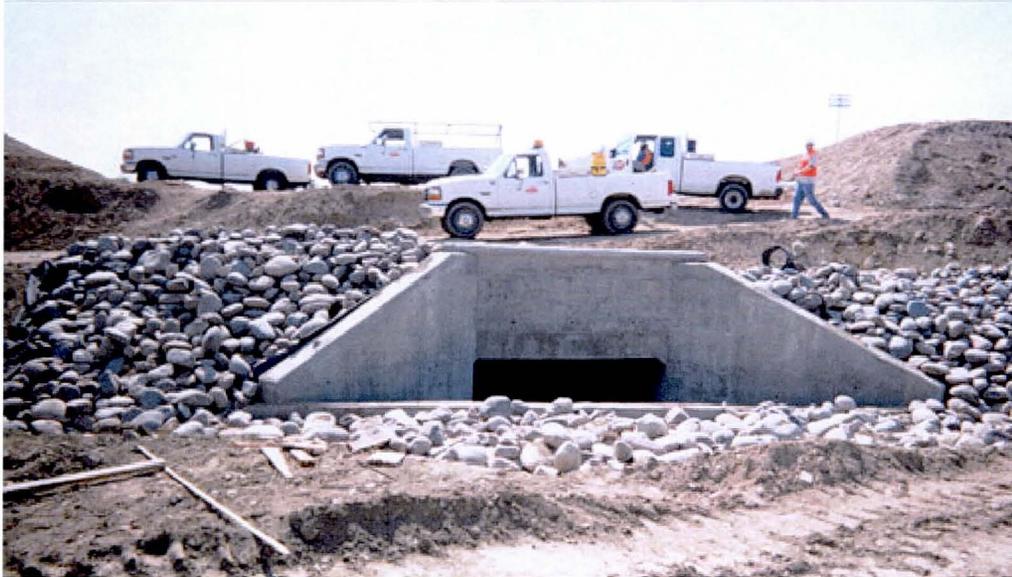
- Date: August 2000
- Location: auxiliary outlet works inlet structure
- Description: riprap placed around structure

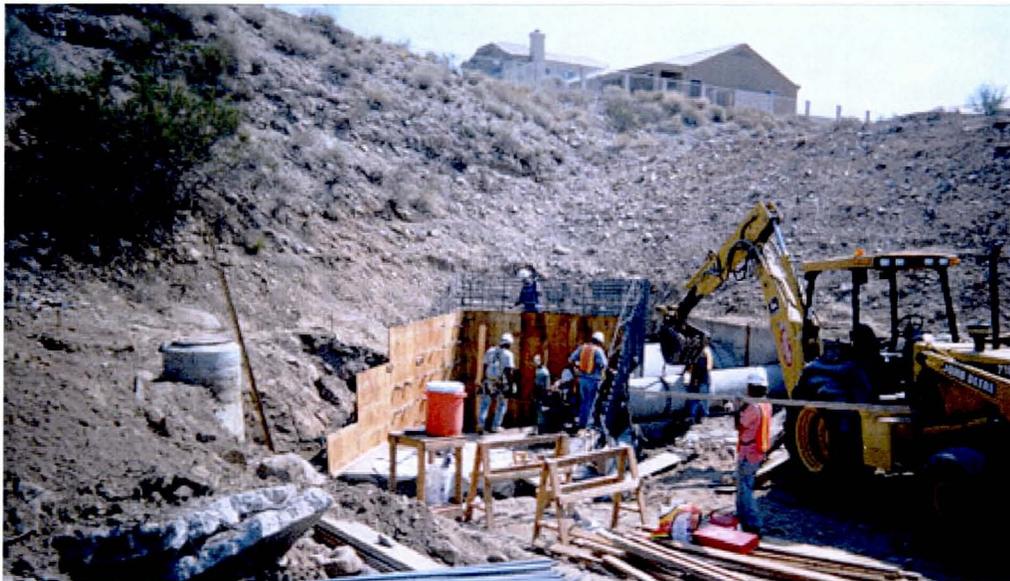
- Date: August 2000
- Location: principal outlet works inlet structure
- Description: forming for the inlet structure

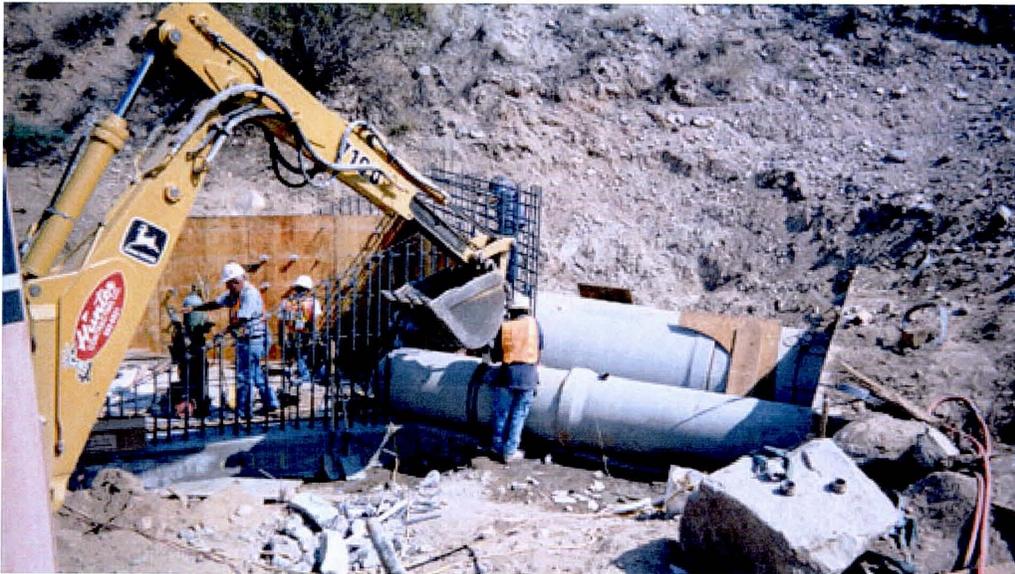
- Date: August 2000
- Location: principal outlet works
- Description: installing pipe and connection to the new structure

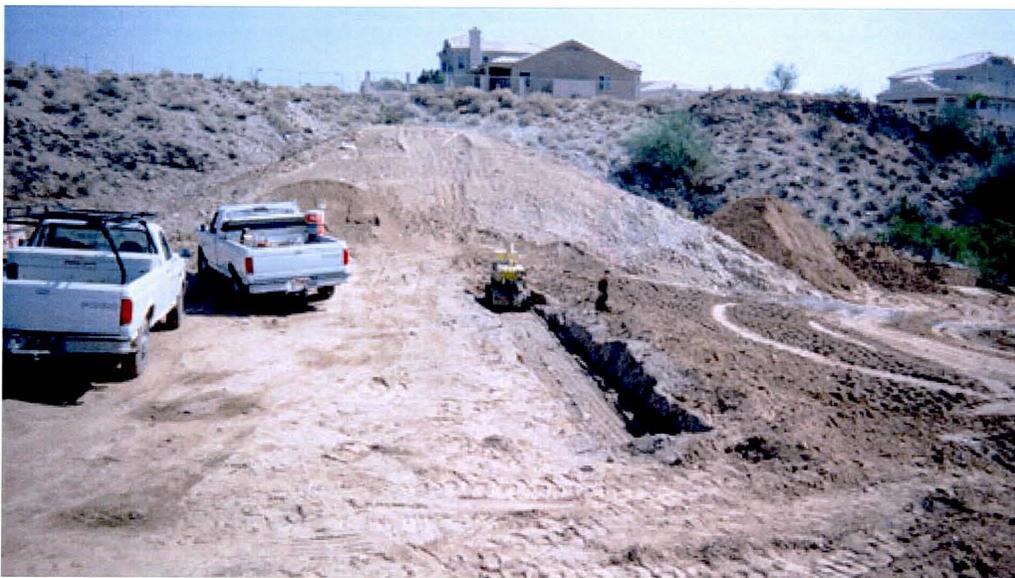
- Date: August 2000
- Location: auxiliary outlet works
- Description: backfilling over the box culvert, placing sand diaphragm in trench

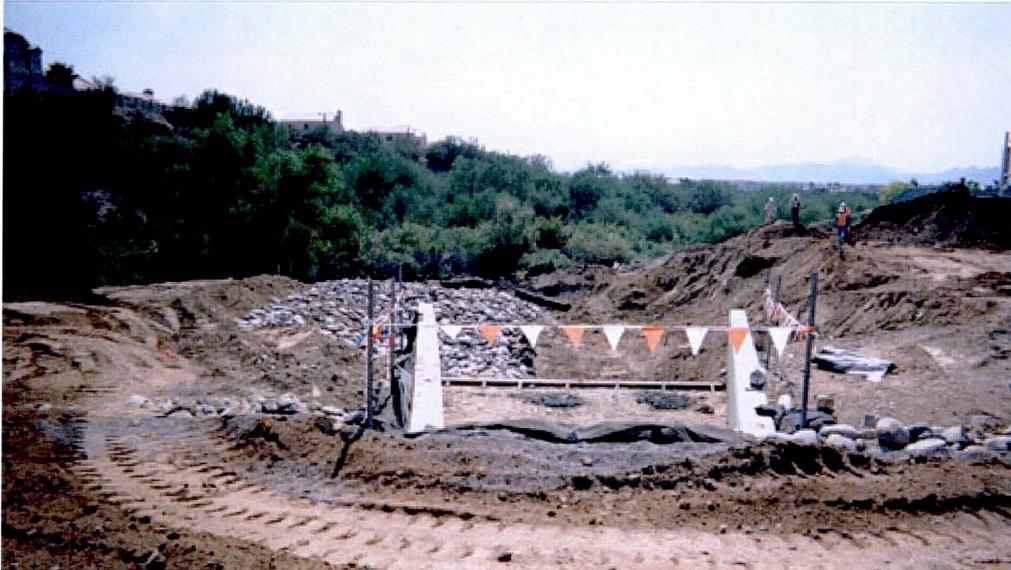
- Date: August 2000
- Location: auxiliary outlet works
- Description: outlet structure and channel partially lined with riprap

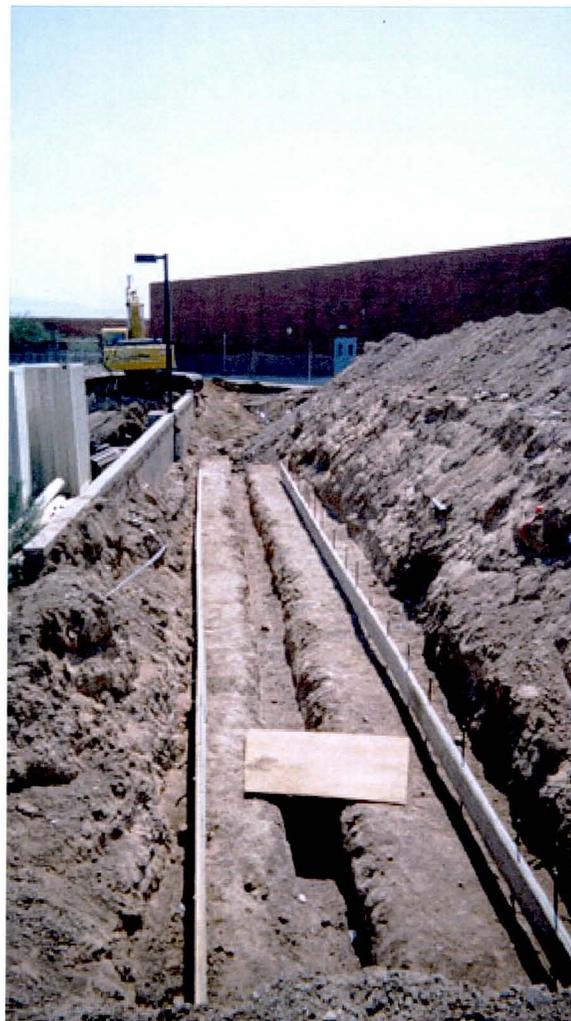
- Date: August 2000
- Location: spillway floodwall
- Description: trenching and forming for wall footing

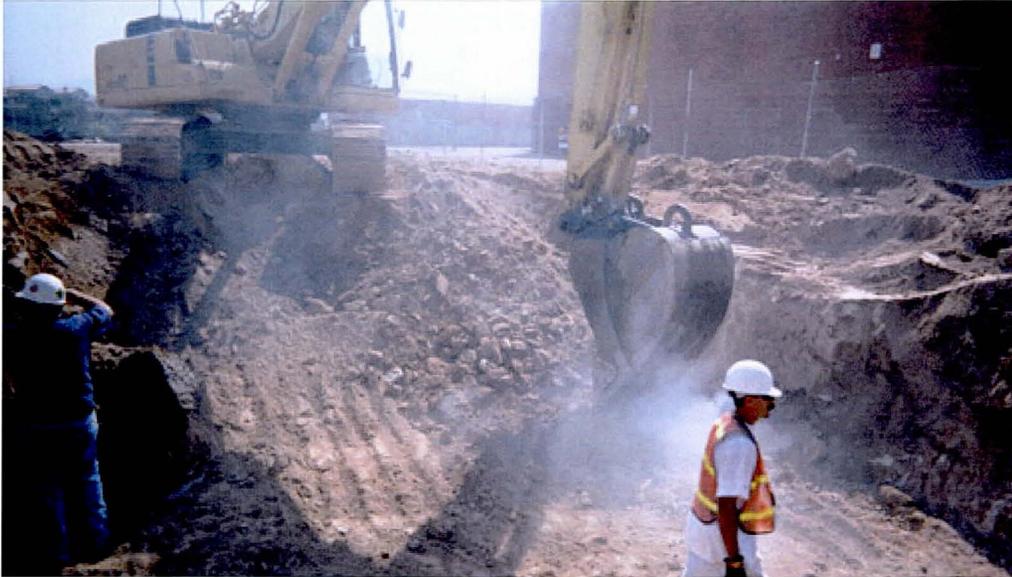
- Date: August 2000
- Location: spillway floodwall
- Description: excavation through caliche for wall footing

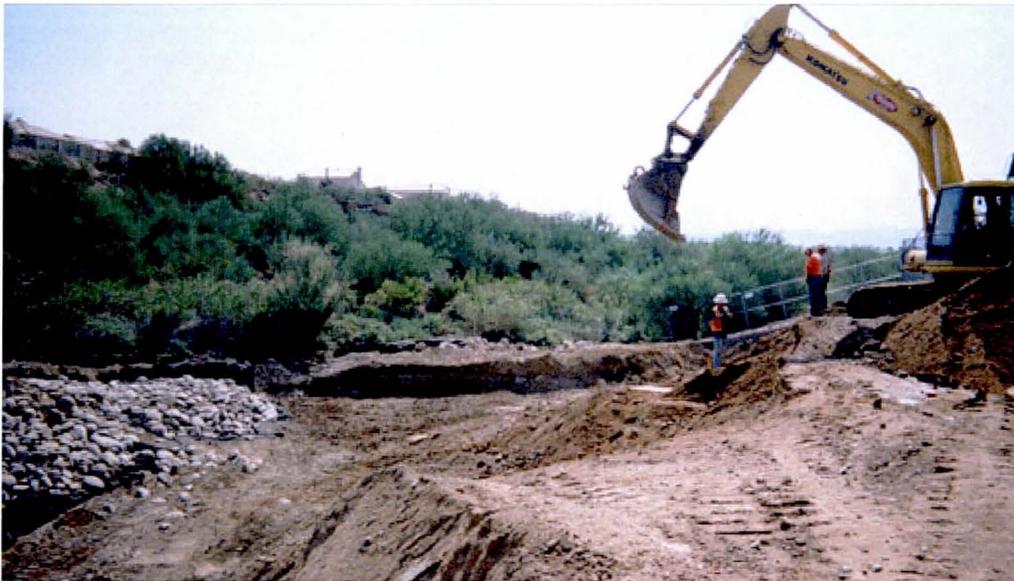
- Date: August 2000
- Location: auxiliary outlet works
- Description: excavating outlet channel and lining with riprap

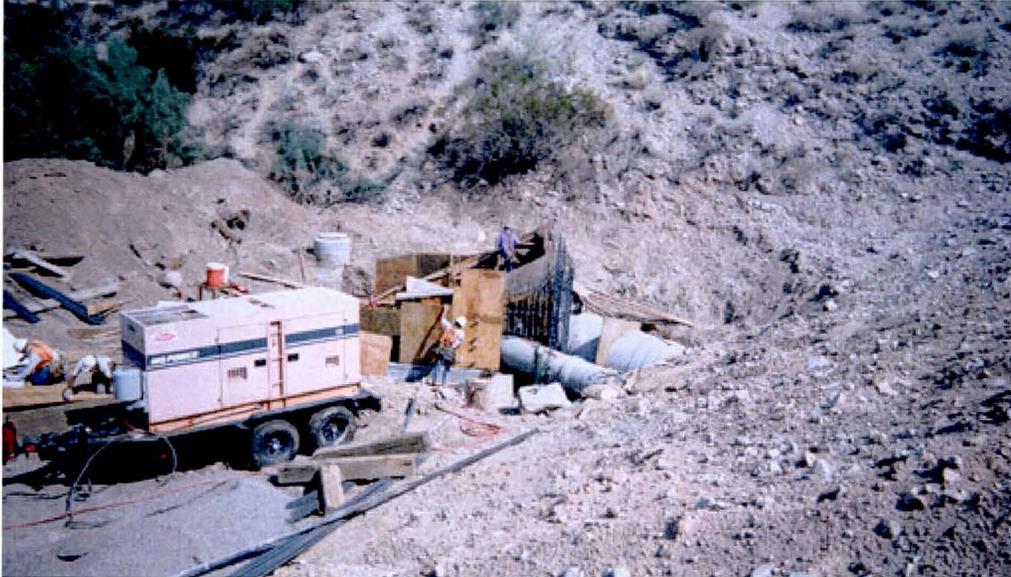
- Date: August 2000
- Location: principal outlet works
- Description: forming for inlet structure

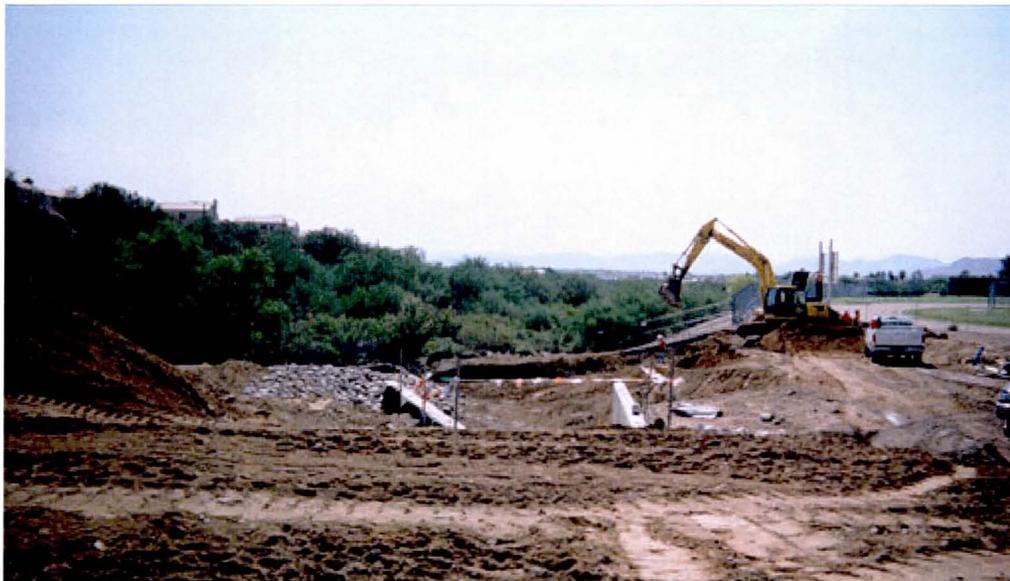
- Date: August 2000
- Location: auxiliary outlet works
- Description: excavation of outlet channel and lining with riprap

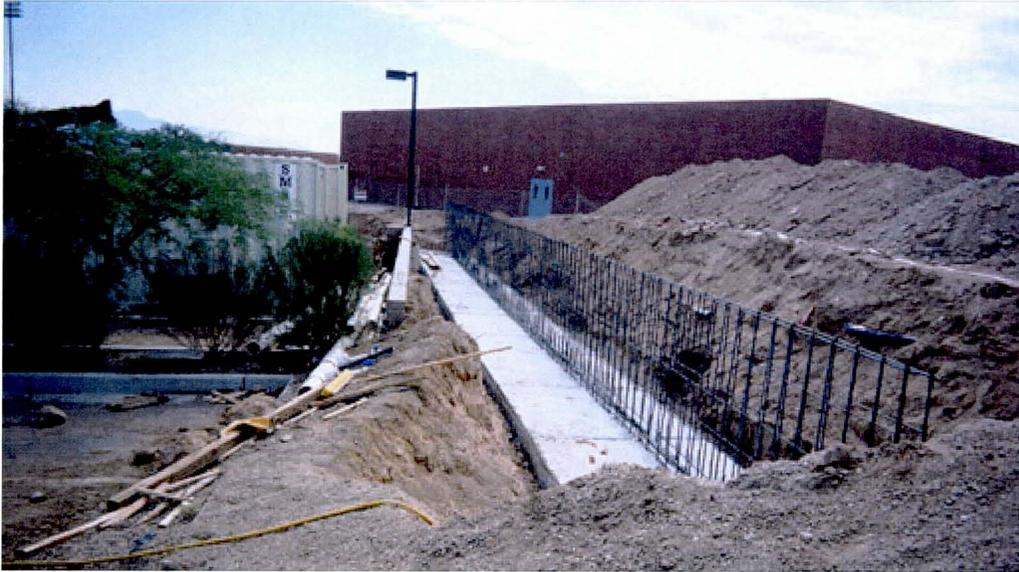
- Date: August 2000
- Location: spillway floodwall
- Description: footing and rebar for low wall

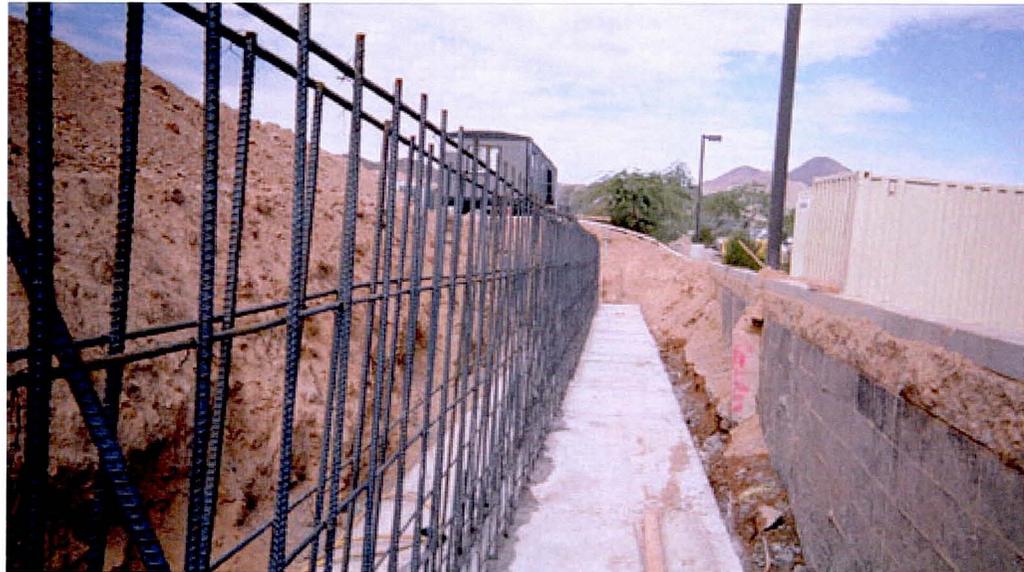
- Date: August 2000
- Location: spillway floodwall
- Description: footing and rebar for short wall

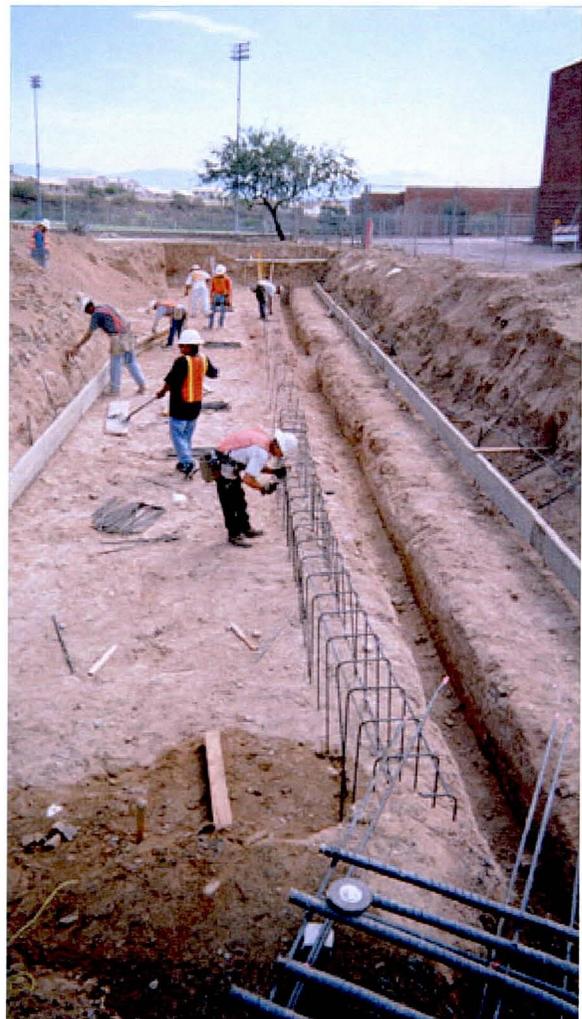
- Date: August 2000
- Location: spillway floodwall
- Description: footing and rebar for tall wall

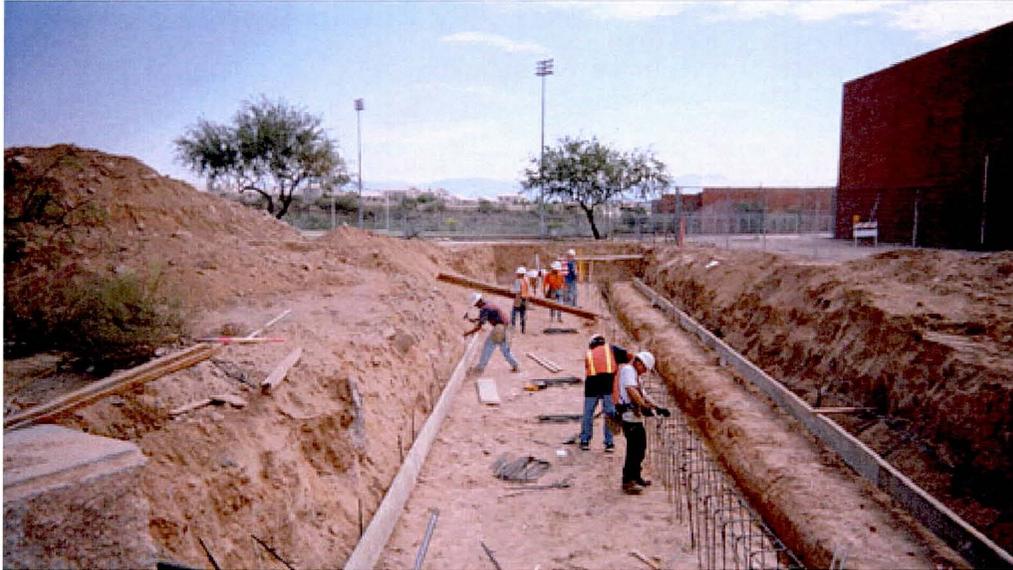
- Date: August 2000
- Location: spillway floodwall
- Description: footer and steel for tall wall

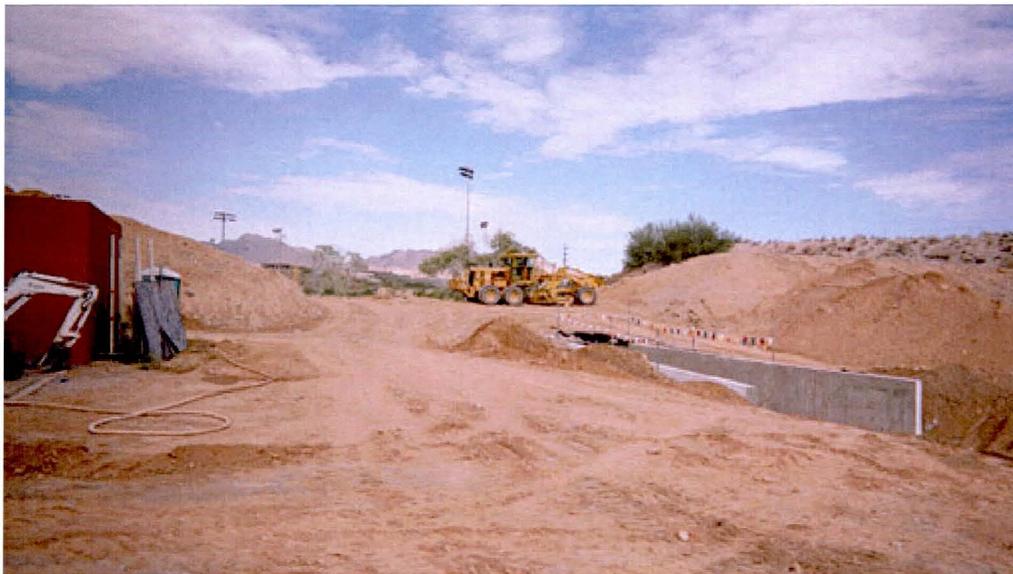
- Date: August 2000
- Location: auxiliary outlet works
- Description: outlet structure

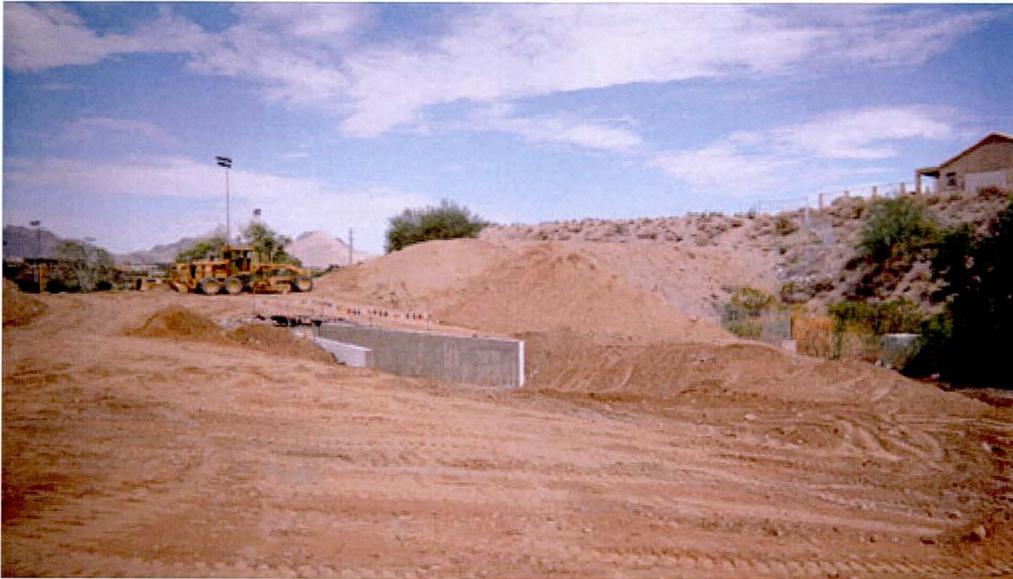
- Date: August 2000
- Location: auxiliary outlet works
- Description: outlet structure

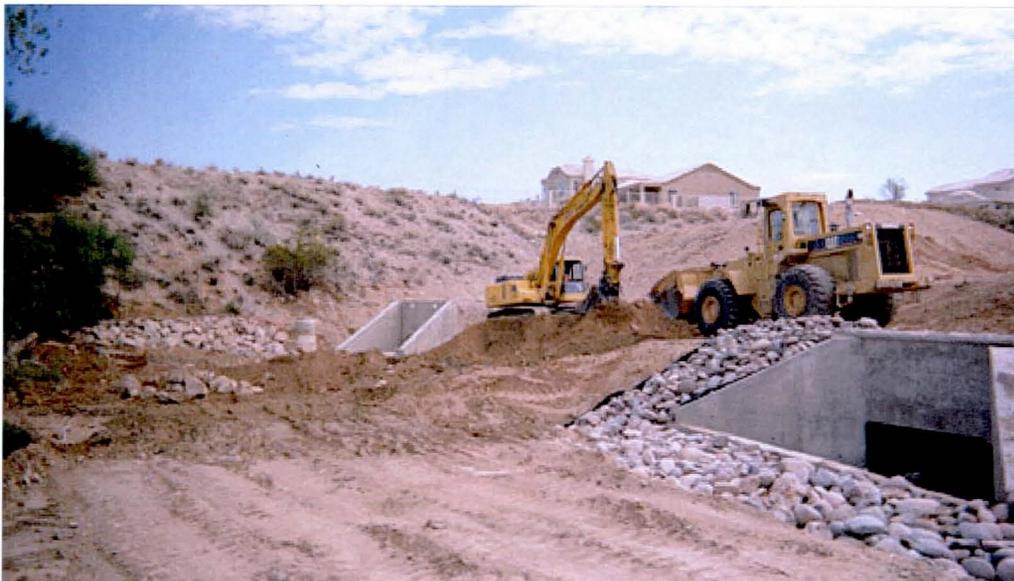
- Date: August 2000
- Location: auxiliary and principal outlet works
- Description: backfilling over auxiliary outlet works box culvert, principal inlet structure forms stripped

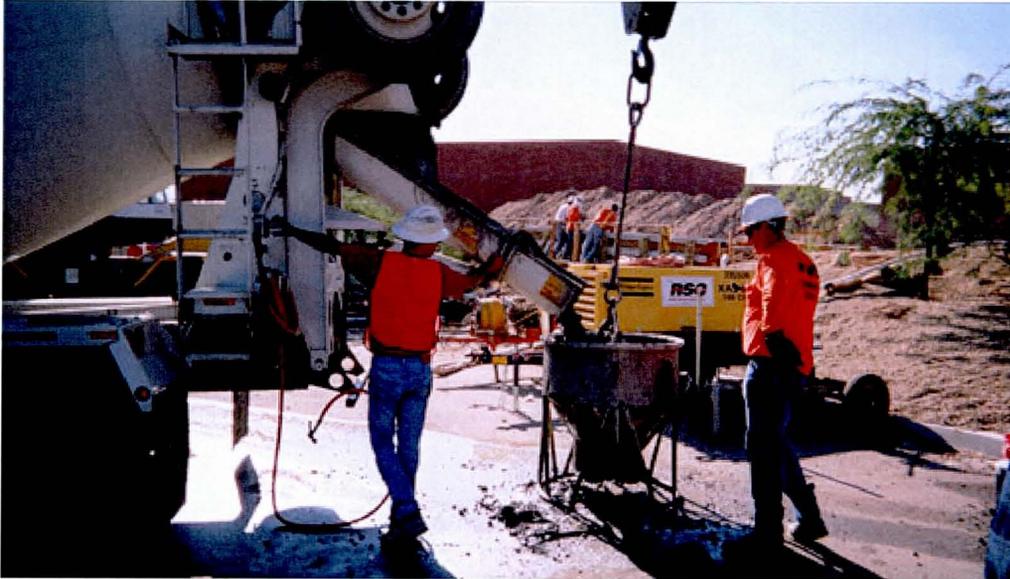
- Date: August 2000
- Location: spillway floodwall
- Description: pouring concrete using crane and bucket

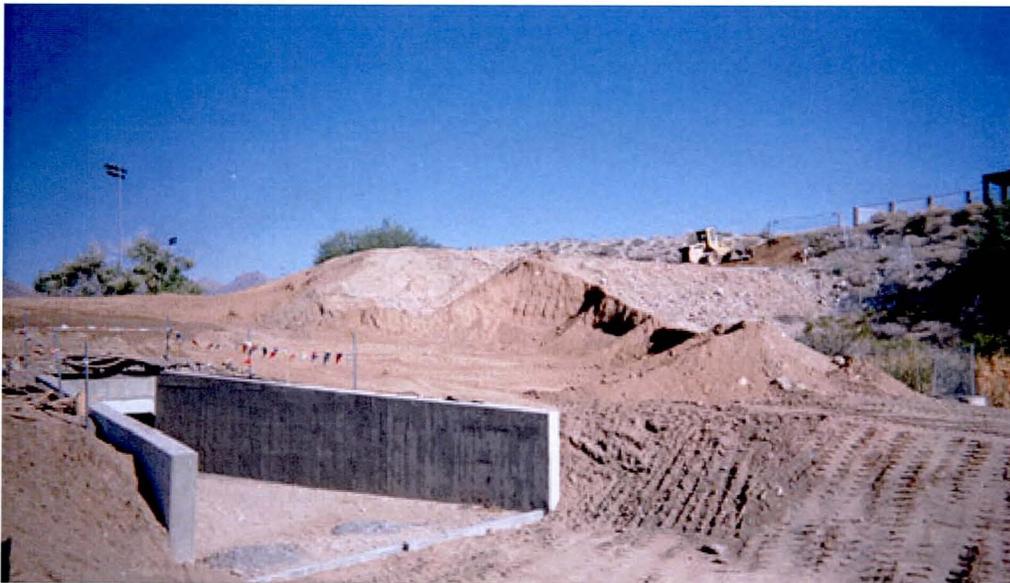
- Date: August 2000
- Location: auxiliary outlet works
- Description: outlet structure and channel

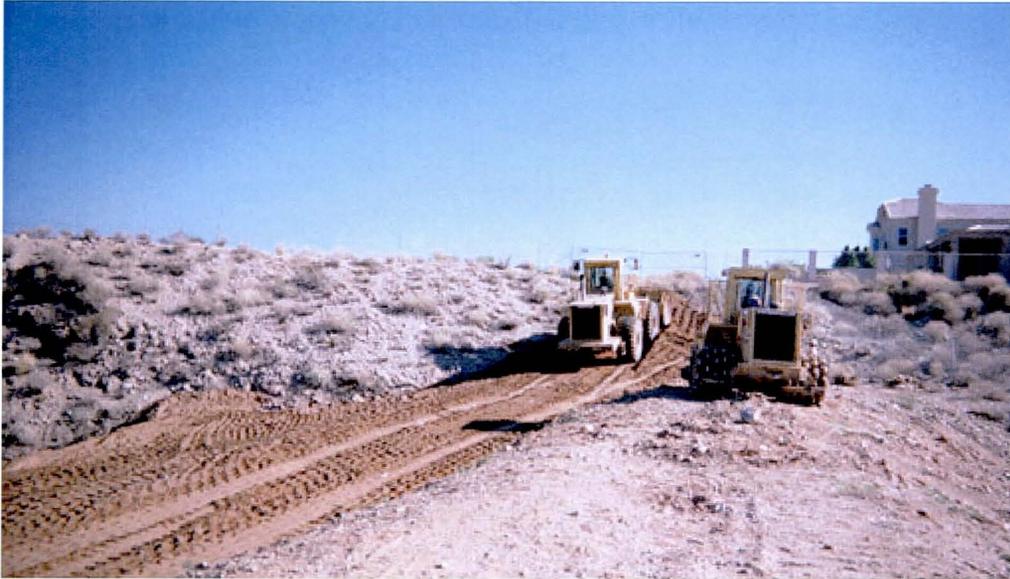
- Date: August 2000
- Location: left abutment of dam
- Description: grading haul road up the abutment to the church property

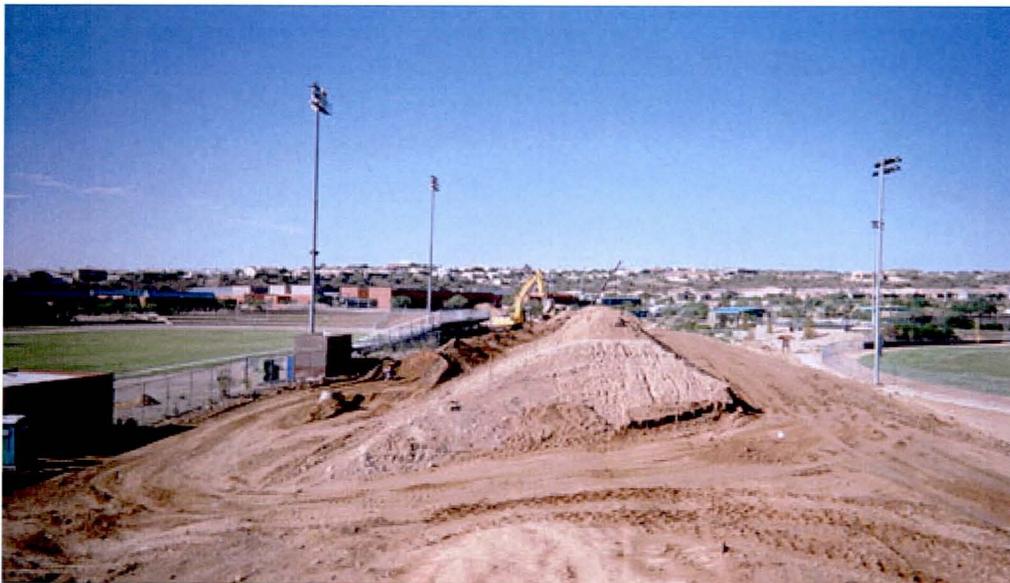
- Date: August 2000
- Location: left abutment looking south
- Description: auxiliary outlet works trench backfilled and upstream embankment being raised

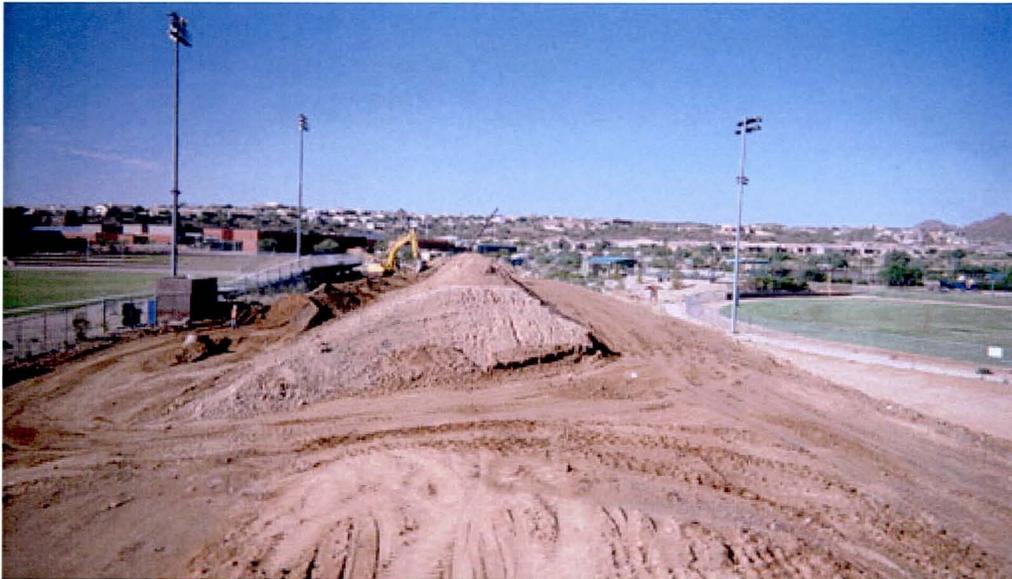
- Date: August 2000
- Location: left abutment looking south
- Description: auxiliary outlet works trench backfilled and upstream embankment being raised

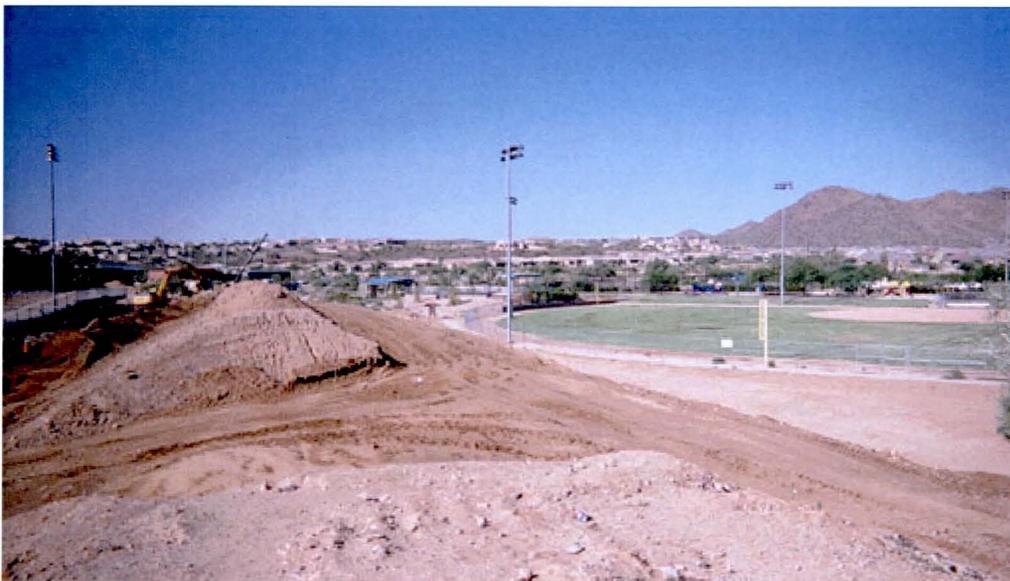
- Date: August 2000
- Location: left abutment looking south
- Description: auxiliary outlet works trench backfilled and upstream embankment being raised

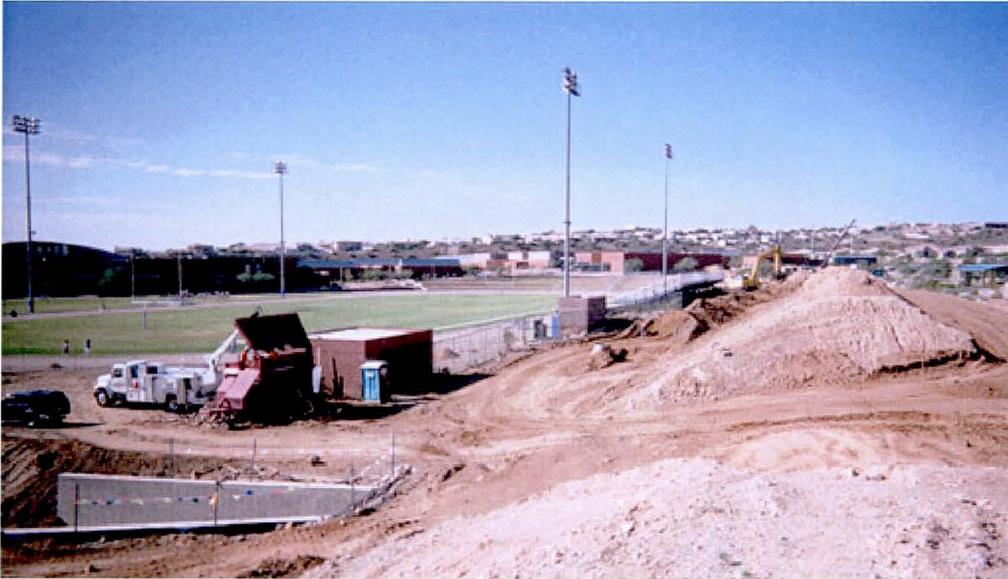
- Date: August 2000
- Location: left abutment looking south
- Description: auxiliary outlet works trench backfilled and upstream embankment being raised

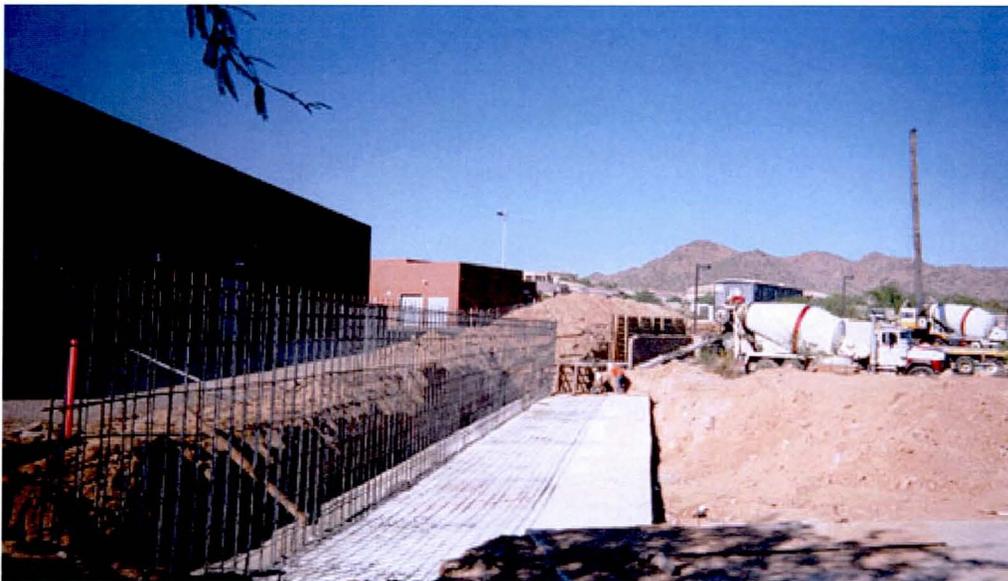
- Date: August 2000
- Location: spillway floodwall looking south
- Description: footing and rebar for tall floodwall

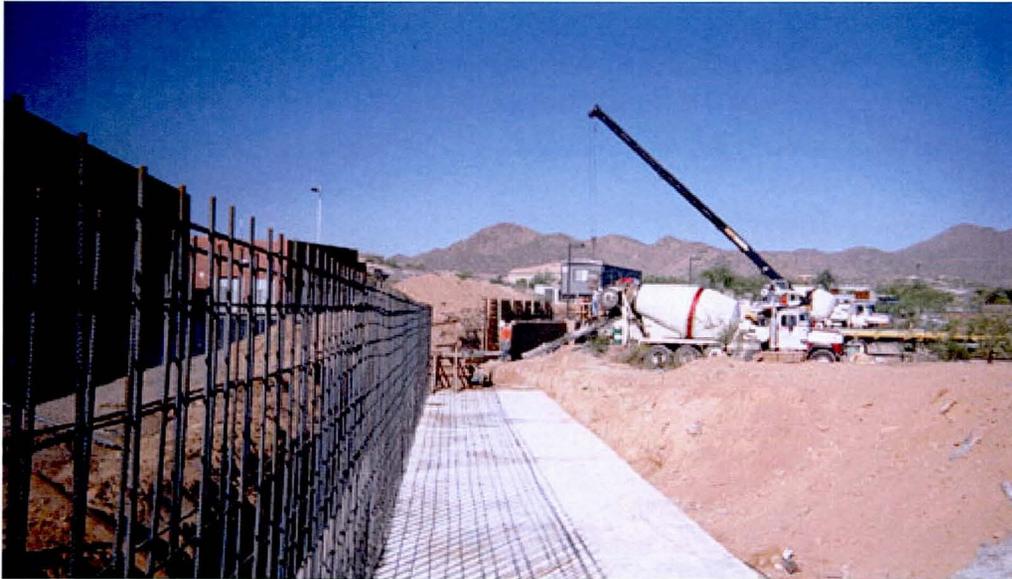
- Date: August 2000
- Location: spillway floodwall looking south
- Description: footing and rebar for tall floodwall, pouring concrete stem for short wall in the distance

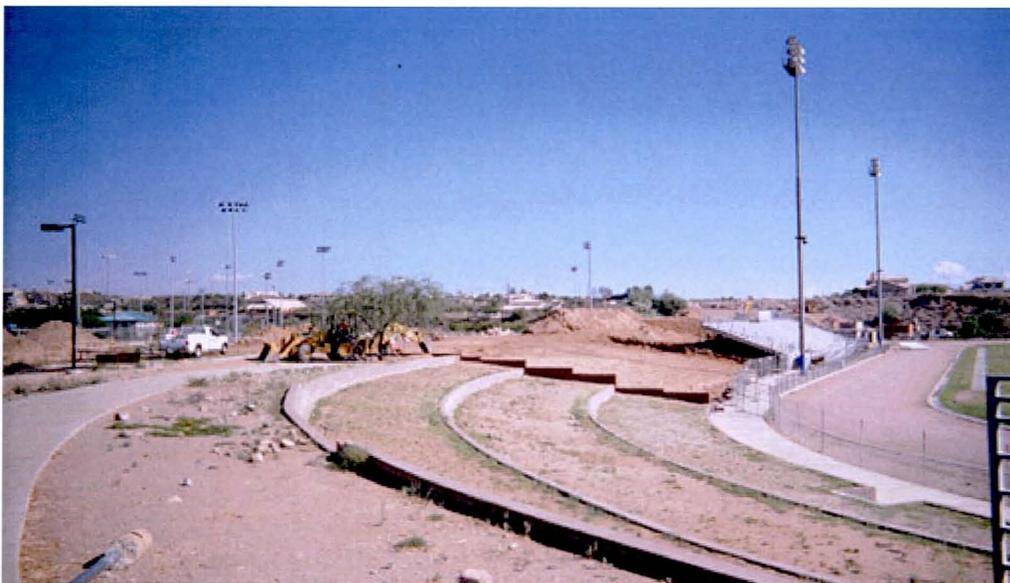
- Date: August 2000
- Location: emergency spillway looking north
- Description: excavating to subgrade for gabions

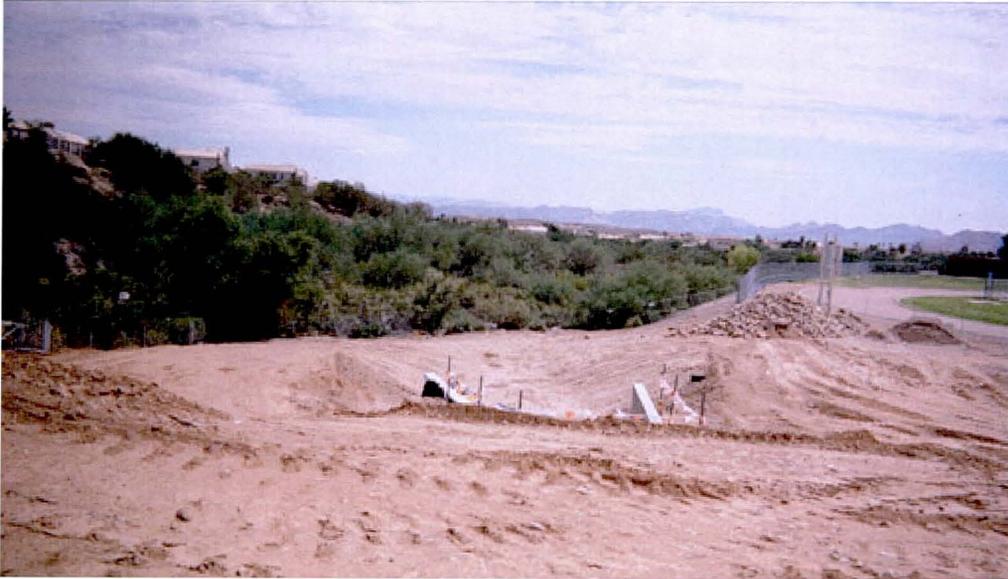
- Date: August 2000
- Location: auxiliary outlet works
- Description: outlet structure and channel looking east

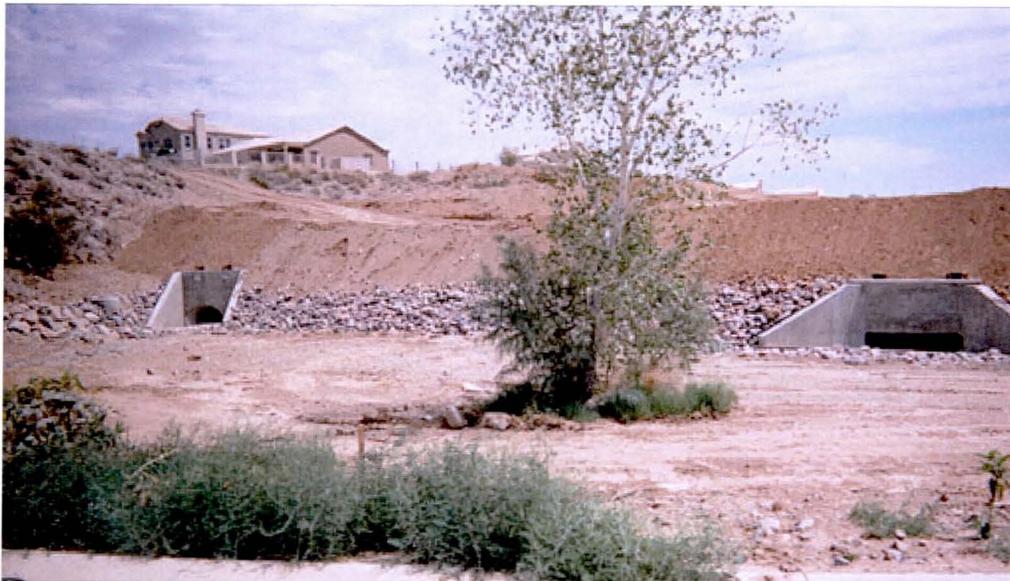
- Date: August 2000
- Location: upstream side of dam looking east toward outlet works
- Description: inlet structures completed, riprap placed and embankment is being raised

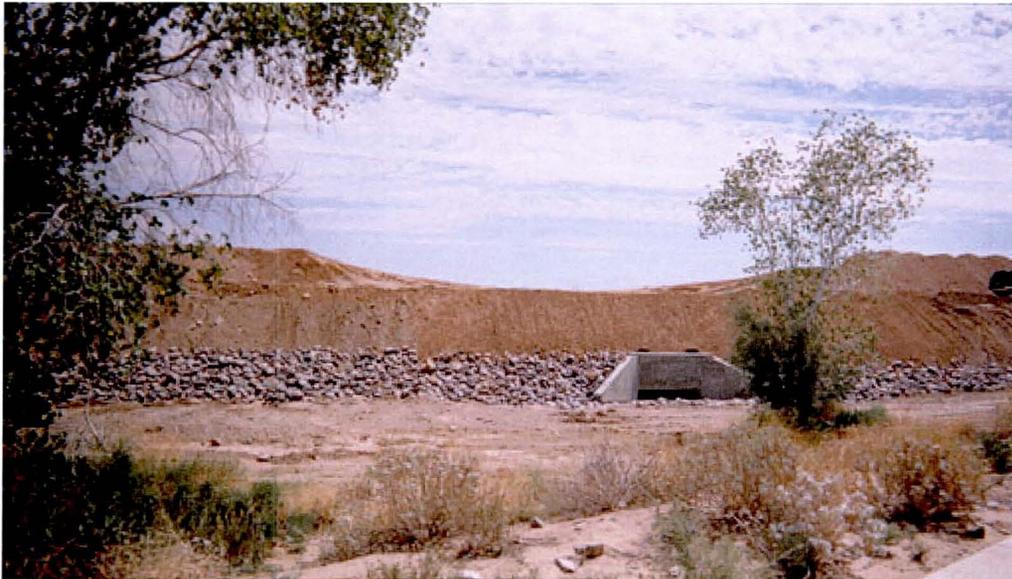
- Date: August 2000
- Location: upstream side of dam looking east toward outlet works
- Description: inlet structures completed, riprap placed and embankment is being raised

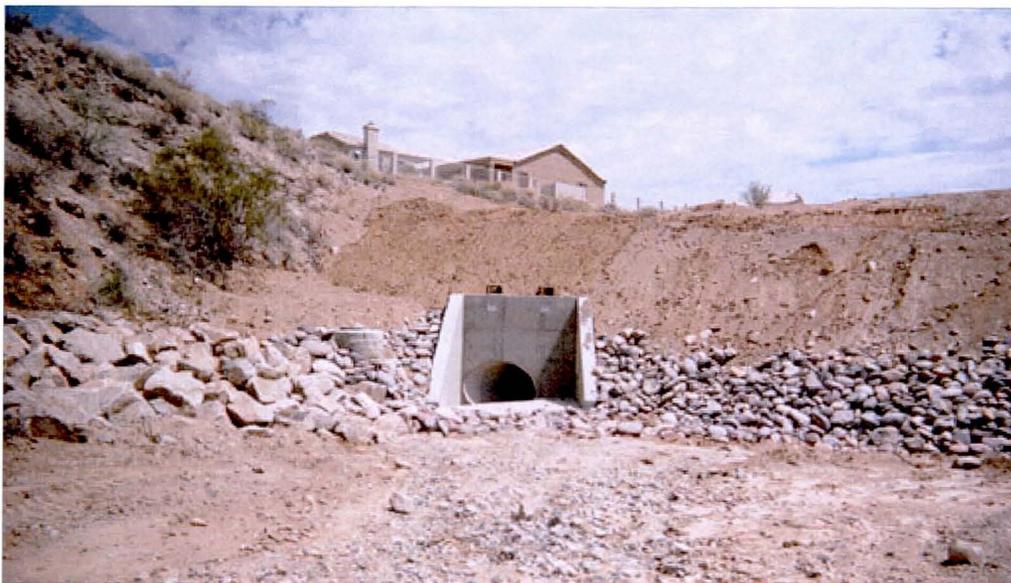
- Date: August 2000
- Location: upstream side of dam looking east toward outlet works
- Description: inlet structures completed, riprap placed and embankment is being raised

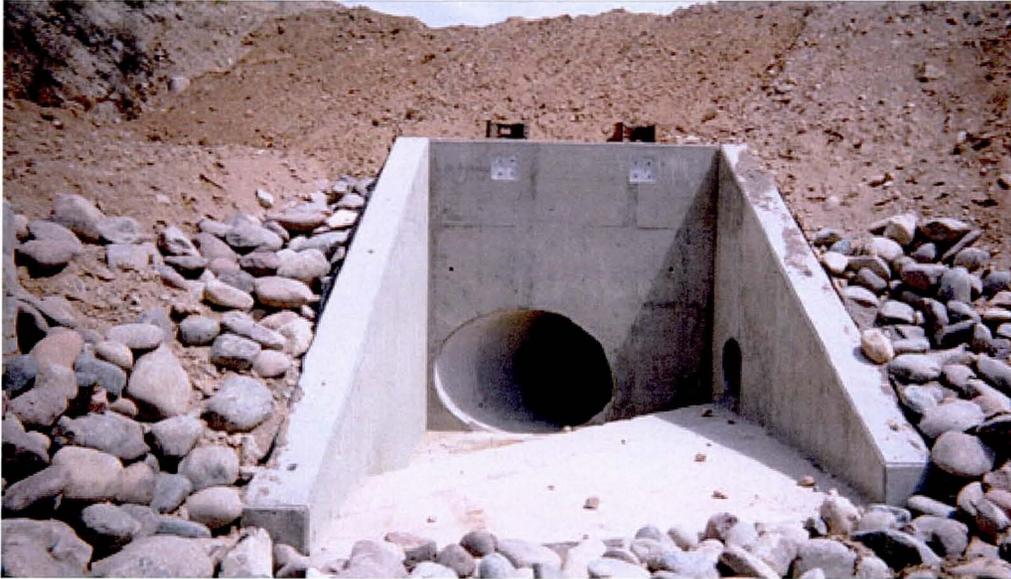
- Date: August 2000
- Location: principal outlet works
- Description: inlet structures completed, riprap placed and embankment is being raised

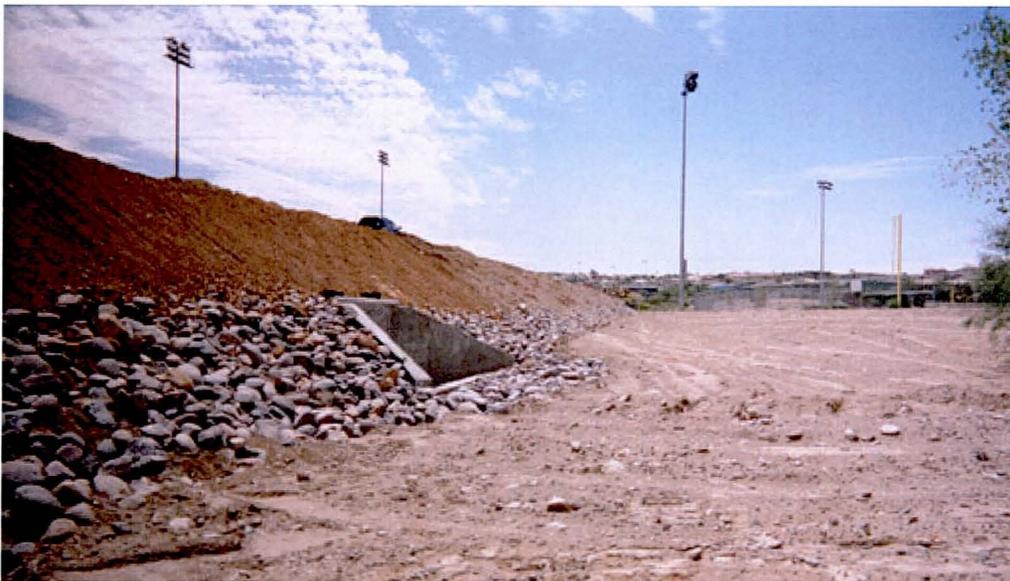
- Date: August 2000
- Location: upstream side of dam looking south along toe of embankment
- Description: inlet structures completed, riprap placed and embankment is being raised

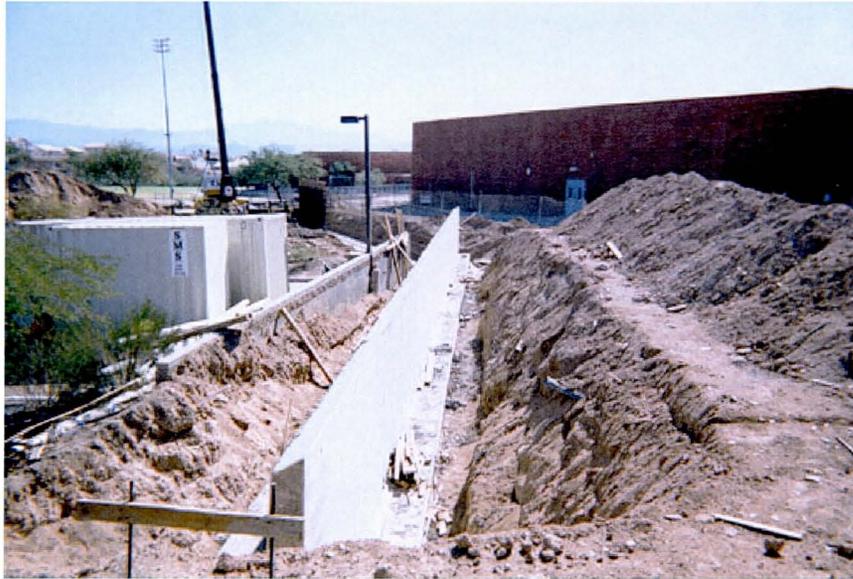
- Date: September 2000
- Location: right end of spillway
- Description: south end of floodwall
