**Golden Eagle
Park Dam
Construction
Photos**

DISK 10

JUNE 2000

Golden Eagle Park Dam Construction of Improvements in 2000

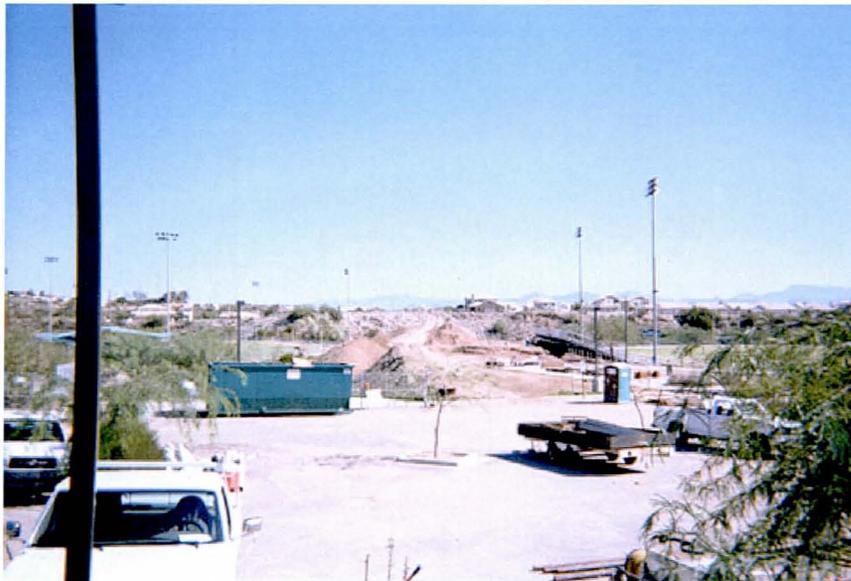
- Date: September 2000
- Location: southwest of spillway
- Description: staging area and dam embankment in background

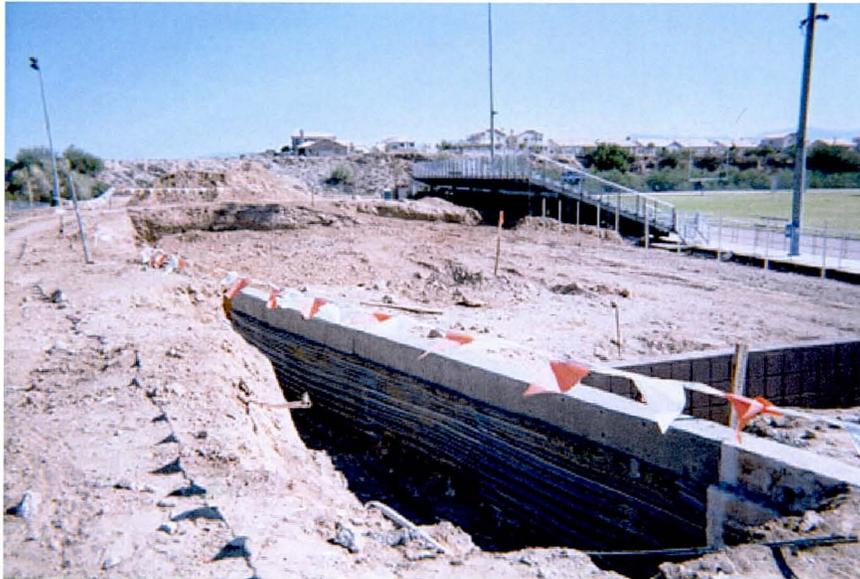
- Date: September 2000
- Location: emergency spillway
- Description: excavation for gabions, spillway cutoff wall

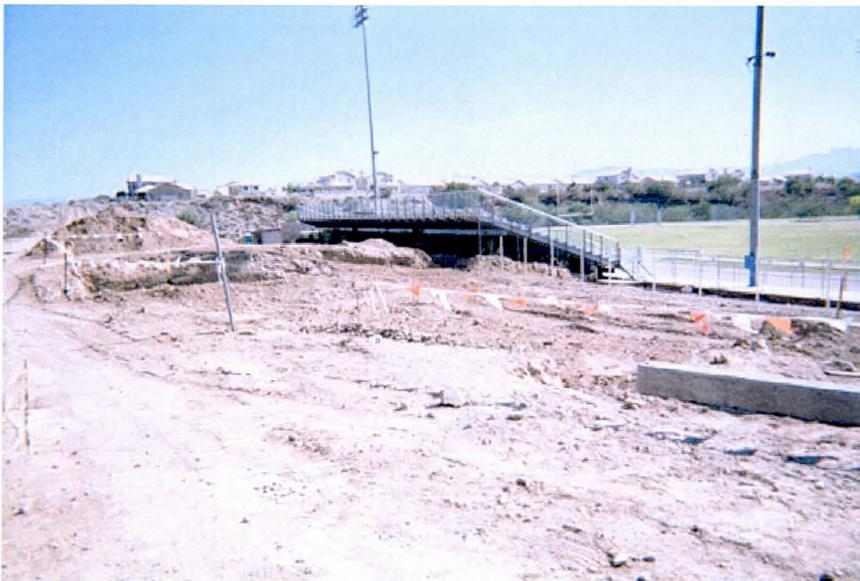
- Date: September 2000
- Location: emergency spillway
- Description: excavation for gabions, spillway cutoff wall

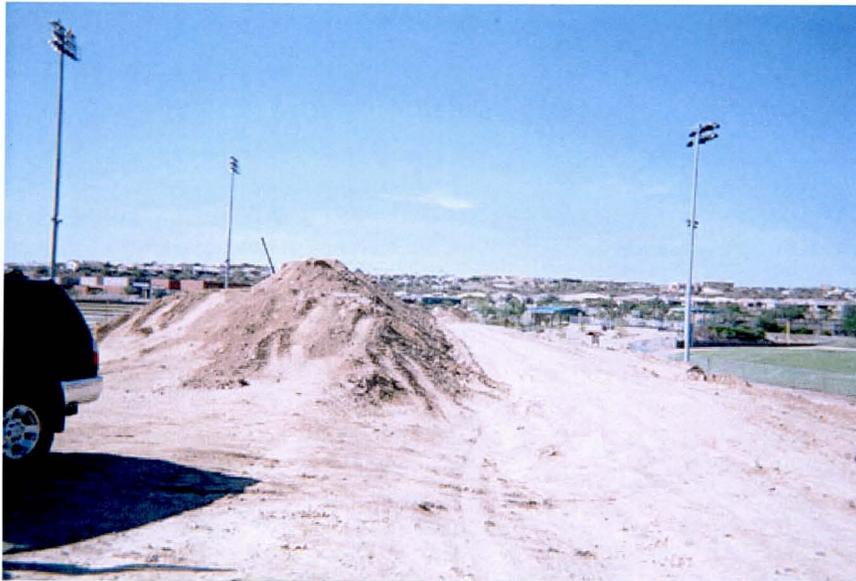
- Date: September 2000
- Location: north end of dam looking south
- Description: dam embankment partially raised

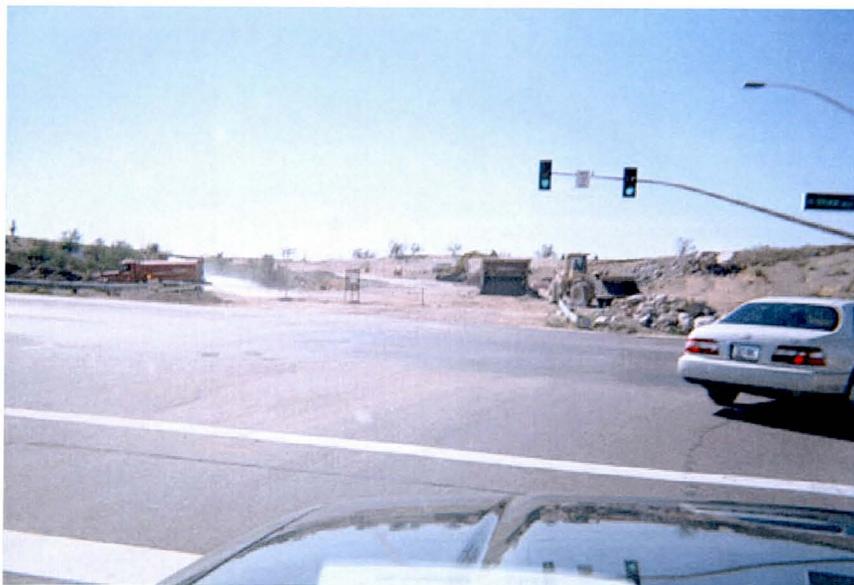
- Date: September 2000
- Location: intersection of Palisades and Shea Blvd
- Description: excavating and screening proposed borrow material for impervious fill

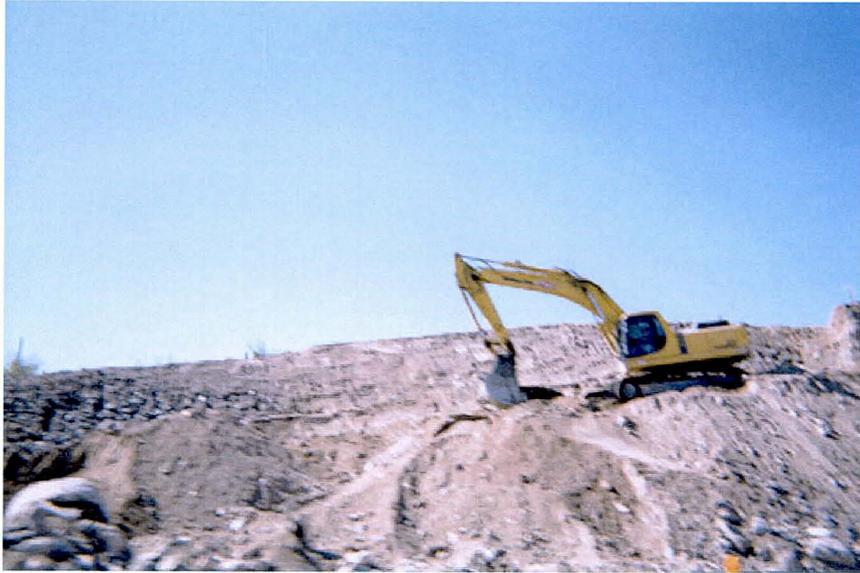
- Date: September 2000
- Location: intersection of Palisades and Shea Blvd
- Description: excavating proposed borrow material for impervious fill

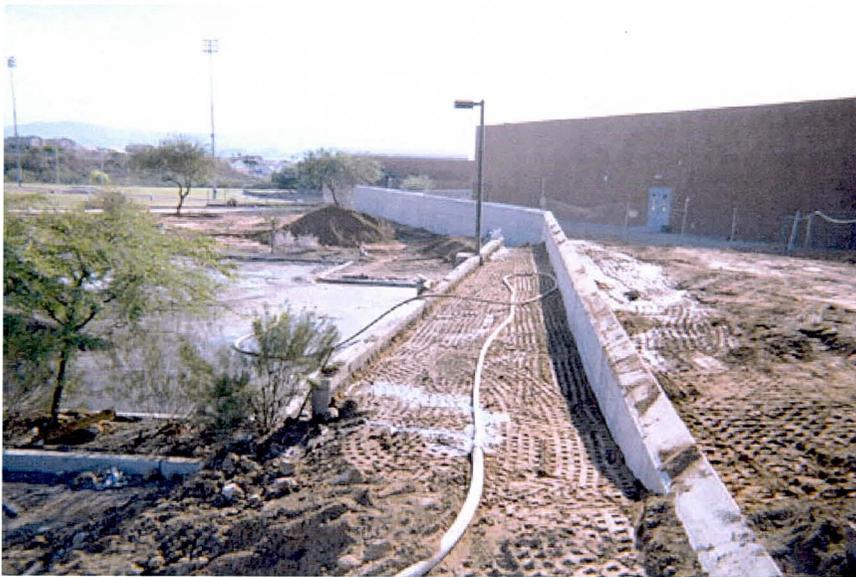
- Date: September 2000
- Location: south end of spillway
- Description: spillway floodwall completed and partially backfilled

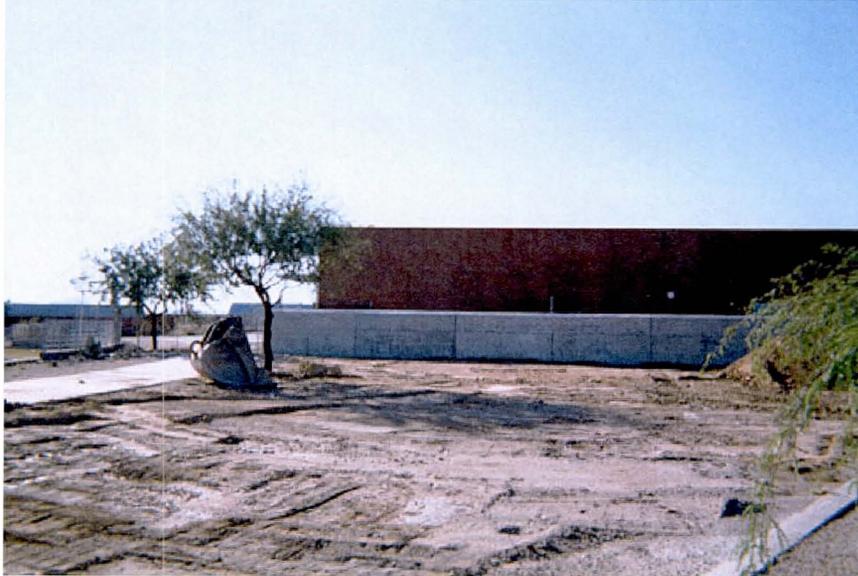
- Date: September 2000
- Location: emergency spillway, looking east
- Description: spillway floodwall completed and partially backfilled

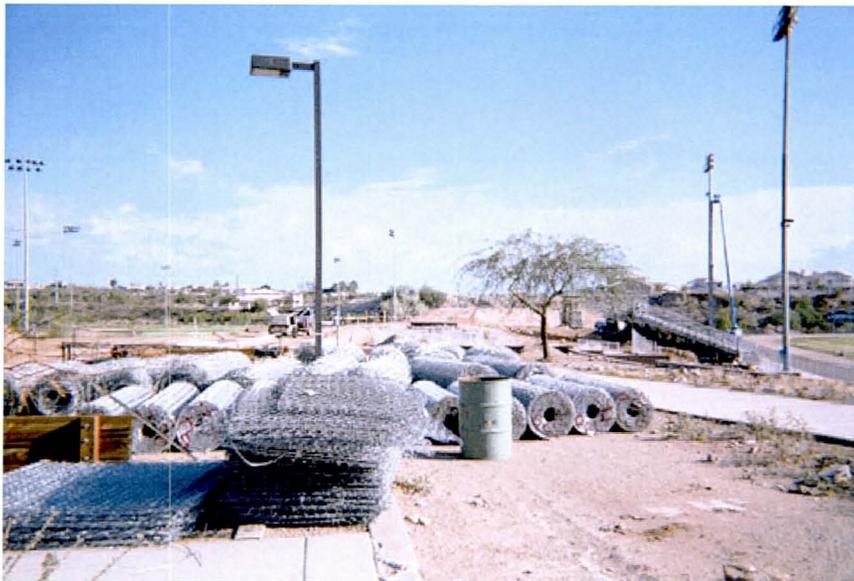
- Date: September 2000
- Location: emergency spillway, looking north
- Description: gabions delivered to site

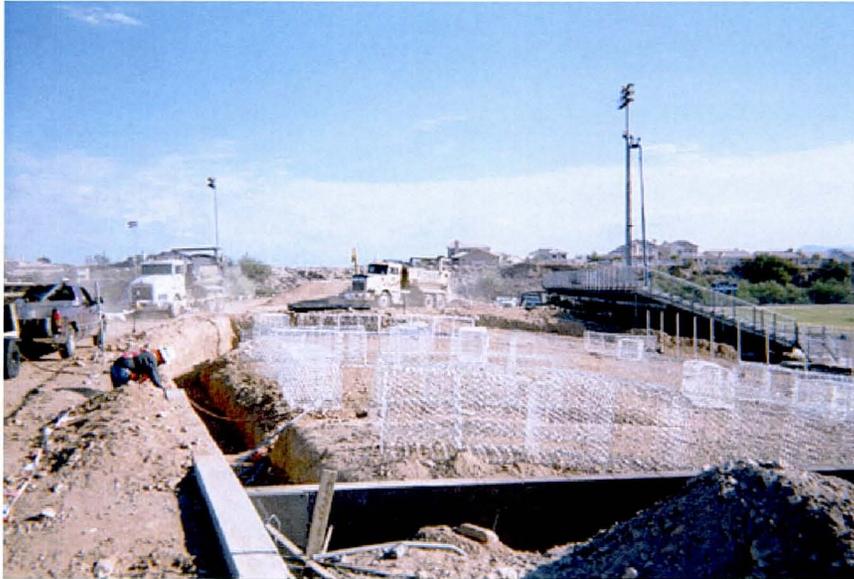
- Date: September 2000
- Location: emergency spillway looking north
- Description: work beginning on gabions

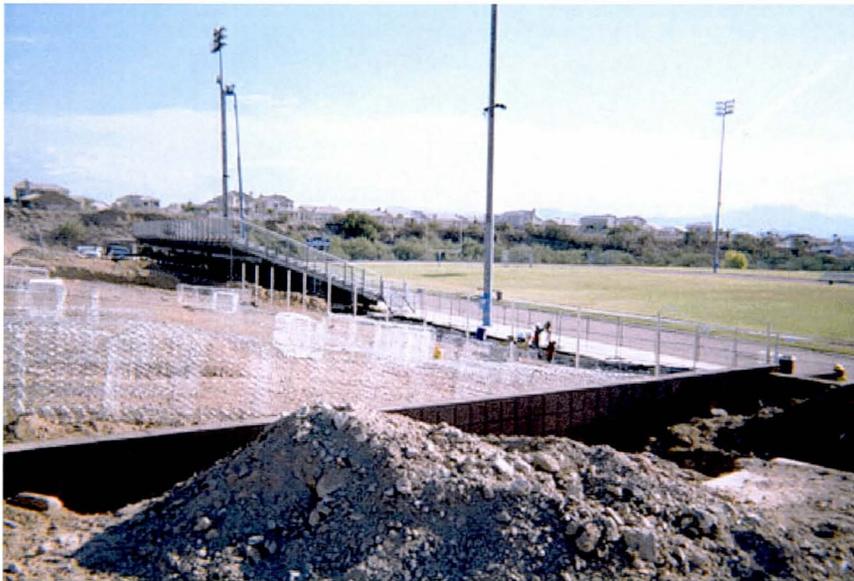
- Date: September 2000
- Location: emergency spillway looking northeast
- Description: work beginning on gabions

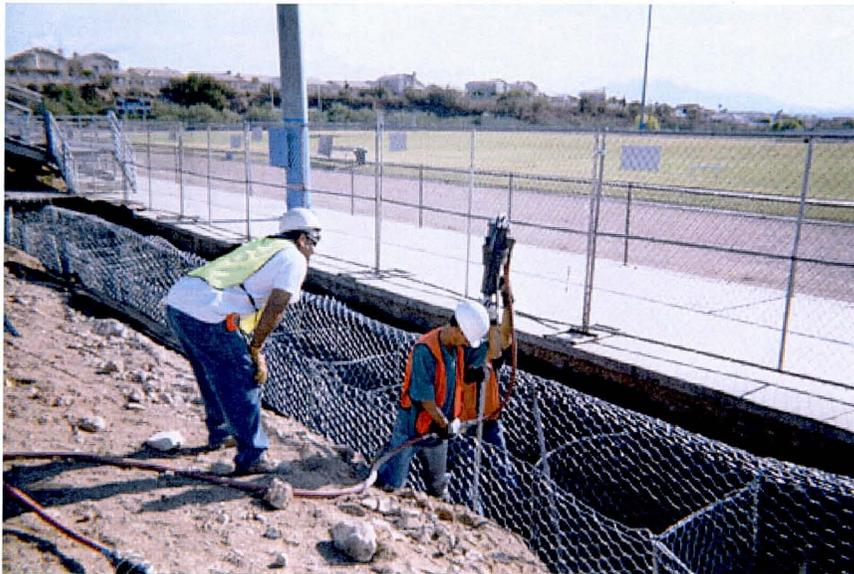
- Date: September 2000
- Location: toe of emergency spillway
- Description: installing gabions and anchor posts

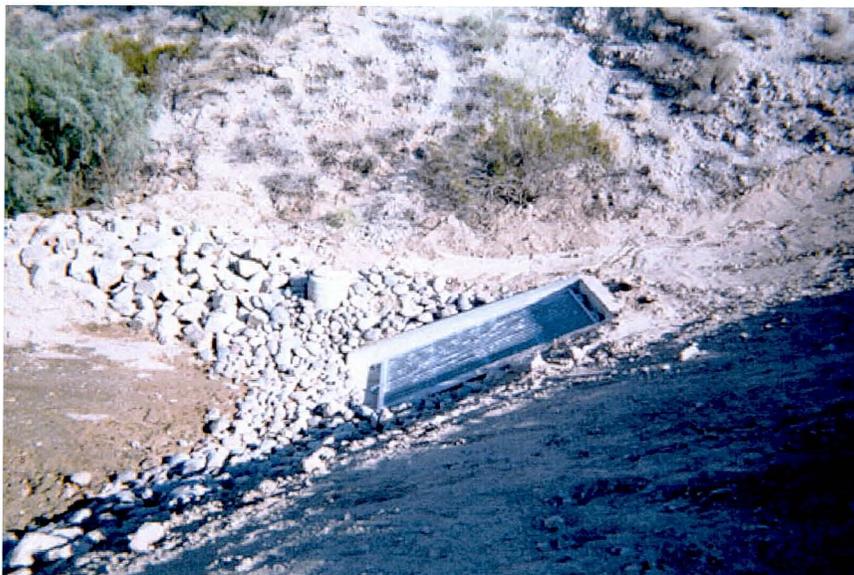
- Date: September 2000
- Location: north end of dam
- Description: principal outlet works inlet structure

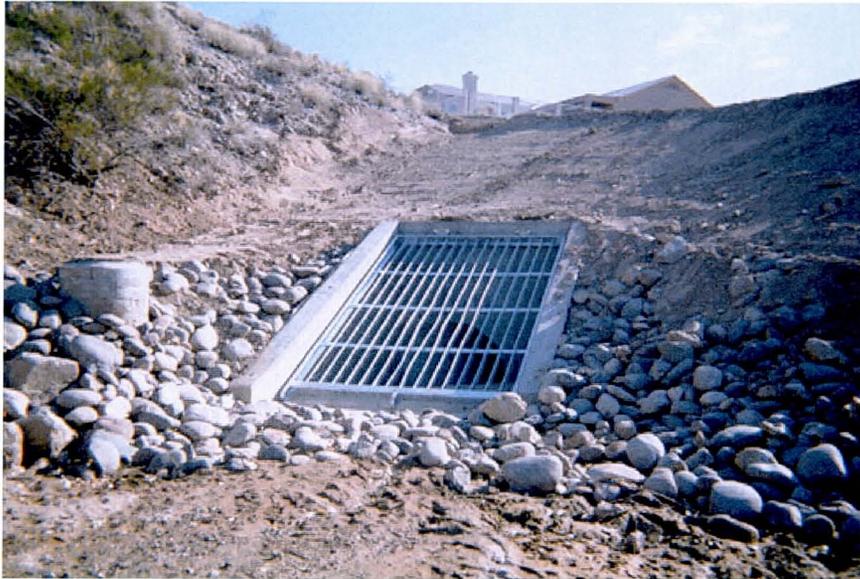
- Date: October 2000
- Location: north end of dam
- Description: principal outlet works inlet structure

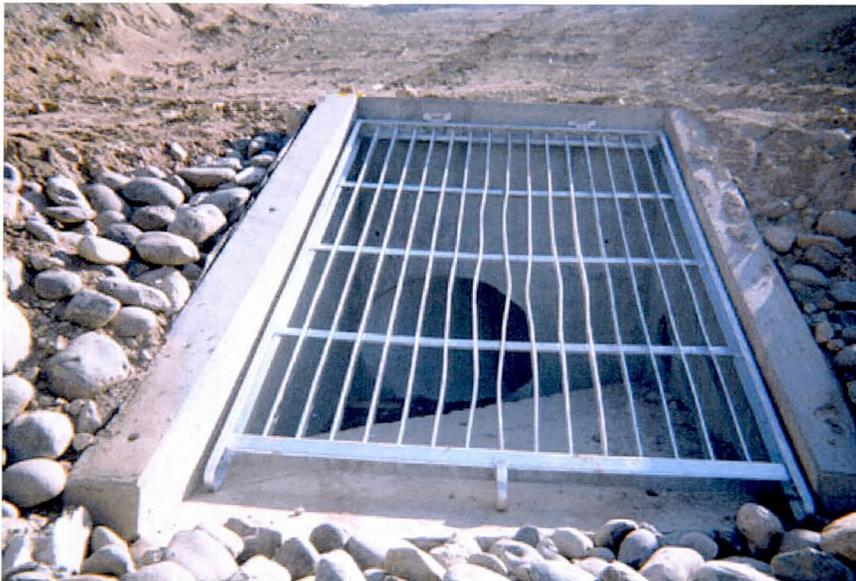
- Date: October 2000
- Location: north end of dam
- Description: principal outlet works inlet structure

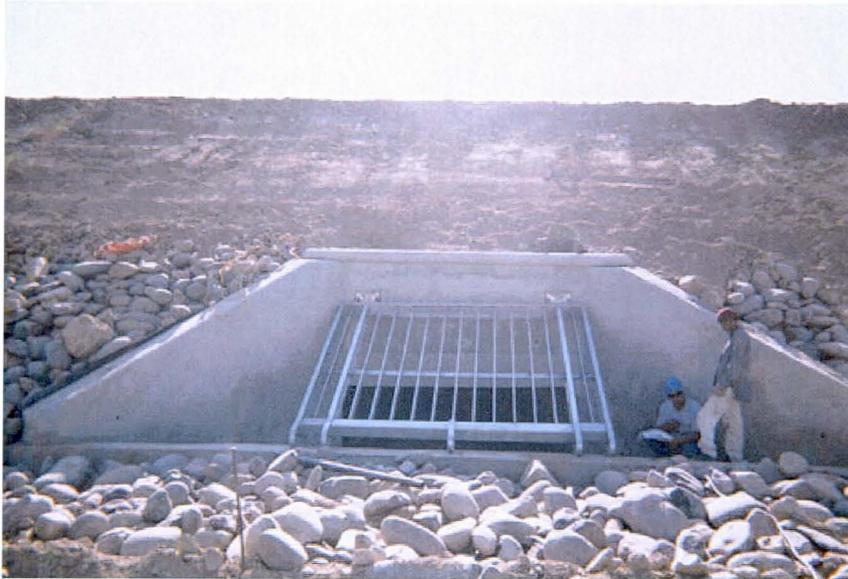
- Date: October 2000
- Location: north end of dam
- Description: auxiliary outlet works inlet structure

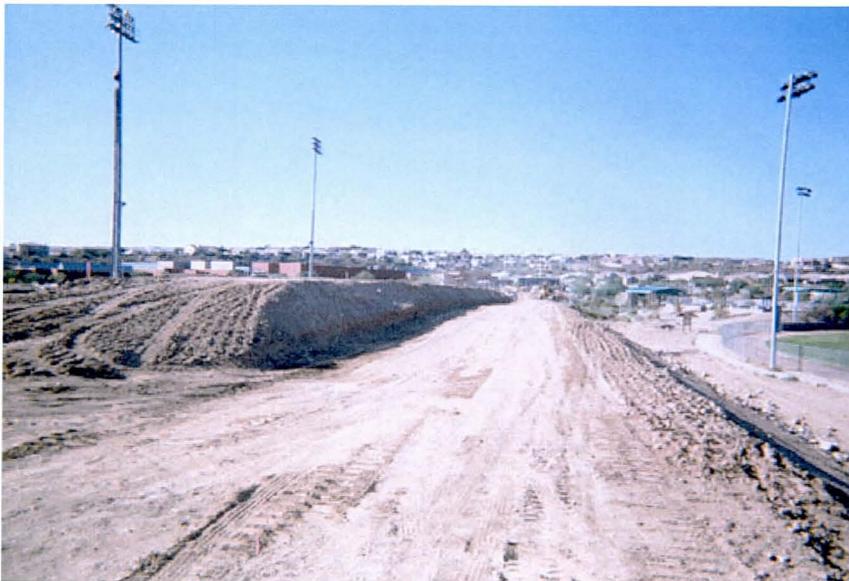
- Date: October 2000
- Location: north end of dam, looking south
- Description: dam embankment partially raised

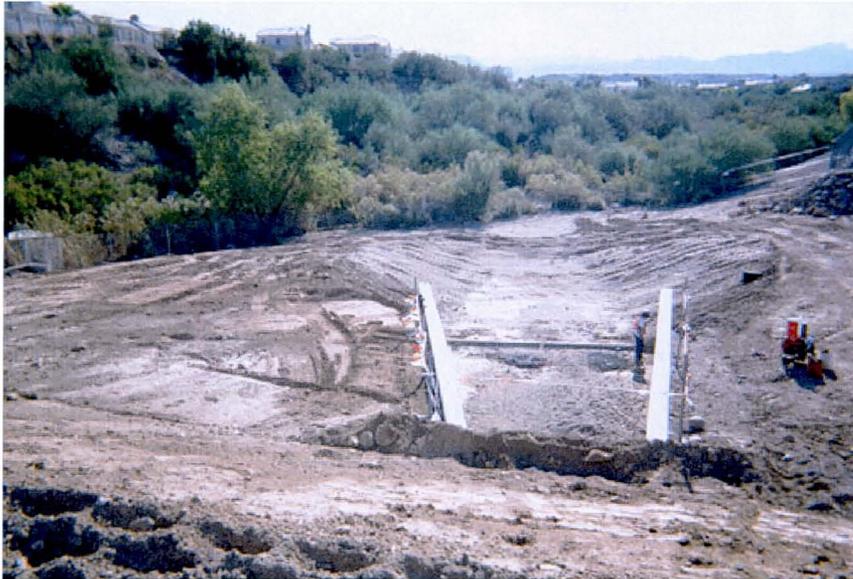
- Date: October 2000
- Location: auxiliary outlet works, looking east
- Description: channel grading partially completed

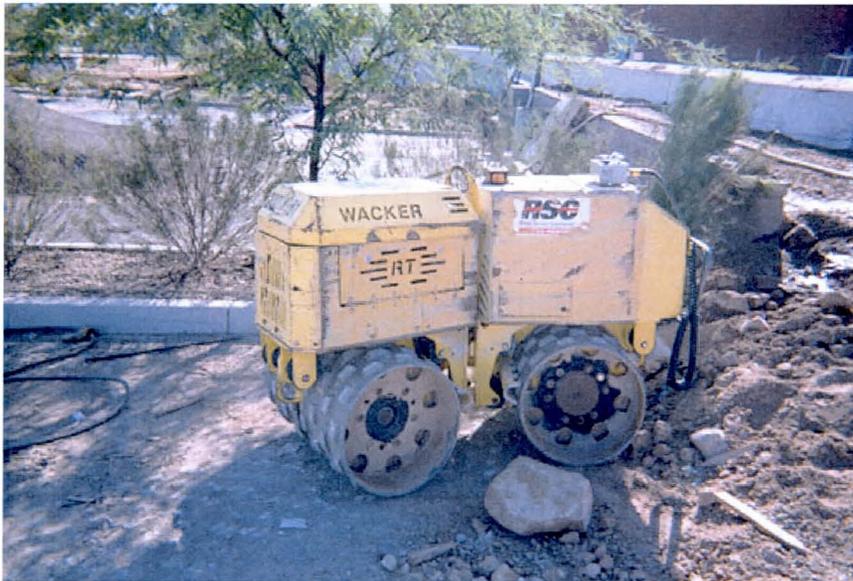
- Date: October 2000
- Location: near floodwall
- Description: small sheepfoot compactor used for compaction around structures

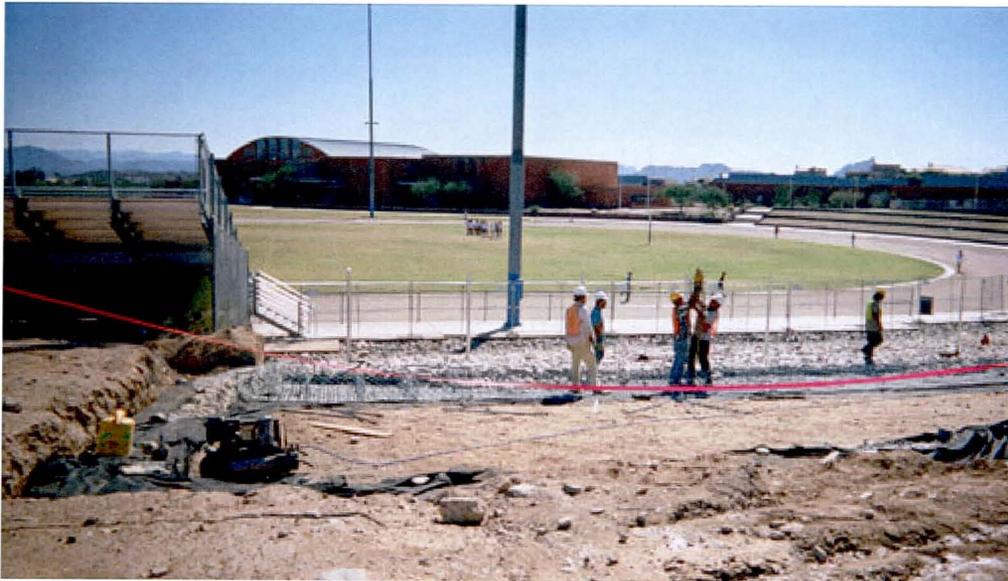
- Date: November 2000
- Location: Emergency Spillway
- Description: Installing gabions

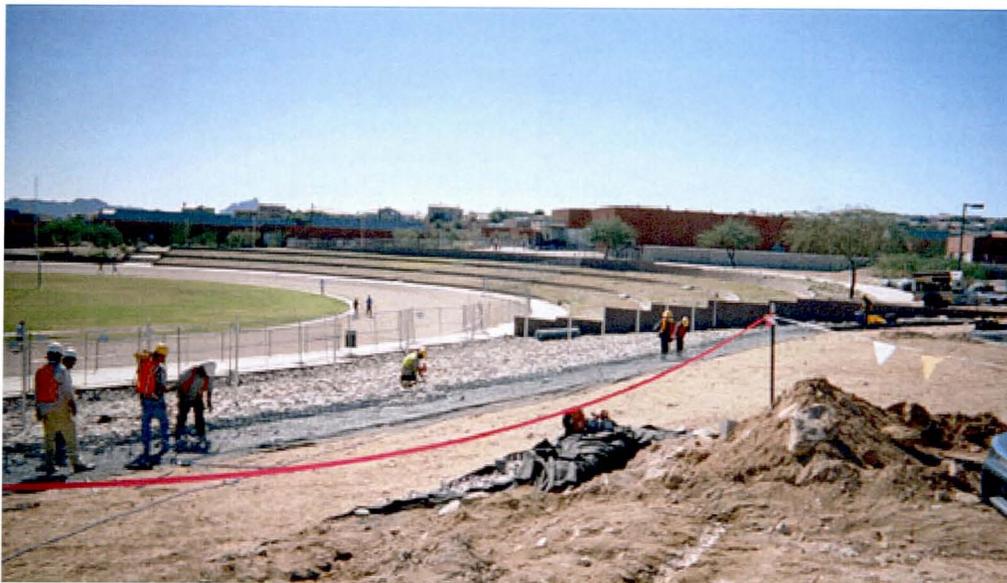
- Date: November 2000
- Location: Emergency Spillway
- Description: Installing gabions

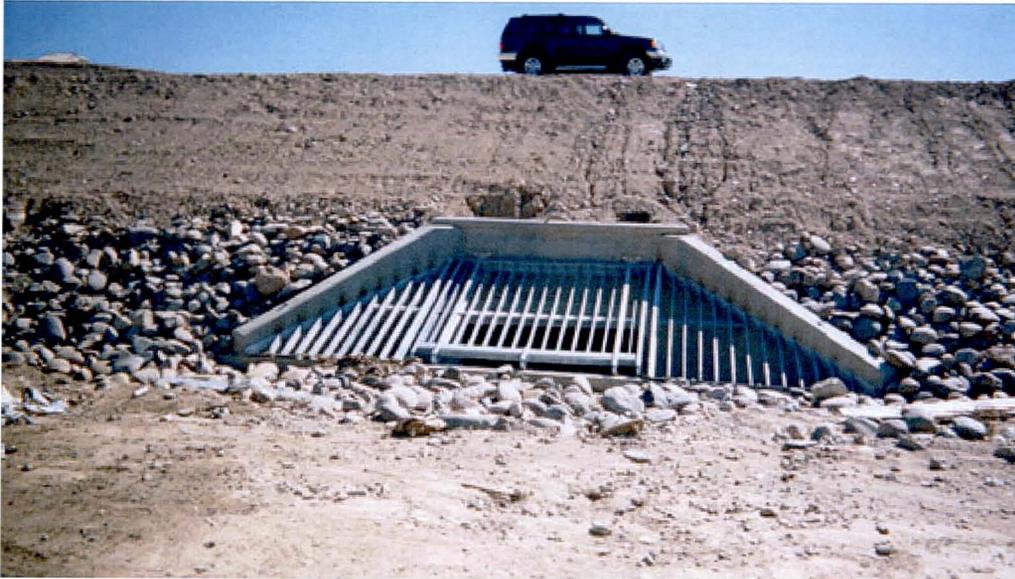
- Date: November 2000
- Location: Auxiliary Spillway
- Description: Inlet structure, embankment partially raised

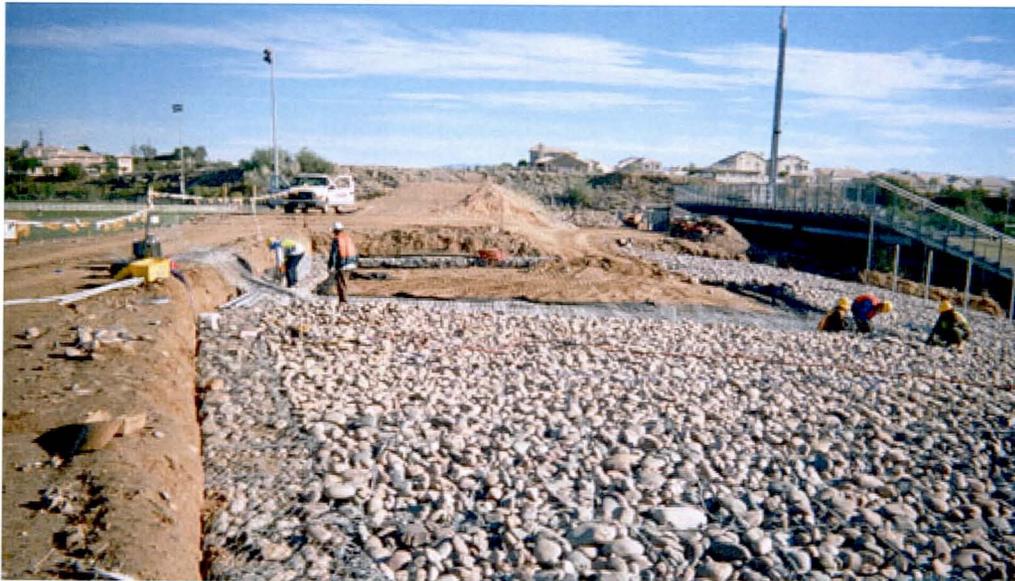
- Date: November 2000
- Location: Emergency Spillway
- Description: Installing gabions

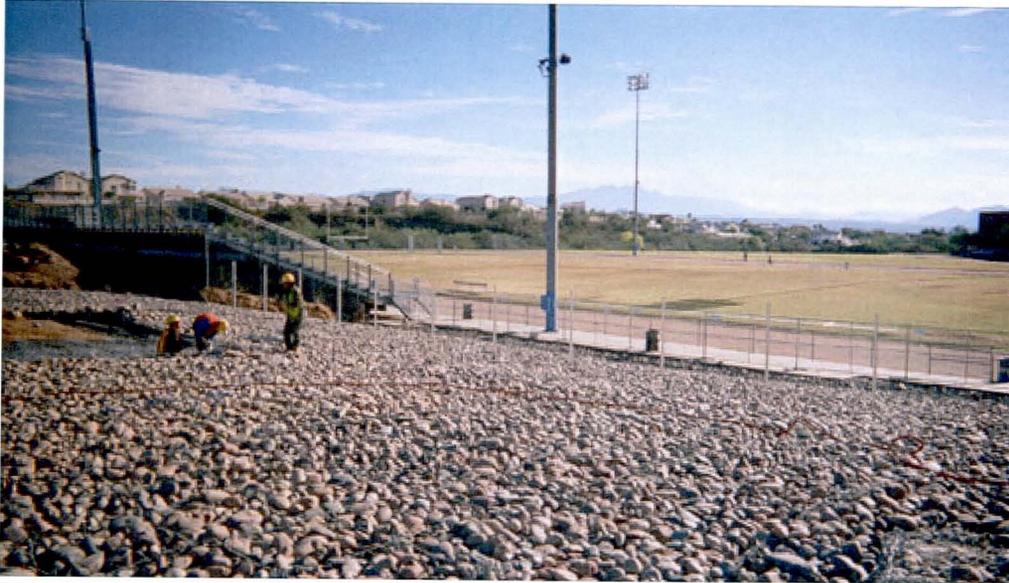
- Date: November 2000
- Location: Emergency Spillway
- Description: Installing gabions

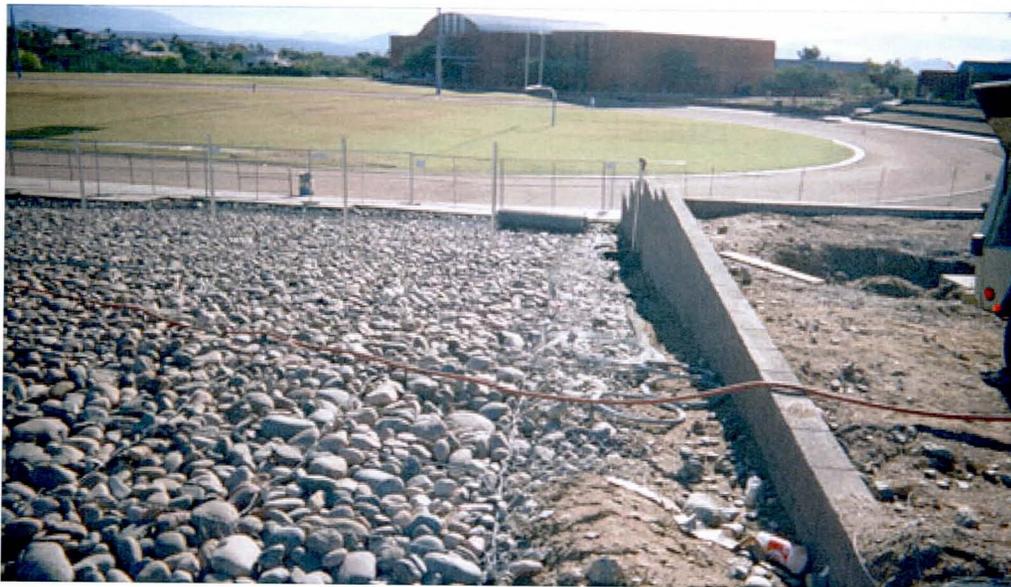
- Date: November 2000
- Location: Emergency Spillway
- Description: Installing gabions

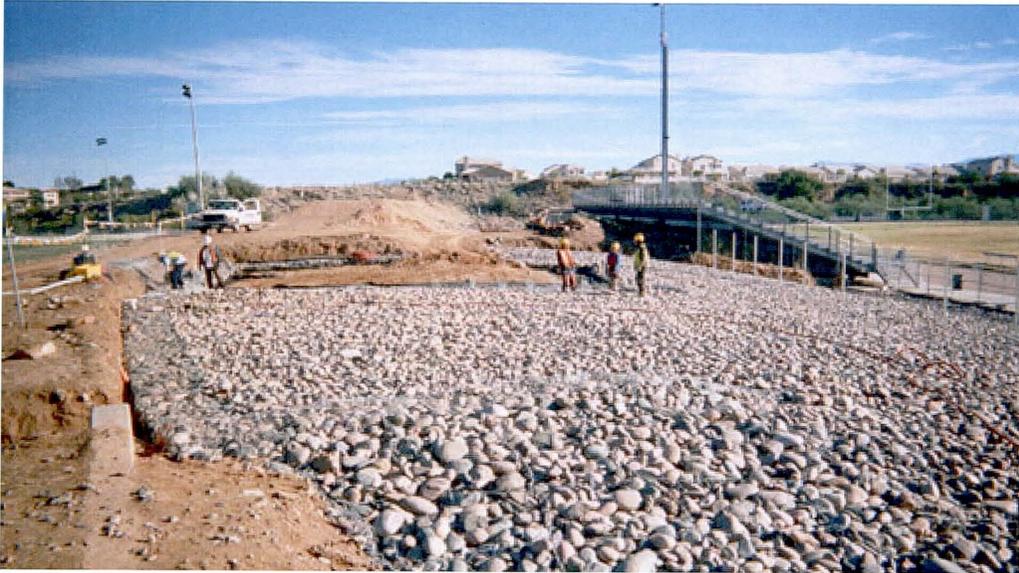
- Date: November 2000
- Location: Emergency Spillway
- Description: Installing gabions

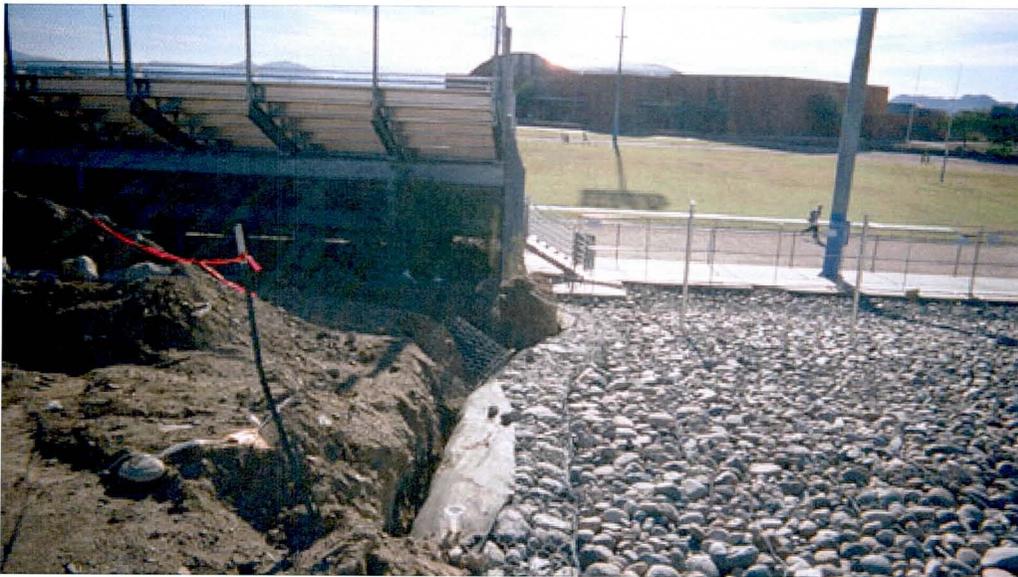
- Date: November 2000
- Location: Emergency Spillway
- Description: Installing gabions

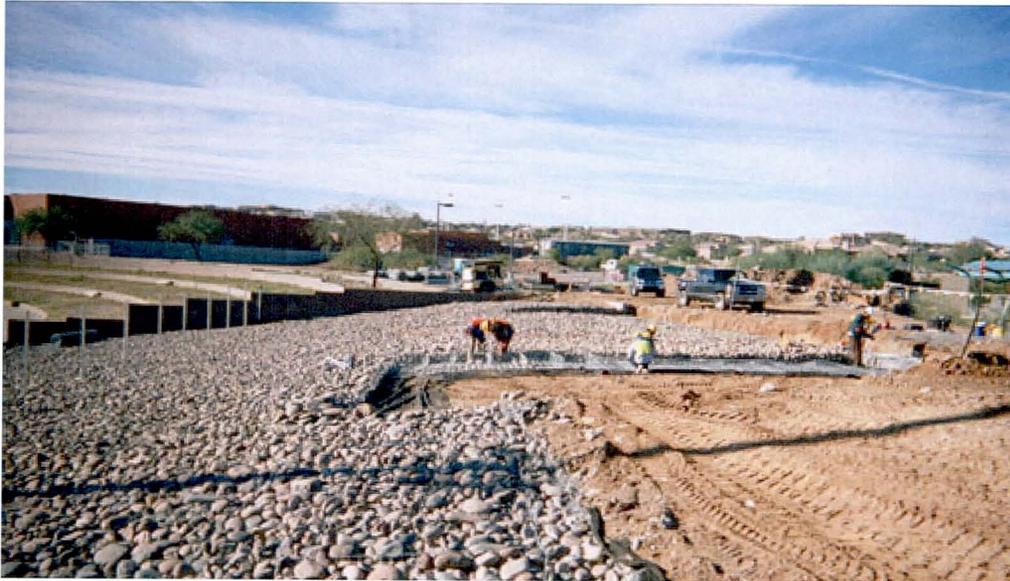
- Date: November 2000
- Location: Emergency Spillway
- Description: Installing gabions

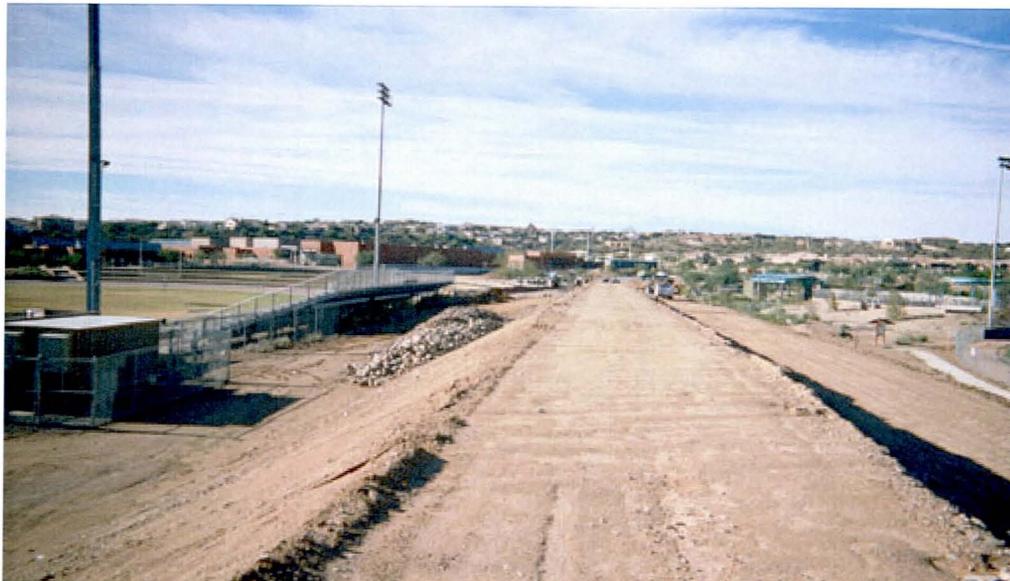
- Date: November 2000
- Location: dam embankment looking south
- Description: embankment partially raised

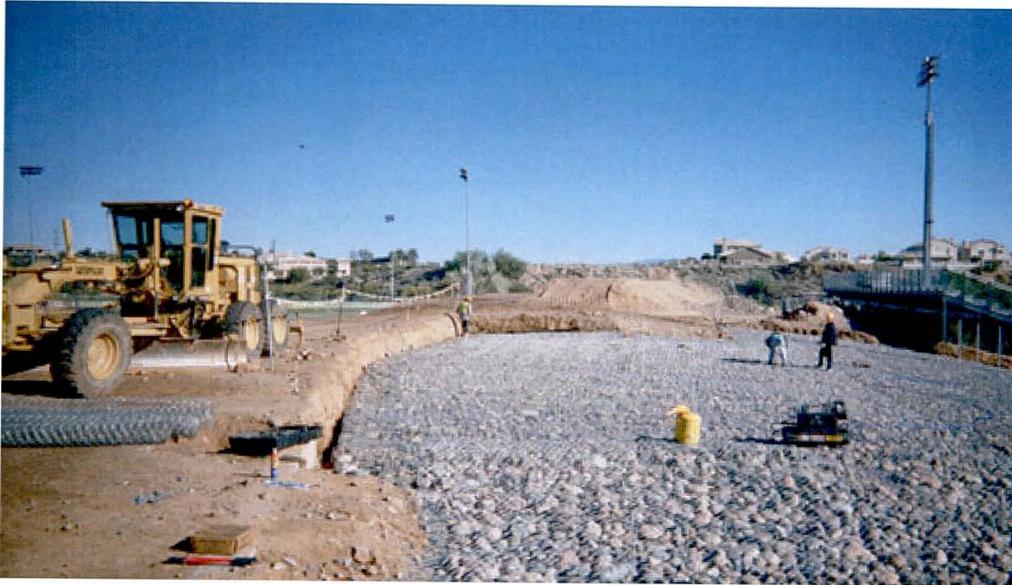
- Date: November 2000
- Location: Emergency Spillway
- Description: Installing gabions

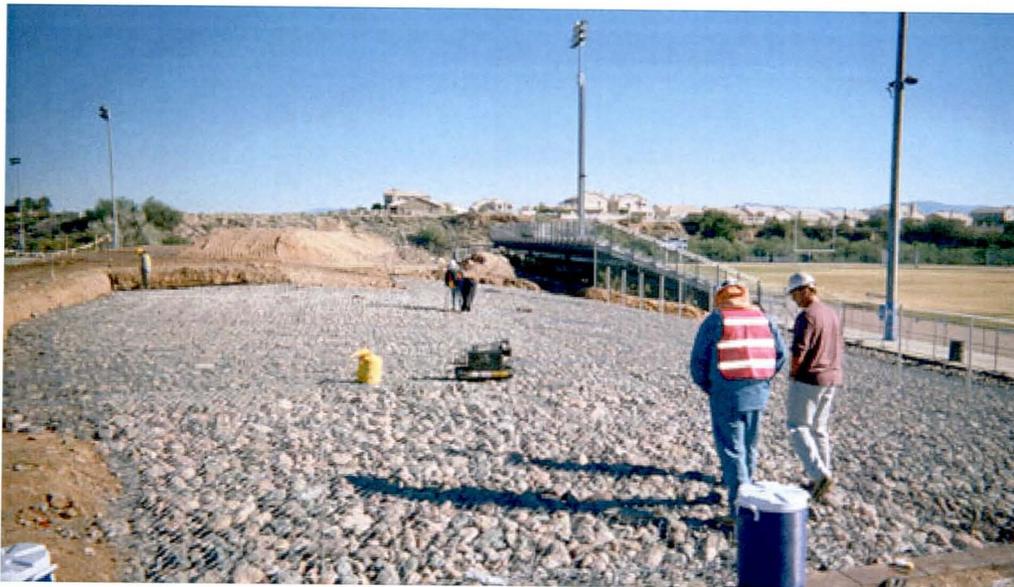
- Date: November 2000
- Location: Emergency Spillway
- Description: Installing gabions

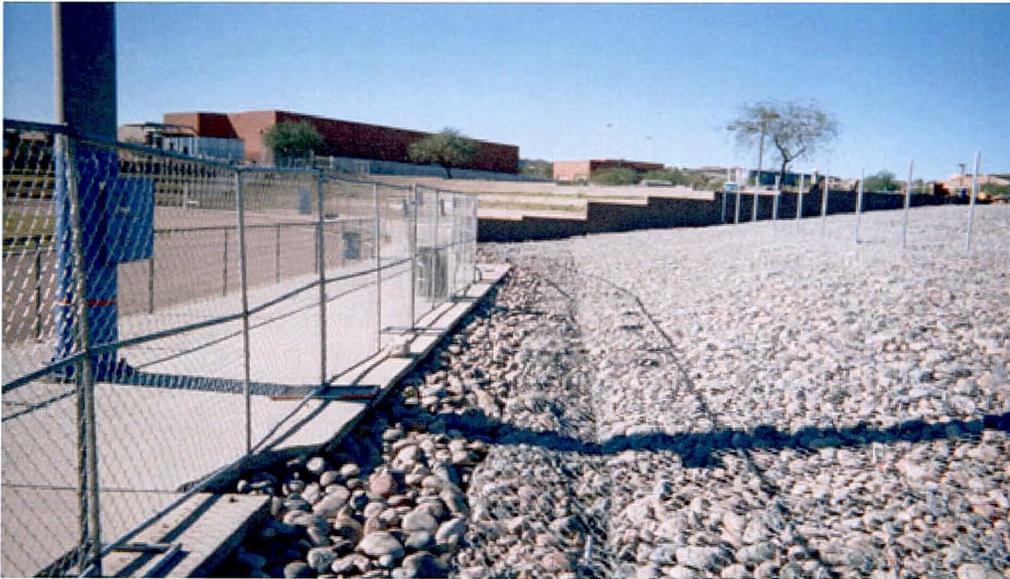
- Date: November 2000
- Location: Emergency Spillway
- Description: Installing gabions

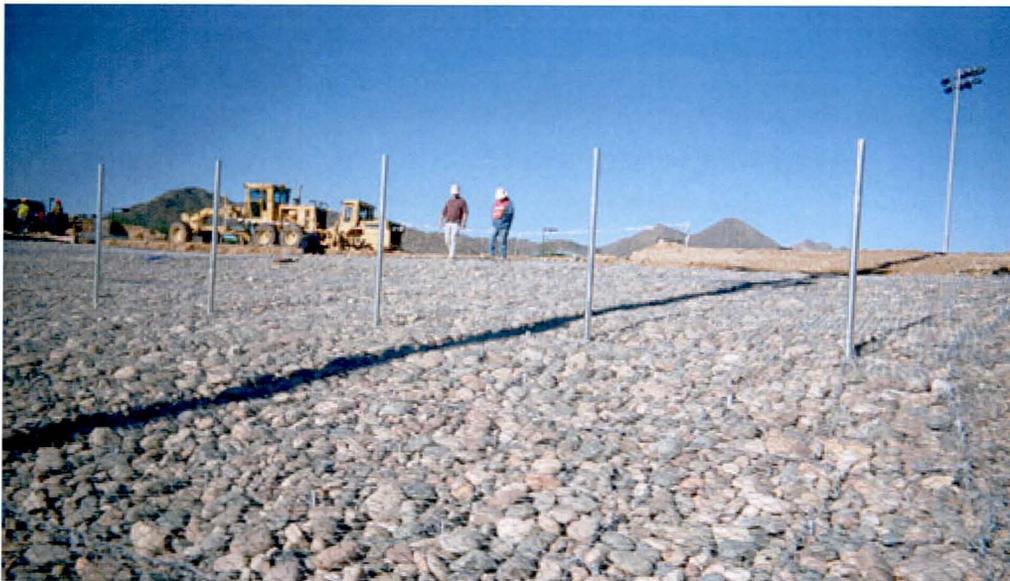
- Date: November 2000
- Location: Emergency Spillway
- Description: Installing gabions

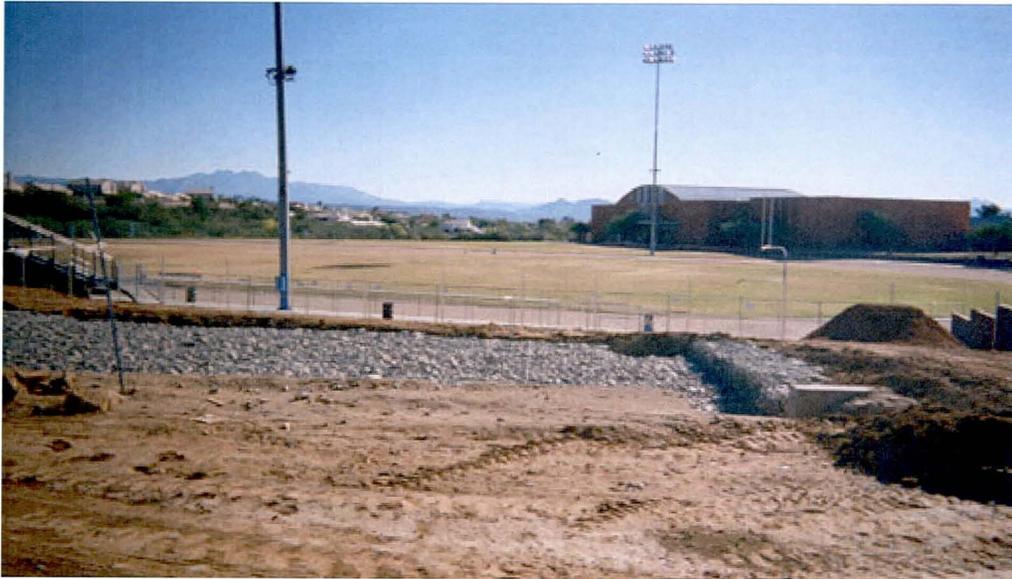
- Date: November 2000
- Location: Emergency Spillway
- Description: Installing gabions and backfilling

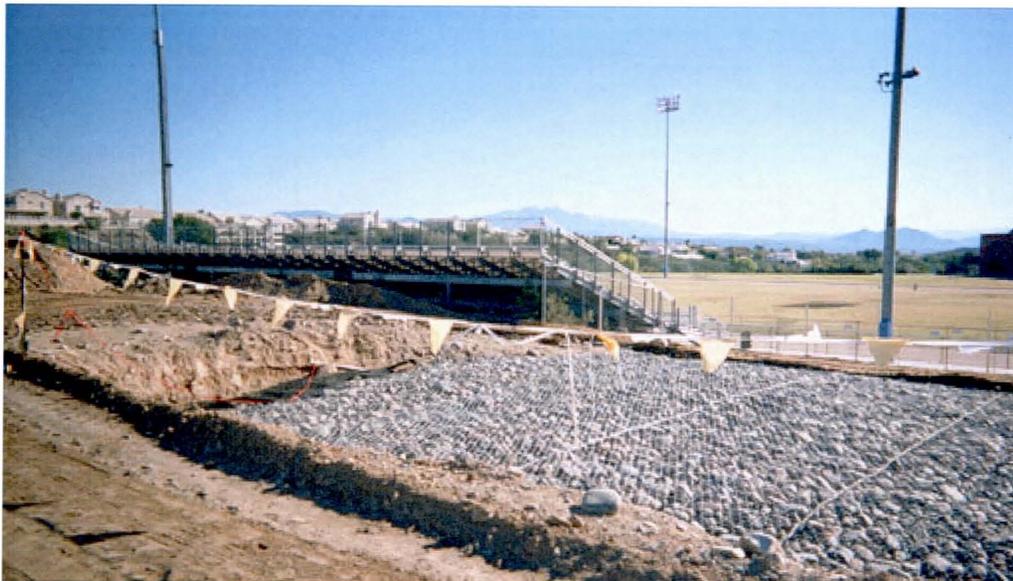
- Date: November 2000
- Location: Emergency Spillway
- Description: Installing gabions and backfilling

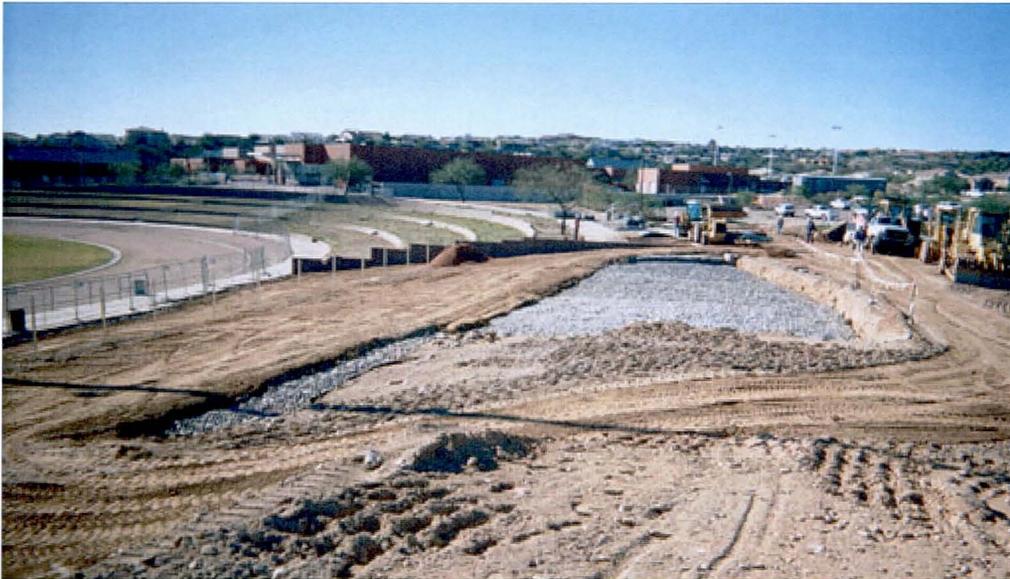
- Date: November 2000
- Location: Emergency Spillway
- Description: Installing gabions and backfilling

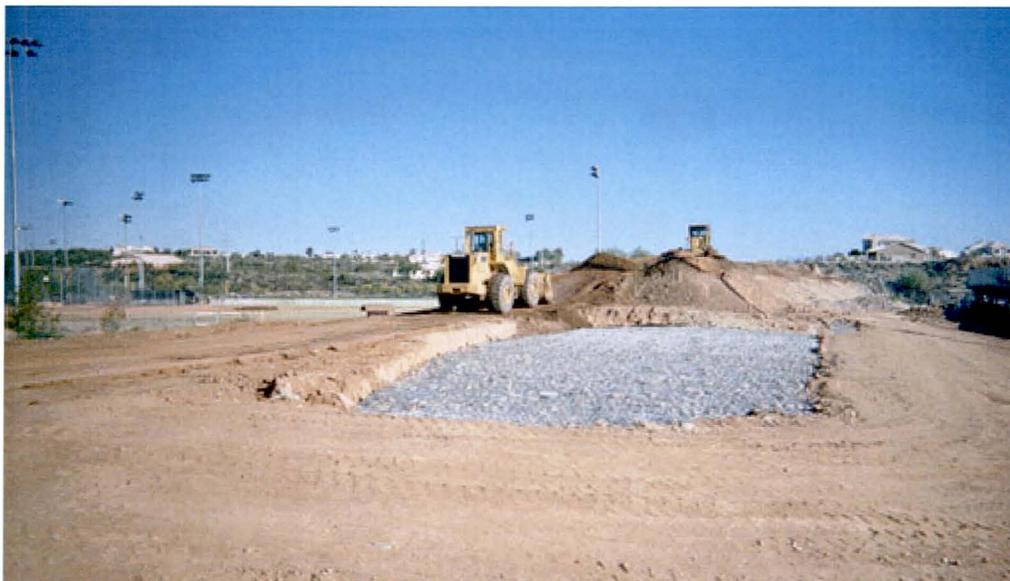
- Date: November 2000
- Location: Emergency Spillway
- Description: Installing gabions

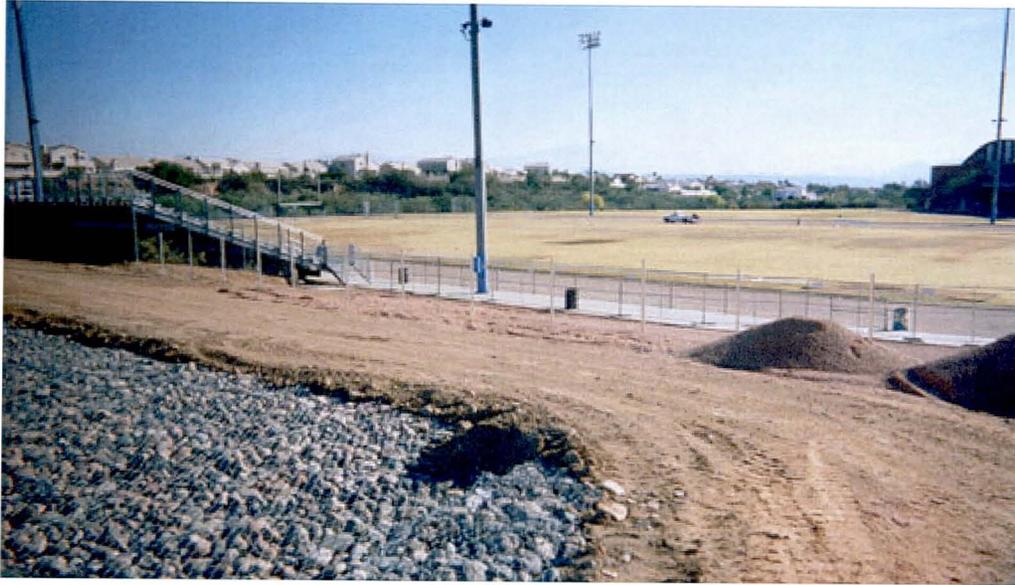
- Date: November 2000
- Location: Emergency Spillway
- Description: Installing gabions and backfilling

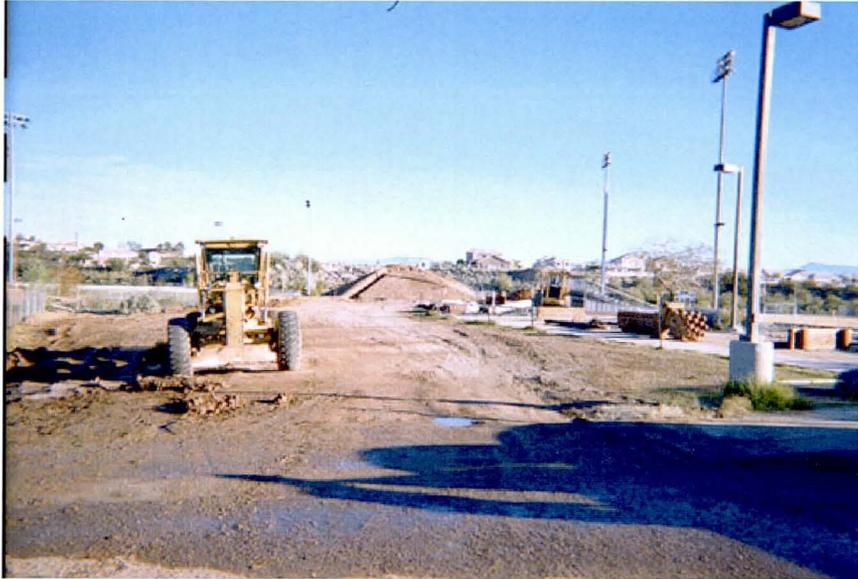
- Date: November 2000
- Location: Emergency spillway looking north
- Description: Grading upstream of the spillway cutoff wall

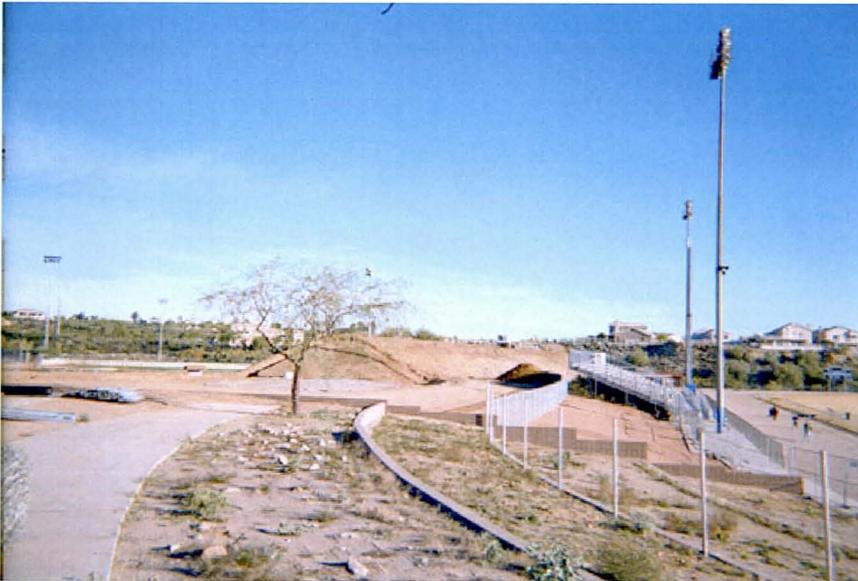
- Date: November 2000
- Location: Emergency Spillway looking northwest
- Description: gabions, fence and wall finished on spillway
