**Golden Eagle
Park Dam
Construction
Photos**

DISK 10

JUNE 2000

Golden Eagle Park Dam Construction of Improvements in 2000

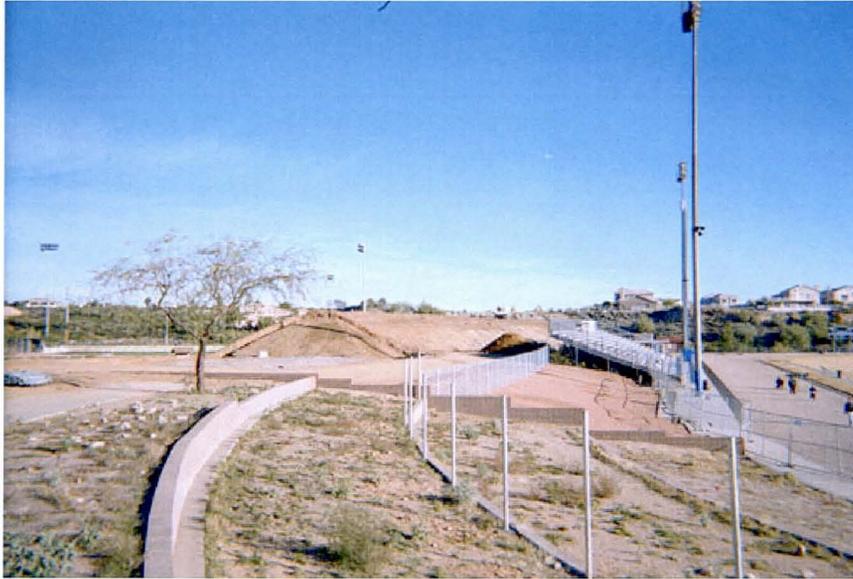
- Date: November 2000
- Location: Emergency Spillway looking northwest
- Description: gabions, fence and wall finished on spillway, working on right dam abutment protection

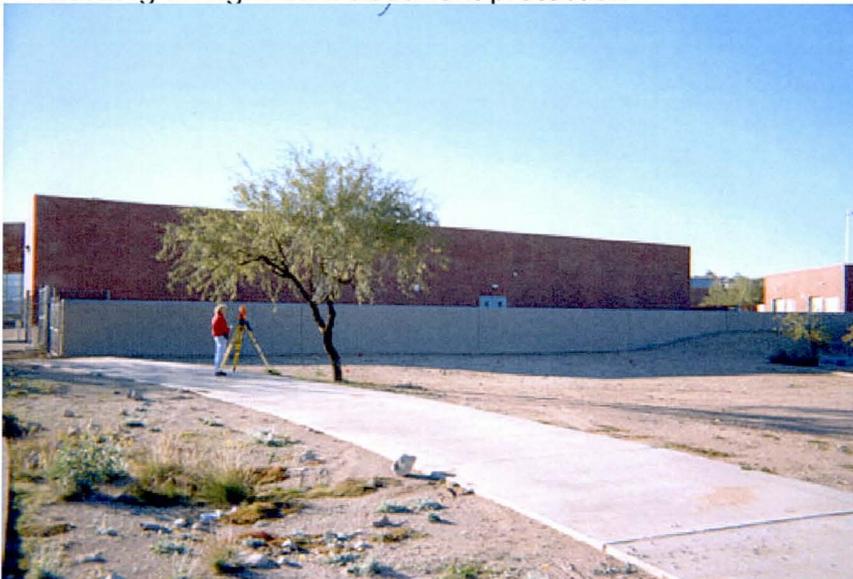
- Date: November 2000
- Location: Emergency Spillway looking southeast
- Description: floodwall and grading finished

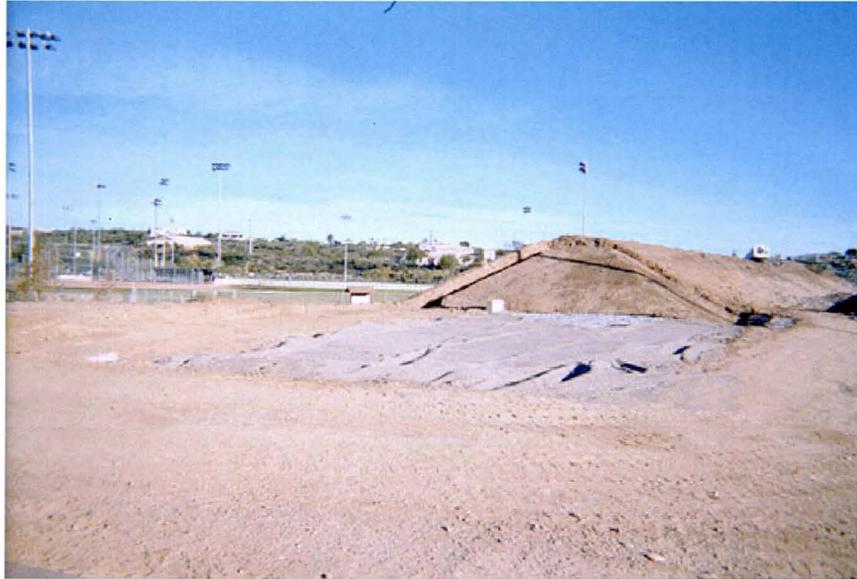
- Date: November 2000
- Location: Emergency Spillway looking northwest
- Description: placing fuseplug over gabions

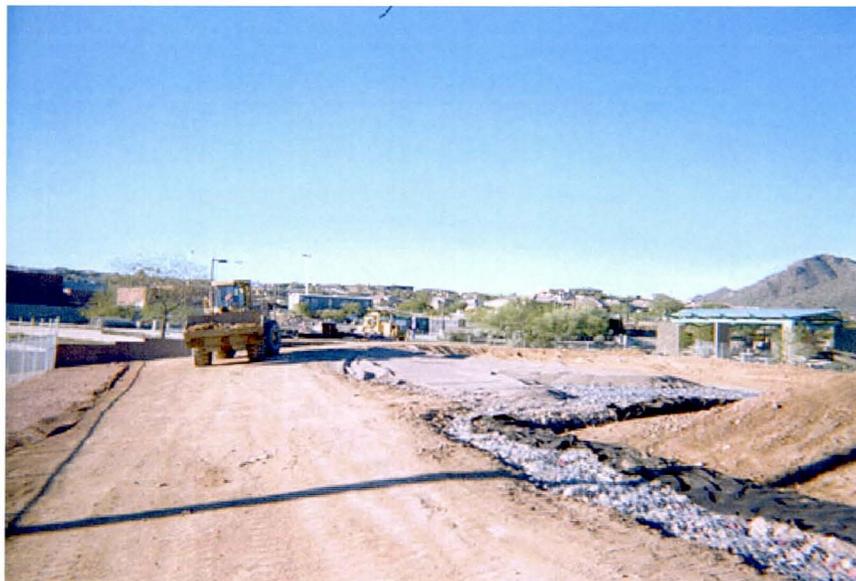
- Date: November 2000
- Location: Emergency Spillway looking southwest
- Description: placing fuseplug over gabions

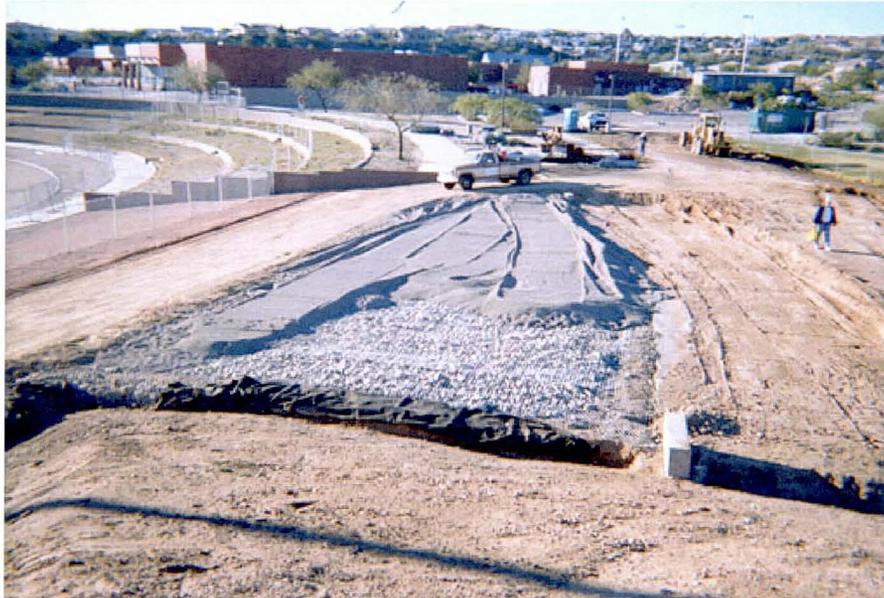
- Date: November 2000
- Location: Emergency Spillway looking south
- Description: placing fuseplug over gabions

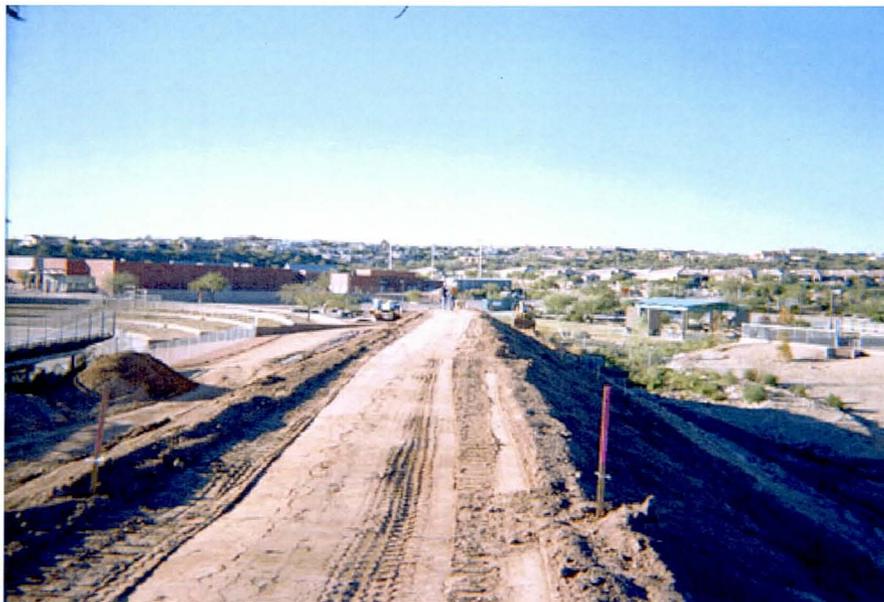
- Date: November 2000
- Location: Dam embankment looking south
- Description: placing imported impervious fill

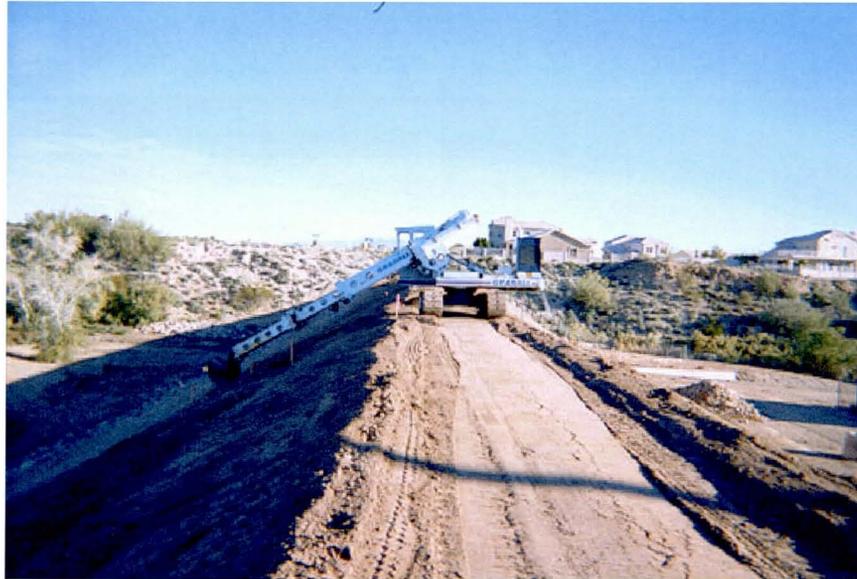
- Date: November 2000
- Location: Dam embankment looking north
- Description: trimming dam embankment with Gradall

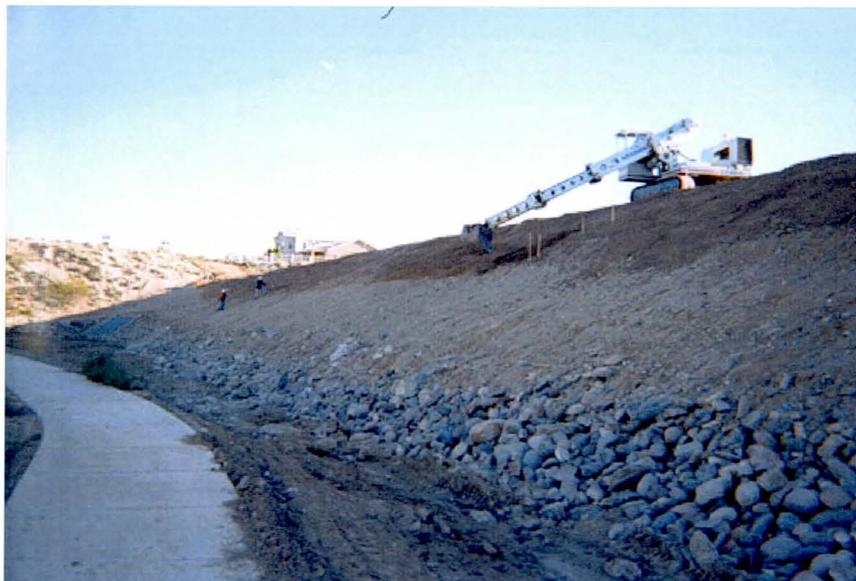
- Date: November 2000
- Location: Dam embankment looking northeast
- Description: trimming dam embankment with Gradall

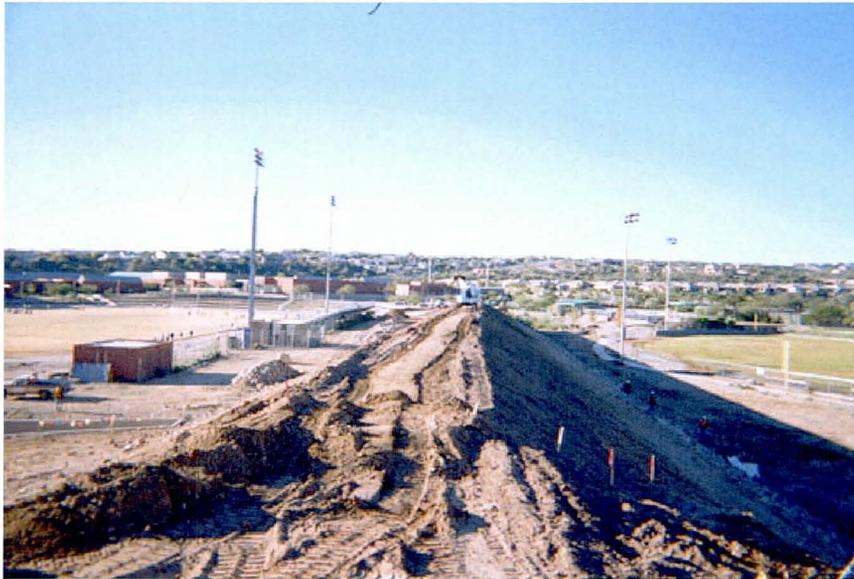
- Date: November 2000
- Location: Dam embankment looking south
- Description: placing imported impervious fill

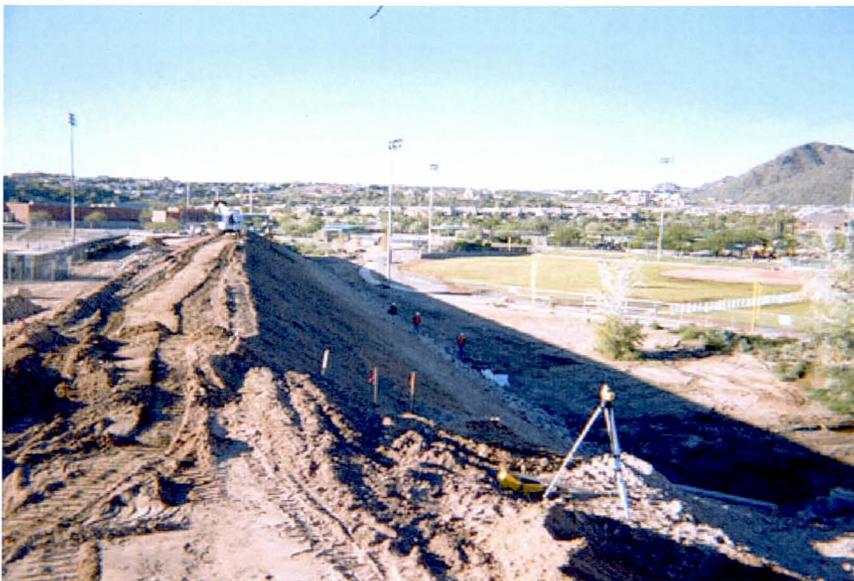
- Date: November 2000
- Location: Dam embankment looking south
- Description: placing imported impervious fill

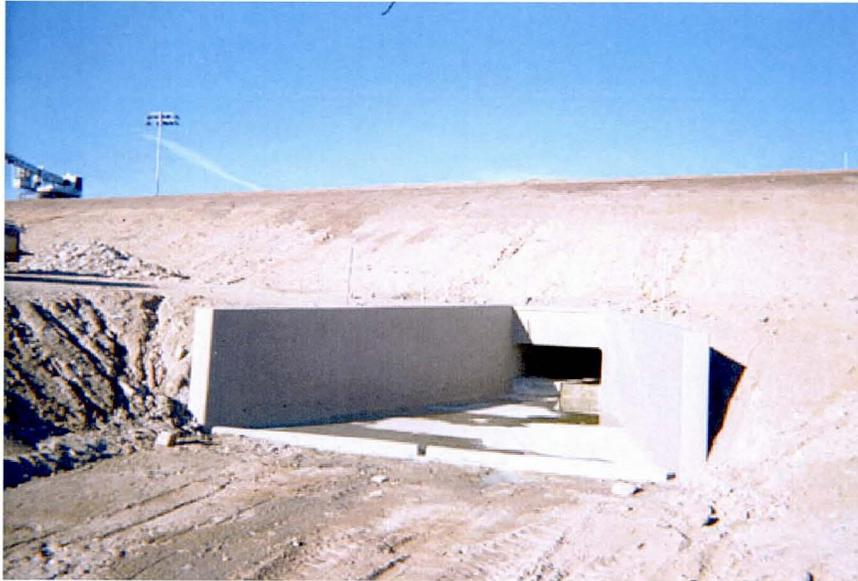
- Date: November 2000
- Location: Auxiliary outlet works looking southwest
- Description: trimming embankment with the Gradall

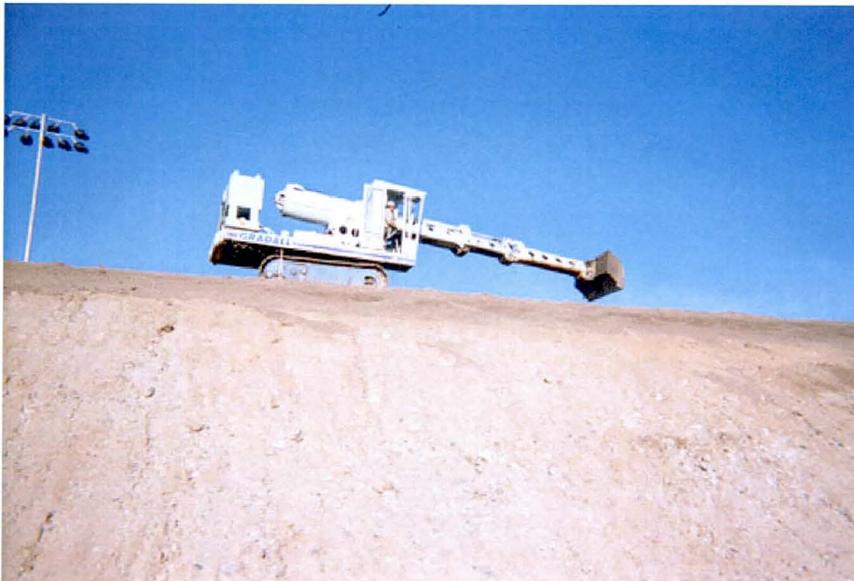
- Date: November 2000
- Location: Dam embankment looking northwest
- Description: trimming dam embankment with Gradall

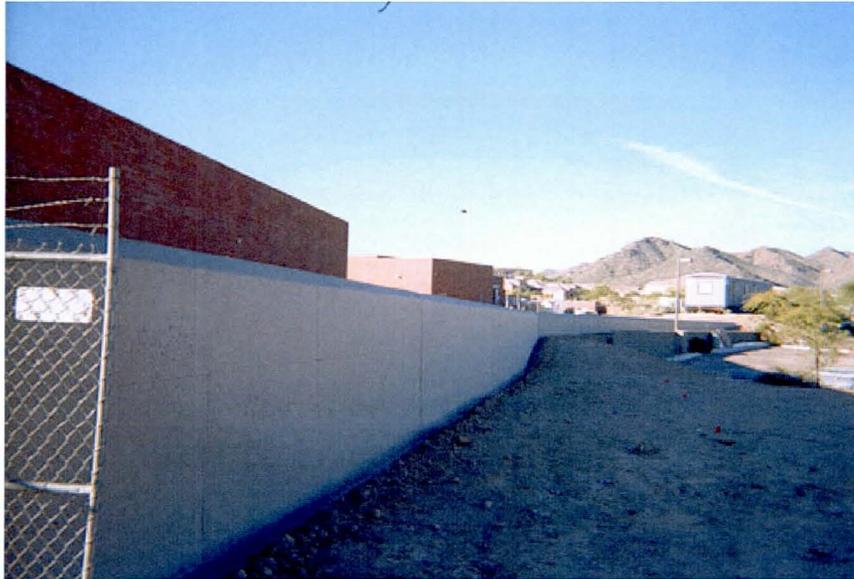
- Date: December 2000
- Location: Right abutment looking southwest
- Description: Spillway floodwall finished

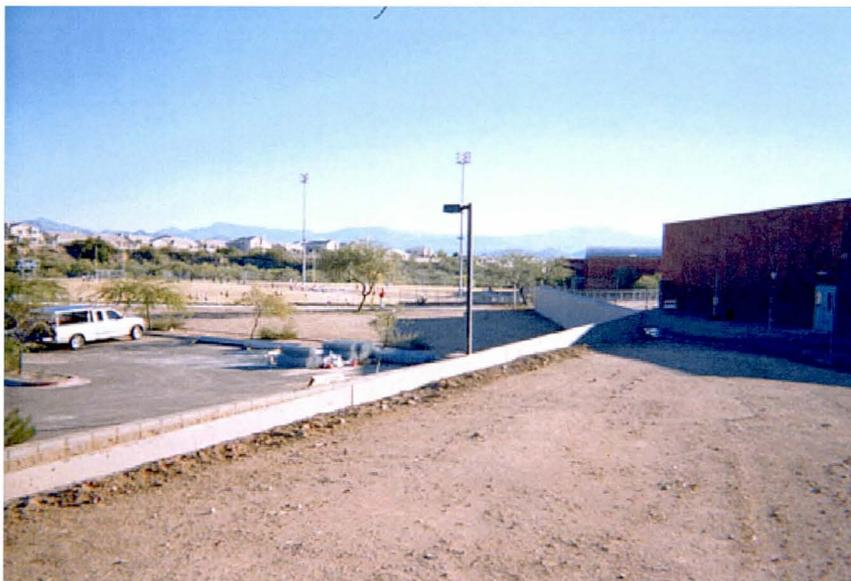
- Date: December 2000
- Location: Right abutment looking northeast
- Description: Spillway floodwall finished

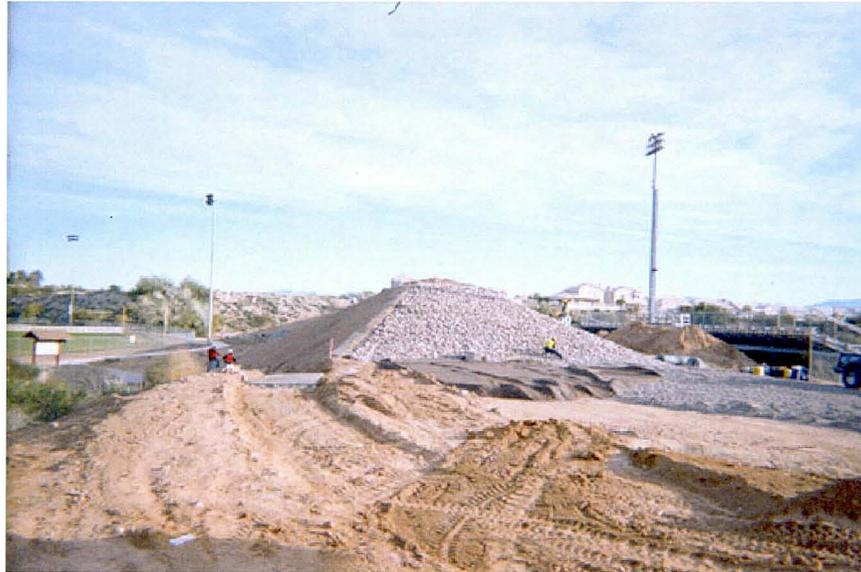
- Date: December 2000
- Location: Emergency spillway looking northeast
- Description: Placing fuseplug, gabions and constructing sidewalk

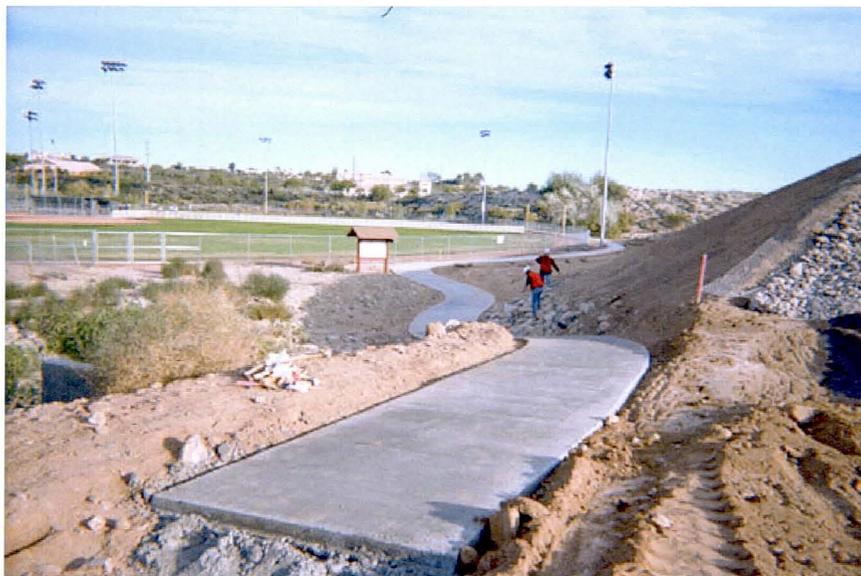
- Date: December 2000
- Location: Emergency spillway looking northwest
- Description: Constructing sidewalk

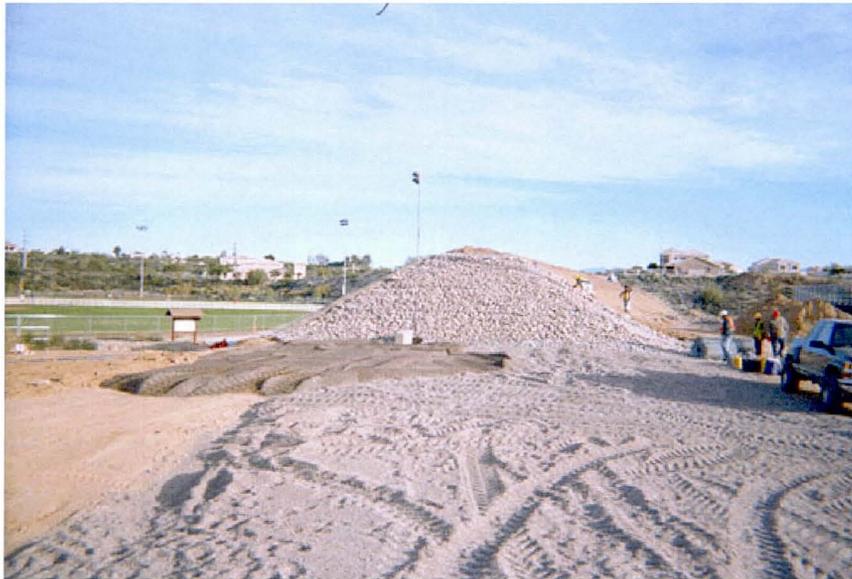
- Date: December 2000
- Location: Emergency spillway looking north
- Description: Placing fuseplug and constructing gabions

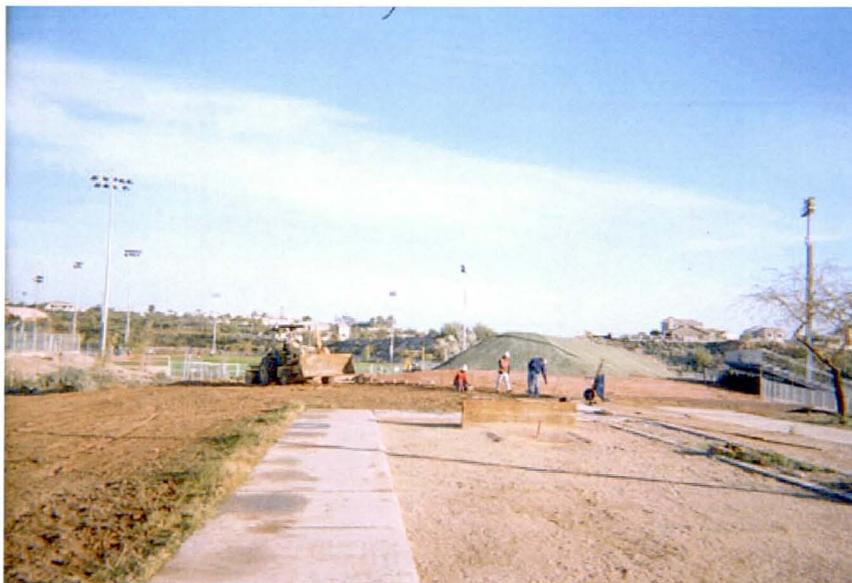
- Date: December 2000
- Location: Emergency spillway looking north
- Description: Hydroseeding the dam and cleaning up the spillway

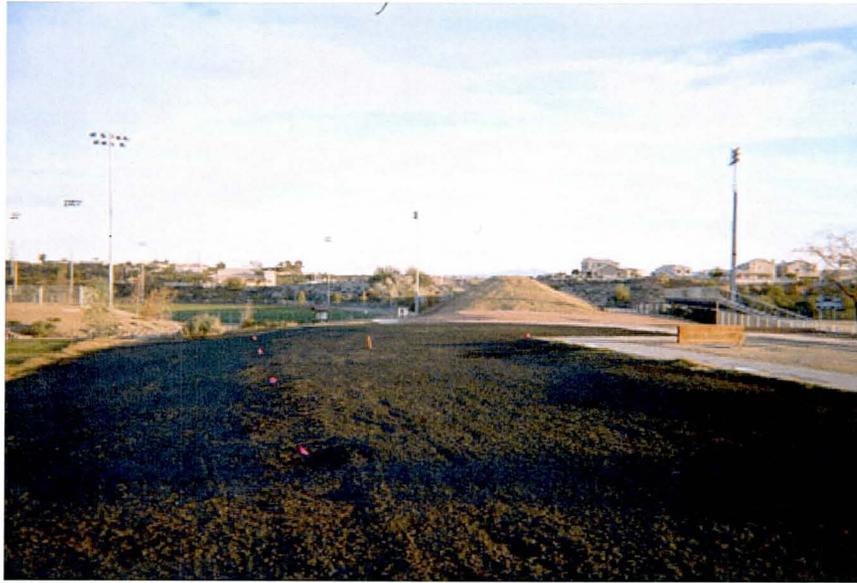
- Date: December 2000
- Location: Emergency spillway looking north
- Description: Hydroseeding the dam and spillway

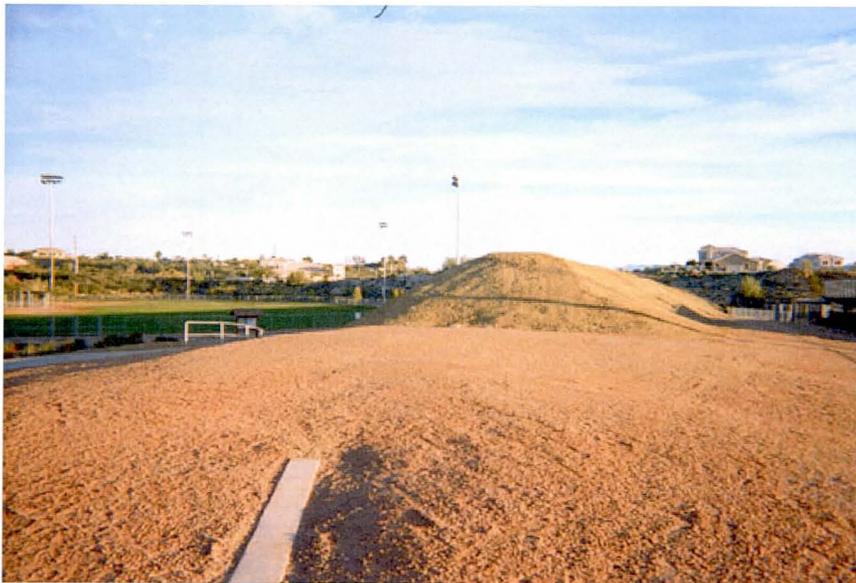
- Date: December 2000
- Location: Emergency spillway looking north
- Description: Finished construction at the spillway
