Wickenburg, FRS

Sunny cove

Sunset

WHITE TANK FRS

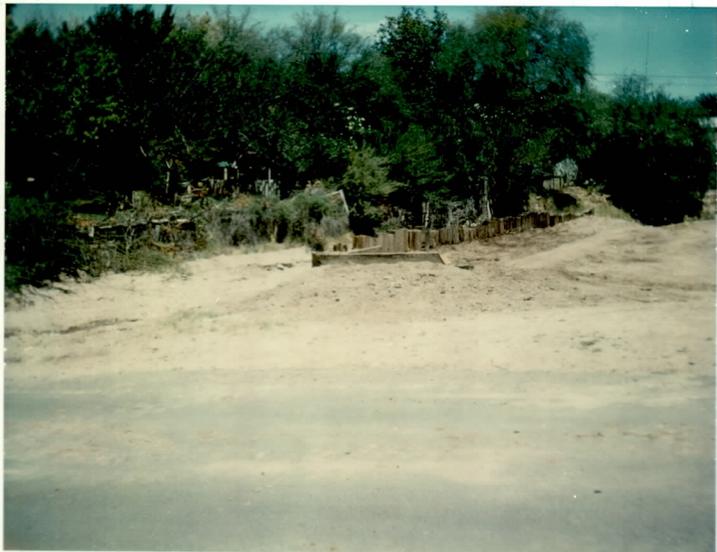
From north looking south at southwest corner. 4-26-76

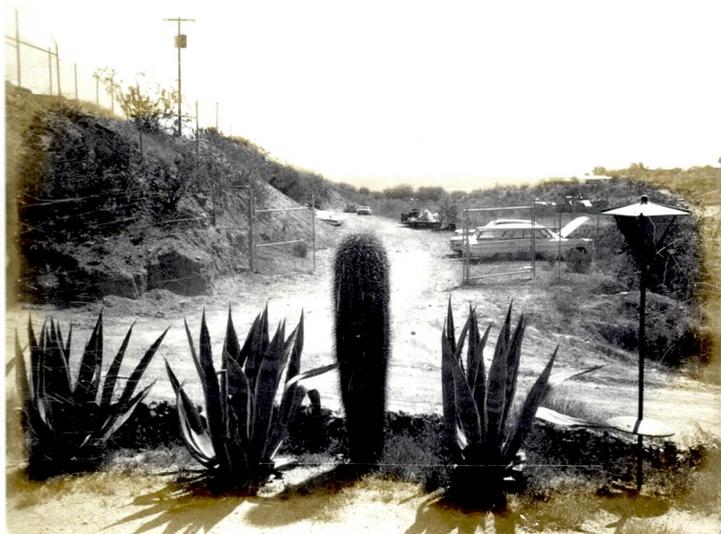
From the north looking south at north side of fence. 4-26-76 Wickenburg.

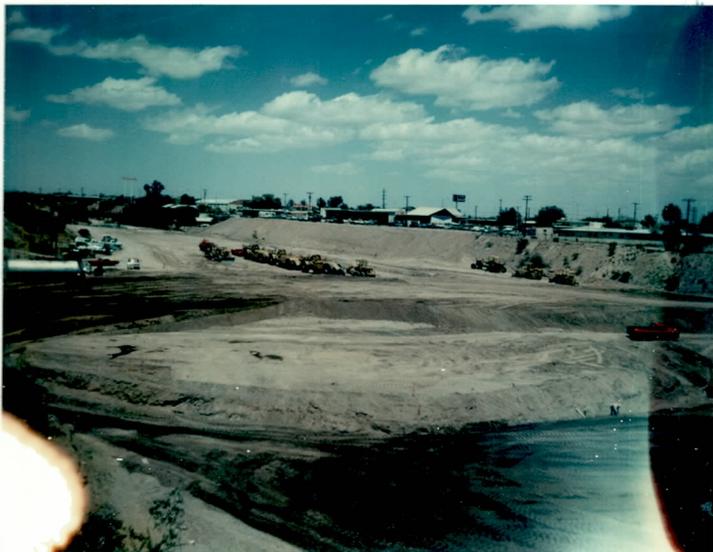
Wickenburg. At Sunset Dam. View of upstream borrow, equipment etc. Looking toward the northwest from south abutment of main embankment. 6-10-76

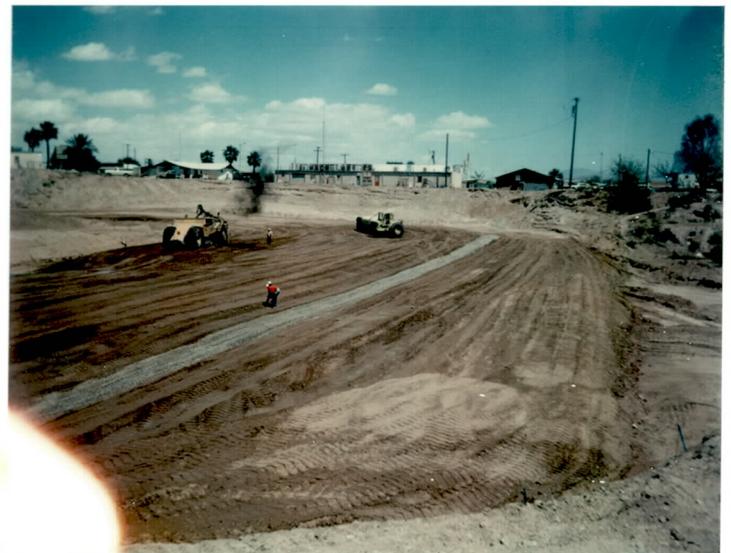
Wickenburg. (at Sunset Dam). View of fill area of main embankment looking to the north from south abutment and downstream of center-line 6-10-76

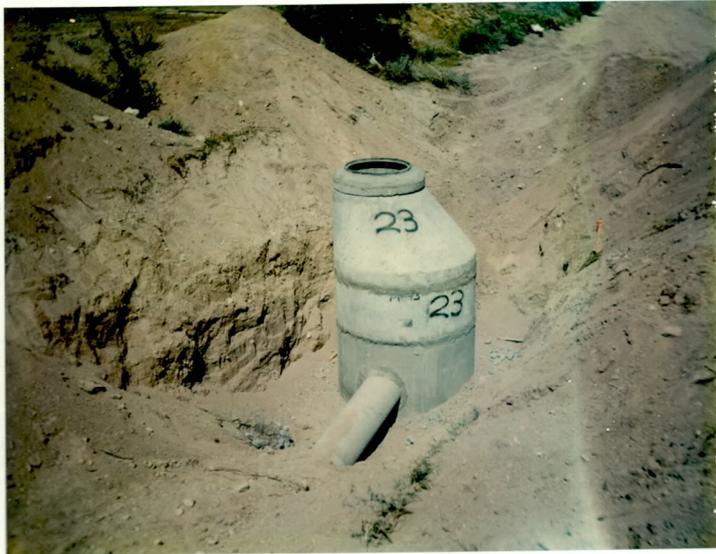
Wickenburg Dams. Pipeline work. Pipeline crossing at Kellis Street. 5-14-76

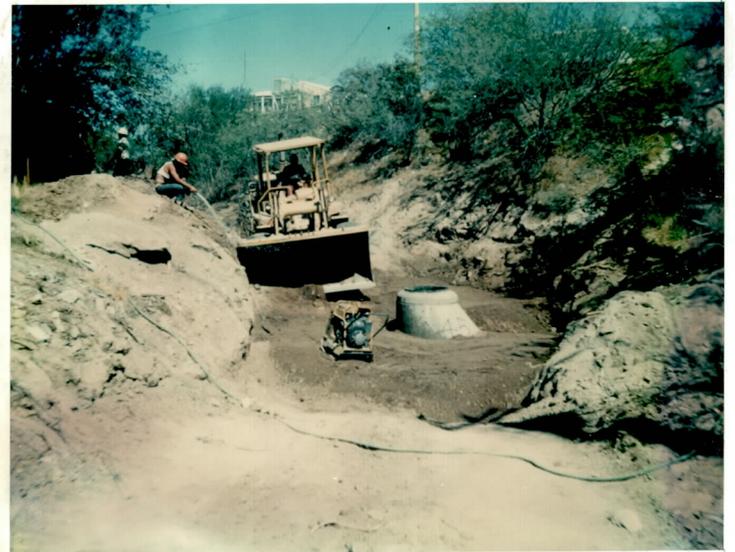
Wickenburg Dams. Backfill operations around man hole of outlet piping. 5-14-76

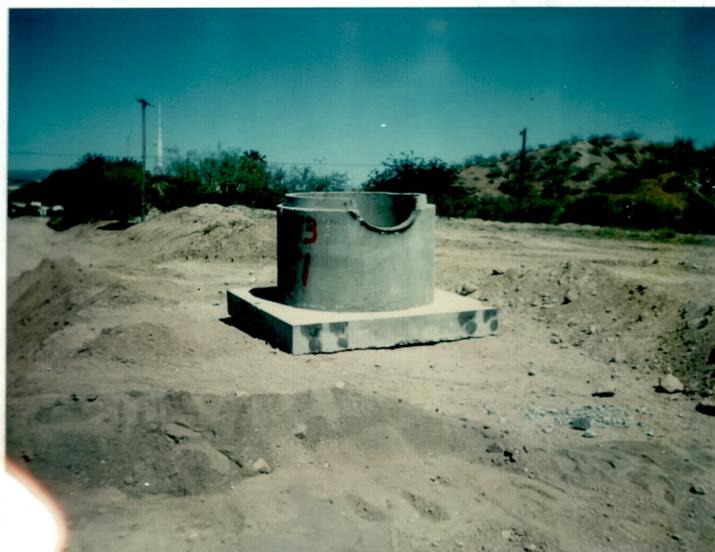
Wickenburg Dams. Pipeline work. View of typical pre-cast base unit for man hole construction on outfall piping. 5-14-76

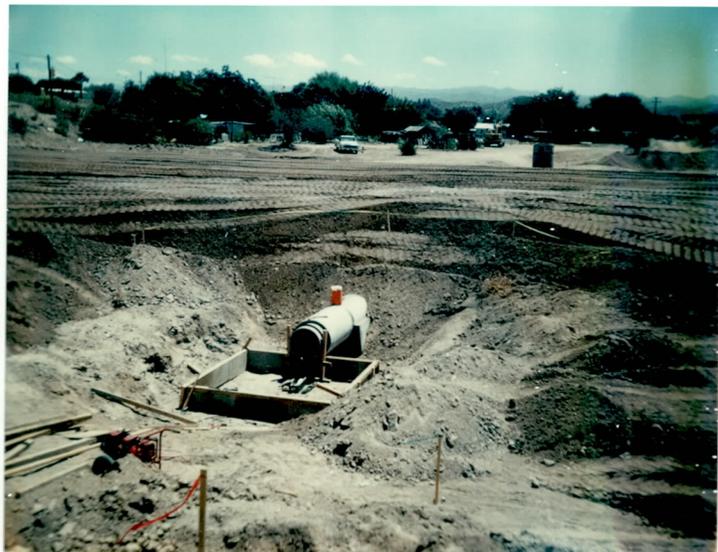
Wickenburg (at Sunnycove). View of downstream and of outlet works piping and looking upstream along pipeline. Note pervious fill and backfill operations. 6-10-76

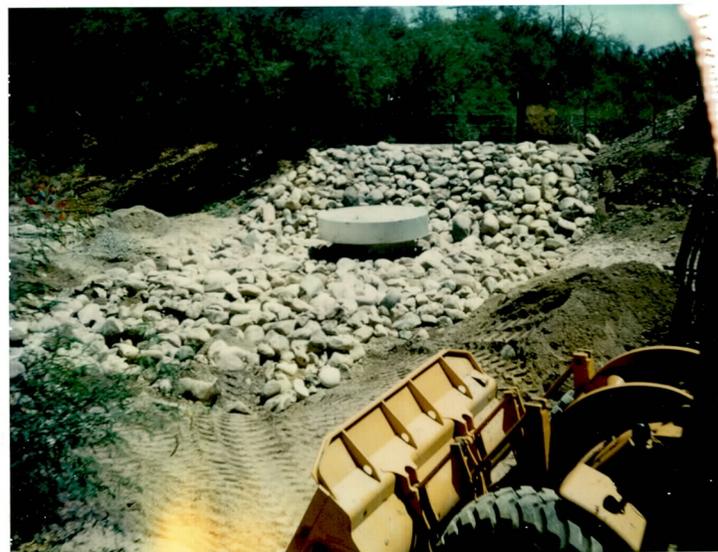
Wickenburg Dams. Pipeline outlet. 8-9-76

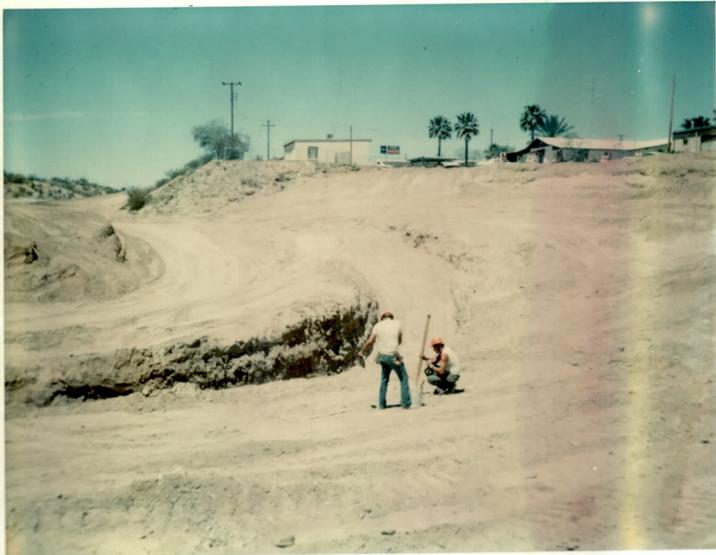
Sunset Dam. View looking along centerline of main embankment from right abutment to left abutment downstream of centerline. 5-11-76

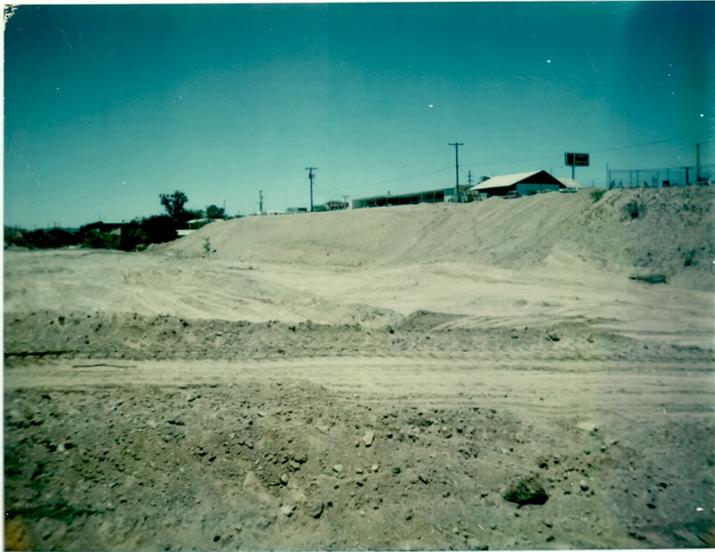
Sunset Dam. View of work area for main embankment looking along centerline from right abutment to left abutment. Area downstream of centerline in view. 6-4-76

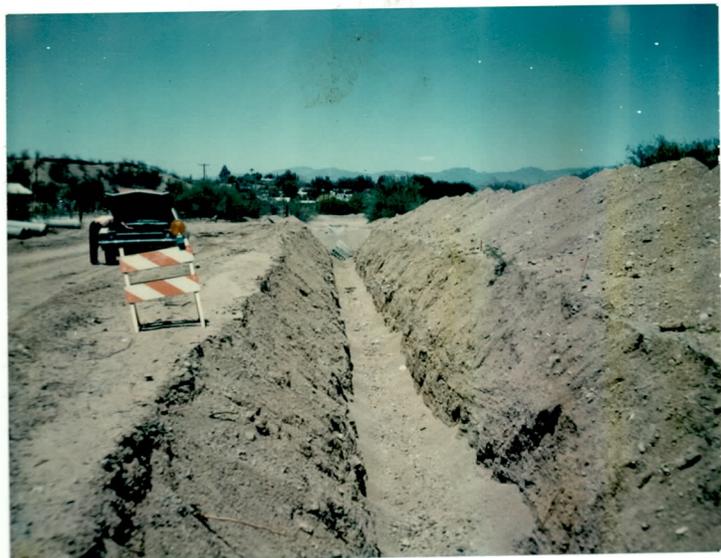
Sunnycove Pipeline. End of pipeline to date (5-24-76) at station 30+00 man hole.

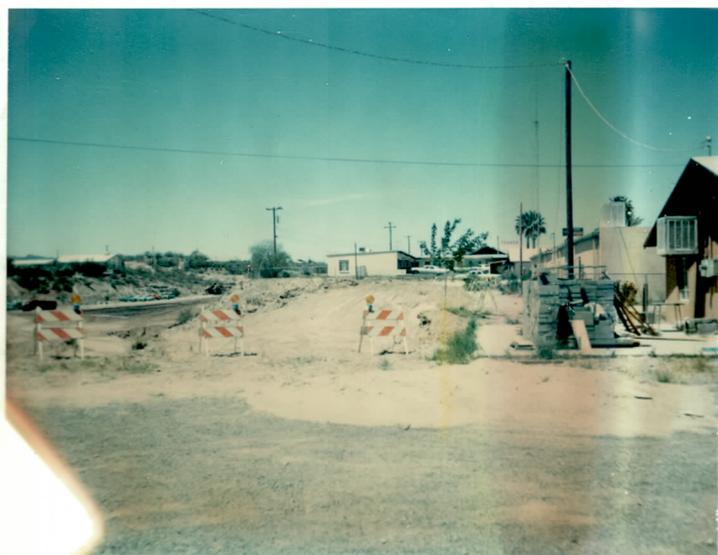
Sunset Dam. View of work area for main embankment showing pipeline after concrete for cradle and collars in place. 6-4-76

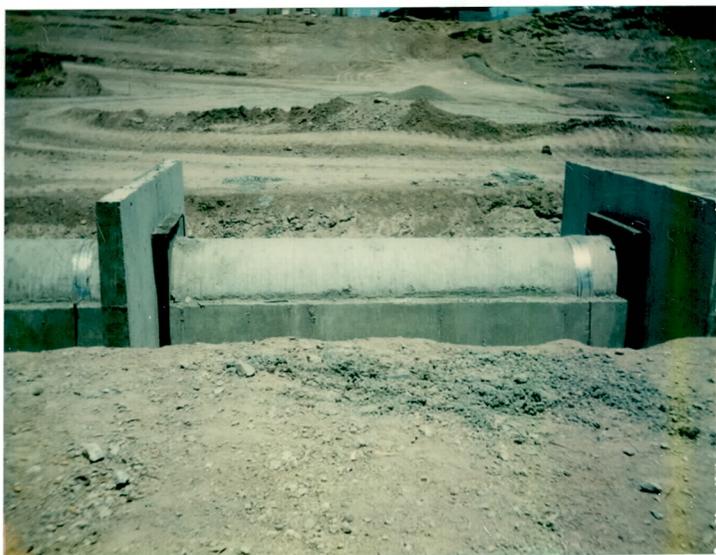
Sunset Dam. Close-up view of pressure pipeline. Concrete in place. 6-4-76

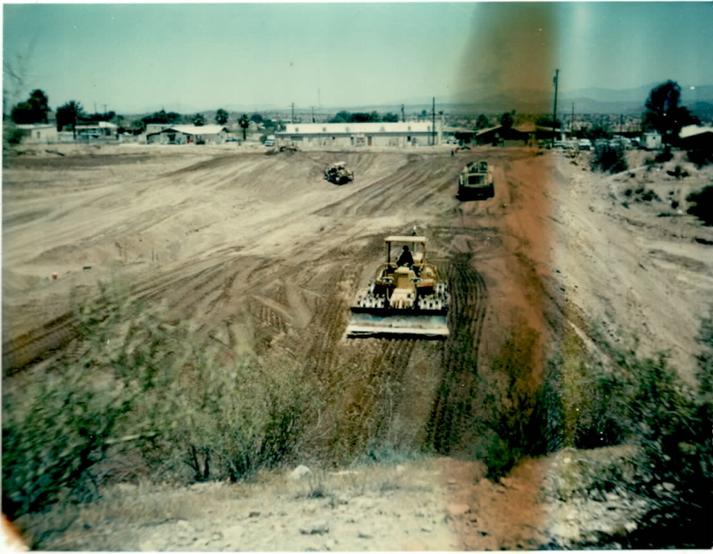
Sunset Dam. View looking upstream
from right abutment just downstream
of main embankment. 6-17-76

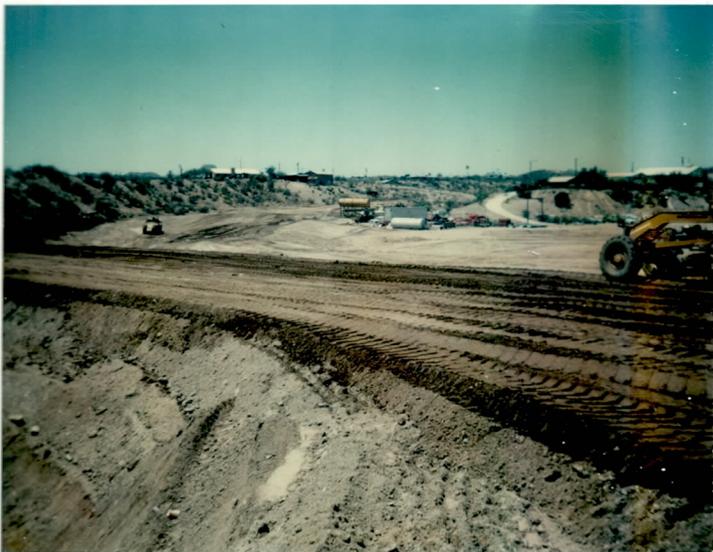
Sunset Dam. View looking left
abutment just downstream of
main abutment. 6-17-76

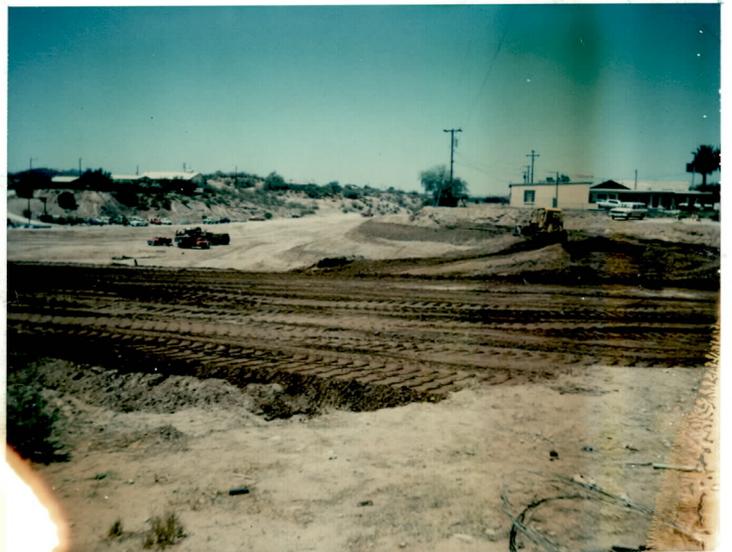
Sunset Dam. View looking upstream
of main abutment just downstream
of main embankment showing
blanket material upstream and on
left side of reservoir. 6-17-76

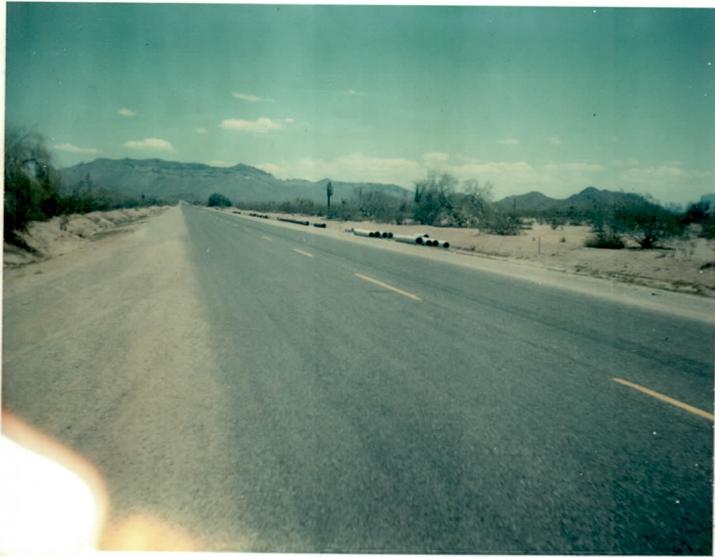
Spook Hill utility relocation.
View of encased waterline along
East Hermosa Vista as it was
when contractor was asked to
discontinue work by SCS to revise
specifications on backfill material.
View looking northeast. 6-9-77

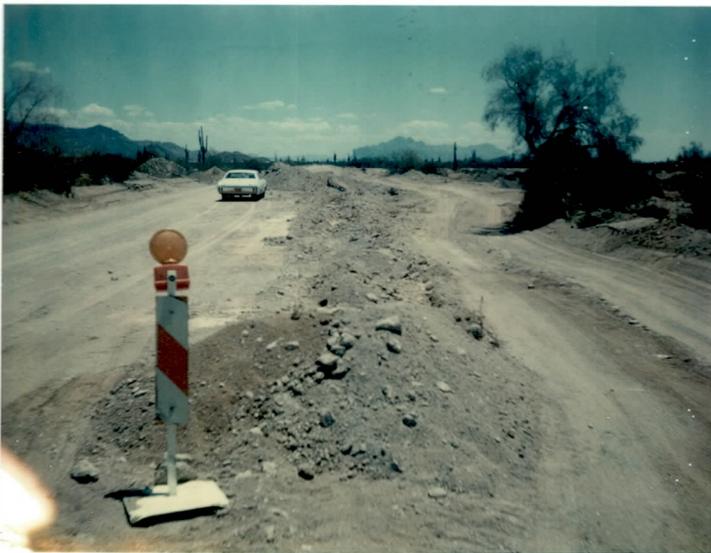
Spook Hill utility relocation. View
of work area for pipeline along East
Hermosa Vista looking northeast.

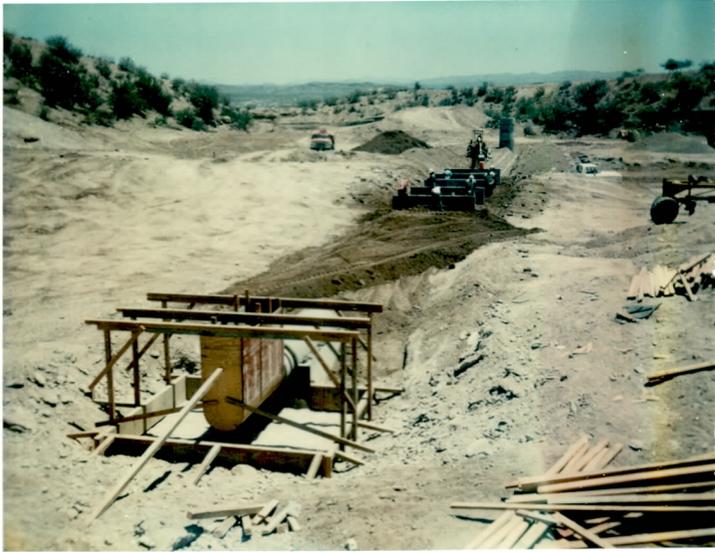
Sunnycove Dam. View from upstream to downstream along outlet works piping. Note back hoe removing material from along pipe - extreme downstream end of piping. 6-17-76

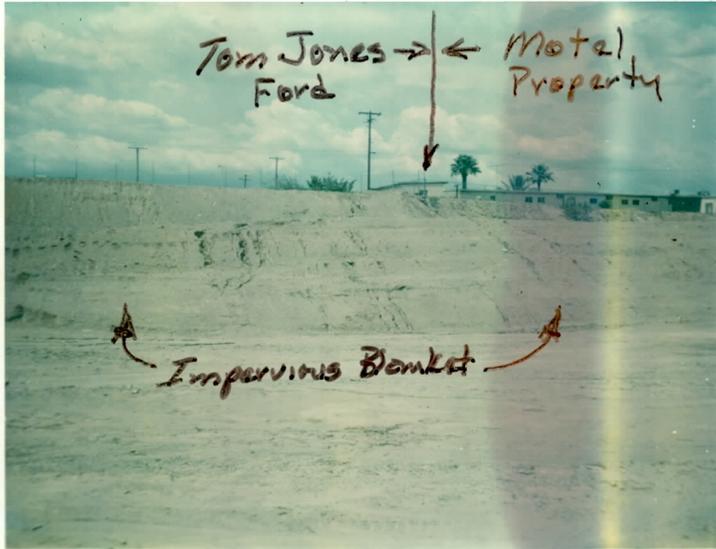
Sunset Dam. View of existing erosion on slope of impervious blanket on north slope of reservoir and upstream from embankment. 7-28-76

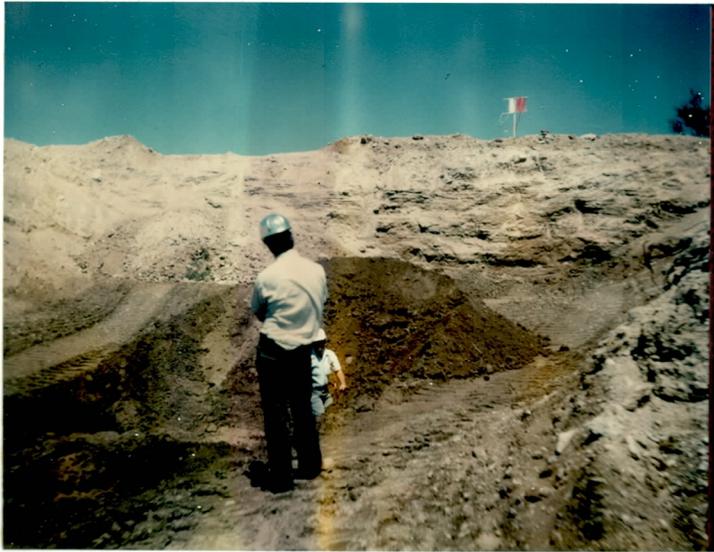
Sunnycove Dam. View of inspection pit by dozer for examination of materials placed in No. abutment cutoff.
8-9-76

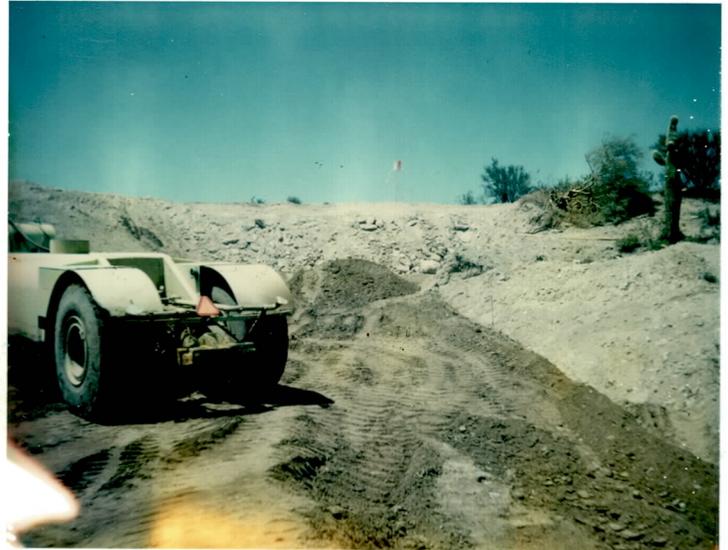
Sunnycove Dam. View of No. abutment after contractor made an attempt to slope cut bank in contest on this date by Inspection Agent and contractor.
8-9-76

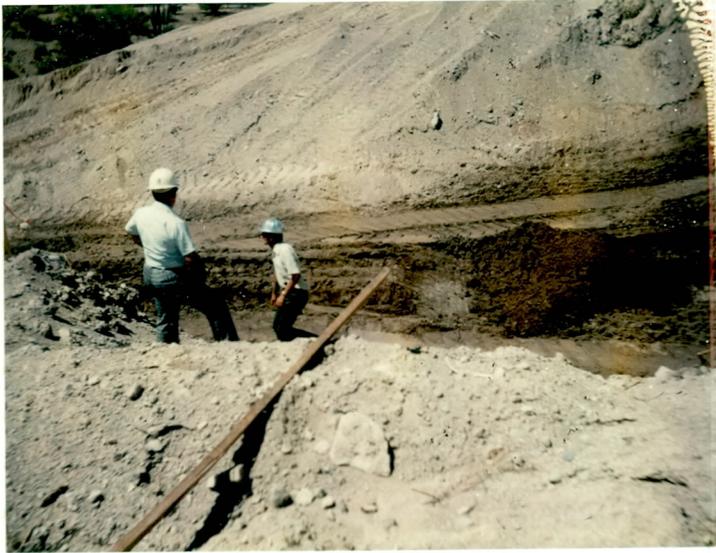
Sunnycove Dam. View of pit made by dozer for the inspection of compacted material in place at No. abutment. 8-9-76

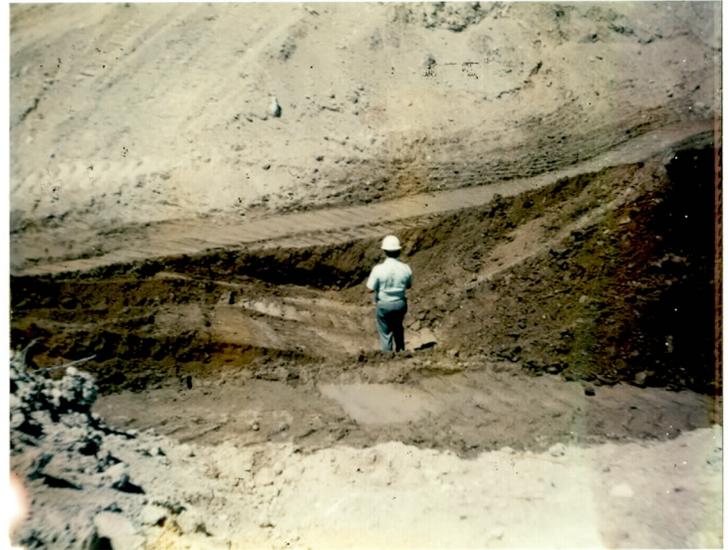
View of pit made by dozer for the inspection of compacted material in place at No. abutment. 8-9-76

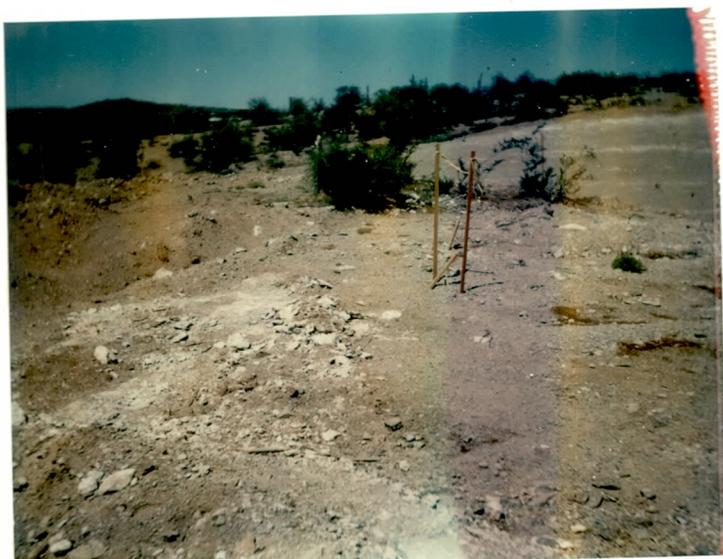
Sunnycove Dam. View of slope stake designating limit of 1 or 2 slope down to core trench termination at No. abutment. 8-9-76

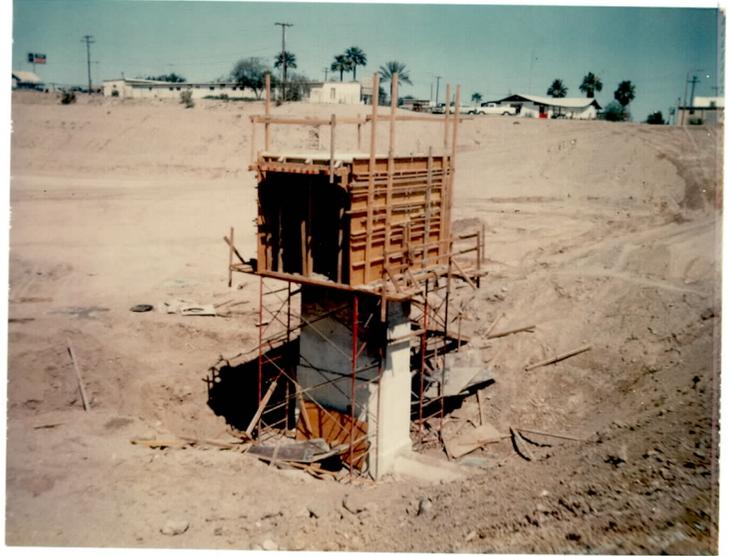
Sunset Dam. View of intake
structure 8-20-76

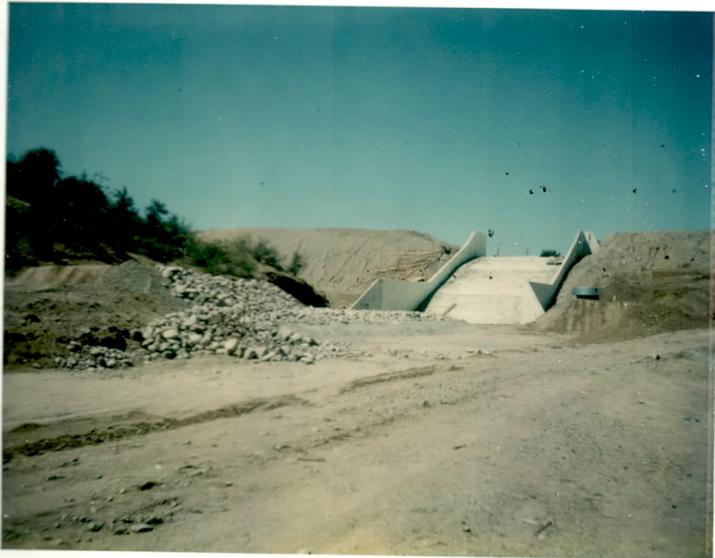
Sunset Dam. View of spillway
structure from downstream. Chute
slab, wing, walls and rip-rap.
8-20-76

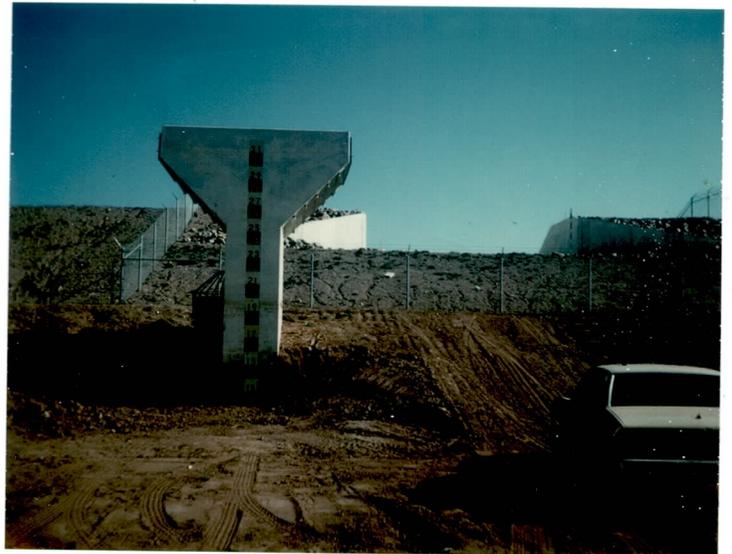
Sunset Dam. View of staff gauge
on upstream side of intake tower.
12-20-76

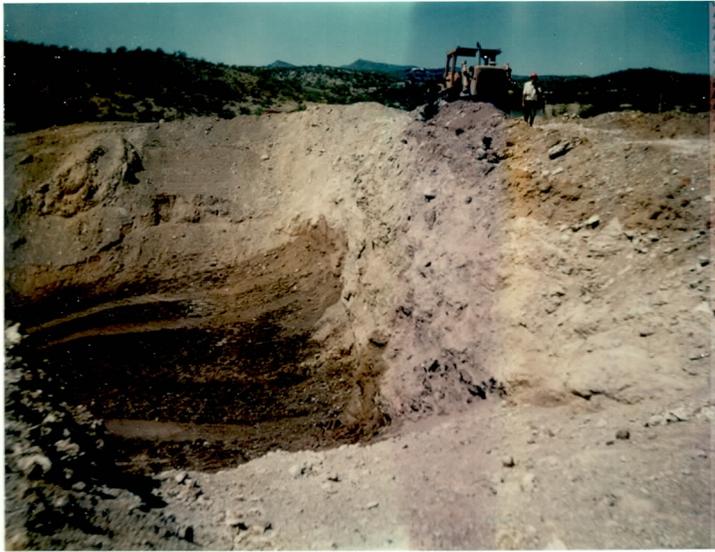
Sunnycove Dam. View of north abutment. Note well shaped slopes. 8-20-76

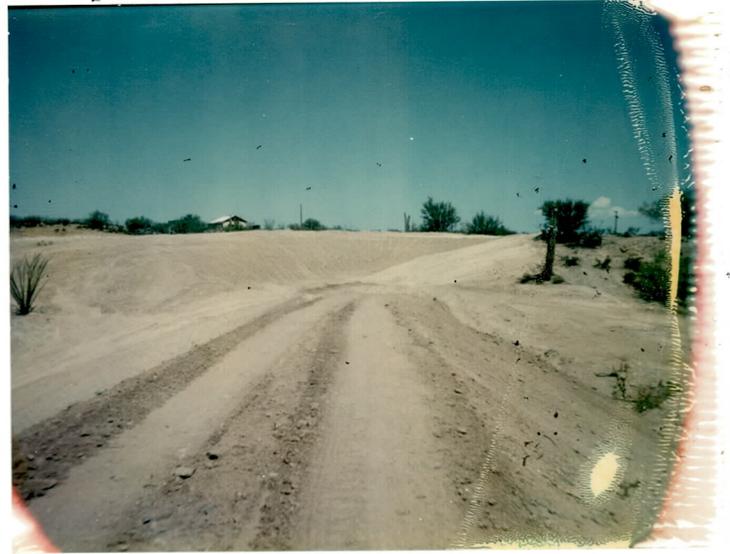
Sunnycove Dam. View of near vertical cut in dispute between Wakefield and Faar on this date. Contractor beginning to cut slope. 8-9-76

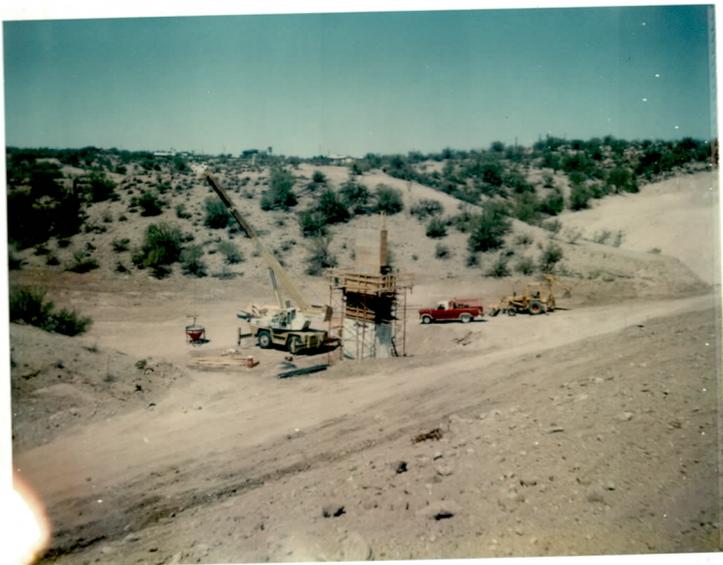
Sunnycove Dam. View of intake structure. 8-20-76

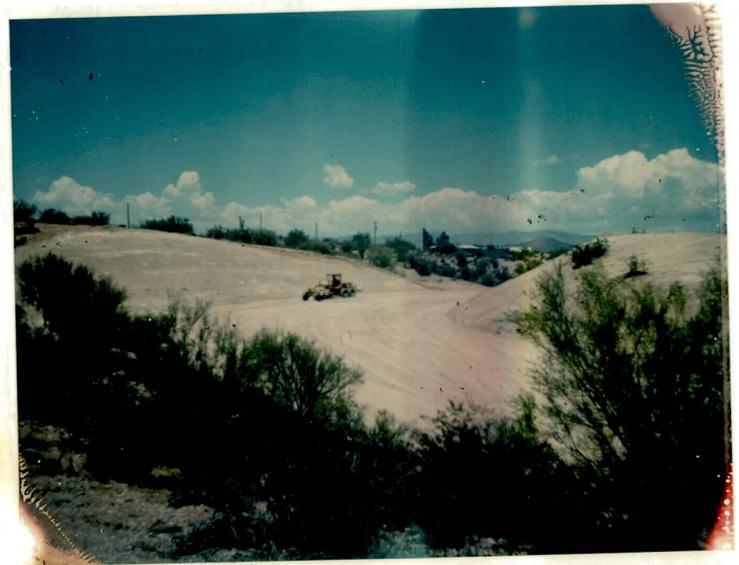
Sunnycove Dam. View of emergency spillway from upstream. 8-20-76

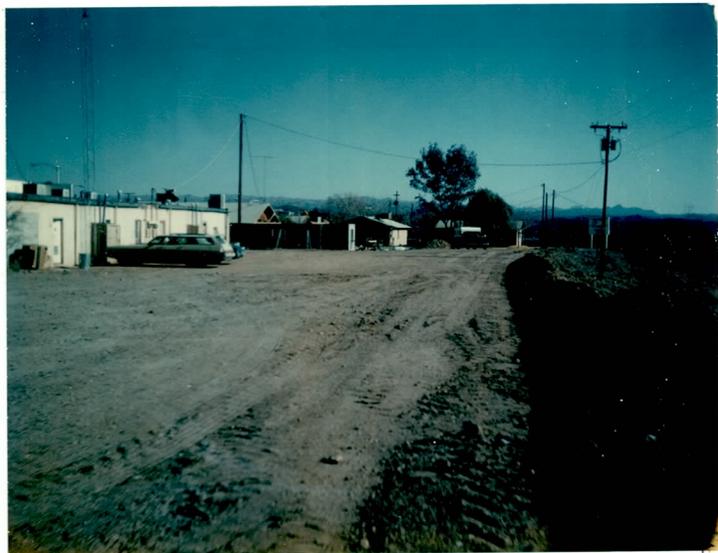
Sunset Dam. View of north abutment gate and adjacent property. 12-20-76

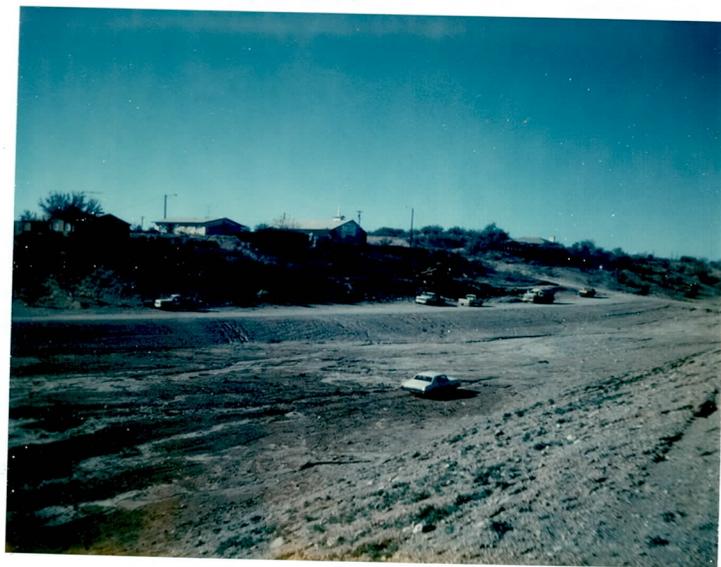
Sunset Dam. View of highwater road being constructed by Highway Department. 12-3-76

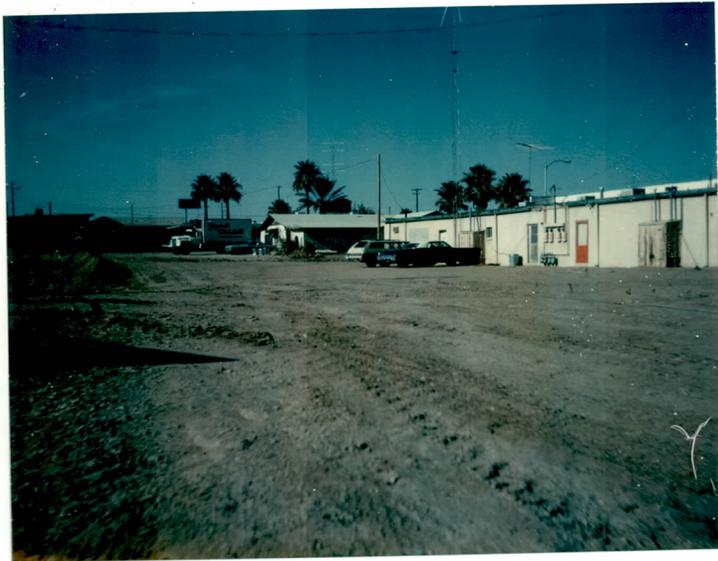
Wickenburg. View of upper end of reservoir showing properties showing on south side of reservoir serviced by highwater road. 12-20-76

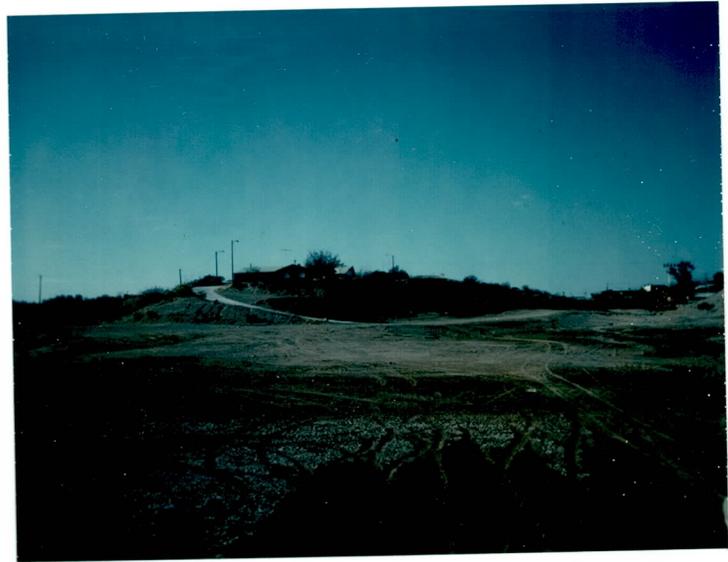
Wickenburg. View of parking area in rear of Young property looking west. 12-20-76

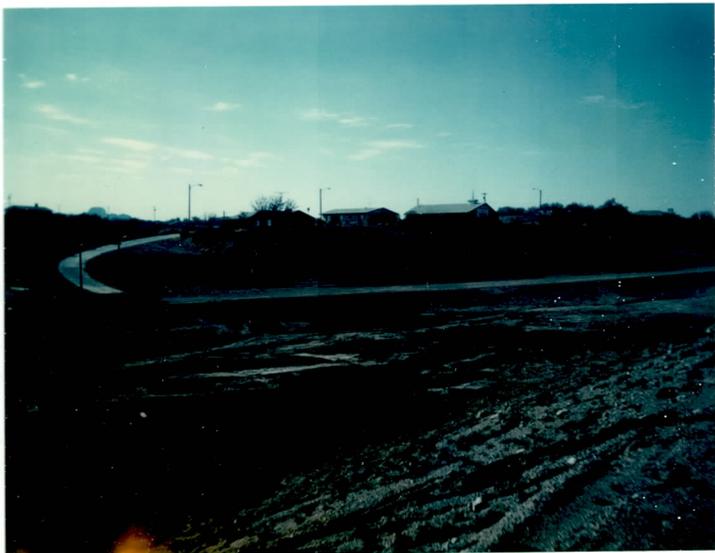
Wickenburg. View of upper end of reservoir showing properties on serviced by highwater road. 12-20-76

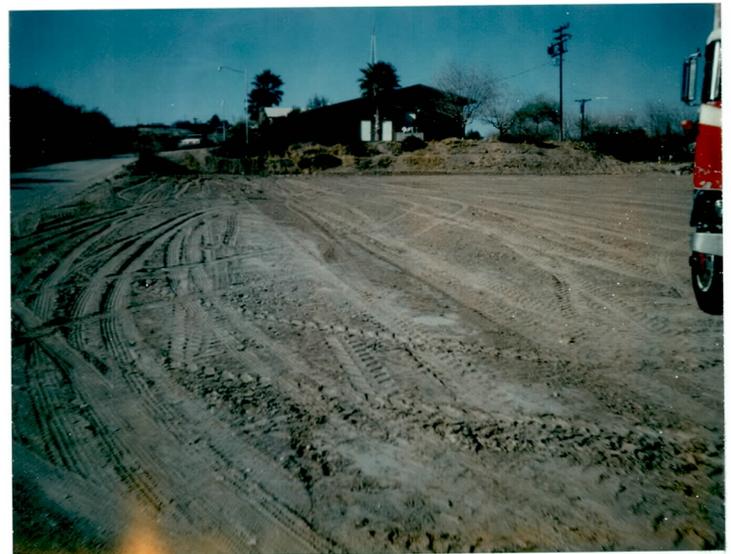
Wickenburg. View of vacant lot adjacent to LDS church after fill placed by FCD. 12-20-76

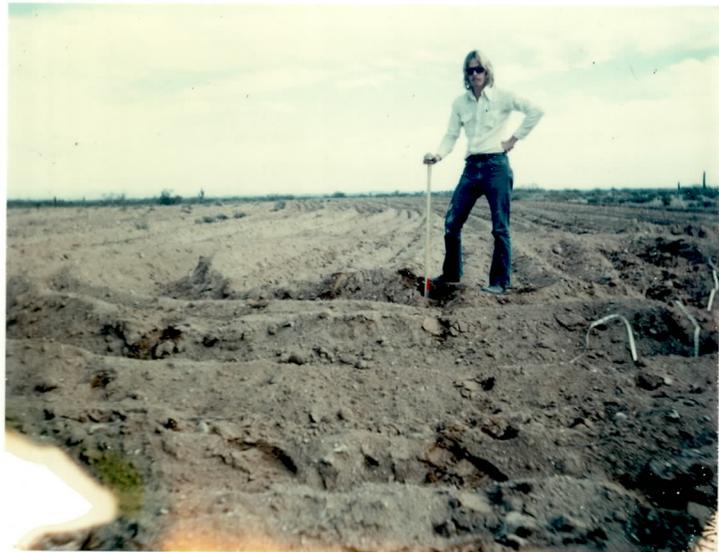
Dam #3. 23" to bottom of ripping.

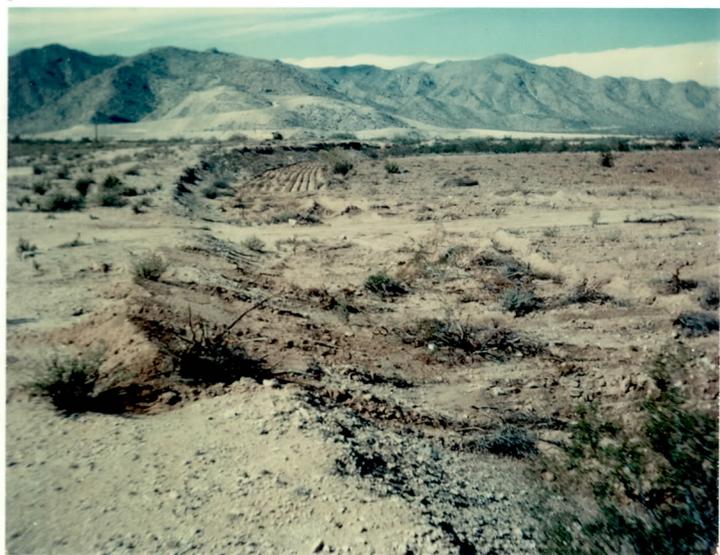
SCS Dam #3. Water was 15' from top
of dam. 9-16-77

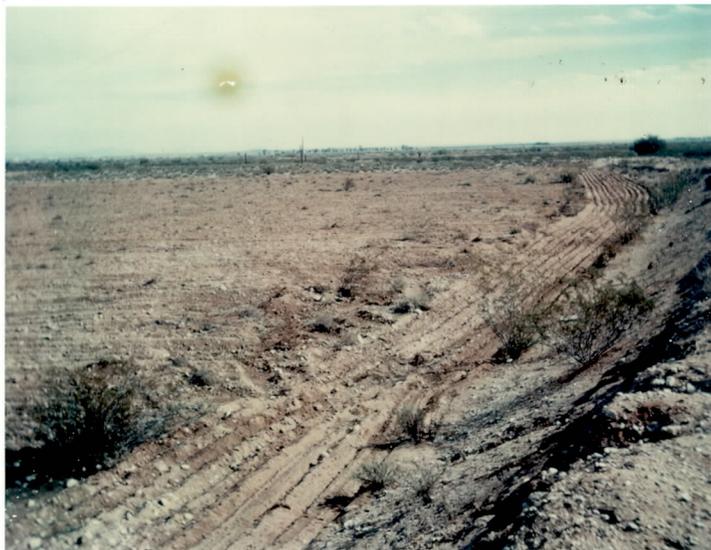
SCS Dam #4 spilled 9-6-70.
(Both pictures)

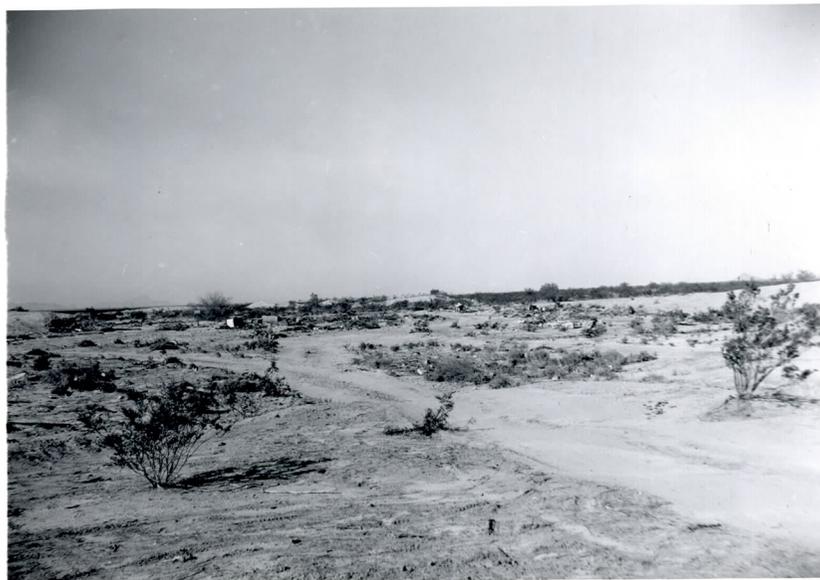
North spillway SCS Dam #4. Flowed 9-6-70.
1-2' deep, 200' wide. 9-6-70

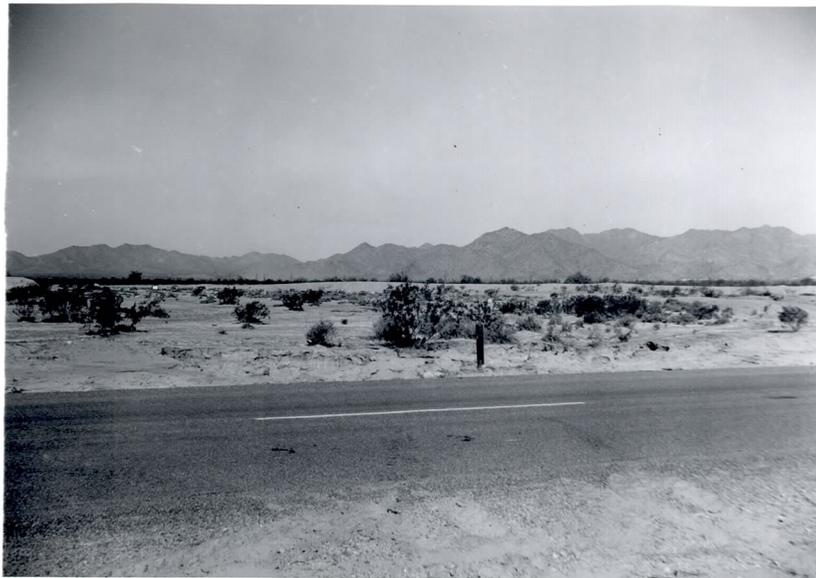
North spillway SCS Dam #4. Entrance to ditch
along Jackrabbit Trail. 9-16-70

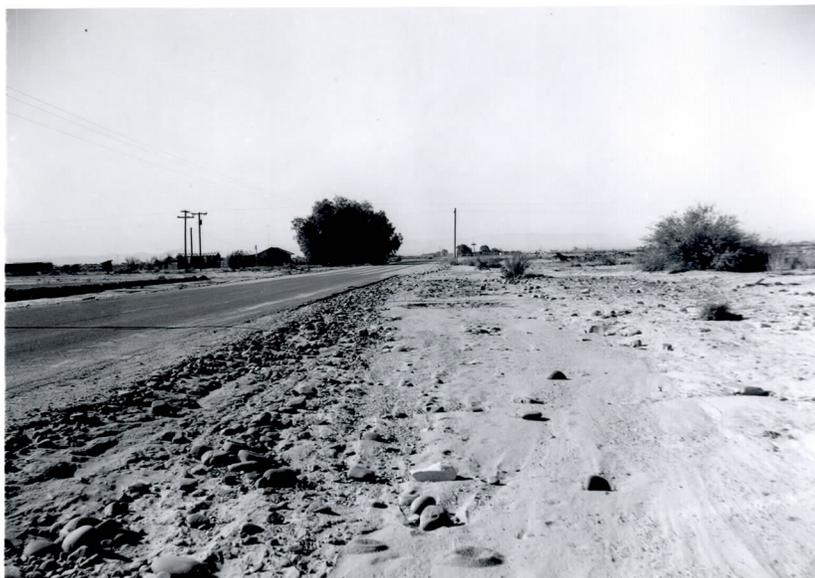
South along channel west side of
Jackrabbit Trail north of SCS Dam
#4. Flowed 9-6-70. 3' deep, 40'
wide. (See report in file dated
9-23-70)

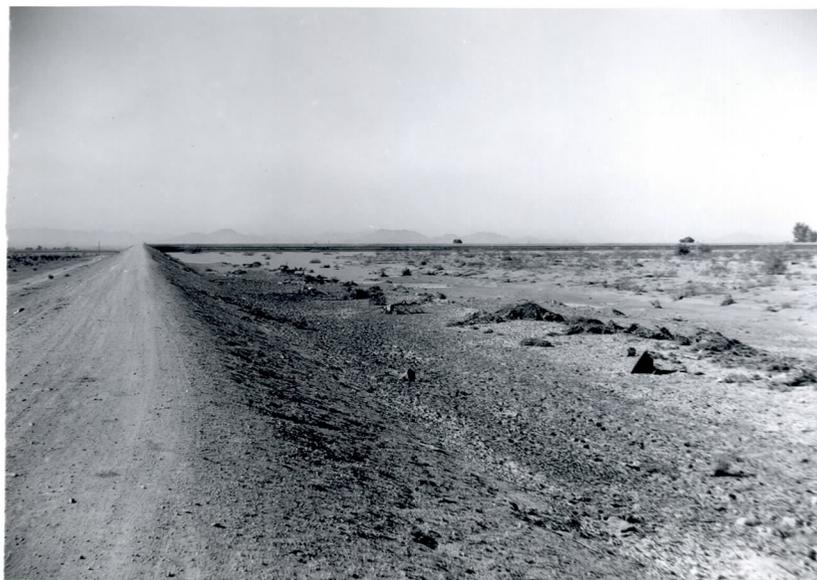
SCS Dam #4 looking south. Dam spilled on 9-6-70.
