Photo Dates: 1923-1993

Cave Creek Dam, Powerline, Rittenhouse, Vineyard Road Dam, Wittmann Wash, Wickenburg Areas various Washes

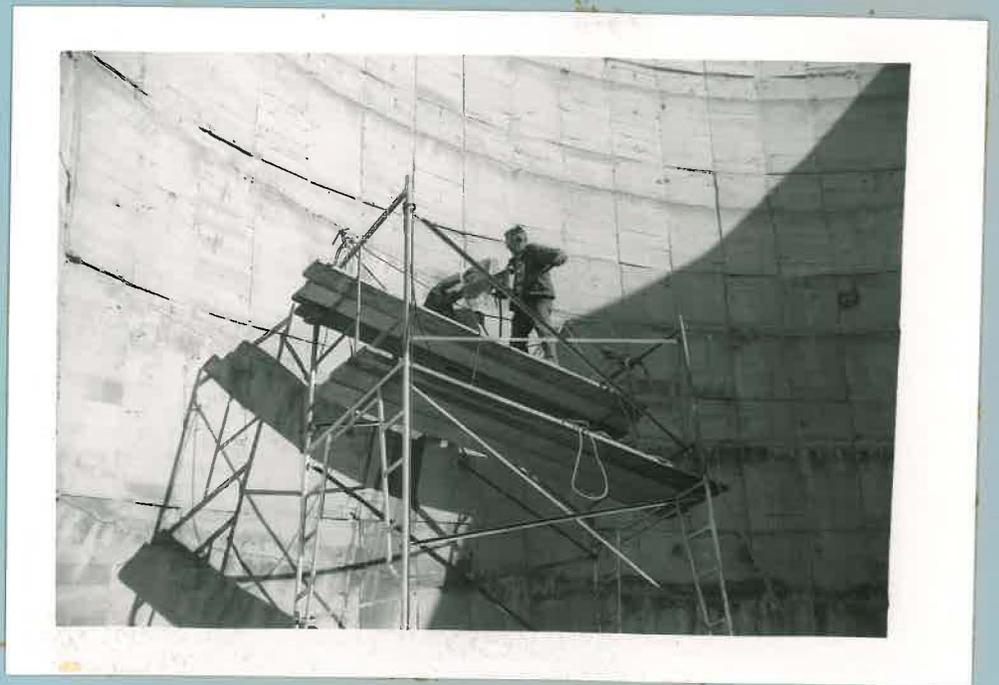
Cave Creek Dam  
A leak in it

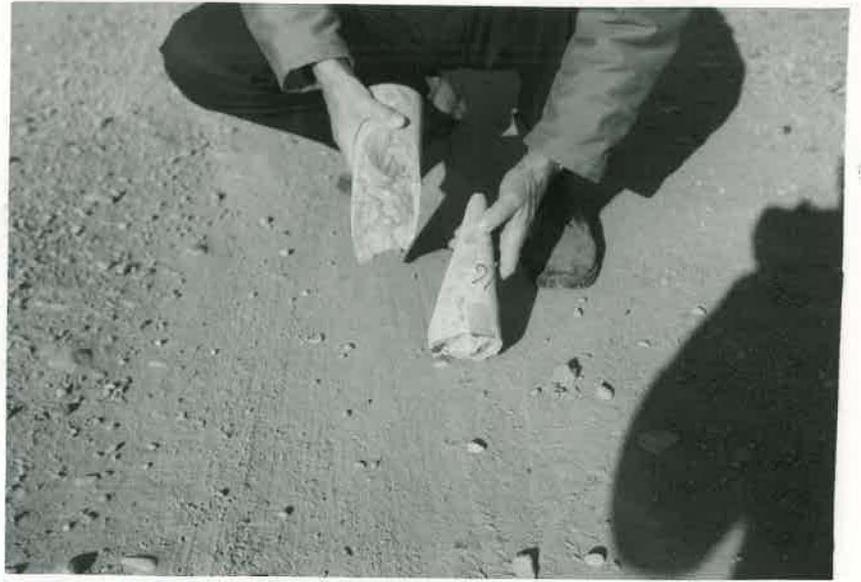
Core sample #16 through  
concrete joint.

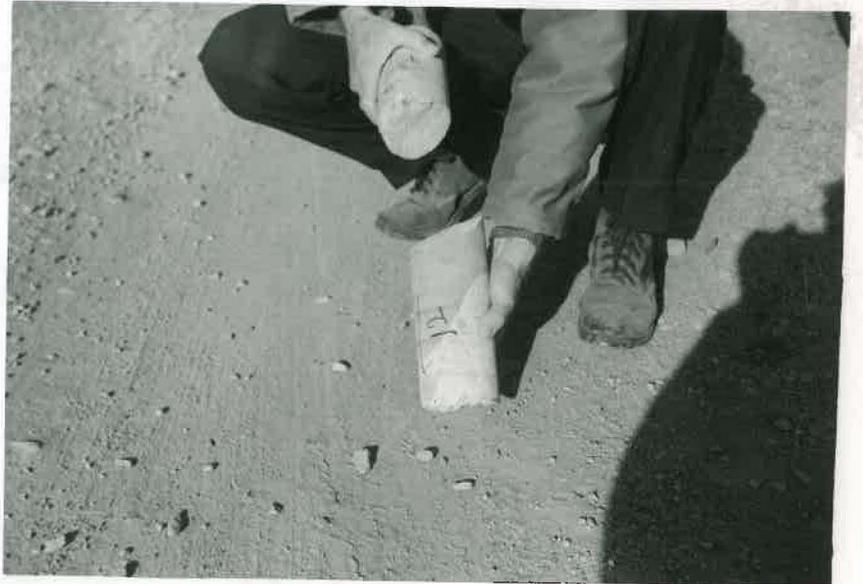
Core sample #12  
insufficient adherence  
of cement to rock.

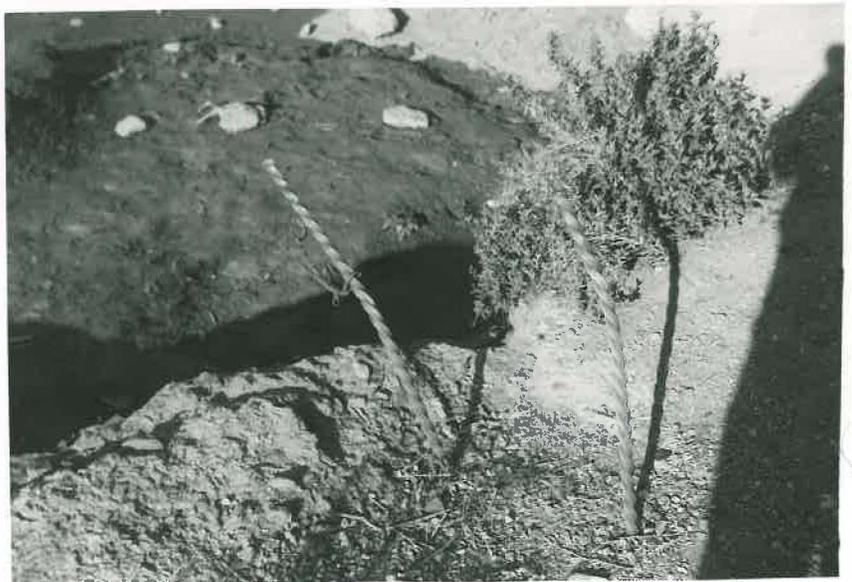
Twisted square rebar,  
type used in construction  
of dam.

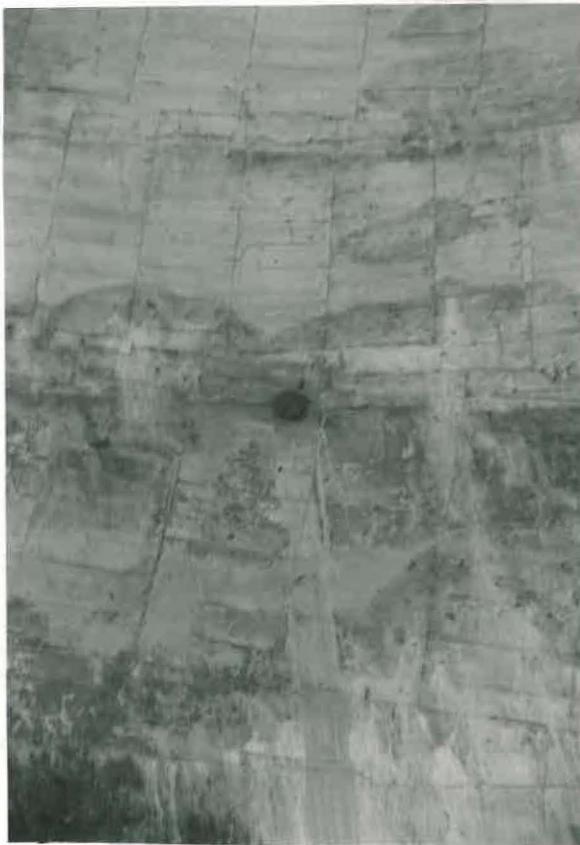
Core sample hole plugged.

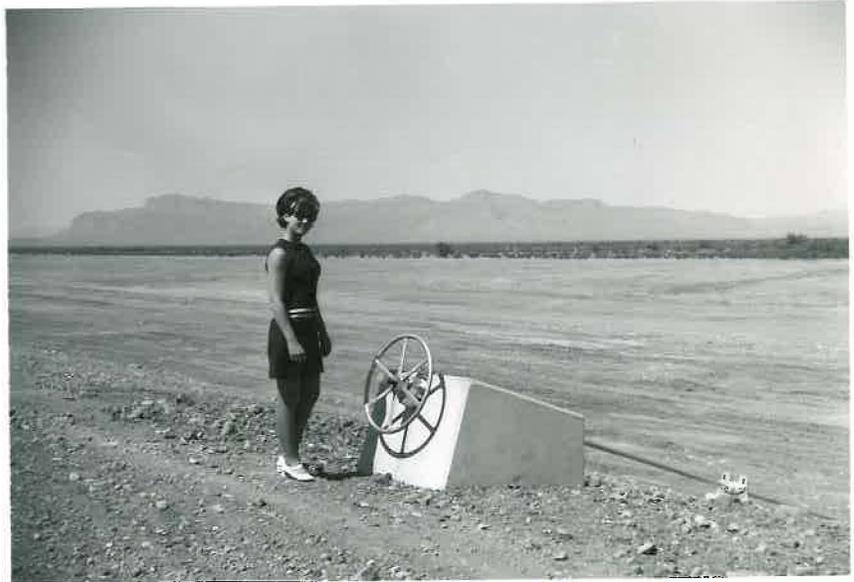
SW $\frac{1}{4}$  Sec. 16, T1S, R8E  
(H. C. Dobson) SE end  
of tank. Overflow has  
occurred around this end.

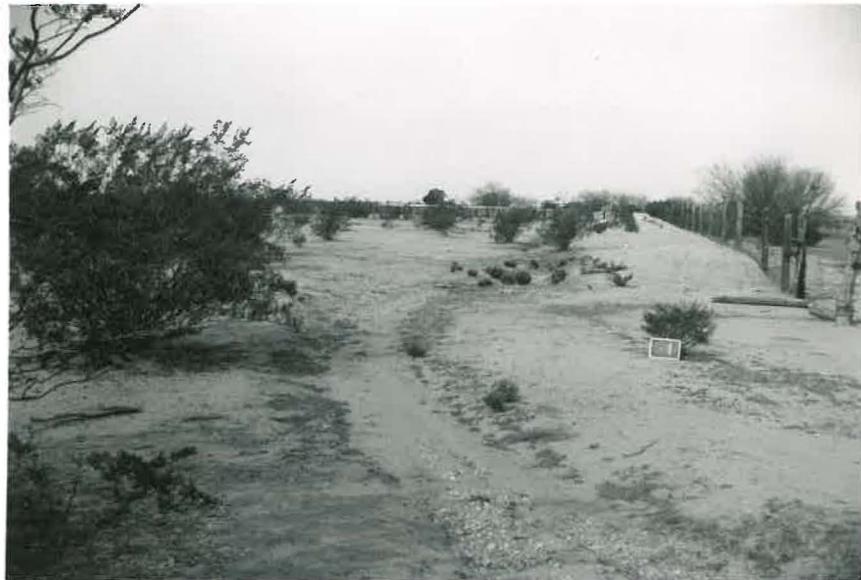
NE end of tank.  
Overflow point is  
5' below elevation  
of dam.

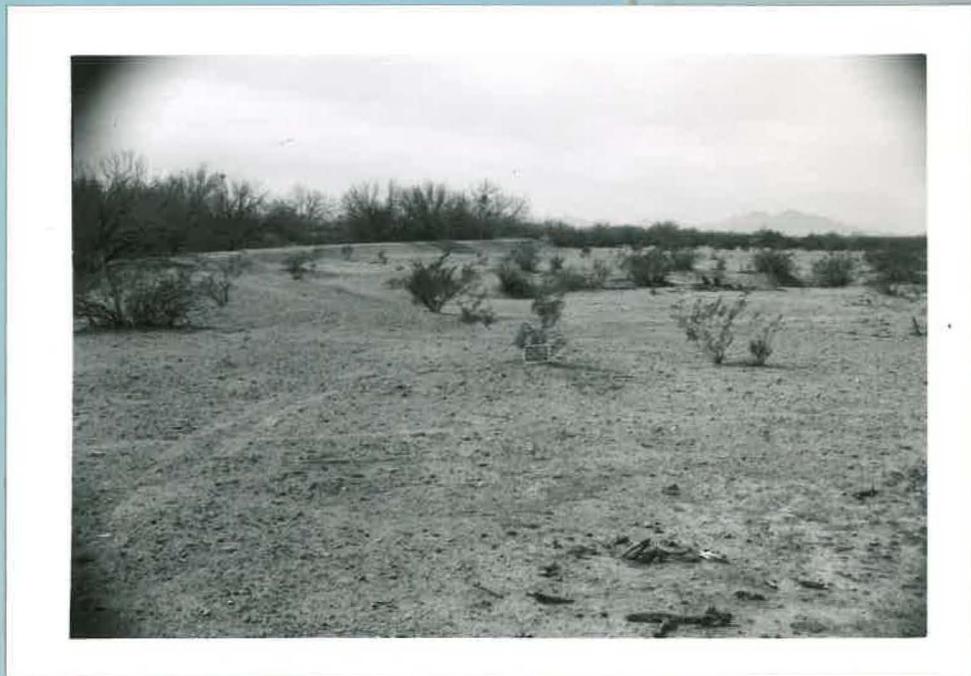
NW $\frac{1}{4}$  Sec. 30, T1S, R8E  
(M. Anderson) SE end.  
Overflows thru channel  
around this end. Channel  
is 7' below top of newly  
rebuilt dike.

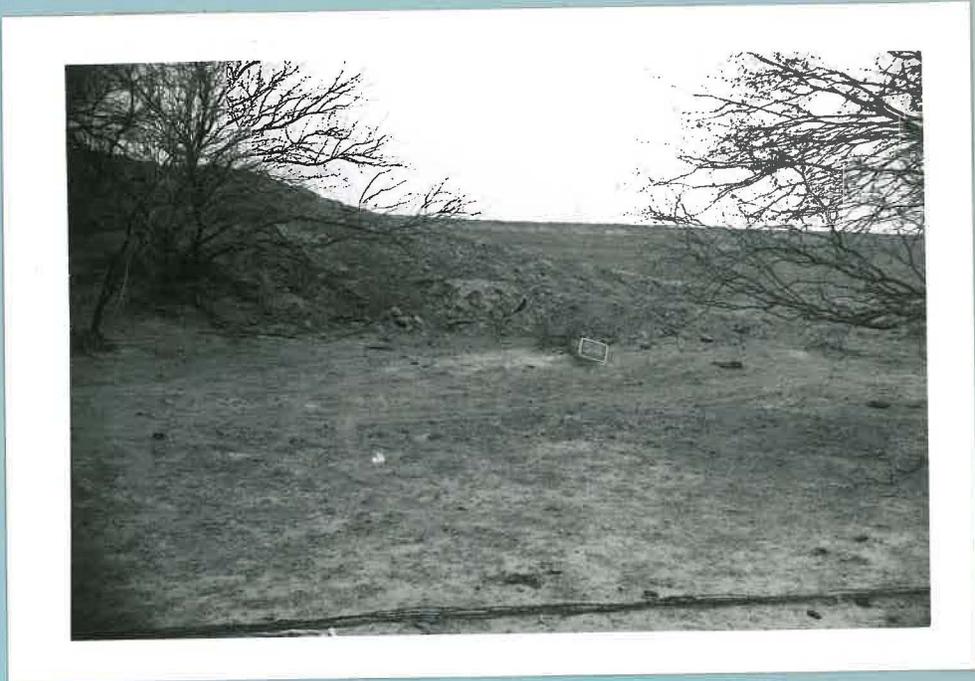
NE end. Can Overflow  
around this end when  
water surface exceeds  
elevation of small dike  
Small dike is 5' below  
top of dam.

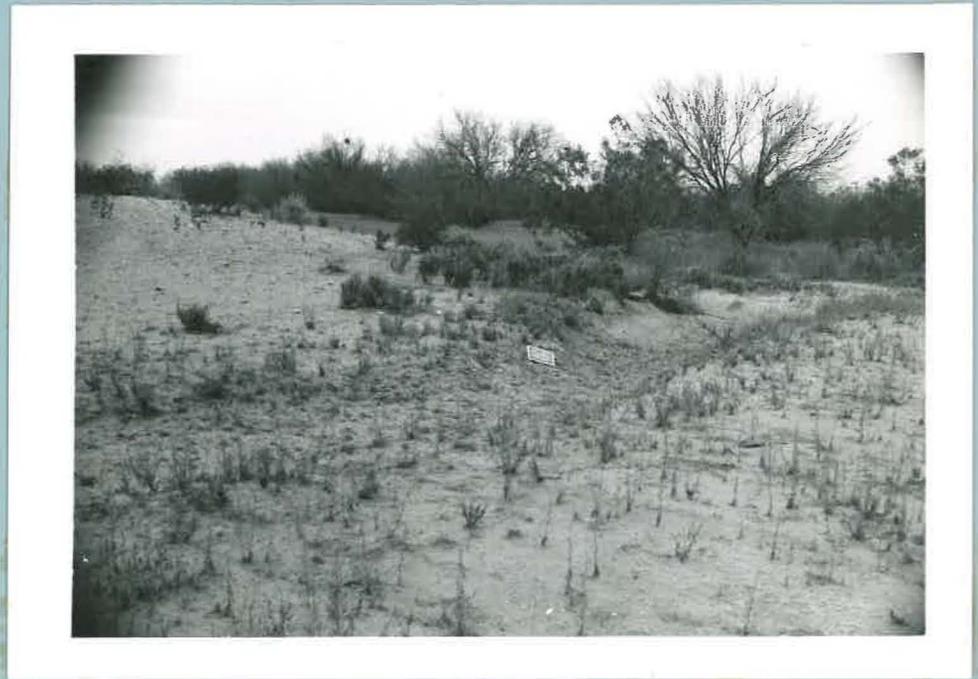
NE end. Can spill  
around this end, 4'  
lower than top of  
dam.

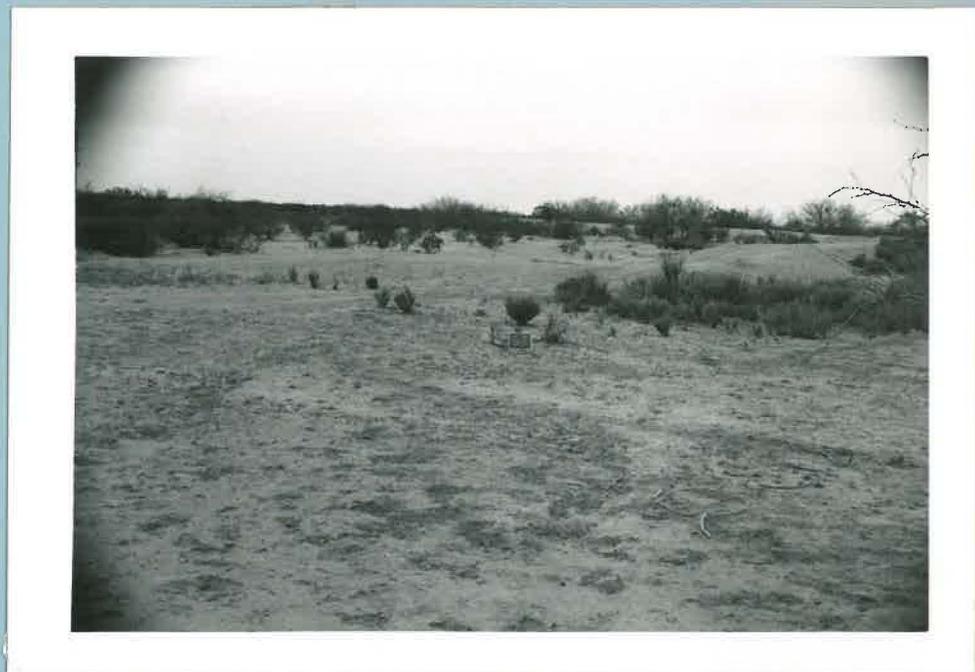
NE end, spills  
around this end,  
4' below top of  
dam.

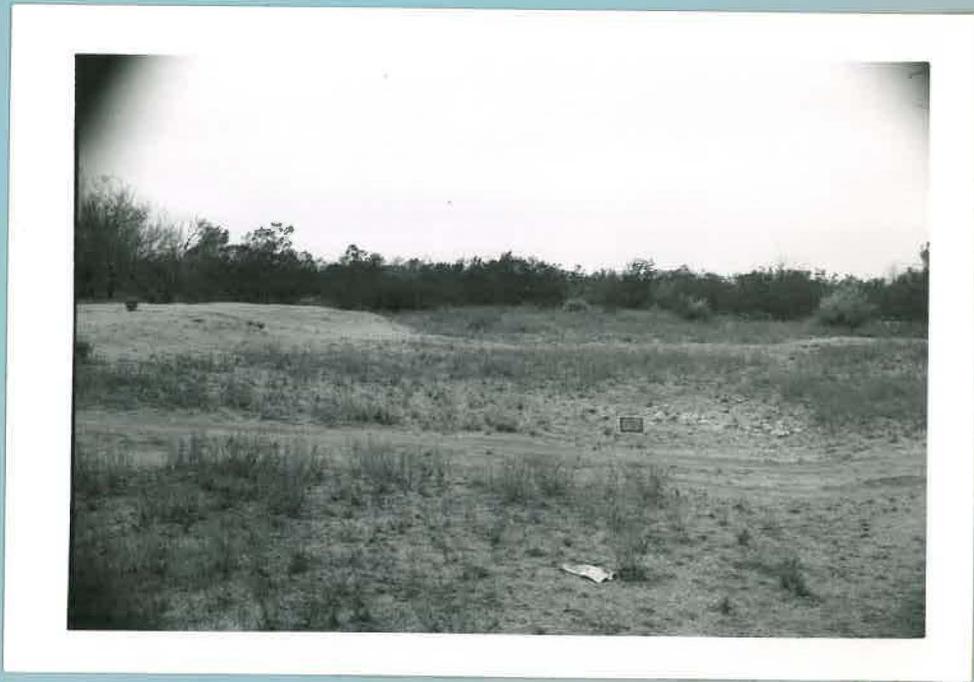
NE $\frac{1}{4}$  Sec 5, T2S R8E  
(Phoenix T&T) SE end  
Tank now dry due to  
break in center of dam.  
Flow has gone around  
this end 3' lower than  
top of dam.

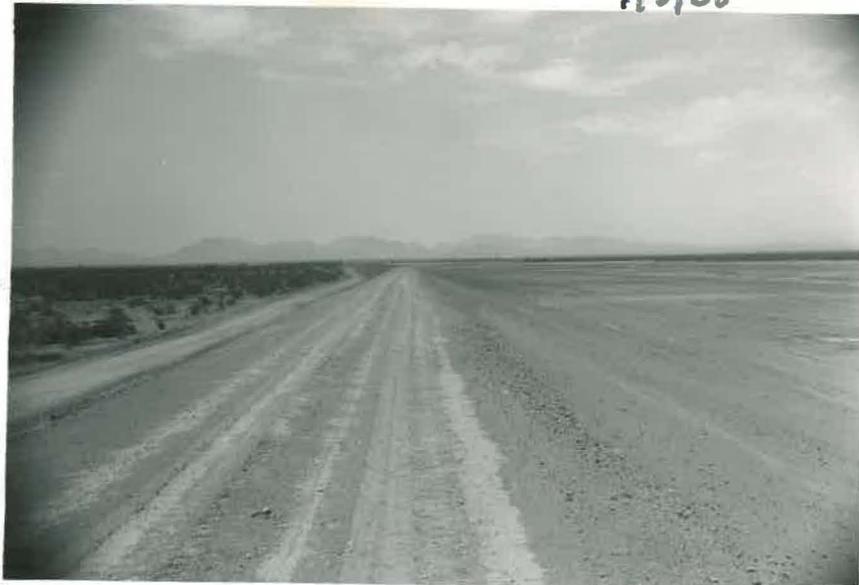
68-56 Crack So. of  
Gate 3

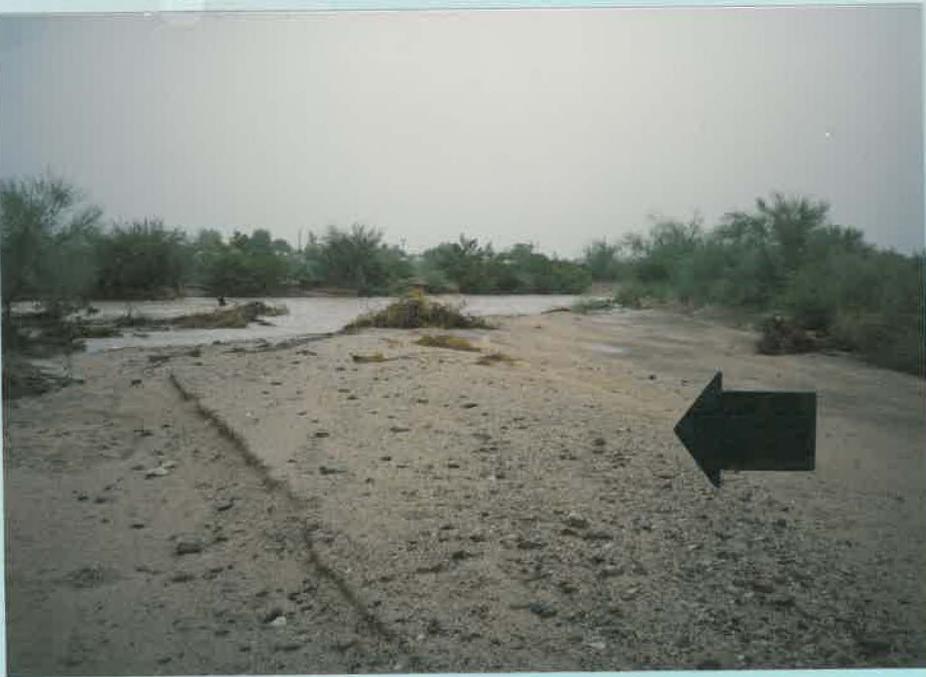
76

POINT OF BREAK OFF

ORIGINAL WASH FILLED WITH SEDIMENT -

- STANDING ON ORIGINAL WASH

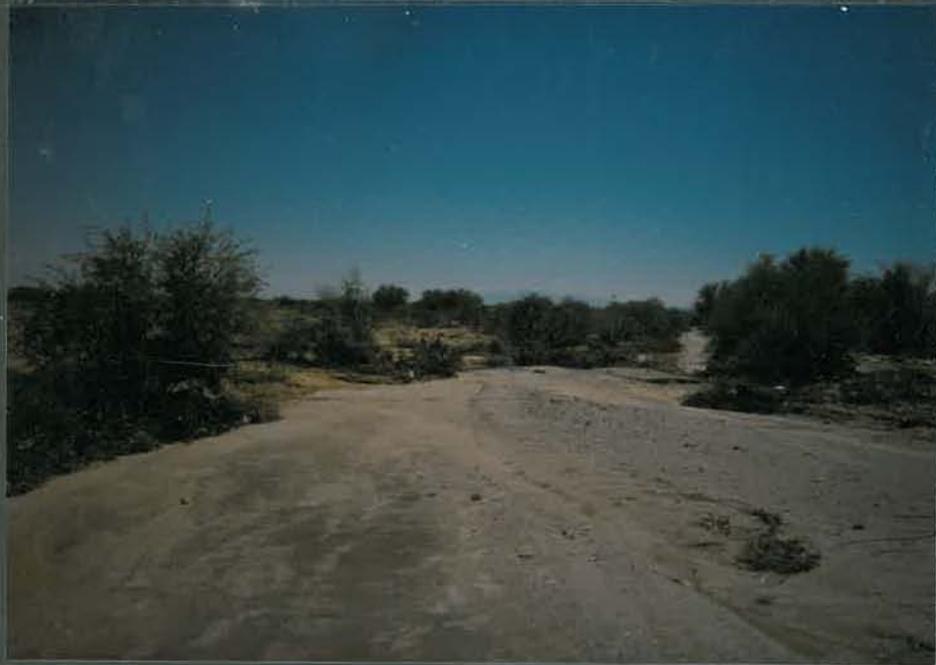
Standing in floodway which was filled in

Wittmann Wash S. of Grand Ave.

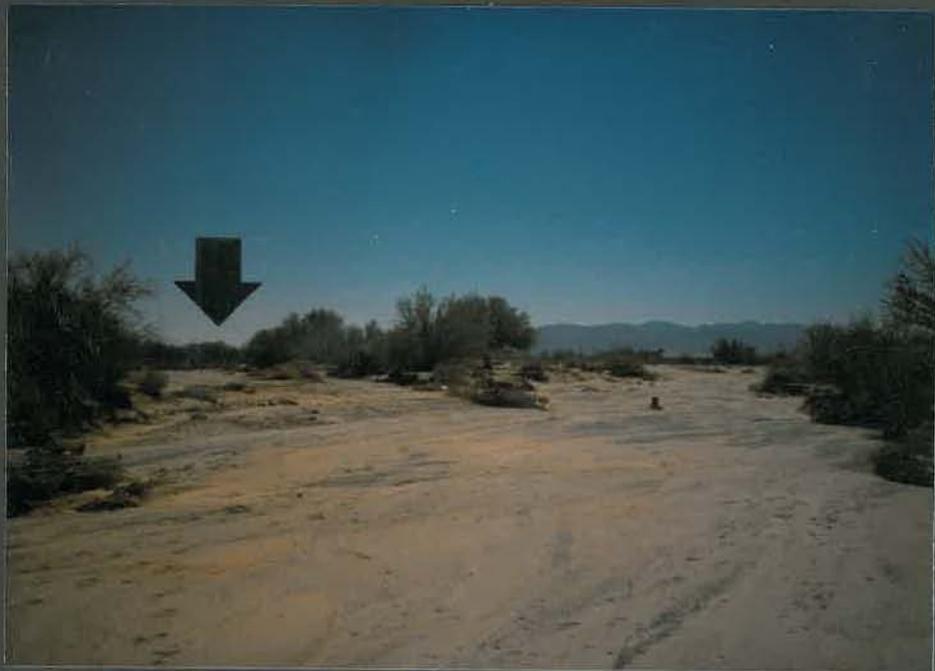
Main channel to east filled in with sediment

Labor Day rains 9-3,5,-90

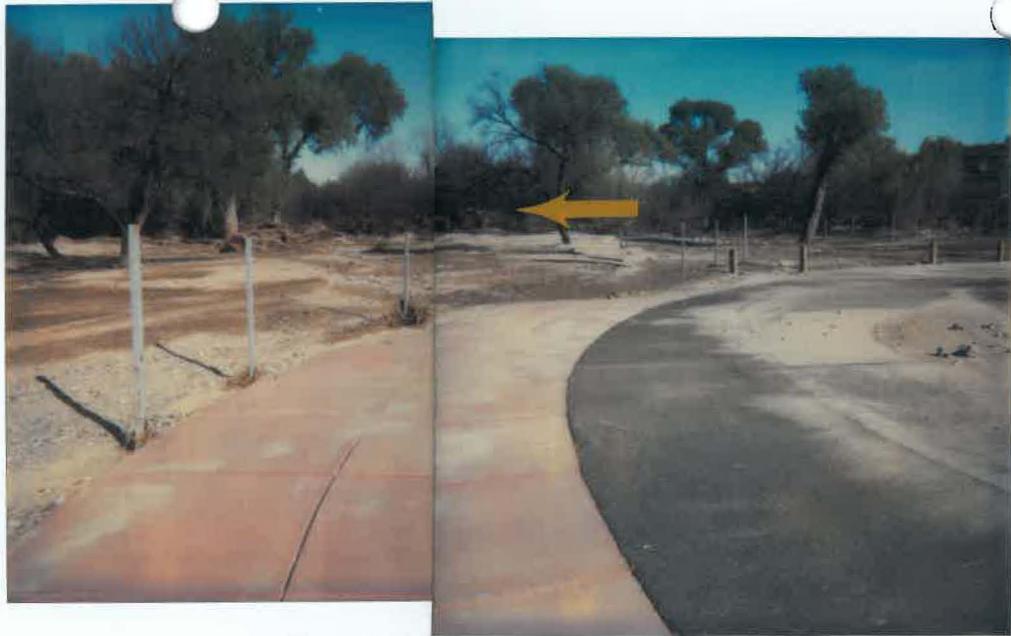
84

ADOT Rest Area along the Hassayampa R.  
Looking upstream  
A Arrow marks debris line 3/5/93

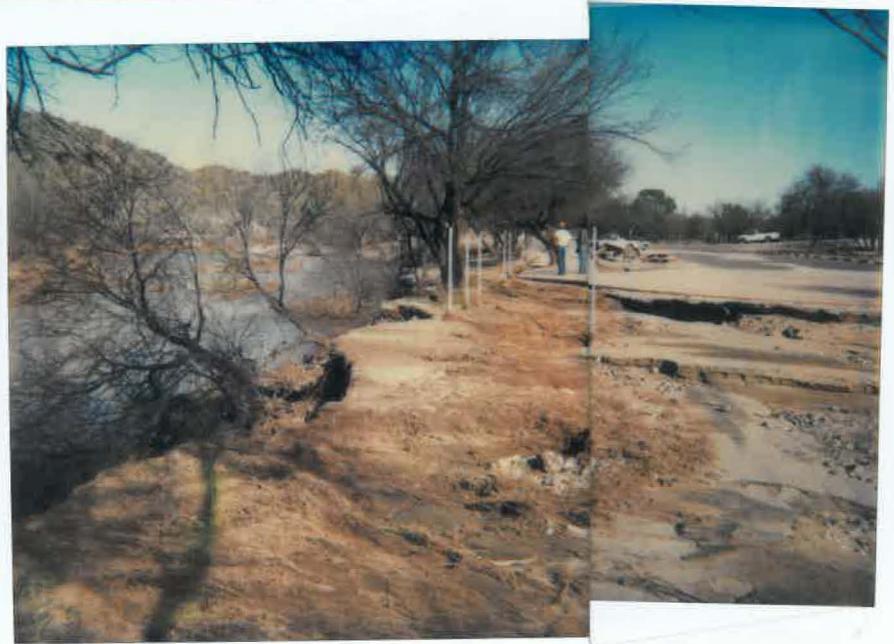
85

ADOT Rest Area along the Hassayampa R.  
Looking upstream in both pictures  
Arrow marks debris line  
3/5/93

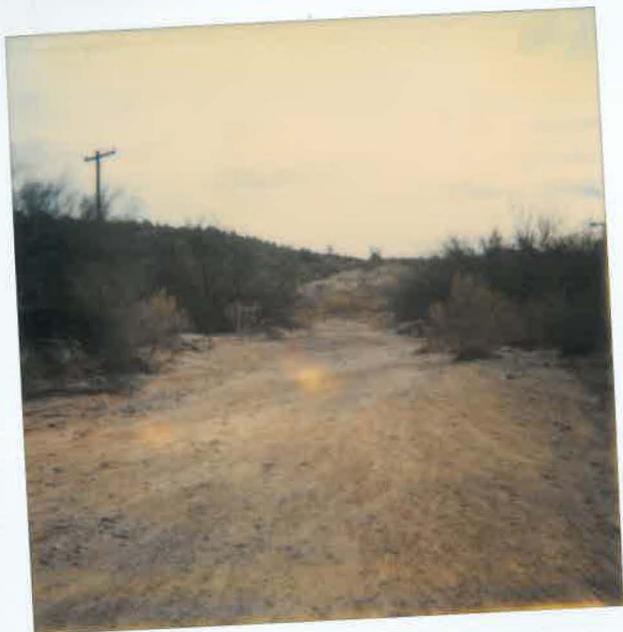
86

Monarch Wash.

(double bridge).  
upstream controlling.

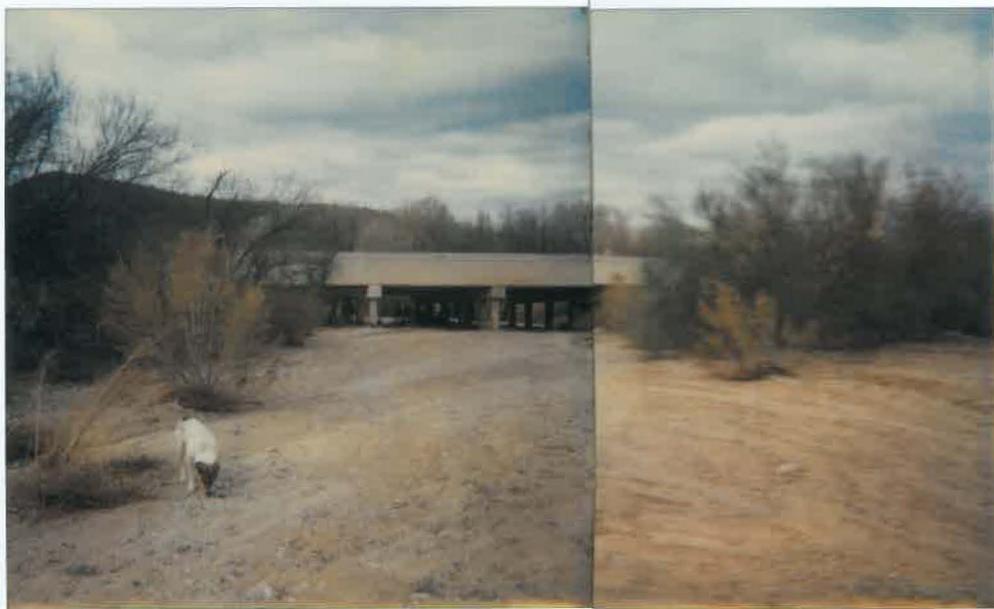
87

upstream face of bridge

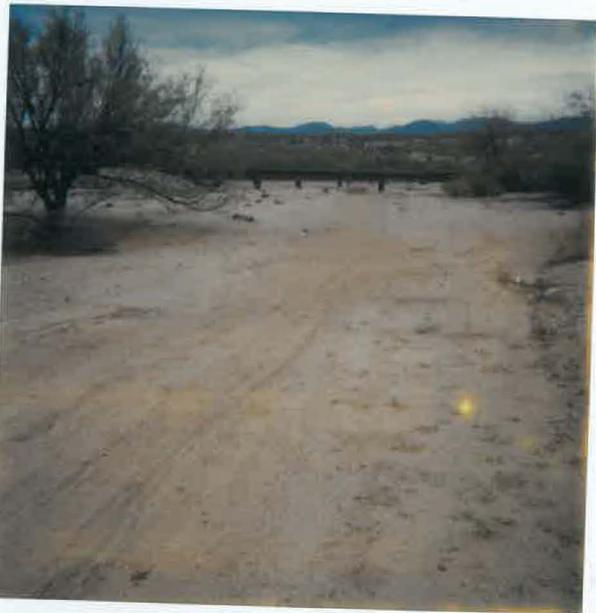
looking downstream toward bridge  
(a 3' drop in grade at entrance to bridge)

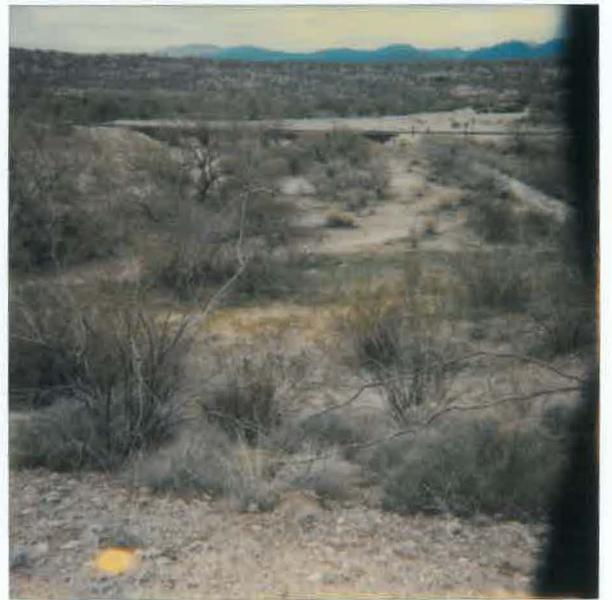
92

standing along right overbank  
looking down stream  
Note dike along ROB  
built in 1929

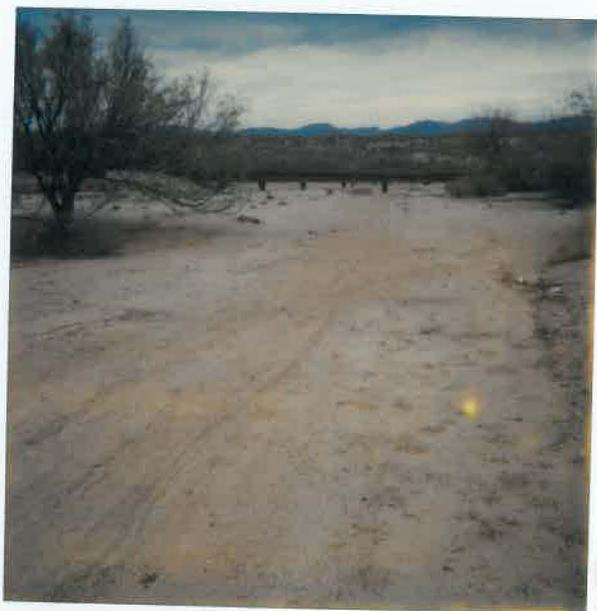
looking downstream toward bridge  
(a 3' drop in grade at entrance to bridge)

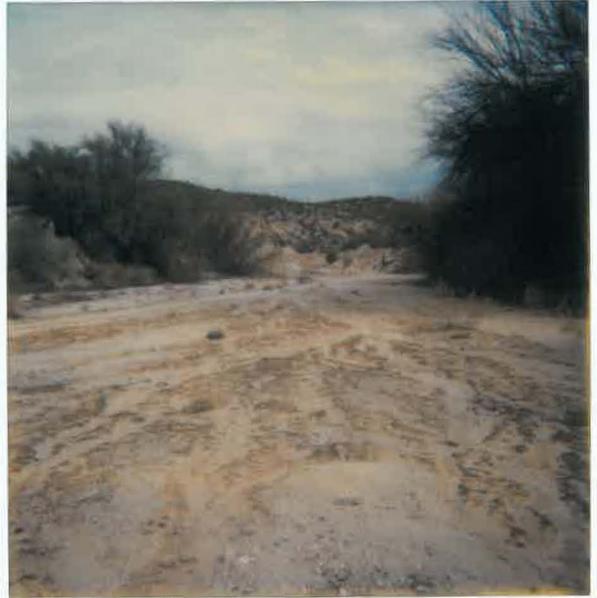
Calamity Wash looking upstream - dike along R.O.B.

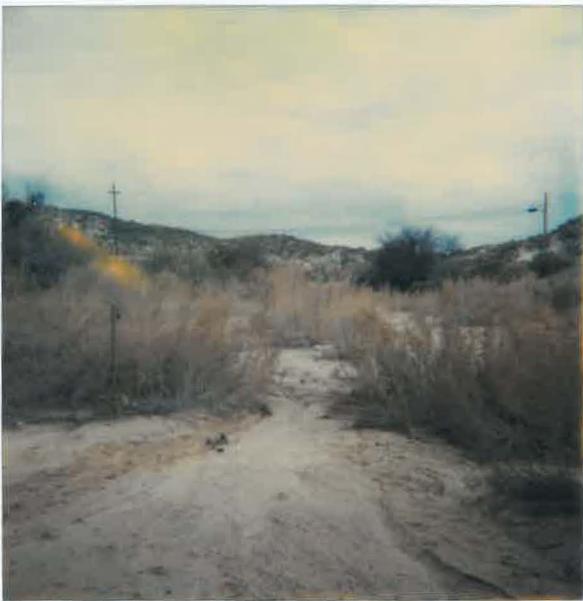
95

looking upstream - recent grading of left over bank - Note dike + drainage pipe placement.

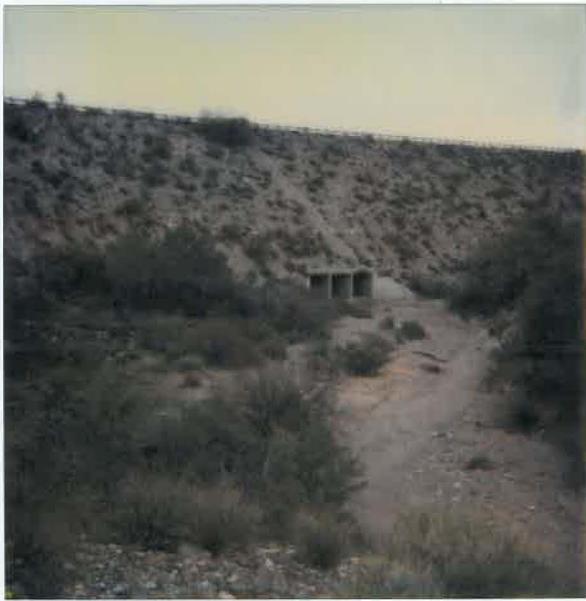
V-Wash  
10 x 10 culverts

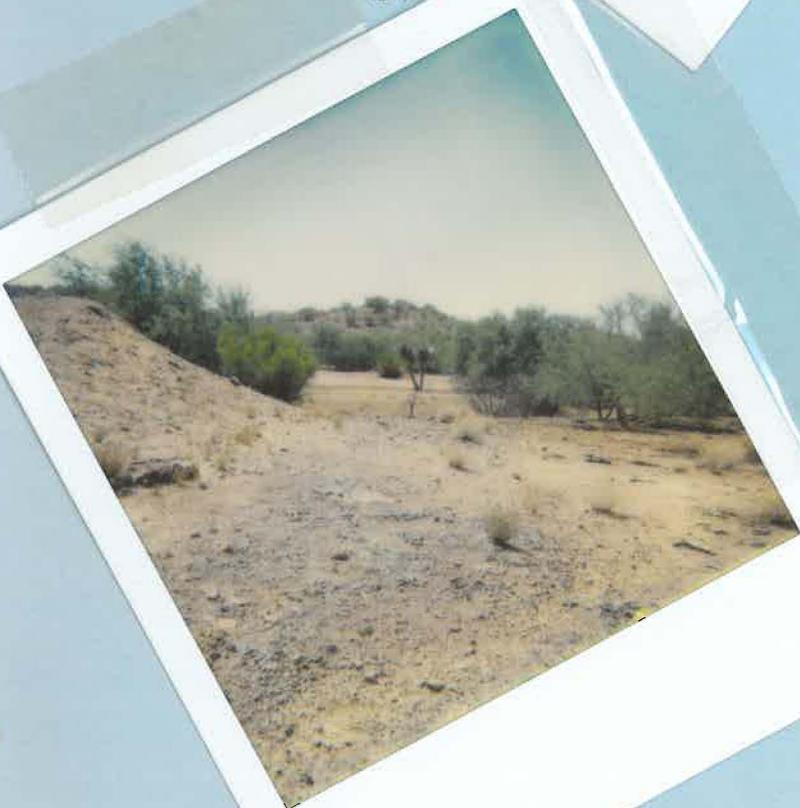
104

Downstream of Siltation  
Basin - (looking S)  
Flying E. Wash - Wickenburg  
8-2-89

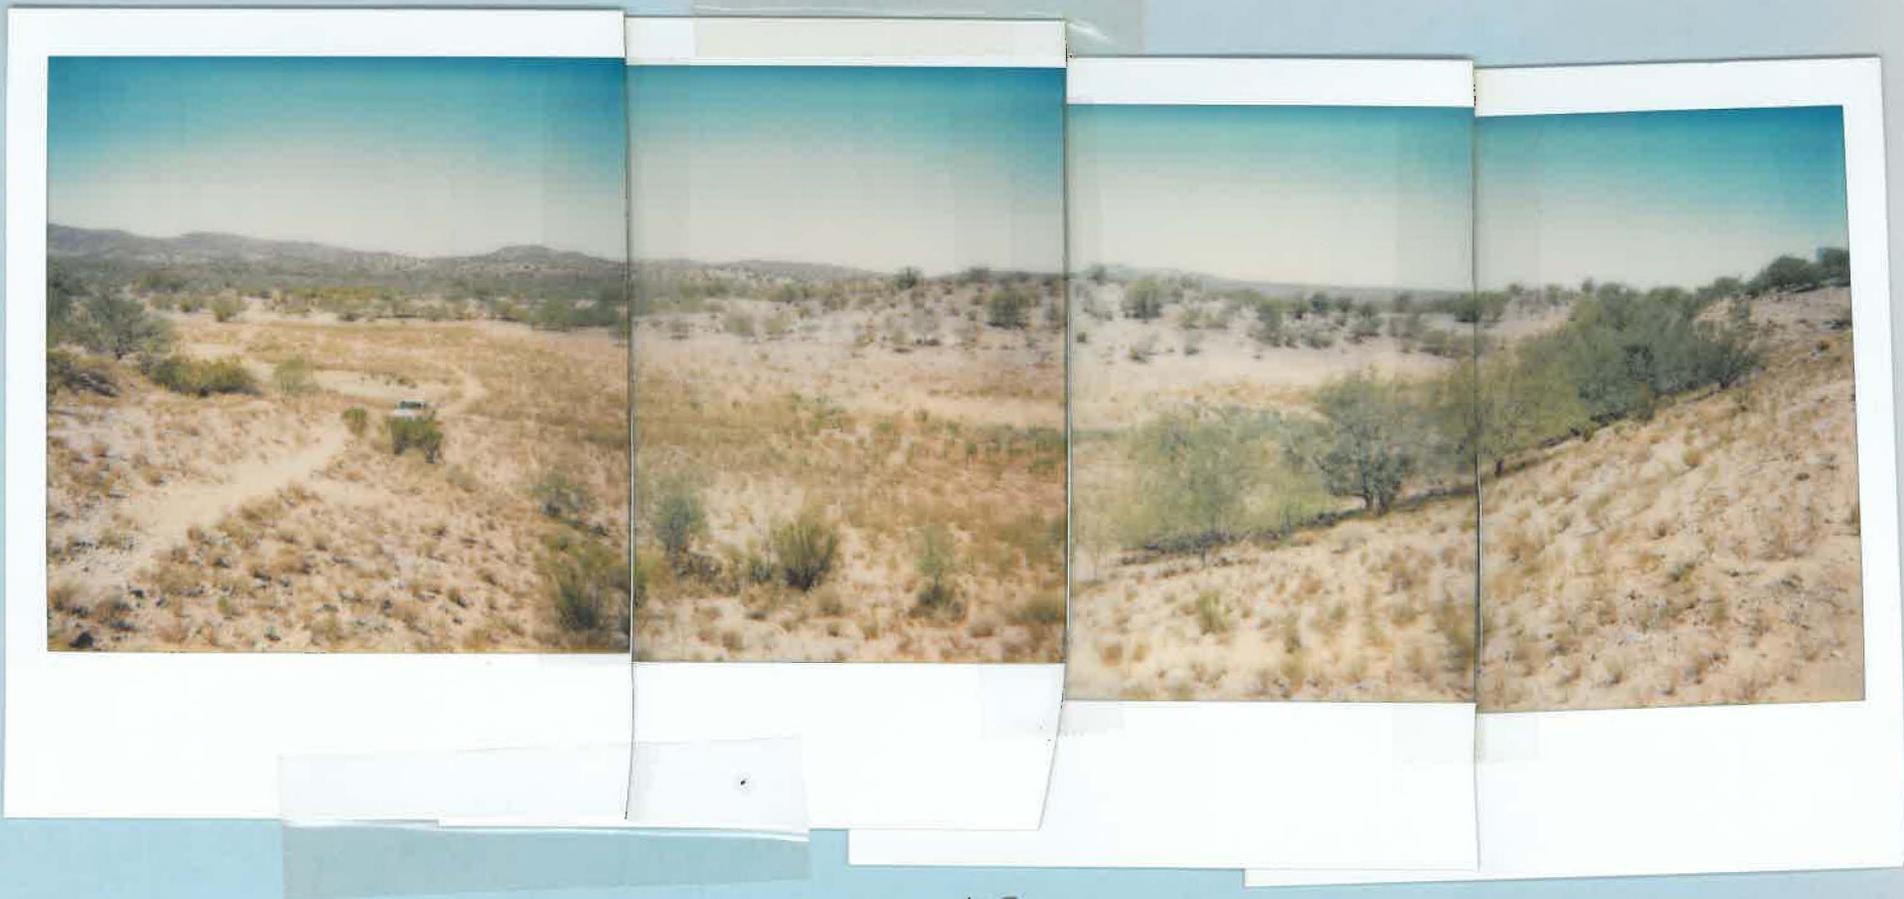
105

STANDING ON DAM looking South - (UPSTREAM of Flying E. Dam).

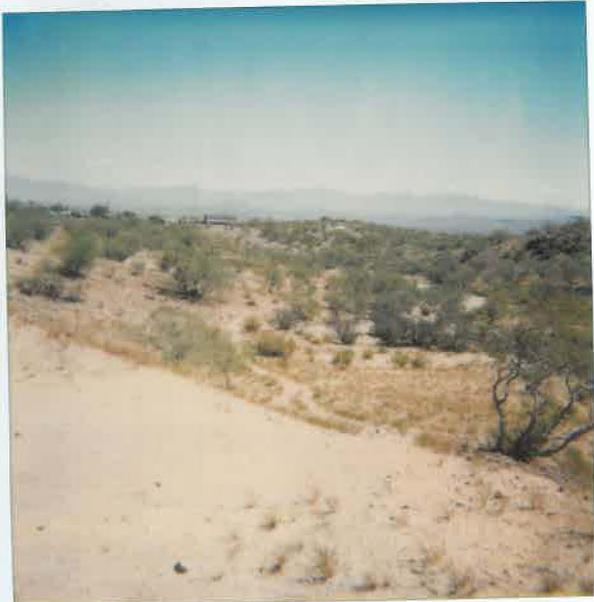
106

Looking Upstream  
(Standing on Dam.)  
AT DEVELOPMENT SITE  
LOCATION

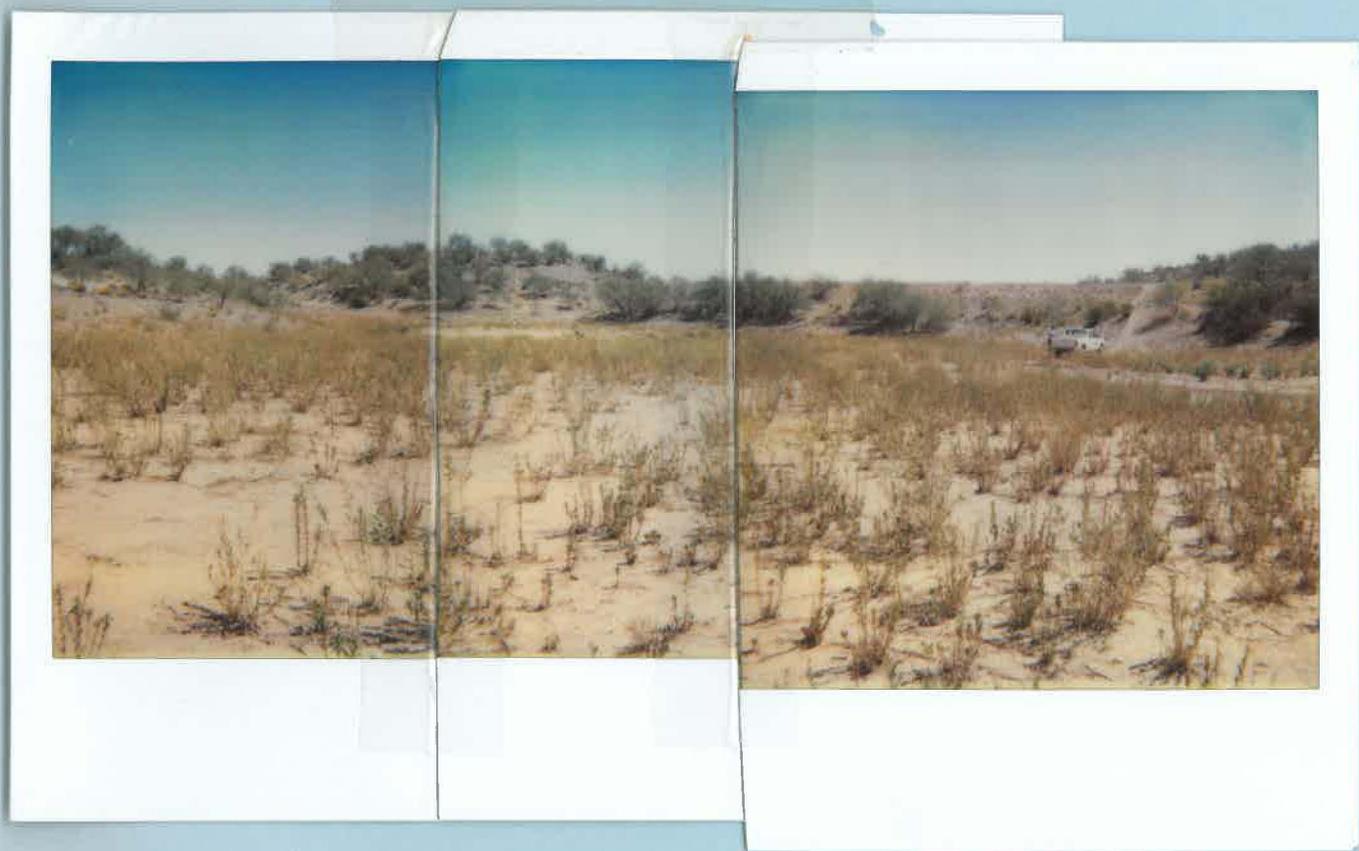
DOWNSTREAM SIDE of Dam.
