1986

The Tucson, Arizona, Flood of October 1983

Committee on Natural Disasters
Commission on Engineering and Technical Systems
National Research Council

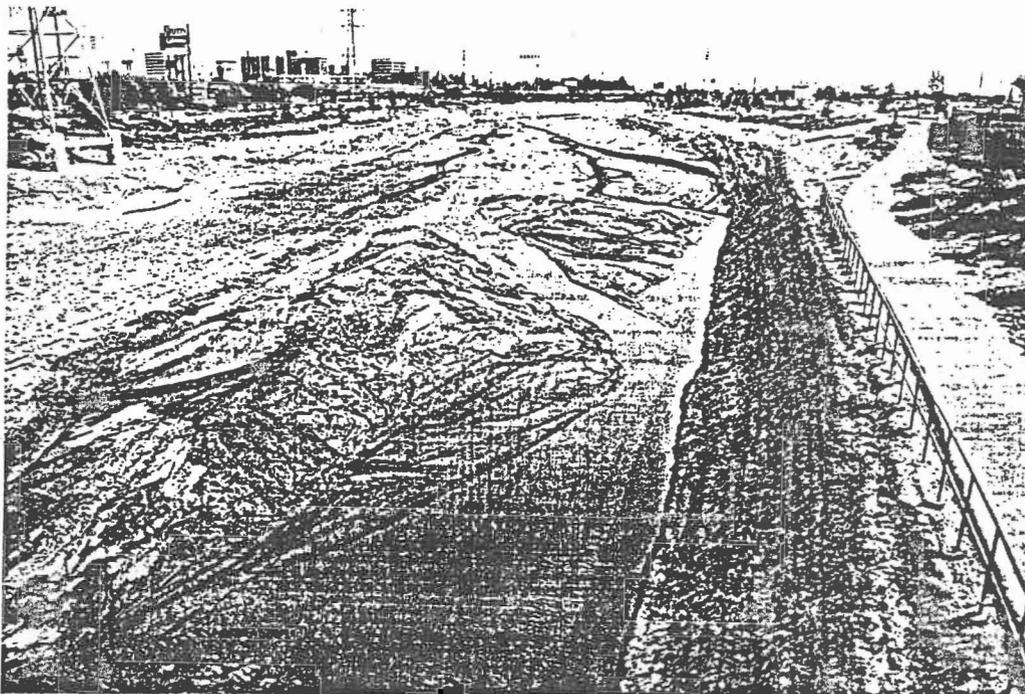
FIGURE 19B View from approximately the same position in late October 1983. Note incision at base of soil-cement slope and meandering thalweg of low-flow channel that developed during waning flow. Photograph by Peter Kresan.

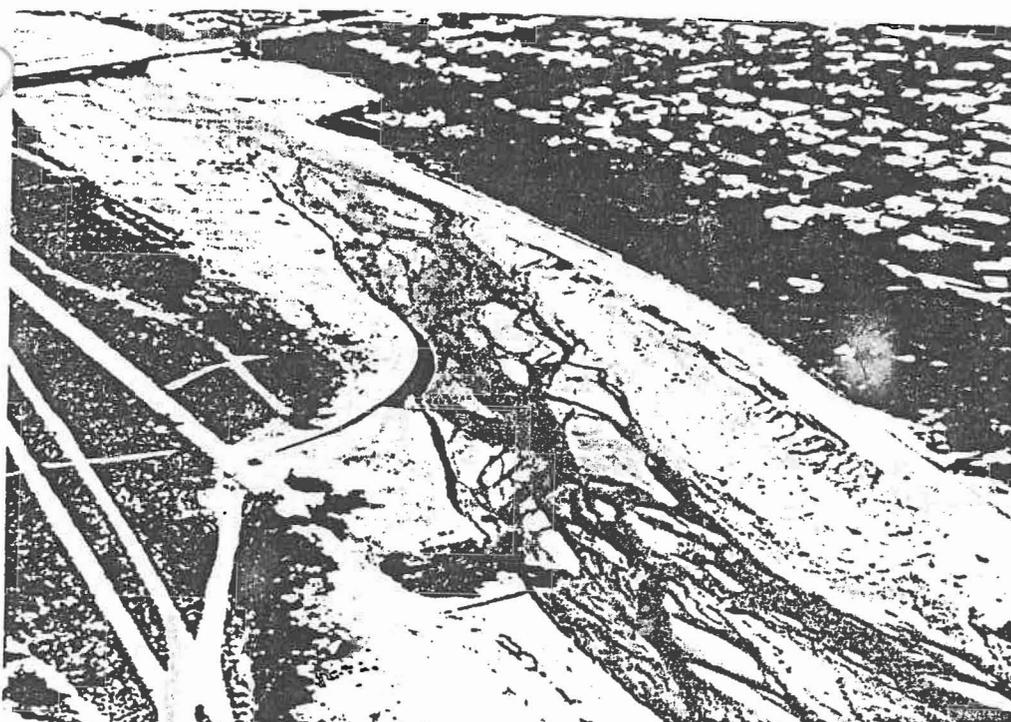
An example of a properly keyed revetment is the protection for the southeast abutment of the Sabino Canyon Road bridge over Tanque Verde Creek (Figure 32). The pronounced channel widening upstream of the revetment terminates abruptly at this key.

FIGURE 32 Soil-cement revetment works lining both banks of the Tanque Verde Creek immediately east of the Sabino Canyon Road bridge (top left) on October 8, 1983. Photograph by V. R. Baker.

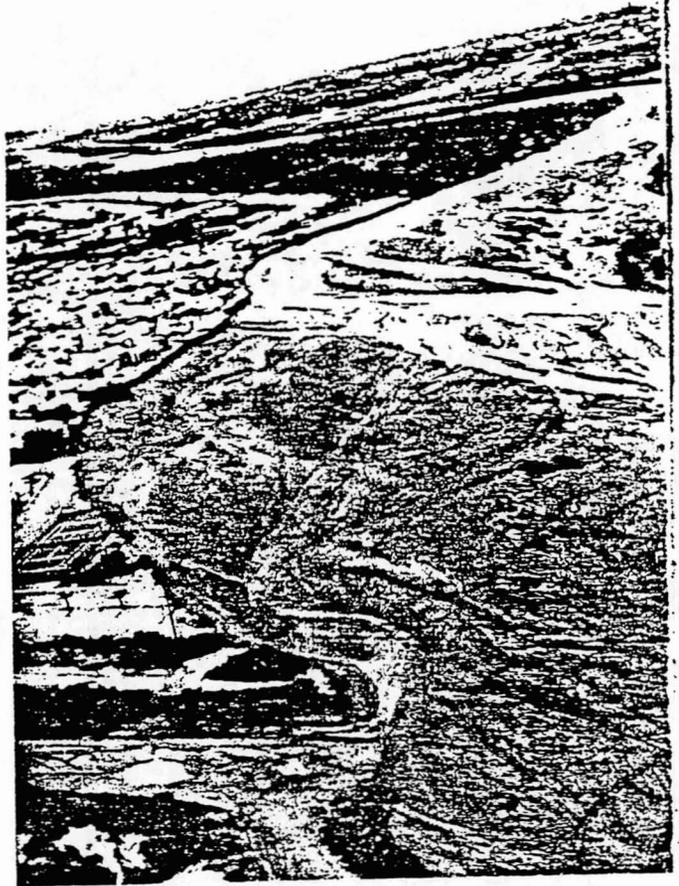
Channel bank erosion, Pantano Wash
Illustrating natural erosion pattern
along unprotected banks

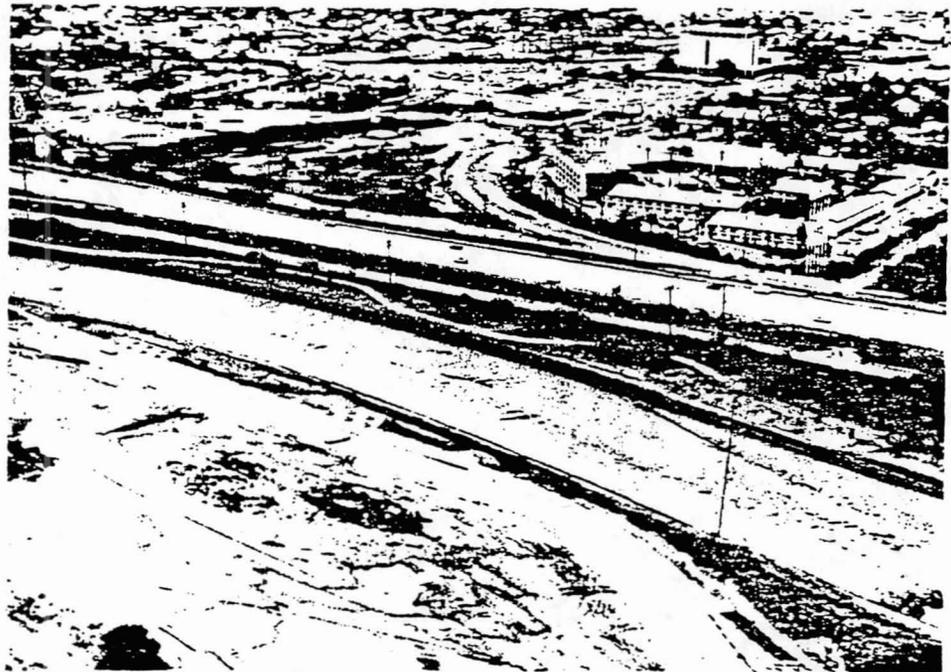
Non-contiguous soil cement bank protection, Pantano Wash
protection did not fail even though it was not continuous

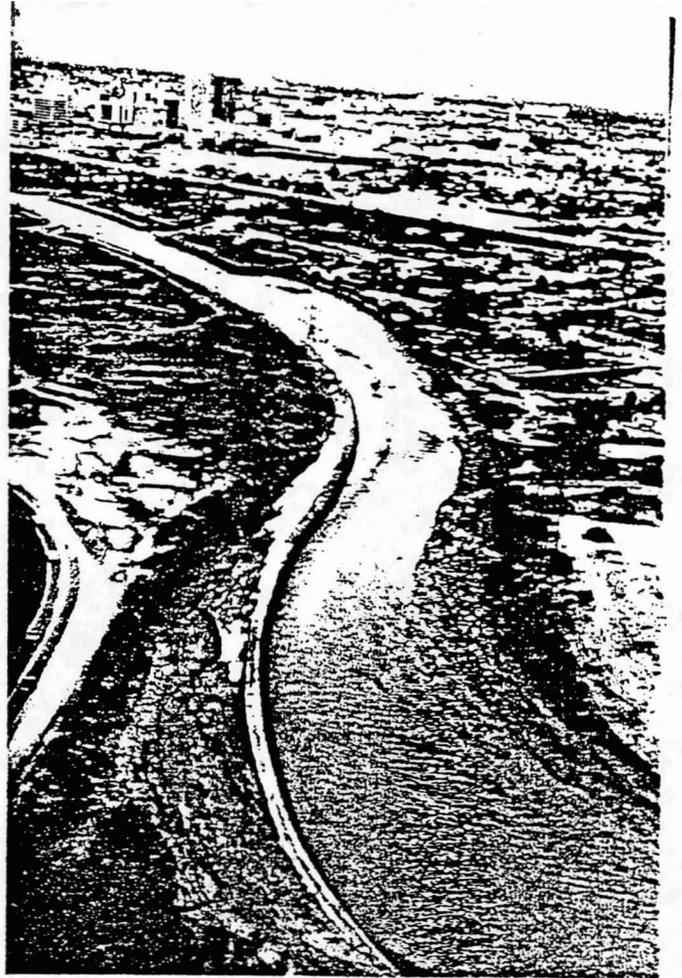
Overtopping of soil cement bank protection
Santa Cruz River at 22nd Street Landfill

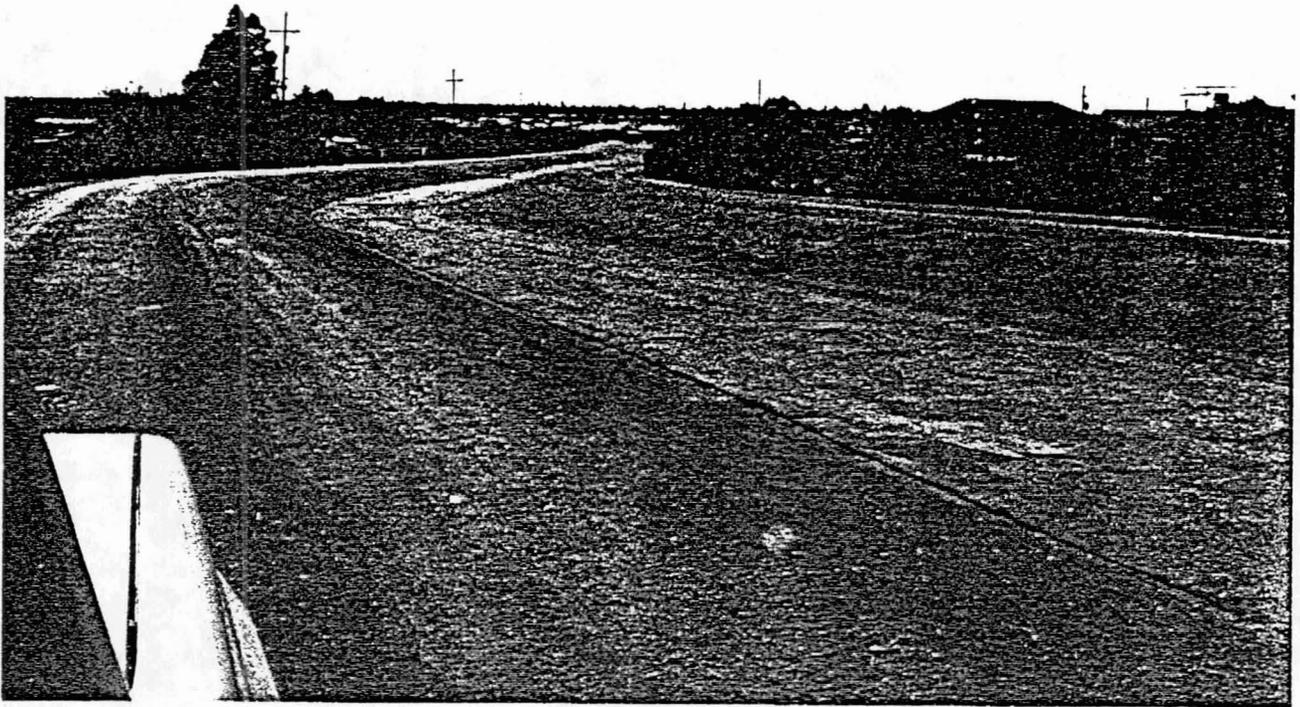
Channel bank erosion, Rillito River upstream of First Avenue

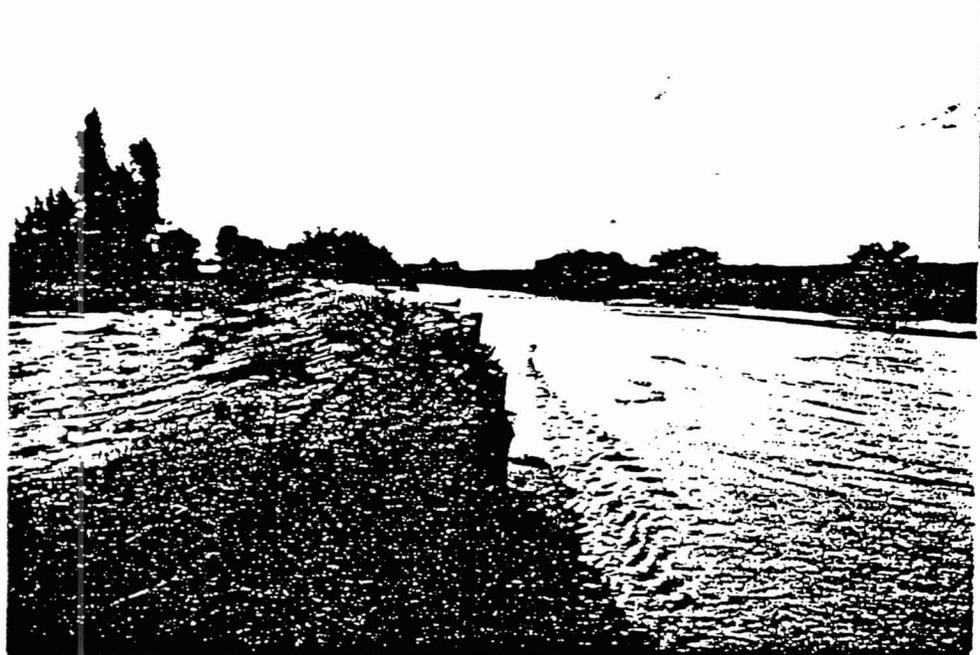
Erosion along original earthen levee at Oro Valley and Canada del Oro Wash, prior to improvements
