SADDLEBACK DIVERSION REPAIR DESIGN FILE

UNITED STATES DEPARTMENT OF AGRICULTURE
SOIL CONSERVATION SERVICE
ARIZONA STATE OFFICE
ENGINEERING STAFF
PHOENIX, ARIZONA
February 8, 1989

DESIGN REPORT

Job: Harquahala
Project: Saddleback Diversion Repair
Location: Maricopa County, Arizona
Authority: PL-566
Phase: Final Design

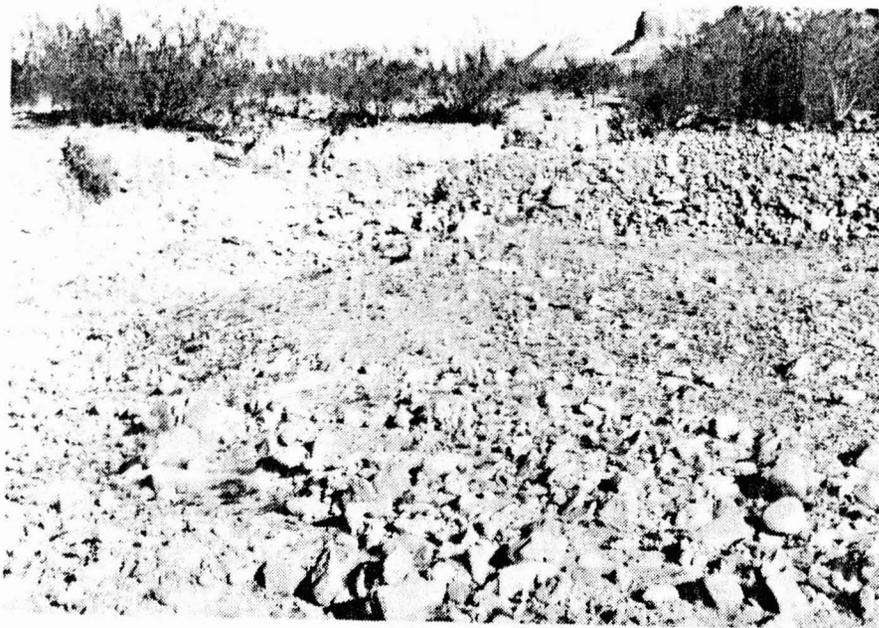
Photo No. 19

APPROXIMATE STATION 133+00
SEVERE EROSION FROM GULLYING

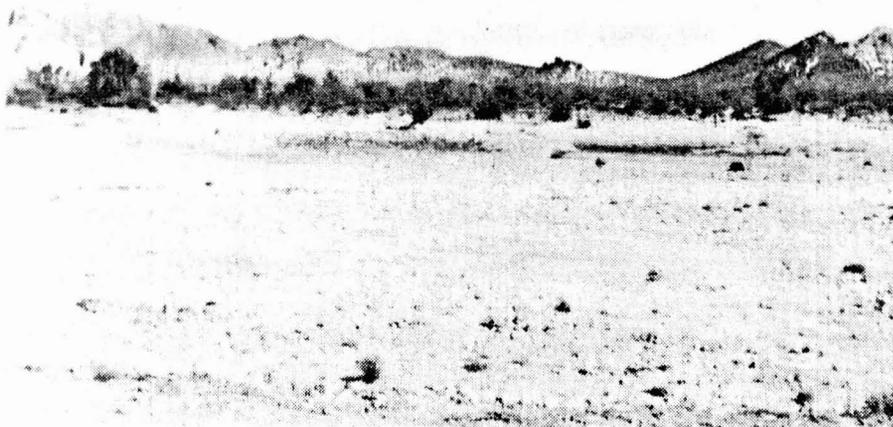
Photo No. 27

STATION 220+80 SIDE INLET #17
EROSION FROM OVERTOPPING ON
BOTH SIDES

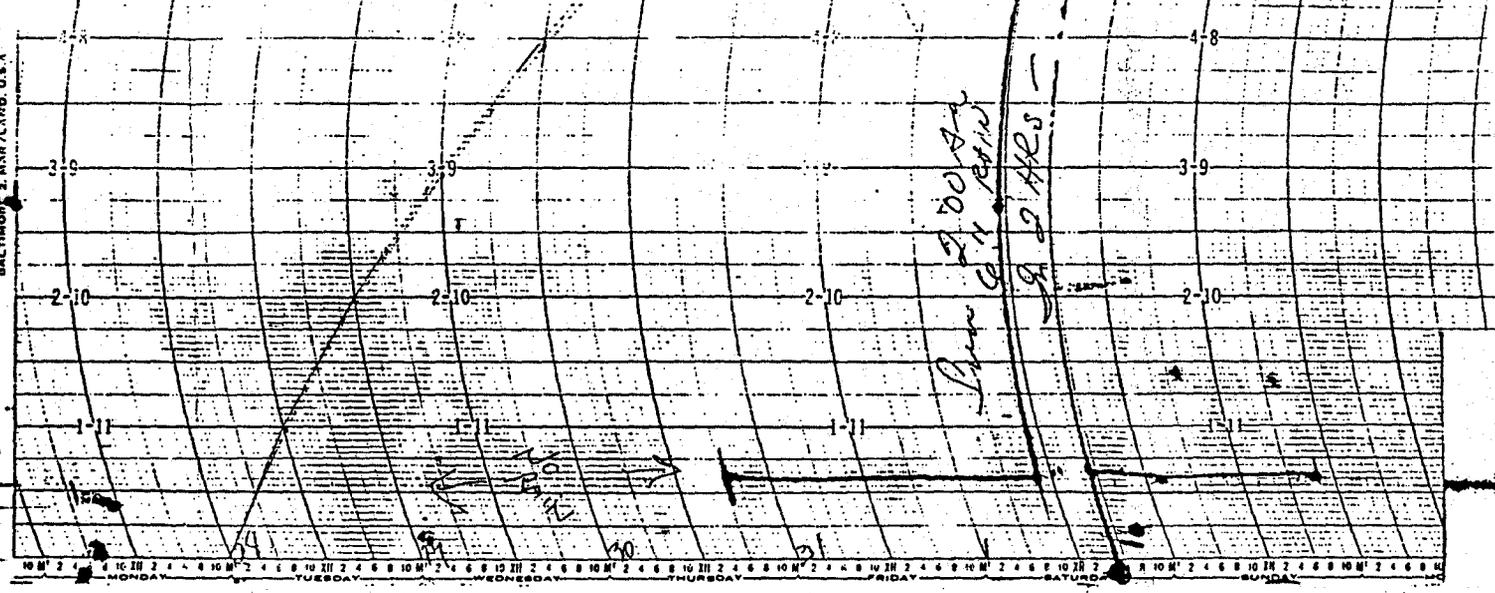
Figure 2

The storm distribution was taken from the recorder chart (Figure 2). The tabulated values were used because it was not possible to accurately read shorter time increments from the chart. It is probable that more intensive rainfall occurred during shorter time increments.
