PHASE I ENVIRONMENTAL
SITE ASSESSMENT

SOUTHEAST MESA AREA DRAINAGE
MASTER PLAN
MARICOPA COUNTY, ARIZONA

WT JOB NO. 2188JK014.01

April 15, 1998

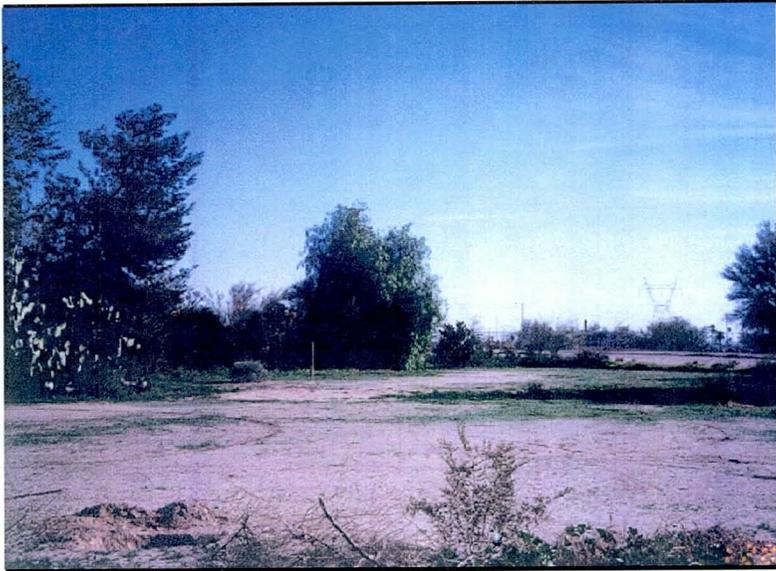
Picture No. 37

Northwest Corner of Basin 4 at Akron Street and Crismon Road Facing South

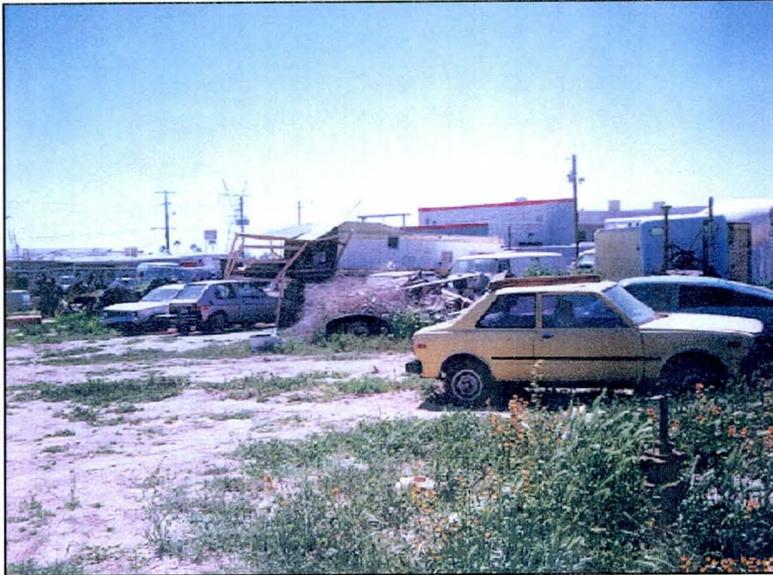
Picture No. 46

Basin 4 currently consists of residential and commercial uses and undeveloped vacant land (Appendix B, Pictures 28 through 39). The commercial businesses with portions of land within Basin 4 included ICU Rental, and the Tire Store. A few large dirt mounds of unknown origin were noted on the vacant land portion of this basin as well as a cement pad, an abandoned car, and a dilapidated road (Appendix B, Picture 40 through 42). The portion of land north of ICU Rental was used for cleaning of equipment and storage of cars, U-Haul trucks and trailers, automobile parts, machinery, batteries, tires, and an above ground storage tank. There were two sheds and a dumpster on this parcel (Appendix B, Pictures 43 through 45). The portion of land north of the Tire Store was used mostly for storage of tires and cars, and contained some areas of debris consisting of wood, metal, and vegetation (Appendix B, Picture 46). There is a groundwater well on the north end of the Tire Store lot (Appendix B, Picture 47).

Northeast Corner of Tire Store Lot
Facing West

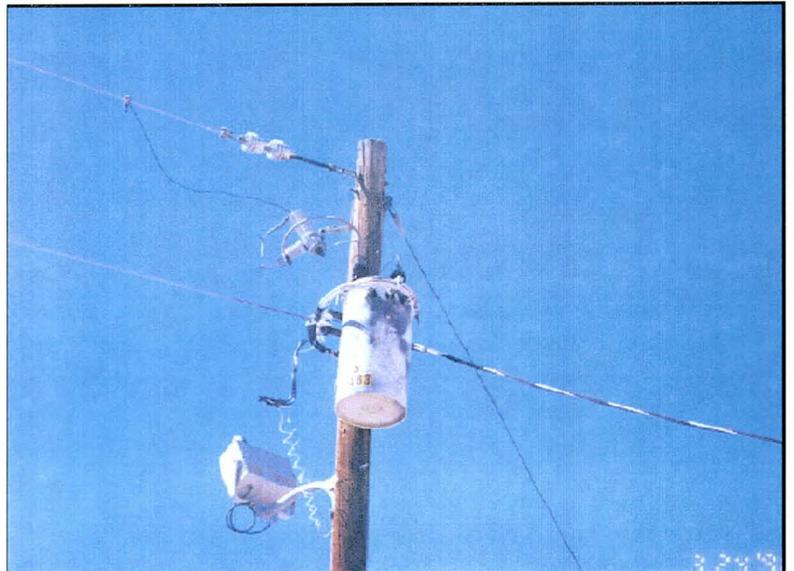
Picture No. 50

WT noted one transformer on Basin 2 and two transformers on Basin 4 (Appendix B, Pictures 48 through 50). These transformers were observed to be in good condition with no evidence of leakage.

Pole Mounted Transformer on ICU
Rental Lot on Basin 4

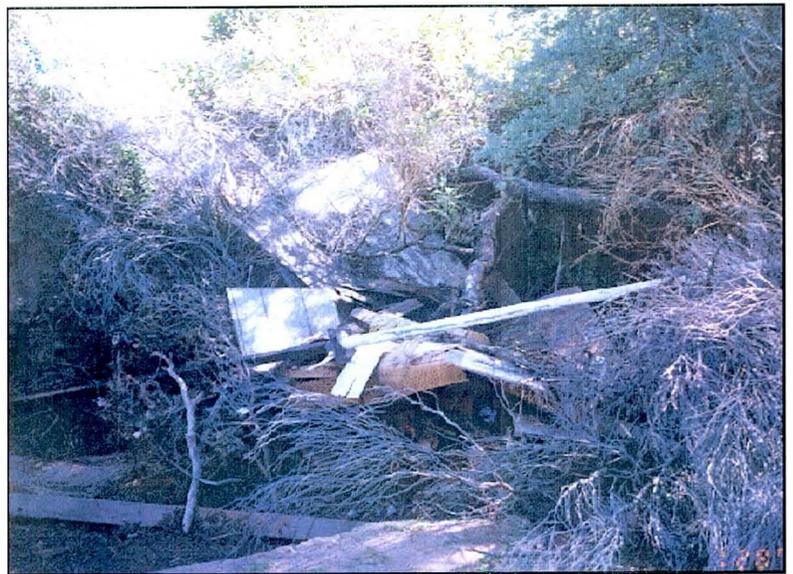
Picture No. 56

Several areas of construction, landscape and miscellaneous debris were observed on Basin 1 consisting of landscape trimmings, a television, foam, carpeting, paper waste, and cement pieces (Appendix B, Pictures 51 through 53). On Basin 2, WT observed the remains of a collapsed house near the south border and a few areas of general debris along the wash transversing Basin 2. The debris consisted of vegetation, wood scrap, foam, carpeting and lawn furniture (Appendix B, Picture 54 through 56). Basin 4 was observed with an area of construction debris on the vacant land near the southwest border of the Property, which consisted of broken concrete slabs and pipe sections, asphalt pavement and vegetation (Appendix B, Picture 57). Several areas of debris were also noted on the lot associated with the Tire Store consisting of scrap metal, scrap wood, vegetative debris, tires and old appliances (Appendix B, Pictures 58 through 60).

General Debris Consisting of Vegetation, Wood Scrap, Foam, Carpeting and Lawn Furniture Along the Southern Portion of the Main Wash Crossing Basin 2

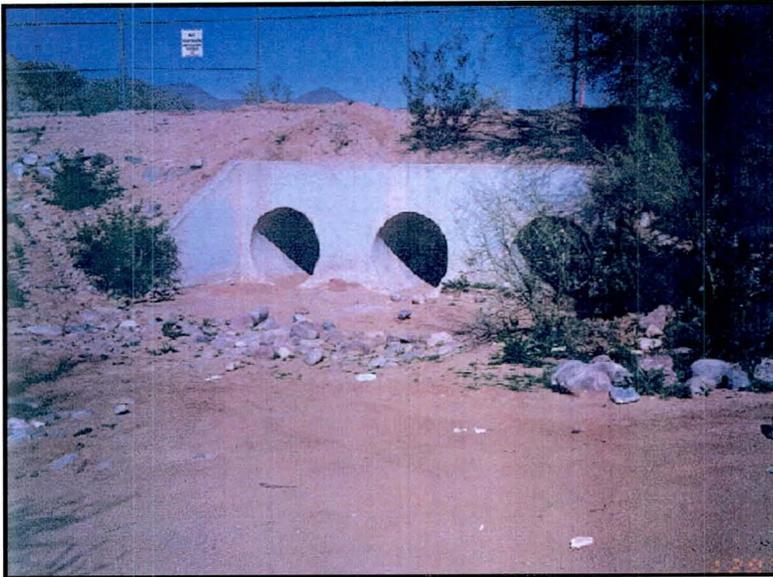
Picture No. 61
Overchute No.1 Near Northwest
Corner of Basin 1

Surface drainage on the Property is directed to a series of washes which generally transverse the four proposed basin locations from the northeast to the southwest (Appendix B, Pictures 61 through 66). In Basins 1, 2, and 3, there is a main wash which originates at a drainage overchute across the CAP canal aqueduct. Smaller tributary washes enter these main channels. Storm water flows onto the Property from the northeastern side of the CAP canal through the overchutes. At Basin 4, there are two main washes which transverse the northern and southern portions of the basin. These

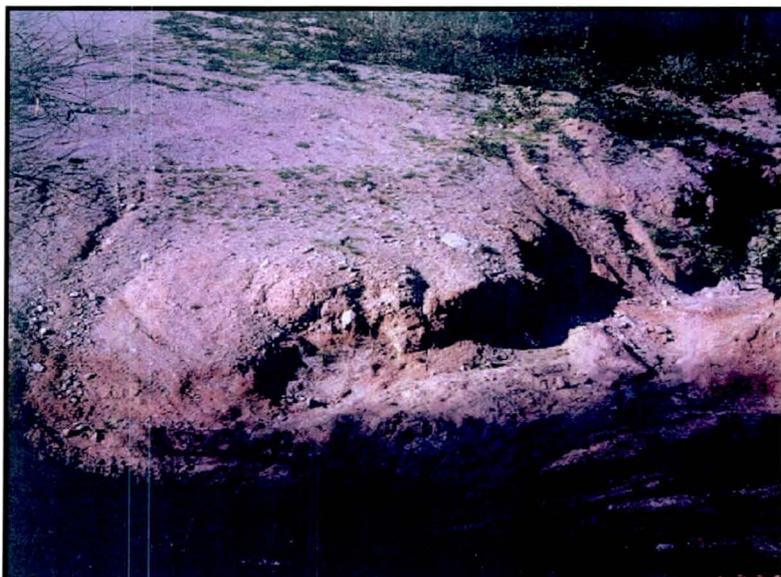
Picture No. 66

Tributary Drainage Into the Northern
Wash Across Basin 4
